CONTENTS

INCIDENT

Aircraft Type and Registration:	DHC-8-402 Dash 8, G-JEDR
No & Type of Engines:	2 Pratt & Whitney Canada PW150A turboprop engines
Year of Manufacture:	2003
Date & Time (UTC):	3 March 2011 at 1255 hrs
Location:	Exeter Airport
Type of Flight:	Commercial Air Transport (Passenger)
Persons on Board:	Crew - 4 Passengers - 39
Injuries:	Crew - None Passengers - None
Nature of Damage:	Right main landing gear inboard wheel detached
Commander's Licence:	Airline Transport Pilot's Licence
Commander's Age:	58 years
Commander's Flying Experience:	6,778 hours (of which 3,417 were on type) Last 90 days - 103 hours Last 28 days - 24 hours
Information Source:	AAIB Field Investigation

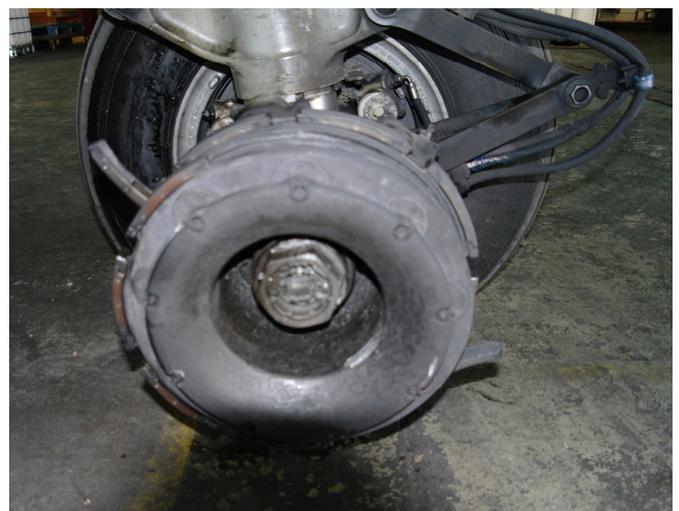
Figure 1
Wheel axle as found

The detached main wheel and bearing debris found on the runway were recovered for AAIB inspection. Initial examination of the aircraft revealed that the wheel nut was still in position on the axle with its locking devices correctly installed. The brake unit was loose on the axle and had sustained damage to the heat pack, Figure 1. The wheel nut and brake unit were then removed from the axle along with the remains of the failed wheel bearings. The axle had light scoring to its bearing surfaces and there was minor flailing damage to components close to the brake unit.

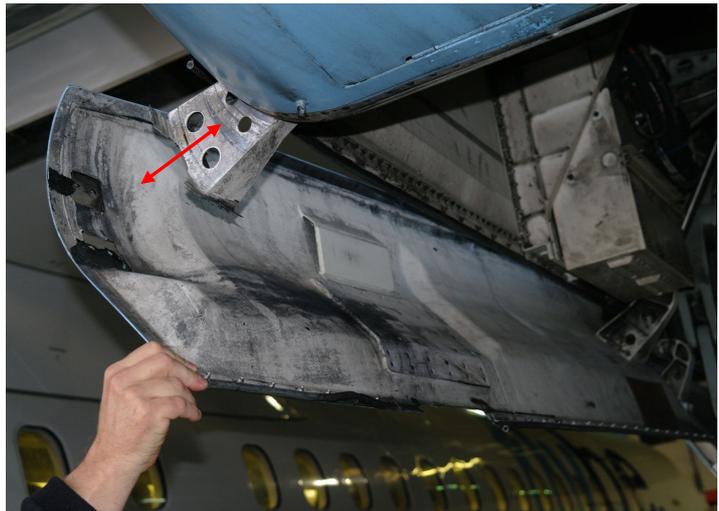
Figure 2

The right main landing gear inboard door showed evidence of contact with the rotating wheel assembly and its rear hinge attachment had been torn away from the door. The door remained attached to the aircraft by the other hinge and operating linkage, Figure 2. The nacelle above the door was slightly damaged by the door.

Inboard main gear door showing detached hinge

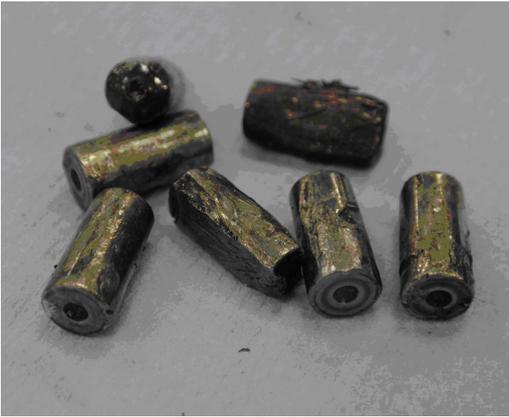
Figure 5

Recovered bearing rollers showing signs of mechanical rather than heat damage

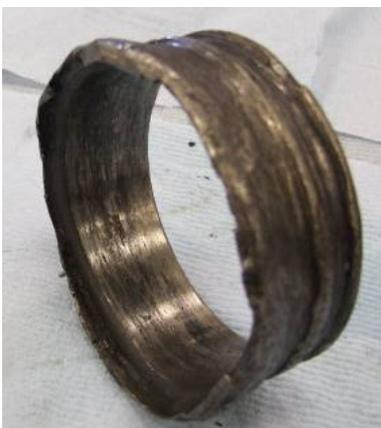
Figure 6

Both inboard and outboard bearings had suffered significant damage. The outboard bearing (closest to the wheel nut) showed that it had failed first and its cone thrust rib had been pushed flat by the forces of the failure, Figure 6, allowing the wheel to detach. The outboard bearing appeared to have suffered a cage trapping episode, where the cage became trapped between the rotating cup and the rollers, instantaneously locking the bearing and causing catastrophic failure. The inboard bearing suffered consequential, low temperature damage as the spinning wheel became unsupported by the severely damaged outboard bearing.

Outer bearing cone, showing deformed thrust rib

It is most likely that the outer wheel bearing suffered a trapped cage which caused it to fail catastrophically. Consequential damage deformed the outer bearing cone, allowing the inboard wheel of the right main landing gear to detach from its axle during landing gear retraction. It was not possible to determine the cause of the trapped cage.

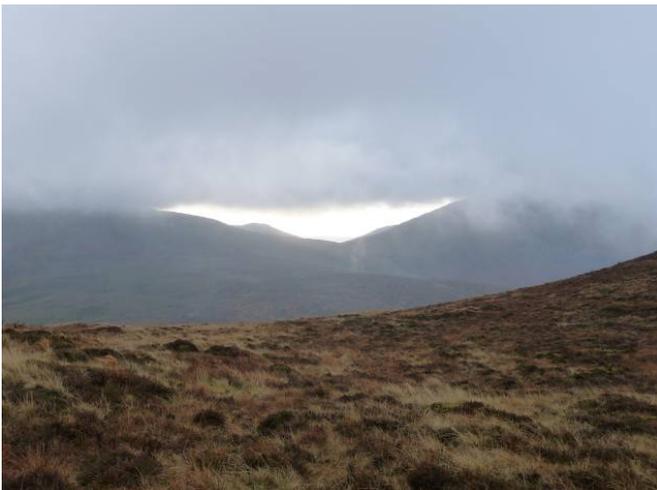
Figure 1

summits of Rocky Mountain and Hen Mountain. On his arrival on the summit of Cock Mountain, the cloud had moved in quite quickly. He took a series of photographs at 1138 hrs, two of which are shown at Figures 1 and 2.

From the photographs, the cloudbase at that time was later estimated at 1,600 ft to 1,700 ft. As he continued, the cloudbase descended, with visibility in the cloud reduced to approximately 150 metres. He descended from Slievemoughanmore into the saddle of Windy Gap (elevation 1,377 ft) and could not recall being clear of the cloud at that height. He arrived at the summit of Shanlieve with the visibility still about 150 metres and at about 1415 hrs he descended towards Pierces Castle. He was approximately 300 metres north of Pierces Castle when he heard a helicopter pass overhead, followed by the sound of an impact. He did not see the helicopter but notified the police using his mobile telephone and commenced a search. He met up with the three other walkers, who had been on Castle Bog and had also heard the helicopter pass overhead. They eventually located the accident site in the cloud.

View from Cock Mountain, looking southeast towards the coast at 1138 hrs

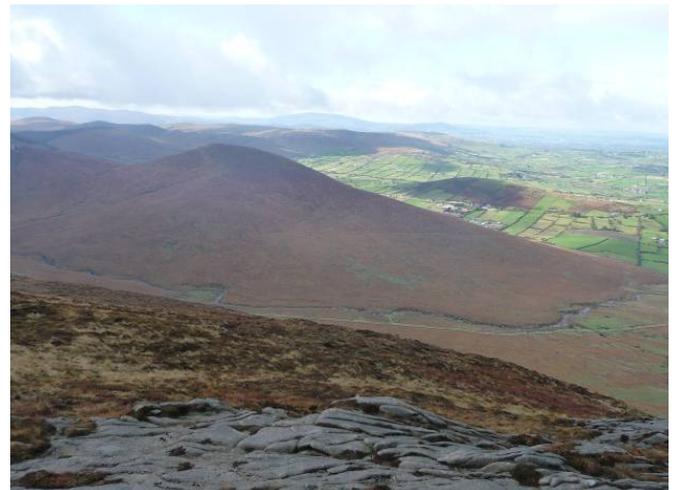
Figure 2

View from Cock Mountain at 1138 hrs, looking west towards the direction from which N2NR approached at about 1445 hrs

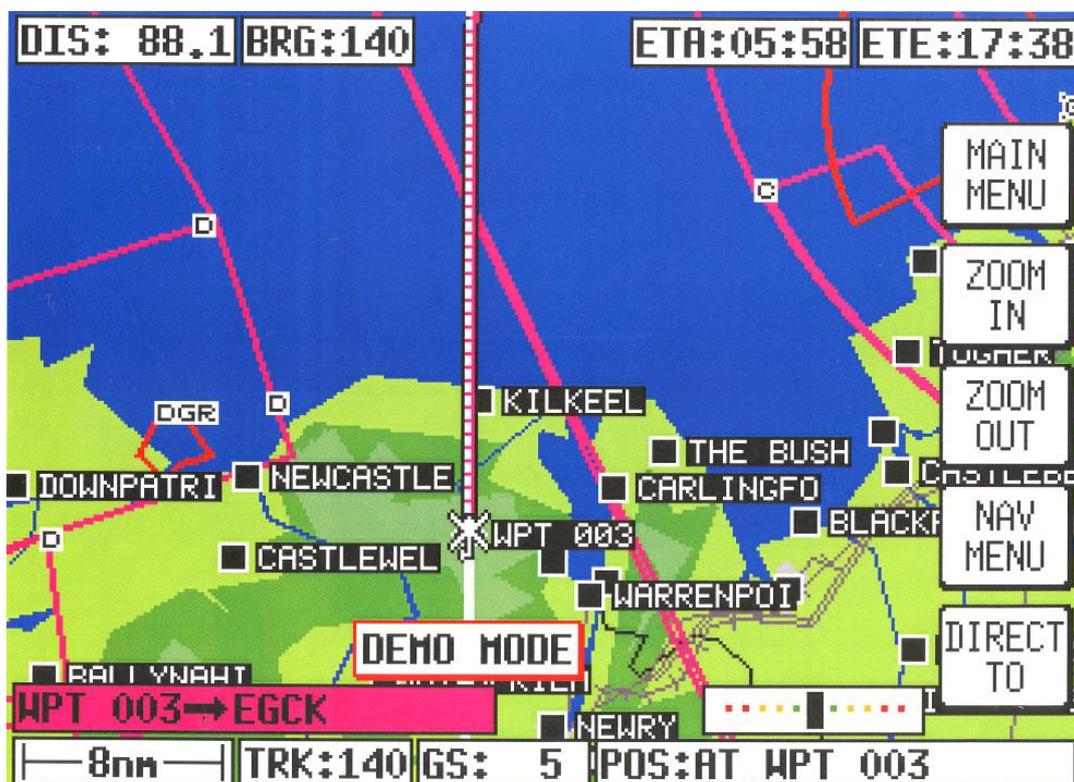
Figure 9

Skymap IIIC screen print on 8 nm range, showing no terrain above 2,000 ft, immediately prior to the impact with Shanlieve

Spot heights were not displayed on the Skymap and the green colour coding would not have indicated that there was ground above 2,000 ft. If the spot heights on the projected track of the helicopter were not noted, and the Skymap were used for navigation, then with the upper slopes and Castle Bog obscured it could have been possible for the pilot to believe that he had overflown the high ground.

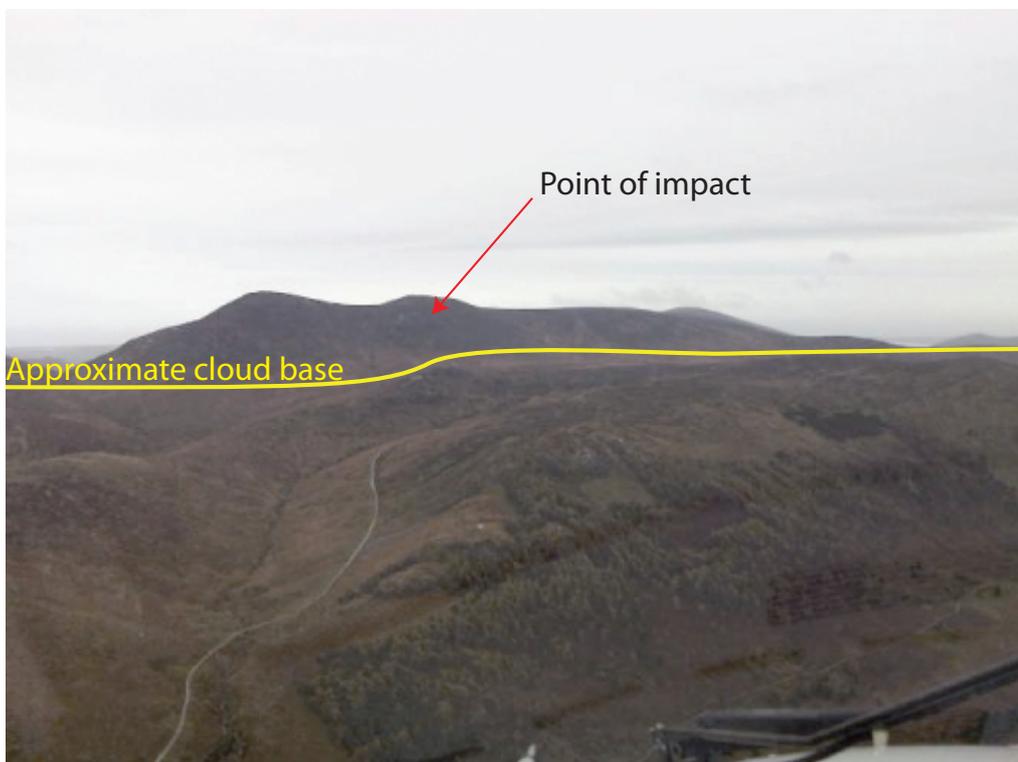
Figure 12

The hill walker witnesses were in cloud and it is not known how extensive the cloud cover was or whether any of the upper slopes or ridge were visible to the pilot; there may have been layers of cloud producing a false impression of the upper limits of the terrain. Whilst the terrain was clearly visible during the flight trial, if the upper slopes were obscured by cloud and the height of the terrain was known, it would have been apparent that it would not be possible to continue on the final

The Shanlieve ridge, showing the point of impact and the approximate cloudbase described by the witnesses

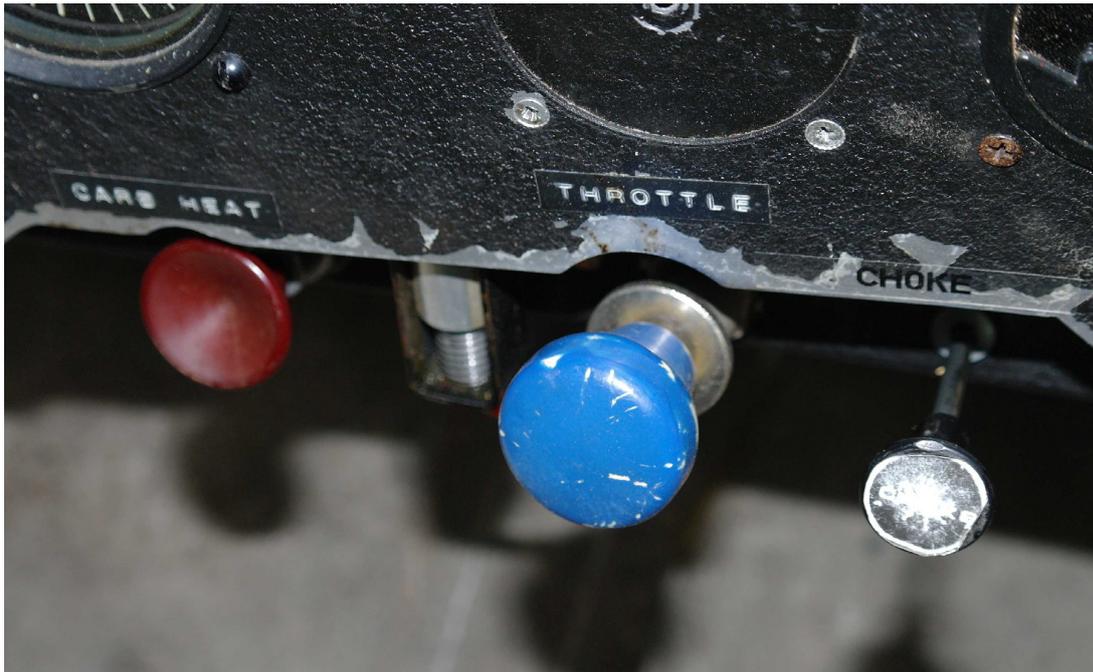
Figure 1

Detail of engine controls in cockpit shown in the 'as found' position

It was noted that although the carburettor heat control and the choke control knobs were of slightly different diameters they were very similar in shape and different in colour, see Figure 1. The carburettor heat control had a long travel and a feature that allowed it to be locked by twisting its knob through 90 degrees. The choke control had a much shorter travel and could not be locked out. The pilot reported after the accident that he had used the carburettor heat control several times during the flight. He commented that the quarter turn locking out mechanism had not always worked.

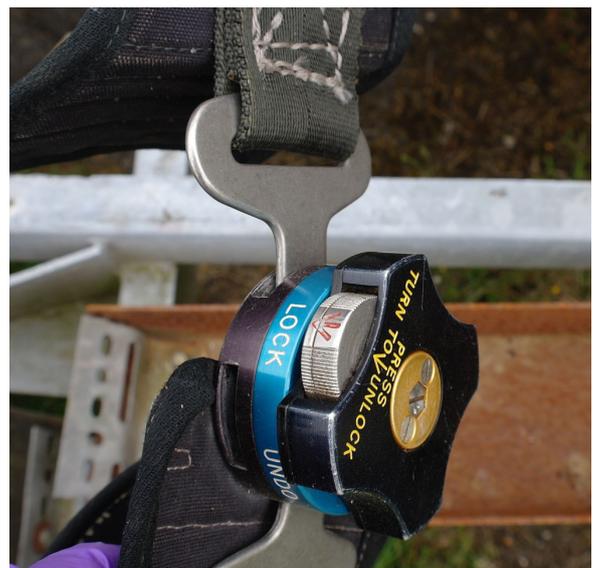
Figure 3

The lap straps of the pilot's harness had pulled away from their mounts and both sides of the lap strap were attached to the buckle. The removable part of the lap strap was attached to one of the buckle slots meant for the shoulder harness, see Figure 3. The pilot's shoulder straps and their mounting point were undamaged and were found separate from the lap strap and buckle.

Close up of pilot's harness lap strap and buckle

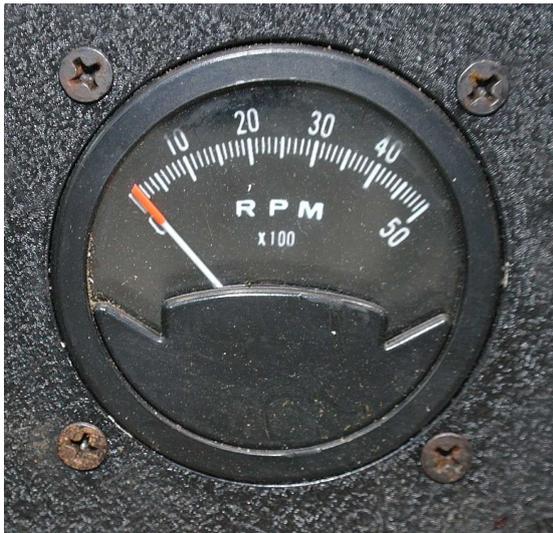
Figure 4
Rpm gauge

The engine rpm gauge was two inches in diameter and had a small scale which covered an arc of approximately 90° of which approximately 45° covered the normal operating range of 800 to 3300 rpm, see Figure 4.

The rpm gauge had only a small scale making it more difficult to determine any rpm drop during either magneto or carburettor heat checks. Discussions with other pilots who had flown the aircraft revealed that it needed frequent applications of carburettor heat and that the rpm drop, when it was selected during the pre-takeoff checks, was more noticeable aurally than on the rpm gauge. A larger scale may have given a clearer indication of the effect of using carburettor heat.

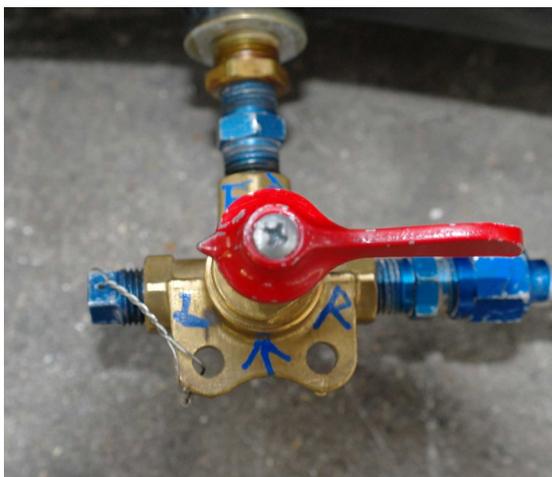
Figure 5
Fuel selector in OFF position

The fuel selector and its placard made it difficult to confirm which tank had actually been selected and the pilot had discussed the fuel selector indication at length with another pilot prior to his departure. The placard is also misleading in that there is only one detented position for the front tank and one for the rear tank and not an arc of 90° as indicated.
