CONTENTS

SERIOUS INCIDENT

Aircraft Type and Registration:	Airbus A319-131, G-EUPZ	
No & Type of Engines:	2 International Aero Engine V2522-A5 turbofan engines	
Year of Manufacture:	2001	
Date & Time (UTC):	15 March 2009 at 1935 hrs	
Location:	London Heathrow Airport	
Type of Flight:	Commercial Air Transport (Passenger)	
Persons on Board:	Crew - 6	Passengers - 87
Injuries:	Crew - None	Passengers - None
Nature of Damage:	Damage due to overheat in the area behind flight deck panel 123VU	
Commander's Licence:	Airline Transport Pilot's Licence	
Commander's Age:	34 years	
Commander's Flying Experience:	6,929 hours (of which 77 were on type) Last 90 days - 116 hours Last 28 days - 39 hours	
Information Source:	AAIB Field Investigation

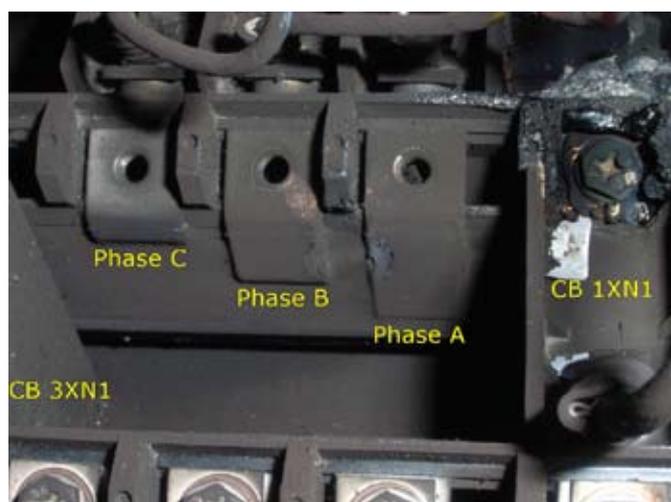
Figure 7

There was evidence of damage from arcing and some fibrous deposits between phases on some of the AC Bus 1 exposed connections (Figure 7).

Exposed AC Bus 1 connections

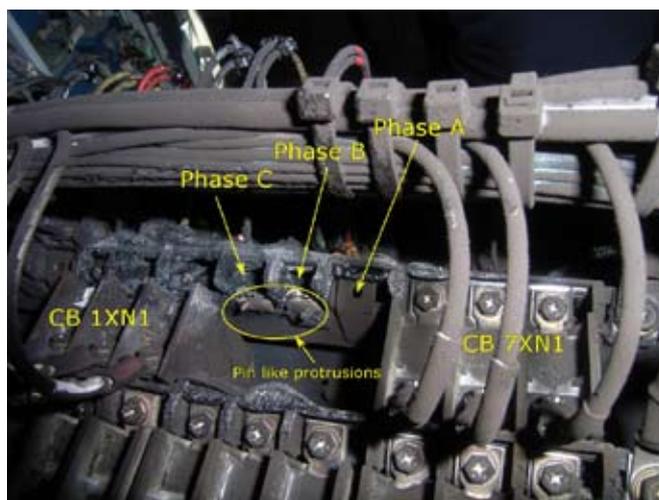
Figure 8

Two exposed terminals on AC Bus 1 had melted and there were ‘pin-like’ protrusions, which were products of the molten copper (Figure 8). A visual inspection of the unaffected wiring found it to be in a good condition and tests of the wiring did not show signs of degradation that could have caused the electrical faults or the fire. The remaining terminals and connections were found to be correctly installed and the examination did not reveal

Exposed AC Bus 1 connections – pin-like protrusion

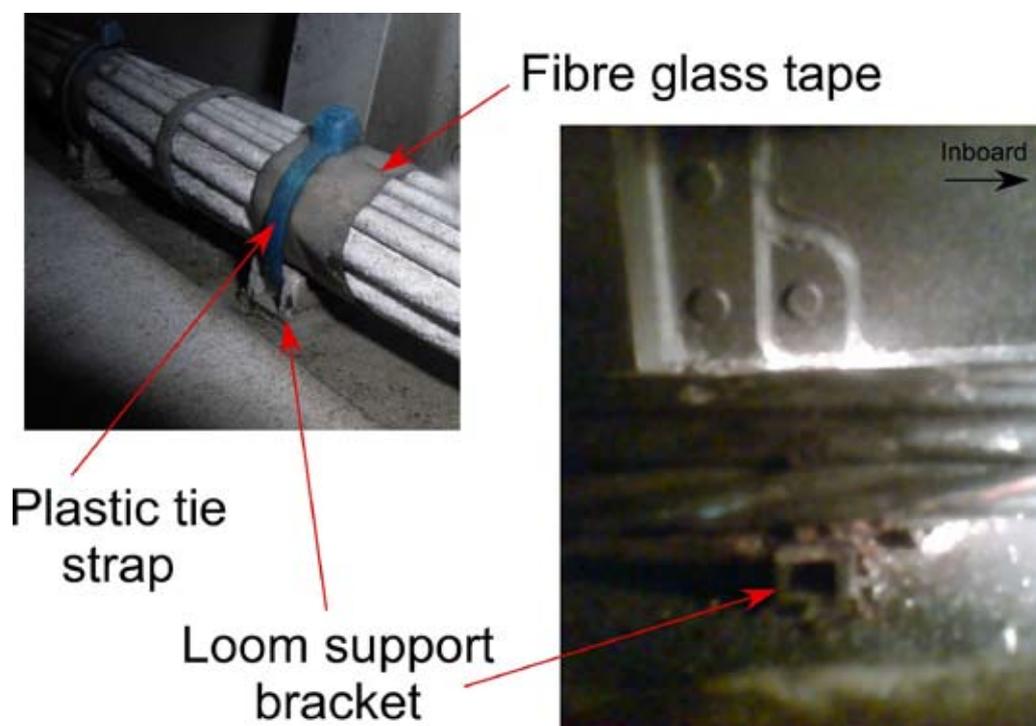
Figure 2

the loom and the plastic support bracket had melted (Figure 2).

Loom support bracket

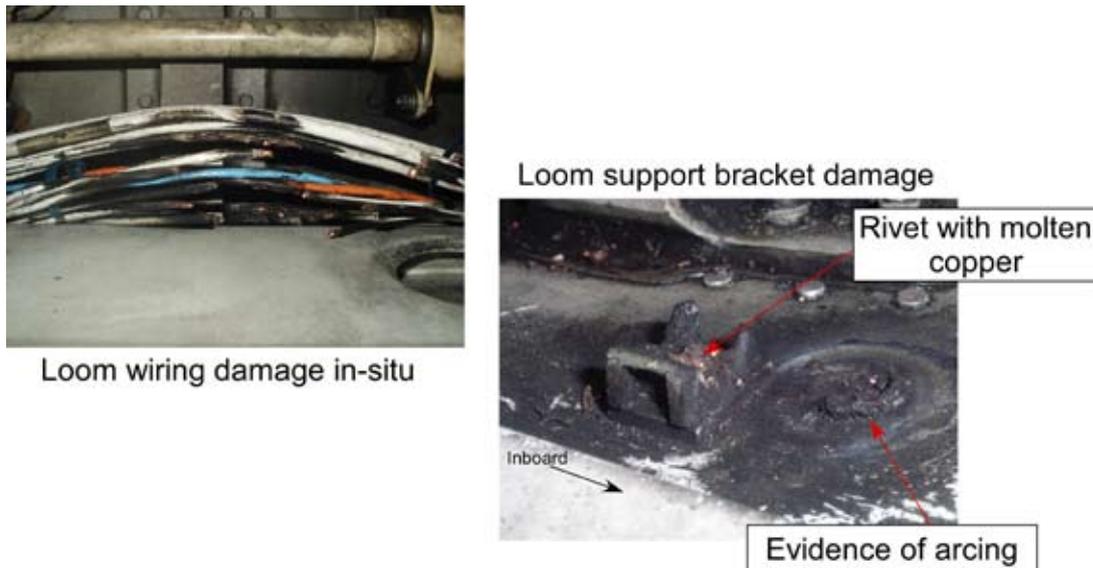
Figure 3

There was evidence of arcing between the wires within the loom, as well as between the wiring and the aircraft structure close to the loom support bracket. Arcing had also taken place between the wiring and the head of the cadmium-plated blind rivet that attached the loom support bracket to the structure (Figure 3).

Wiring damage and evidence of arcing

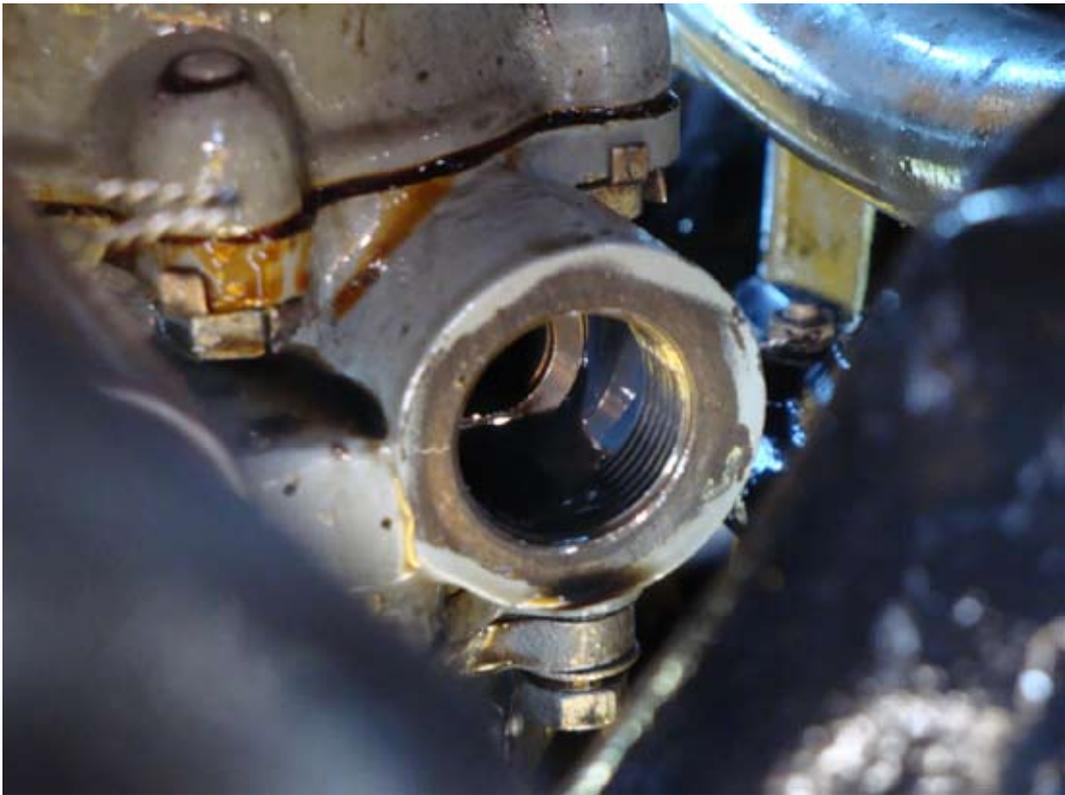
Figure 1

On examining the engine, the pilot identified that the oil pressure adjustment valve was missing from the oil scavenge pump housing (Figure 1). It was found in the

lower cowling with no evidence of the expected wire locking. He believed that the valve had worked loose and fallen out during the accident flight, causing the oil loss. The aircraft had recently undergone extensive maintenance which included an overhaul of the oil scavenge pump assembly. Initial flights following this work revealed a small oil leak in the area of the pump, which at the time, was thought to be have been remedied by an engineer tightening the small vertical bolts adjacent to the pressure adjustment valve.

Photograph of oil scavenge pump showing missing oil pressure adjustment valve
