List of recent aircraft accident reports issued by the AAIB 42
(ALL TIMES IN THIS BULLETIN ARE UTC)

ACCIDENT

Aircraft Type and Registration:	Brandli Cherry BX-2, G-BXUX	
No & Type of Engines:	1 Continental Motors Corp C90-12F piston engine	
Year of Manufacture:	1999	
Date & Time (UTC):	21 July 2008 at 1940 hrs	
Location:	Clipgate Farm Airstrip, Canterbury, Kent	
Type of Flight:	Private	
Persons on Board:	Crew - 1	Passengers - 1
Injuries:	Crew - None	Passengers - None
Nature of Damage:	Damage to the landing gear and associated mechanism, propeller and engine shock-loaded	
Commander's Licence:	Private Pilot's Licence	
Commander's Age:	61 years	
Commander's Flying Experience:	429 hours (of which 322 were on type) Last 90 days - 5 hours Last 28 days - 2 hours	
Information Source:	Aircraft Accident Report Form submitted by the pilot and AAIB examination of the aircraft

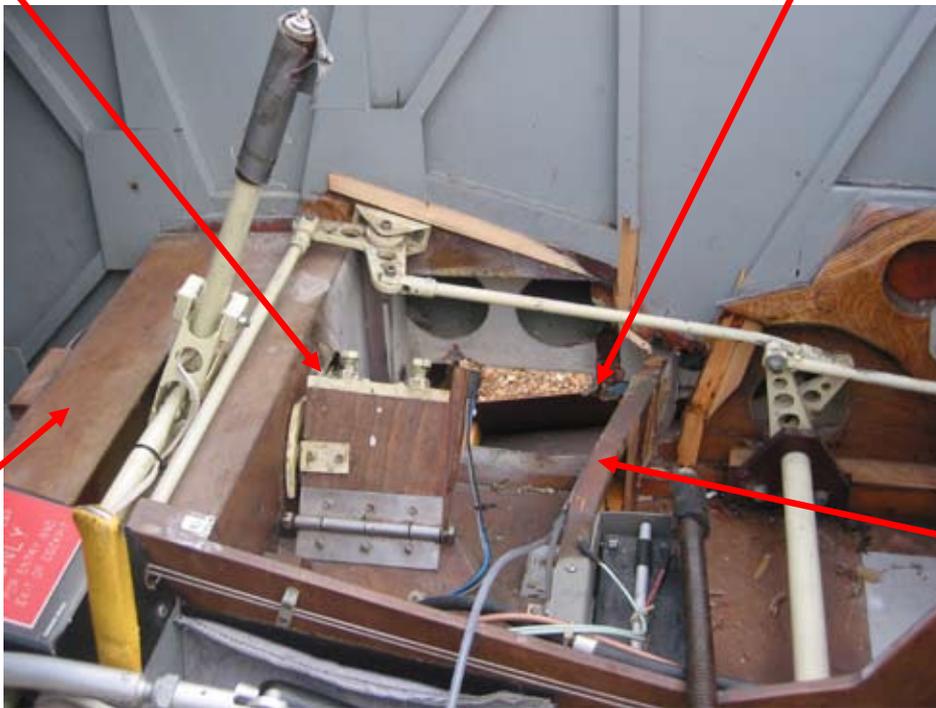
Figure 1

It was apparent that some structural damage had occurred in the region of the right landing gear pivot, in that the rear pivot bearing, located in the end of the fuselage crossbeam, had moved in a rearwards

direction. This movement of the bearing was associated with a failure of the crossbeam. It was difficult to differentiate between the damage arising during the takeoff event and that which occurred on landing. However, the fact that the leg was observed to be trailing when the aircraft was airborne suggests that the rear pivot bearing was no longer properly located which, in turn, means that the cross-beam had failed by this time.

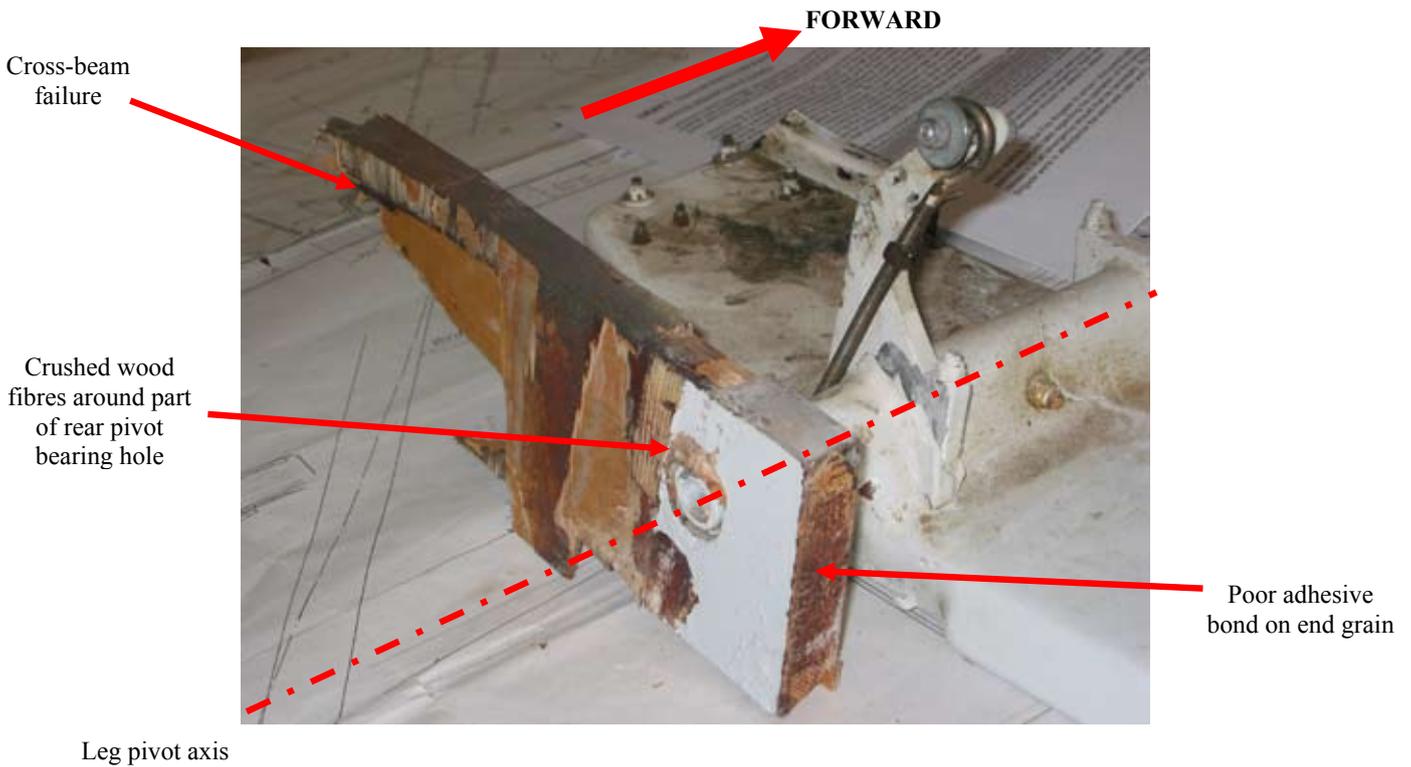
Figure 2 shows a partial reconstruction of the failed section of the crossbeam, with the rear pivot of the leg located in a wooden block at the outboard portion of the beam. It is apparent that the wood fibres around part of the circumference of the rear face of the locating

hole have been crushed by the bearing bush, to the extent that they are standing proud of the surface. This damage is consistent with the leg moving in a rearward and upward direction. It is likely that the crossbeam would need to be secure and in position in order to react the forces generated by the leg in damaging the bearing hole. If so, it follows that at least some of the damage to the hole preceded the beam failure. It should be noted that the crossbeam consisted not of a single plank of timber, but was in fact built up using square-section Sitka spruce strips, top and bottom, with facings made from ply. This was typical of the lightweight construction methods used throughout the aircraft.

Partial reconstruction of failed fuselage crossbeam and right main leg

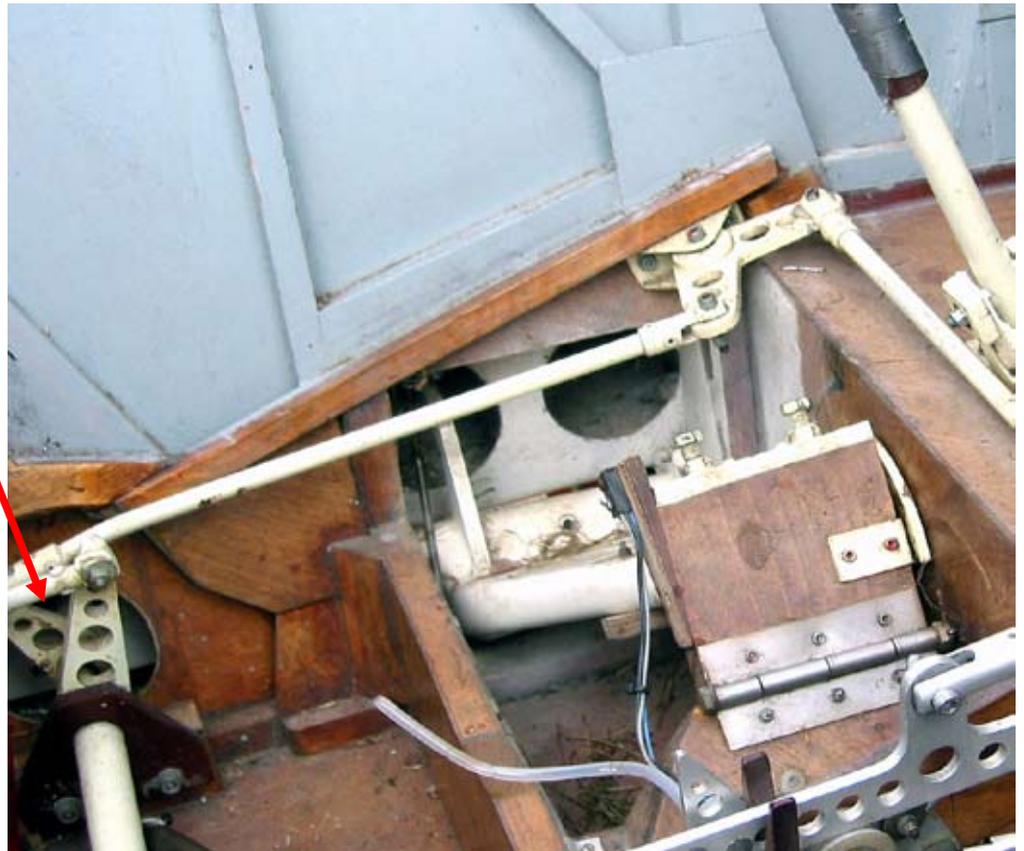
Figure 3

End of beam built into cockpit sidewall using triangular-section fillet strip

View of left side of cockpit, showing how the intact end of the cross-beam is built into the sidewall

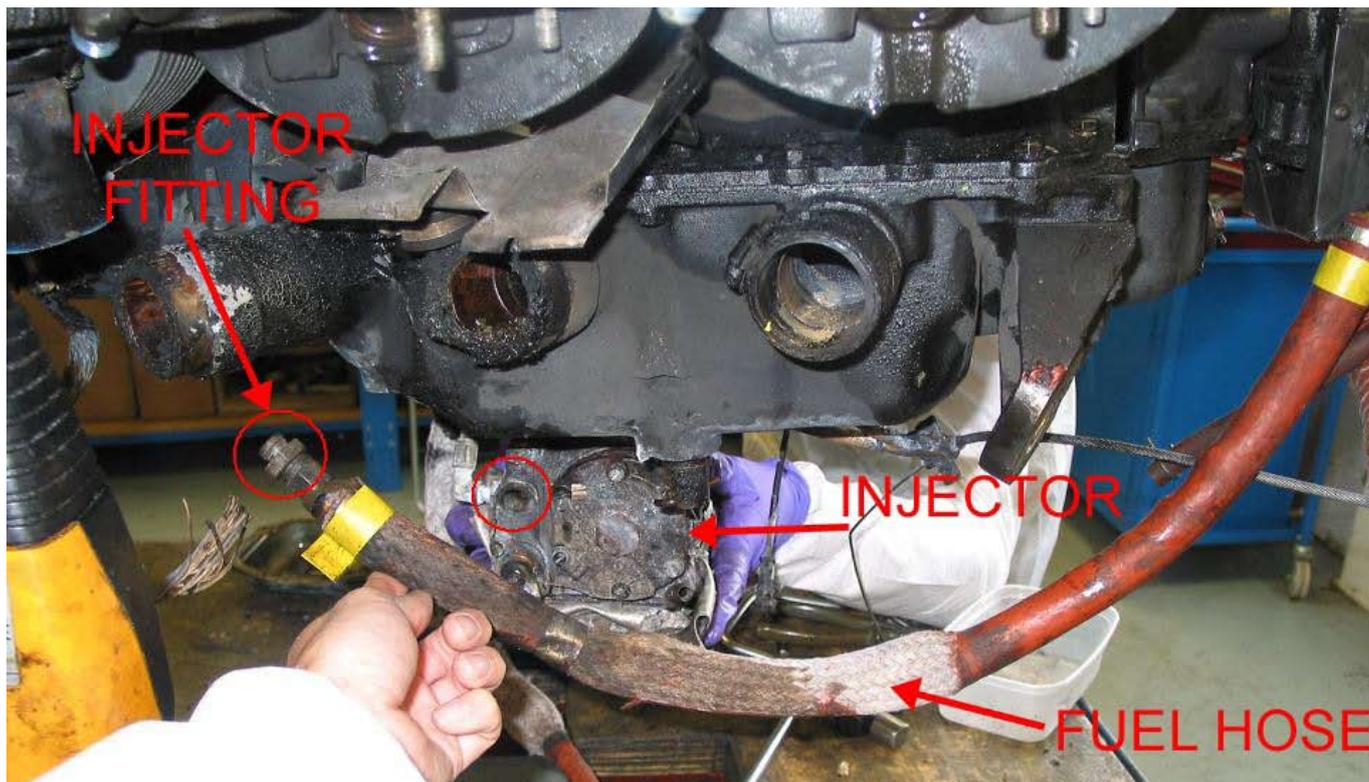
Figure 3

The fuel hose between the engine-driven fuel pump and the fuel injector had separated from the fuel injector (Figure 3). This was not one of the hoses that was replaced during the previous annual inspection. The fuel injector had also separated from the oil sump. The injector fitting (circled) is part of the injector body and connects to a threaded hole (also circled). Four threads from this hole had been stripped and one of the stripped threads was wrapped around the separated injector fitting (Figure 4).

Fuel hose between the engine-driven fuel pump and the fuel injector.
It had separated from the injector at the injector fitting

The fuel hoses were examined for leaks. The fuel hose between the engine-driven fuel pump and injector had a leak in the area where the hose had suffered fire damage. The inner lining exhibited clear evidence of heat damage. The fuel hose between the injector and fuel flow manifold did not leak at its rated pressure. The fuel hose from the firewall to the engine-driven fuel pump had a leak, again in a region where the inner lining had suffered heat damage from the fire.

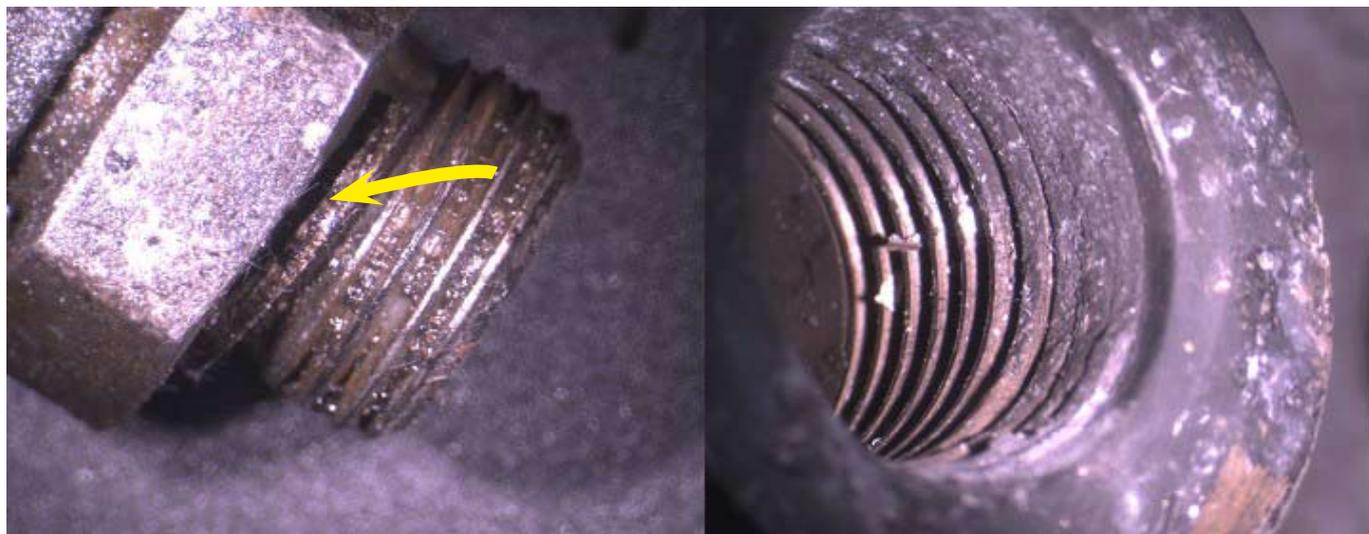
Figure 4

The injector fitting was confirmed to be of the correct type, with the correct number of threads. The silicone seal was missing, but could have been consumed by the post-impact fire. The fitting and injector body were examined by a metallurgist. Microscopic examination did not identify any material deficiencies. It was not possible to establish whether the fitting had been cross-threaded, nor was it possible to establish if the fitting had been tight when the separation occurred. The AAIB investigated a more recent accident to a Piper aircraft with a similar injector and injector fitting. In this accident, which did not involve suspicion of an engine problem, the injector fitting had pulled out and stripped the threads in a similar manner, probably due to impact forces.

Left: close-up of injector fitting with separated thread (arrowed).
Right: close-up of threaded hole on the injector body showing the stripped threads

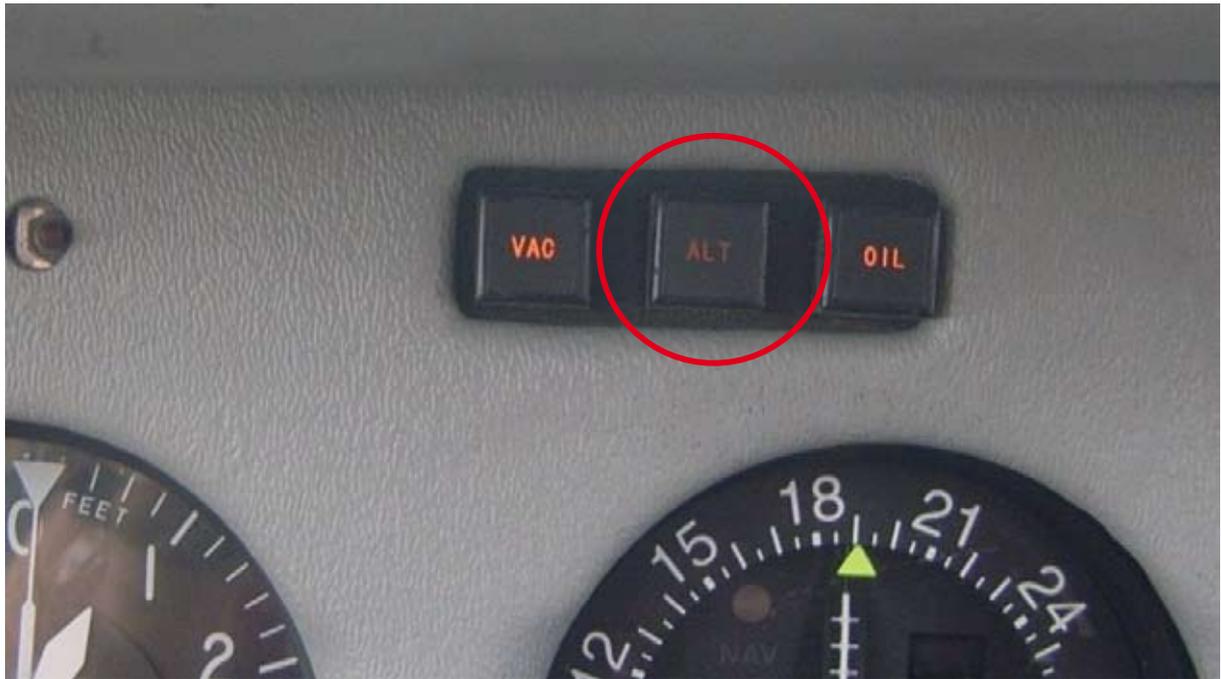
Figure 1
Alternator fail warning light

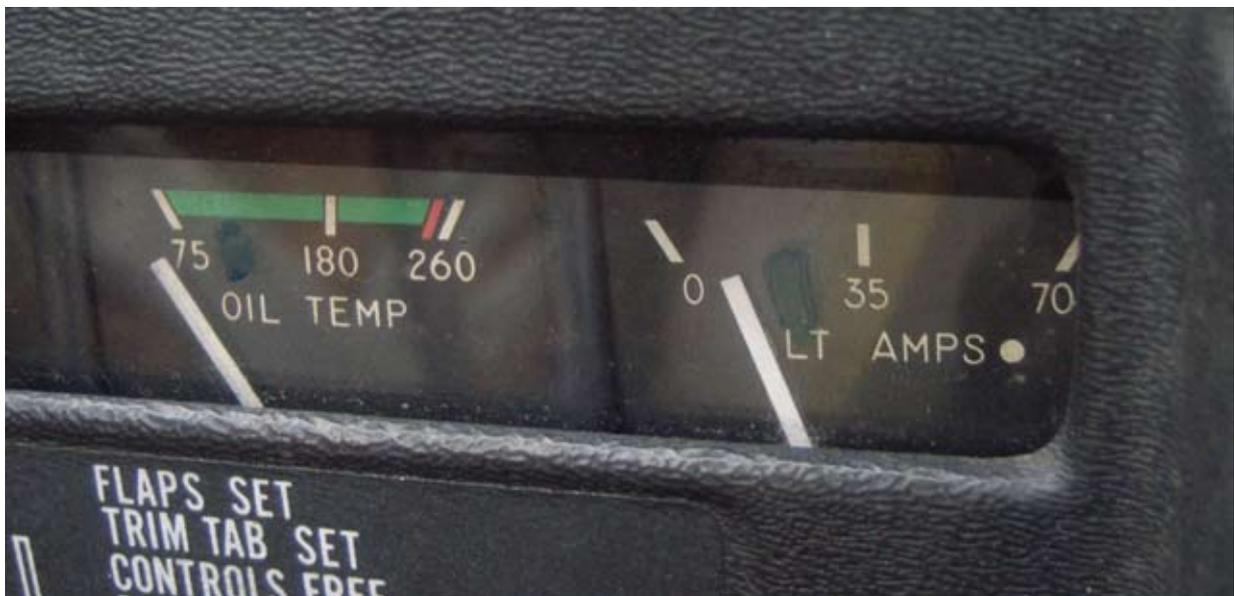
The battery had remained connected and, off-load, registered 11.6 volts when measured with a voltmeter. The avionics were all still selected to the ON position and, when the battery master switch was selected to ON, all electrical systems initially appeared to work normally. However, the battery voltage quickly dropped to 6.5 volts. It was apparent that the ALT caption, which illuminates whenever there is no output from the alternator, mounted between two other warning lights on the instrument panel, was very dim in comparison to these lights, Figure 1. Some of the ancillary instruments had a line drawn on the instrument glass, possibly indicating their normal operating position. It was apparent that, with no output from the alternator, the ammeter incorrectly indicated an output current of approximately 10 amps, Figure 2.

Figure 2
Ammeter zero error of approximately 10 amps

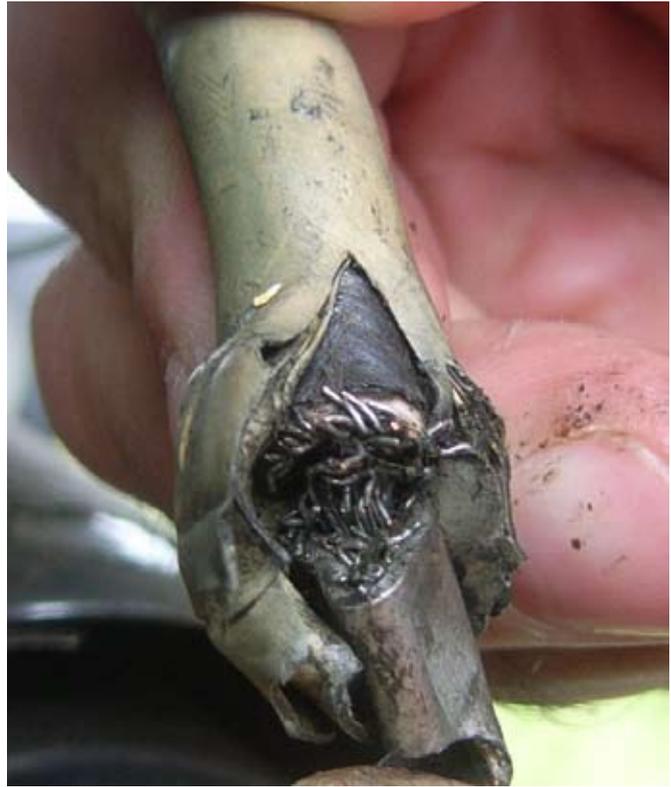
Figure 3

Examination of the alternator installation found it to be properly mounted with the drive belt correctly tensioned, but it was evident that several of the terminations of its associated wiring were of a poor standard. For example, the main power output cable had failed through most of its cross-sectional area where it attached to the lug connecting it to the alternator, Figure 3.

Main alternator feed cable and alternator connecting lug
