## ACCIDENT

<b>Aircraft Type and Registration:</b>	Brandli Cherry BX-2, G-BXUX	
<b>No &amp; Type of Engines:</b>	1 Continental Motors Corp C90-12F piston engine	
<b>Year of Manufacture:</b>	1999	
<b>Date &amp; Time (UTC):</b>	21 July 2008 at 1940 hrs	
<b>Location:</b>	Clipgate Farm Airstrip, Canterbury, Kent	
<b>Type of Flight:</b>	Private	
<b>Persons on Board:</b>	Crew - 1	Passengers - 1
<b>Injuries:</b>	Crew - None	Passengers - None
<b>Nature of Damage:</b>	Damage to the landing gear and associated mechanism, propeller and engine shock-loaded	
<b>Commander's Licence:</b>	Private Pilot's Licence	
<b>Commander's Age:</b>	61 years	
<b>Commander's Flying Experience:</b>	429 hours (of which 322 were on type) Last 90 days - 5 hours Last 28 days - 2 hours	
<b>Information Source:</b>	Aircraft Accident Report Form submitted by the pilot and AAIB examination of the aircraft

## Synopsis

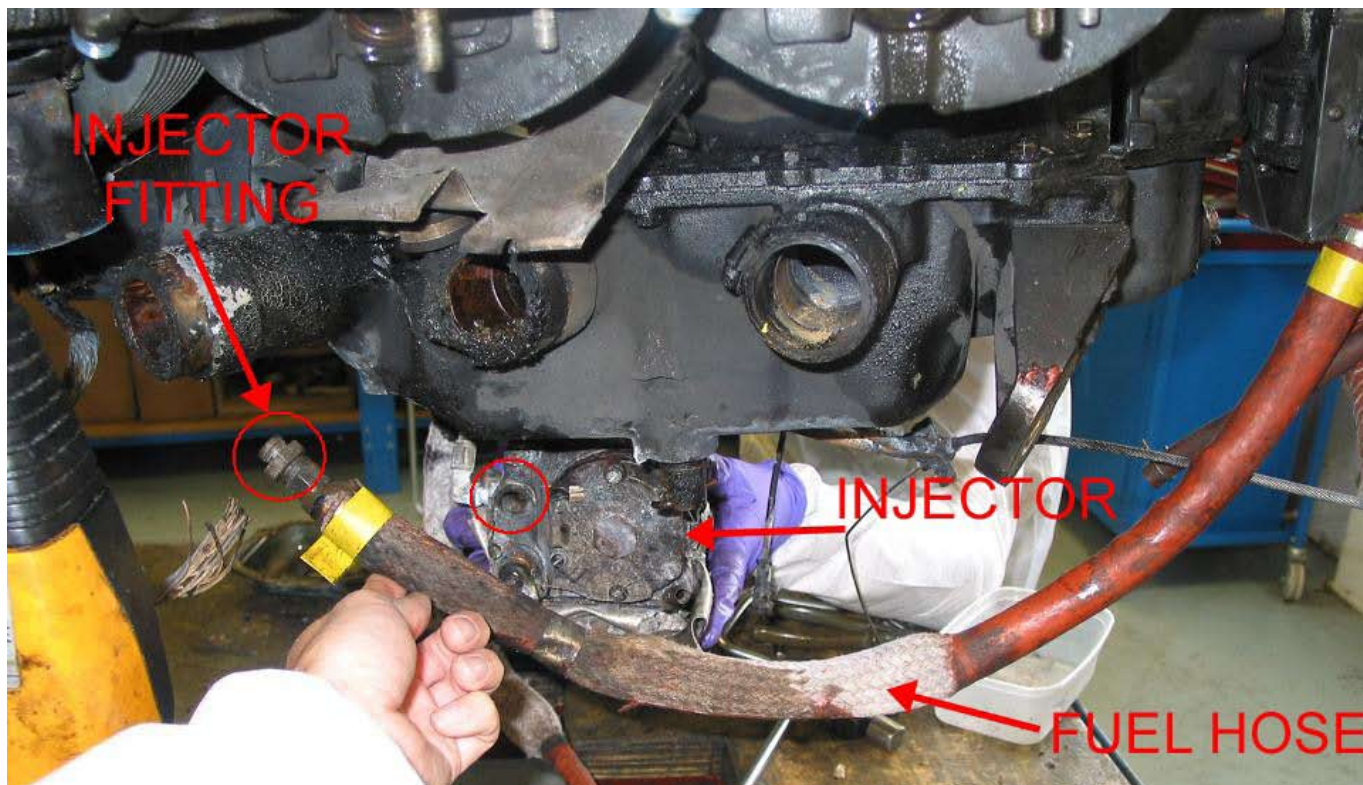
**Figure 3**

The fuel hose between the engine-driven fuel pump and the fuel injector had separated from the fuel injector (Figure 3). This was not one of the hoses that was replaced during the previous annual inspection. The fuel injector had also separated from the oil sump. The injector fitting (circled) is part of the injector body and connects to a threaded hole (also circled). Four threads from this hole had been stripped and one of the stripped threads was wrapped around the separated injector fitting (Figure 4).

Fuel hose between the engine-driven fuel pump and the fuel injector.  
It had separated from the injector at the injector fitting

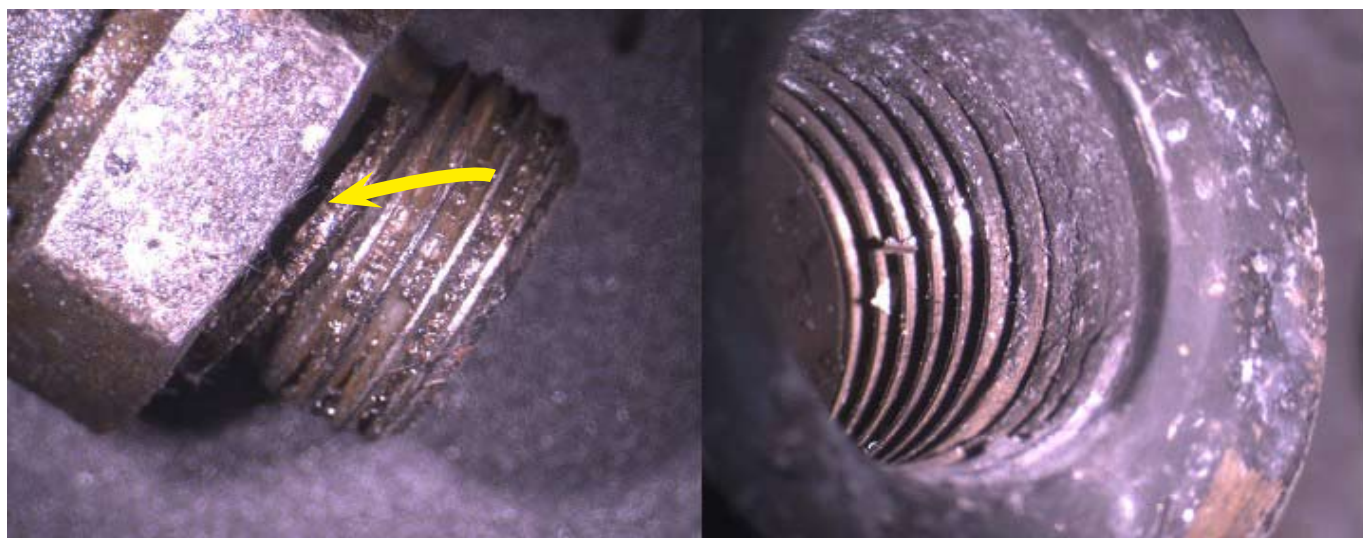
**Figure 4**

The injector fitting was confirmed to be of the correct type, with the correct number of threads. The silicone seal was missing, but could have been consumed by the post-impact fire. The fitting and injector body were examined by a metallurgist. Microscopic examination did not identify any material deficiencies. It was not possible to establish whether the fitting had been cross-threaded, nor was it possible to establish if the fitting had been tight when the separation occurred. The AAIB investigated a more recent accident to a Piper aircraft with a similar injector and injector fitting. In this accident, which did not involve suspicion of an engine problem, the injector fitting had pulled out and stripped the threads in a similar manner, probably due to impact forces.

Left: close-up of injector fitting with separated thread (arrowed).  
Right: close-up of threaded hole on the injector body showing the stripped threads
