## CONTENTS

## ACCIDENT

<b>Aircraft Type and Registration:</b>	Brandli Cherry BX-2, G-BXUX	
<b>No &amp; Type of Engines:</b>	1 Continental Motors Corp C90-12F piston engine	
<b>Year of Manufacture:</b>	1999	
<b>Date &amp; Time (UTC):</b>	21 July 2008 at 1940 hrs	
<b>Location:</b>	Clipgate Farm Airstrip, Canterbury, Kent	
<b>Type of Flight:</b>	Private	
<b>Persons on Board:</b>	Crew - 1	Passengers - 1
<b>Injuries:</b>	Crew - None	Passengers - None
<b>Nature of Damage:</b>	Damage to the landing gear and associated mechanism, propeller and engine shock-loaded	
<b>Commander's Licence:</b>	Private Pilot's Licence	
<b>Commander's Age:</b>	61 years	
<b>Commander's Flying Experience:</b>	429 hours (of which 322 were on type) Last 90 days - 5 hours Last 28 days - 2 hours	
<b>Information Source:</b>	Aircraft Accident Report Form submitted by the pilot and AAIB examination of the aircraft

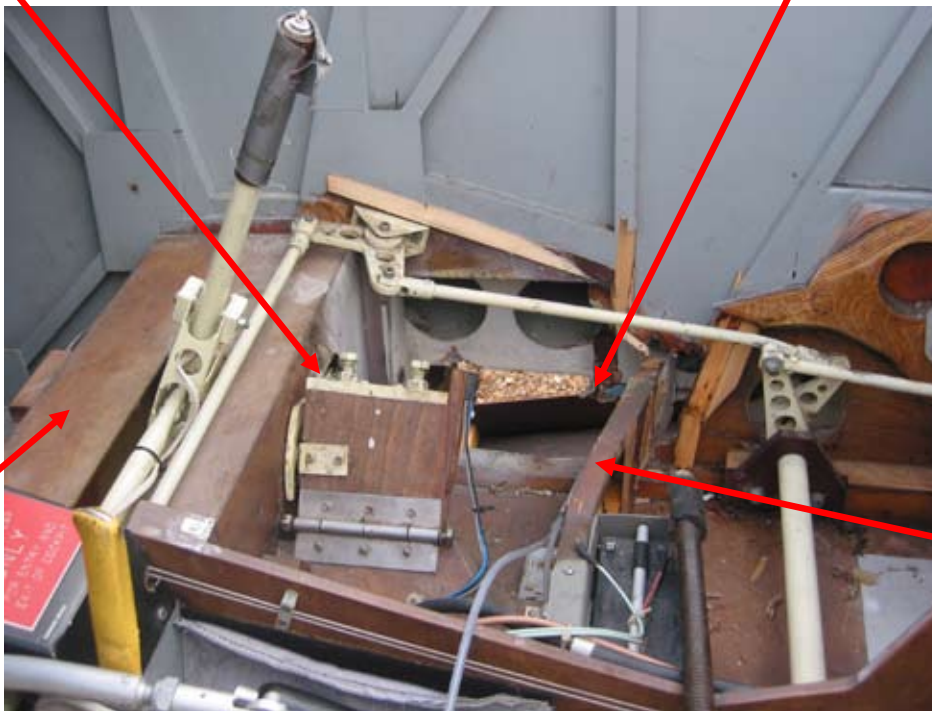
**Figure 1**

It was apparent that some structural damage had occurred in the region of the right landing gear pivot, in that the rear pivot bearing, located in the end of the fuselage crossbeam, had moved in a rearwards

Right leg rear  
pivot position

Failed cross-beam

direction. This movement of the bearing was associated with a failure of the crossbeam. It was difficult to differentiate between the damage arising during the takeoff event and that which occurred on landing. However, the fact that the leg was observed to be trailing when the aircraft was airborne suggests that the rear pivot bearing was no longer properly located which, in turn, means that the cross-beam had failed by this time.

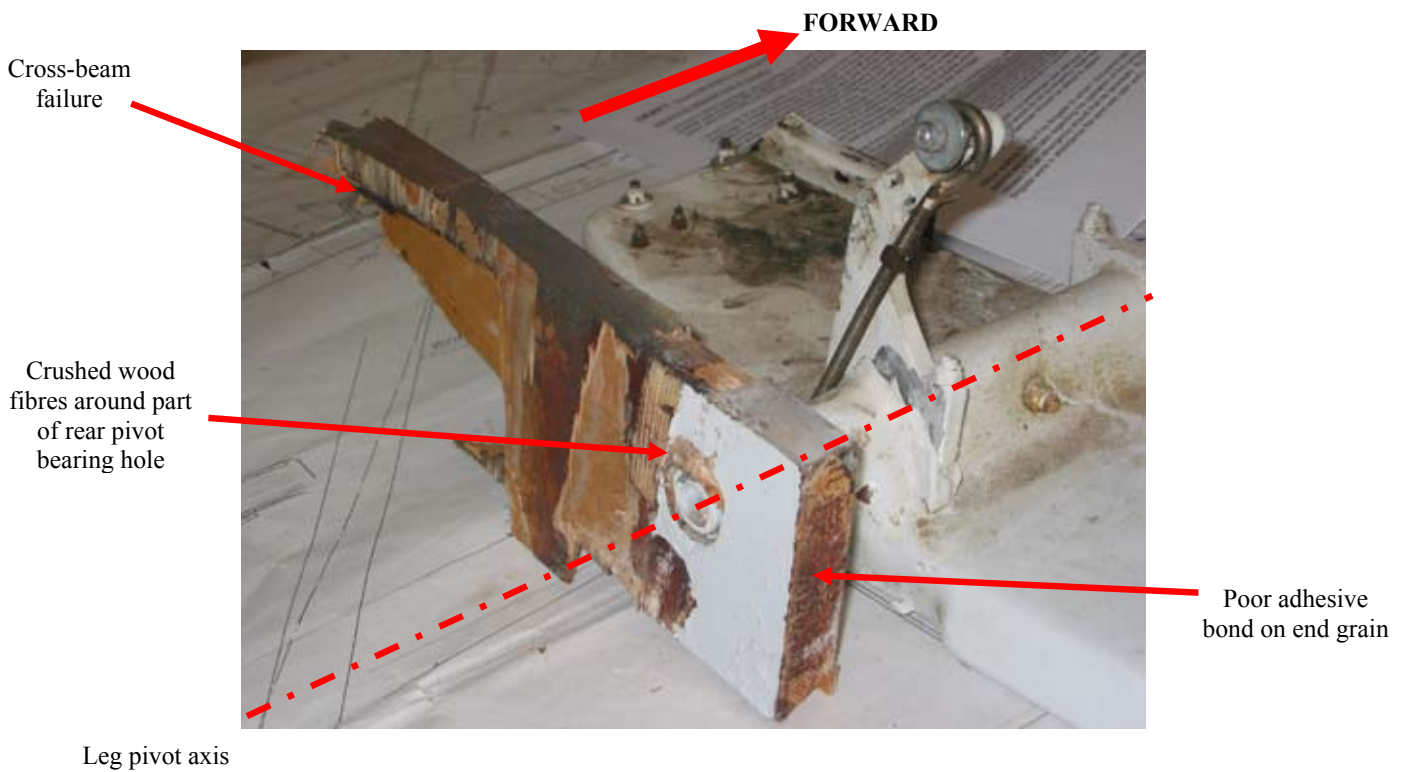
**Figure 2**

Figure 2 shows a partial reconstruction of the failed section of the crossbeam, with the rear pivot of the leg located in a wooden block at the outboard portion of the beam. It is apparent that the wood fibres around part of the circumference of the rear face of the locating

hole have been crushed by the bearing bush, to the extent that they are standing proud of the surface. This damage is consistent with the leg moving in a rearward and upward direction. It is likely that the crossbeam would need to be secure and in position in order to react the forces generated by the leg in damaging the bearing hole. If so, it follows that at least some of the damage to the hole preceded the beam failure. It should be noted that the crossbeam consisted not of a single plank of timber, but was in fact built up using square-section Sitka spruce strips, top and bottom, with facings made from ply. This was typical of the lightweight construction methods used throughout the aircraft.

Partial reconstruction of failed fuselage crossbeam and right main leg

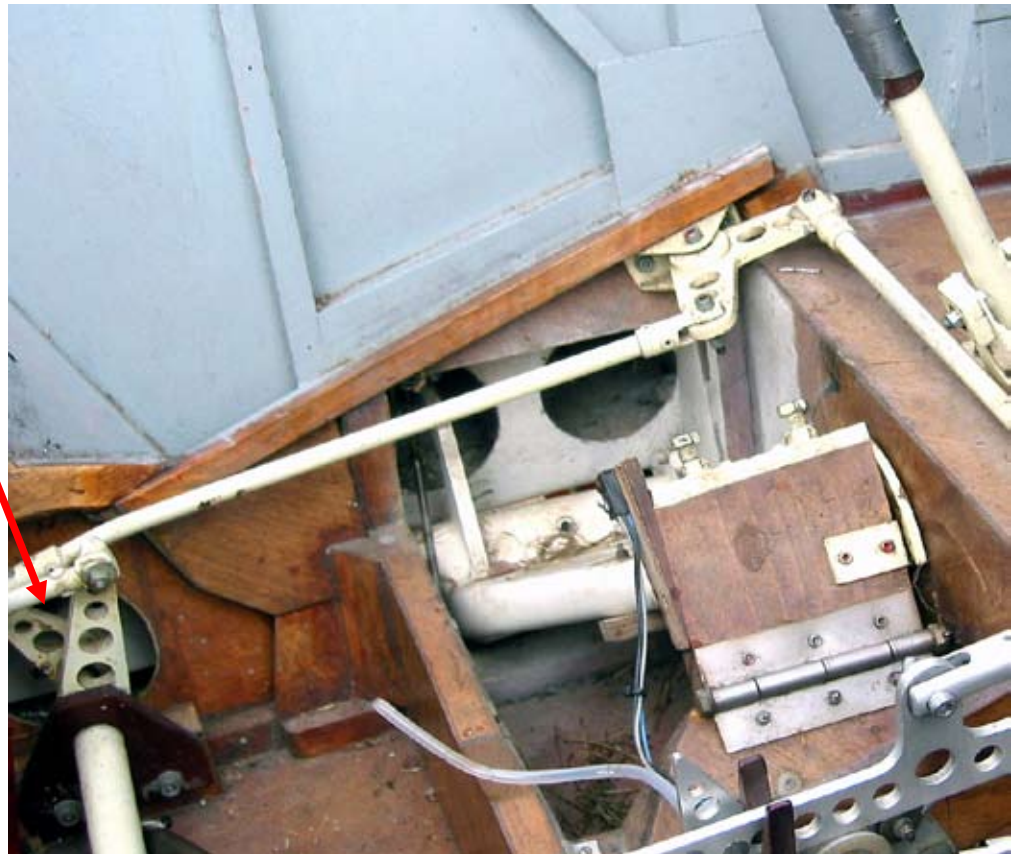
**Figure 3**

End of beam built into cockpit sidewall using triangular-section fillet strip

View of left side of cockpit, showing how the intact end of the cross-beam is built into the sidewall

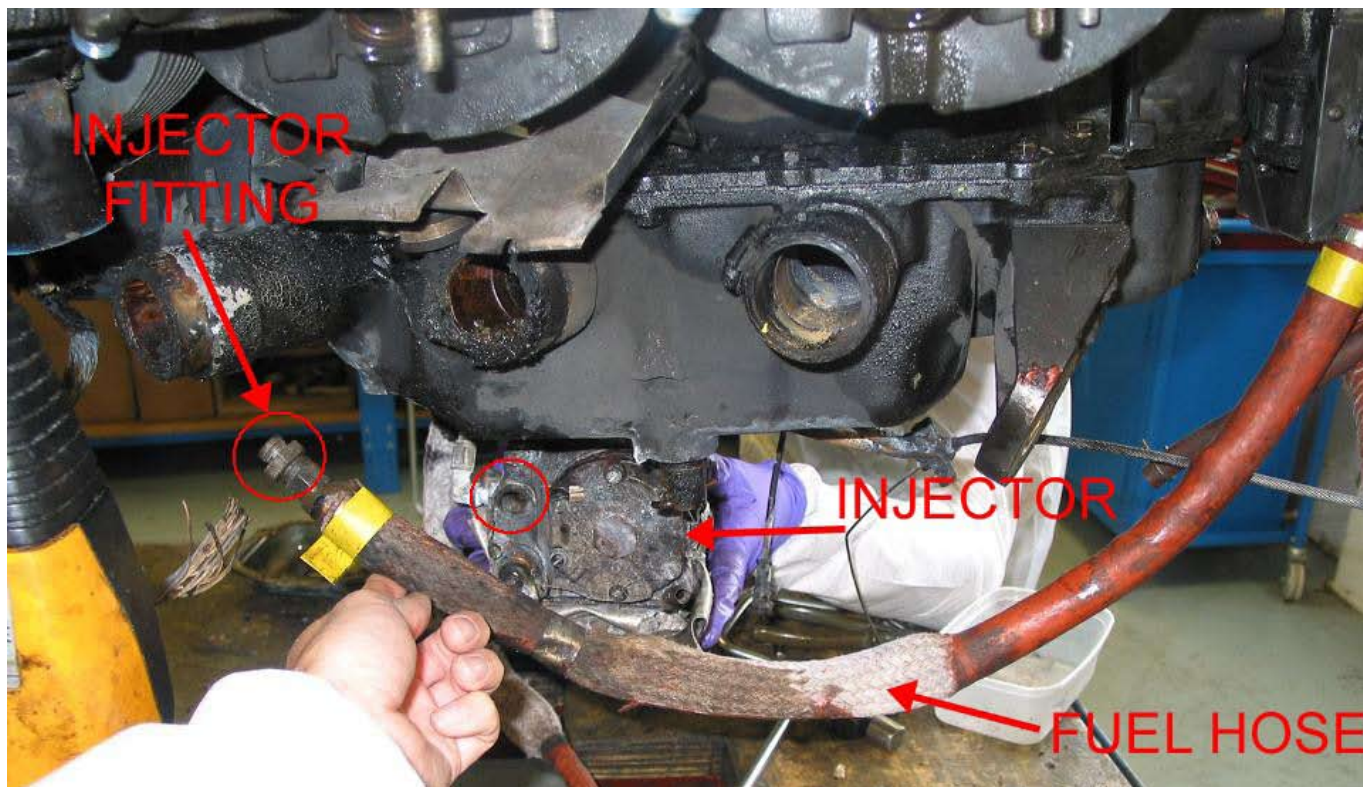
**Figure 3**

The fuel hose between the engine-driven fuel pump and the fuel injector had separated from the fuel injector (Figure 3). This was not one of the hoses that was replaced during the previous annual inspection. The fuel injector had also separated from the oil sump. The injector fitting (circled) is part of the injector body and connects to a threaded hole (also circled). Four threads from this hole had been stripped and one of the stripped threads was wrapped around the separated injector fitting (Figure 4).

Fuel hose between the engine-driven fuel pump and the fuel injector.  
It had separated from the injector at the injector fitting

The fuel hoses were examined for leaks. The fuel hose between the engine-driven fuel pump and injector had a leak in the area where the hose had suffered fire damage. The inner lining exhibited clear evidence of heat damage. The fuel hose between the injector and fuel flow manifold did not leak at its rated pressure. The fuel hose from the firewall to the engine-driven fuel pump had a leak, again in a region where the inner lining had suffered heat damage from the fire.

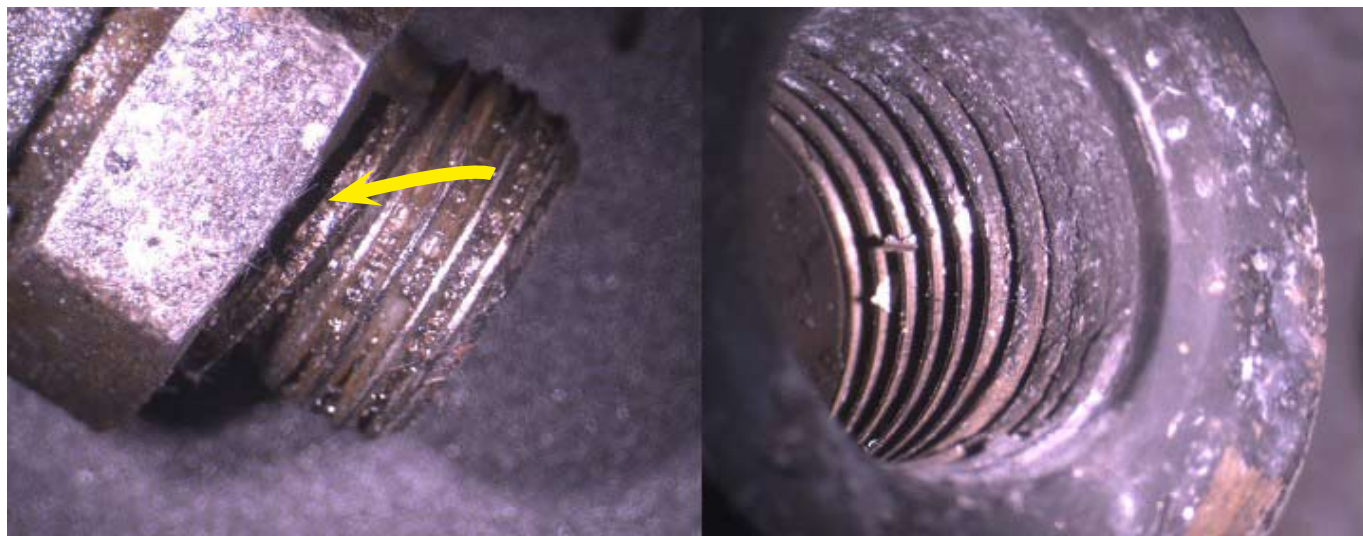
**Figure 4**

The injector fitting was confirmed to be of the correct type, with the correct number of threads. The silicone seal was missing, but could have been consumed by the post-impact fire. The fitting and injector body were examined by a metallurgist. Microscopic examination did not identify any material deficiencies. It was not possible to establish whether the fitting had been cross-threaded, nor was it possible to establish if the fitting had been tight when the separation occurred. The AAIB investigated a more recent accident to a Piper aircraft with a similar injector and injector fitting. In this accident, which did not involve suspicion of an engine problem, the injector fitting had pulled out and stripped the threads in a similar manner, probably due to impact forces.

Left: close-up of injector fitting with separated thread (arrowed).  
Right: close-up of threaded hole on the injector body showing the stripped threads

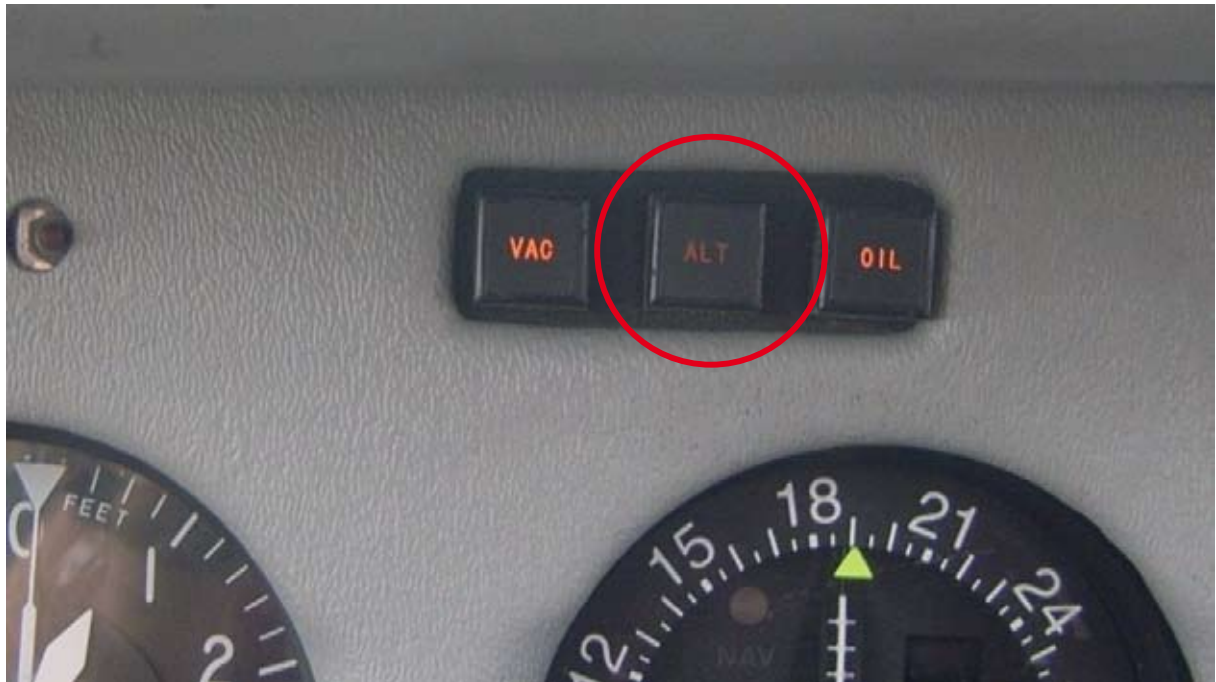
**Figure 1**  
Alternator fail warning light

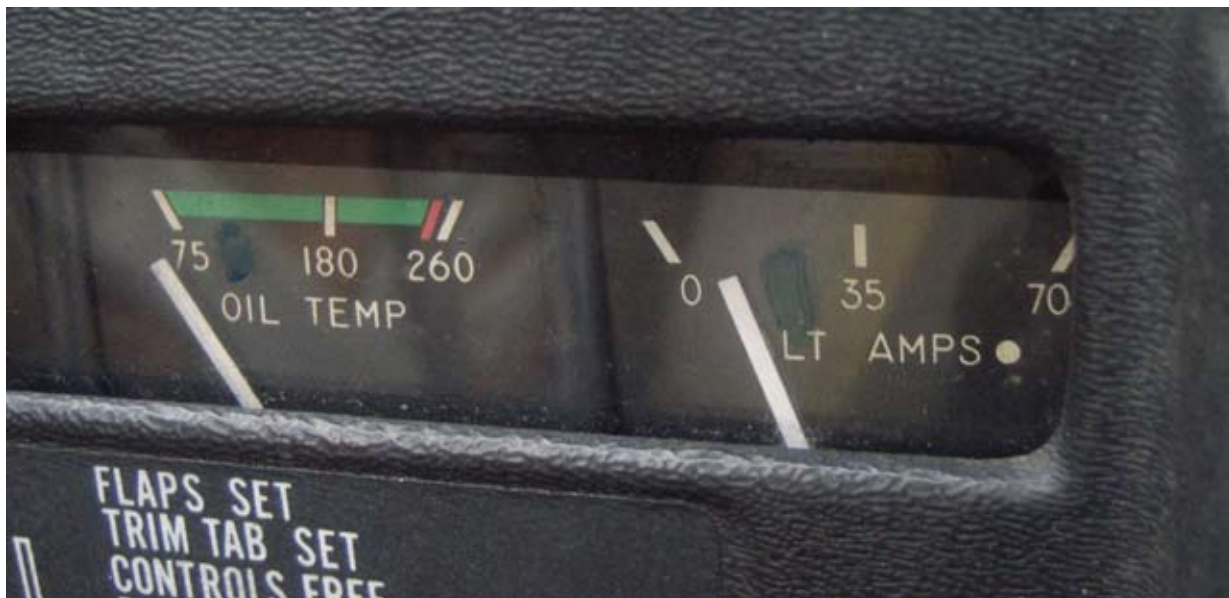
The battery had remained connected and, off-load, registered 11.6 volts when measured with a voltmeter. The avionics were all still selected to the ON position and, when the battery master switch was selected to ON, all electrical systems initially appeared to work normally. However, the battery voltage quickly dropped to 6.5 volts. It was apparent that the ALT caption, which illuminates whenever there is no output from the alternator, mounted between two other warning lights on the instrument panel, was very dim in comparison to these lights, Figure 1. Some of the ancillary instruments had a line drawn on the instrument glass, possibly indicating their normal operating position. It was apparent that, with no output from the alternator, the ammeter incorrectly indicated an output current of approximately 10 amps, Figure 2.

**Figure 2**  
Ammeter zero error of approximately 10 amps

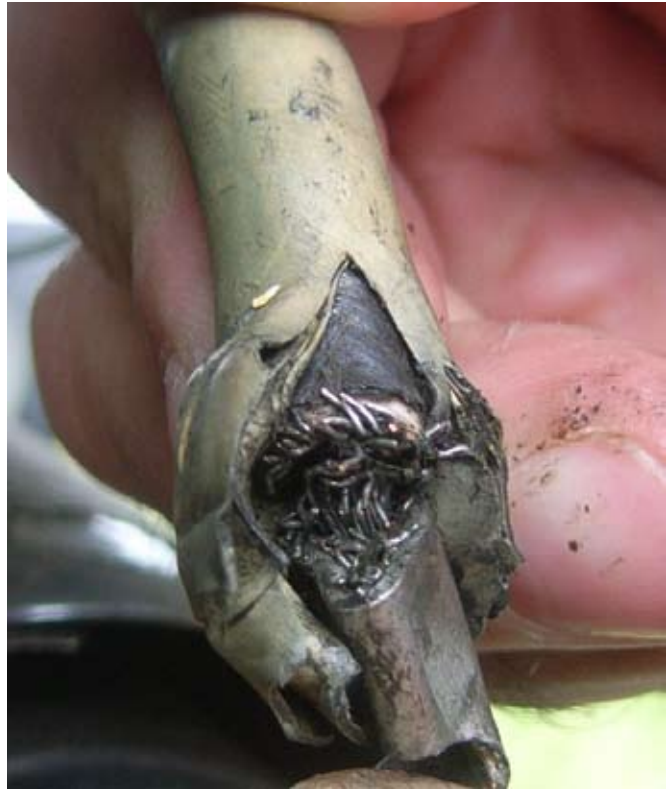
**Figure 3**

Examination of the alternator installation found it to be properly mounted with the drive belt correctly tensioned, but it was evident that several of the terminations of its associated wiring were of a poor standard. For example, the main power output cable had failed through most of its cross-sectional area where it attached to the lug connecting it to the alternator, Figure 3.

Main alternator feed cable and alternator connecting lug
