CONTENTS

SPECIAL BULLETINS

Embraer 190-200	G-FBEH	15-Jan-09	1
-----------------	--------	-----------	---

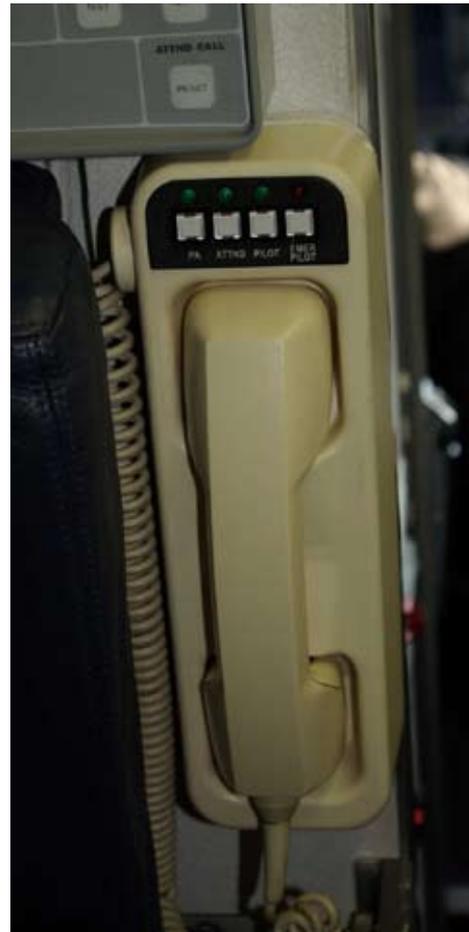
Figure 1

Cabin interphone handset at front galley

The interphone system includes handsets with illuminated pushbuttons at the forward and aft galleys (Figure 1) and illuminated push-buttons on audio panels in the flight deck (Figure 2). With normal power applied to the aircraft, removing the handset from its cradle and then pressing the PILOT call pushbutton above the handset causes a single chime to sound in the flight deck, and the CAB pushbuttons on the pilots' audio panels illuminate to show an incoming communication. Pressing the pushbutton

It is recommended that Embraer (Empresa Brasileira de Aeronautica SA) immediately notify all operators, of the Embraer 190 family of aircraft, to inform their flight and cabin crew of the functioning of the interphone system when the aircraft is supplied only with emergency electrical power.

It is recommended that Embraer (Empresa Brasileira de Aeronautica SA) modify the functioning of the interphone systems of Embraer 190 family aircraft to provide crew with the facility to make both normal and emergency calls when the aircraft is supplied only with emergency electrical power.

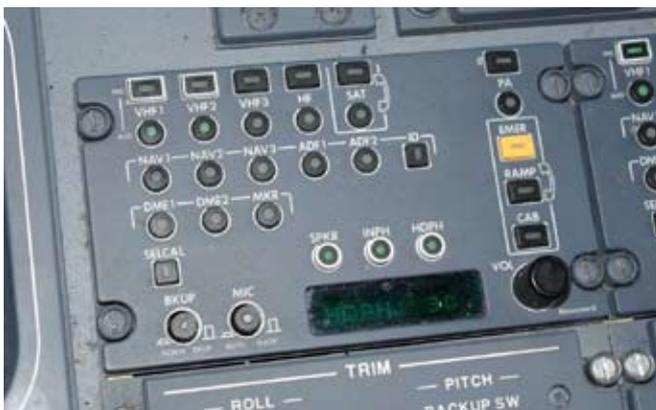
Figure 2

on either pilot's panel enables voice communications. Pressing the EMER PILOT pushbutton on the handset causes a triple chime to sound in the flight deck, and the EMER pushbuttons on the pilots' audio panels illuminate to show an incoming communication. Pressing the pushbutton on either pilot's panel enables voice communications.

Pilot's audio panel in flight deck

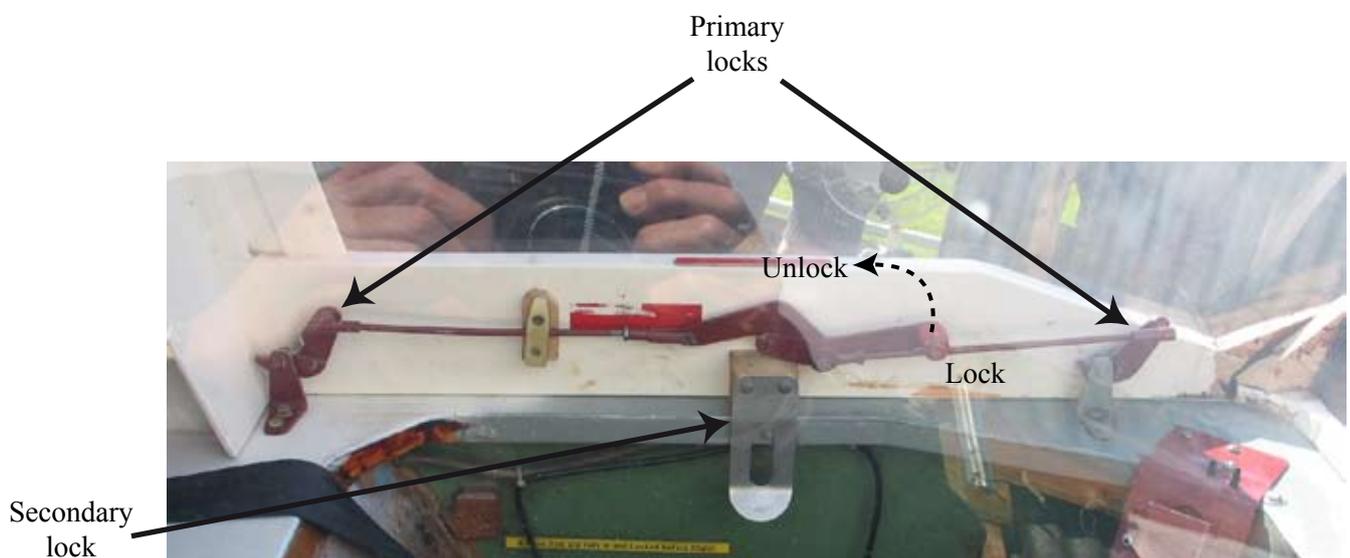
Figure 1

The canopy was later found with no evidence of a component failure. The aircraft was fitted with a secondary canopy lock mechanism (Figure 1) but this was unserviceable and not in use on the accident flight.

In retrospect the pilot thinks that he may have inadvertently caught the canopy lock handle with his map whilst entering co-ordinates into his GPS.

Primary and secondary canopy lock mechanisms
(photograph of a similar aircraft)
