CONTENTS

COMMERCIAL AIR TRANSPORT

(ALL TIMES IN THIS BULLETIN ARE UTC)

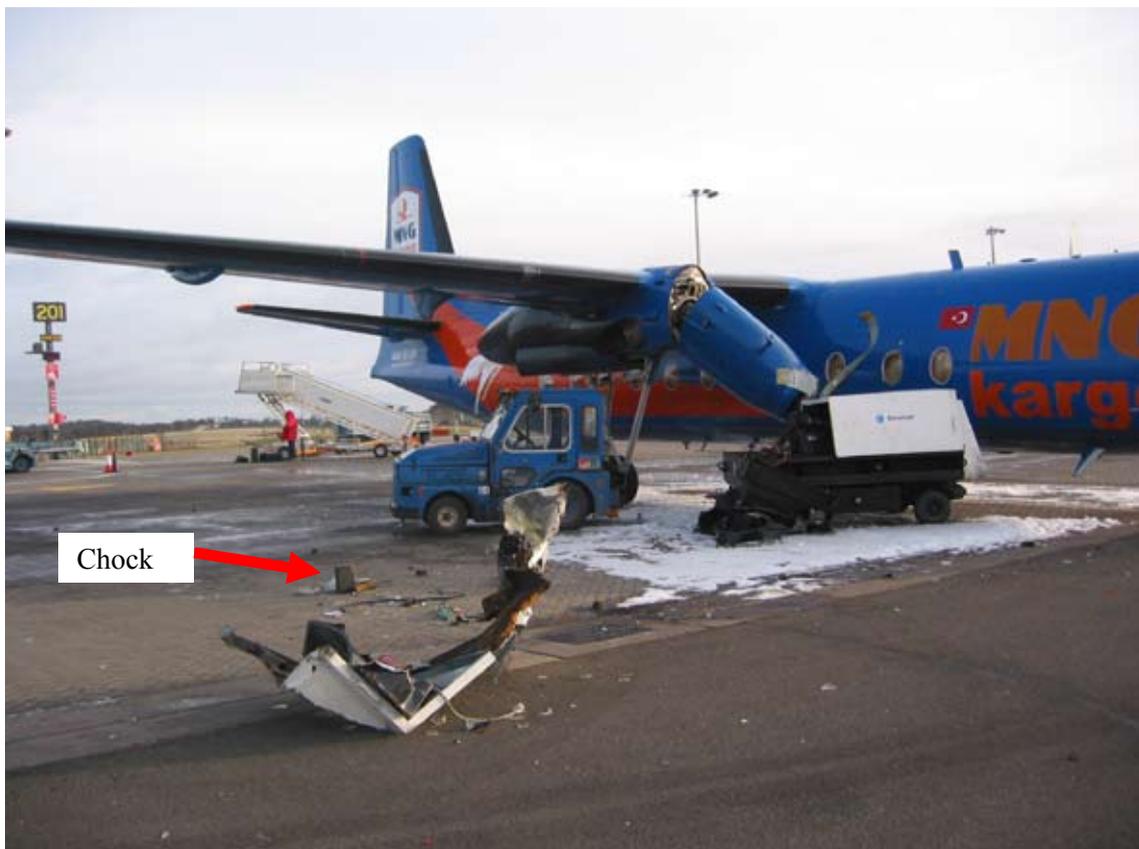
Figure 1

A photograph of the accident scene, taken on the morning after the event, is shown at Figure 1. Chocks had been placed at all the wheels at this stage. According to the AFRS, no chocks were found in the vicinity of any of the wheels on their arrival and they chocked the wheels as a precaution, prior to applying foam. Two chocks were found in the wreckage of the GPU, with one of them being visible in Figure 1.

View of the accident site. Position of chock is indicated. The other is located within GPU debris in foreground

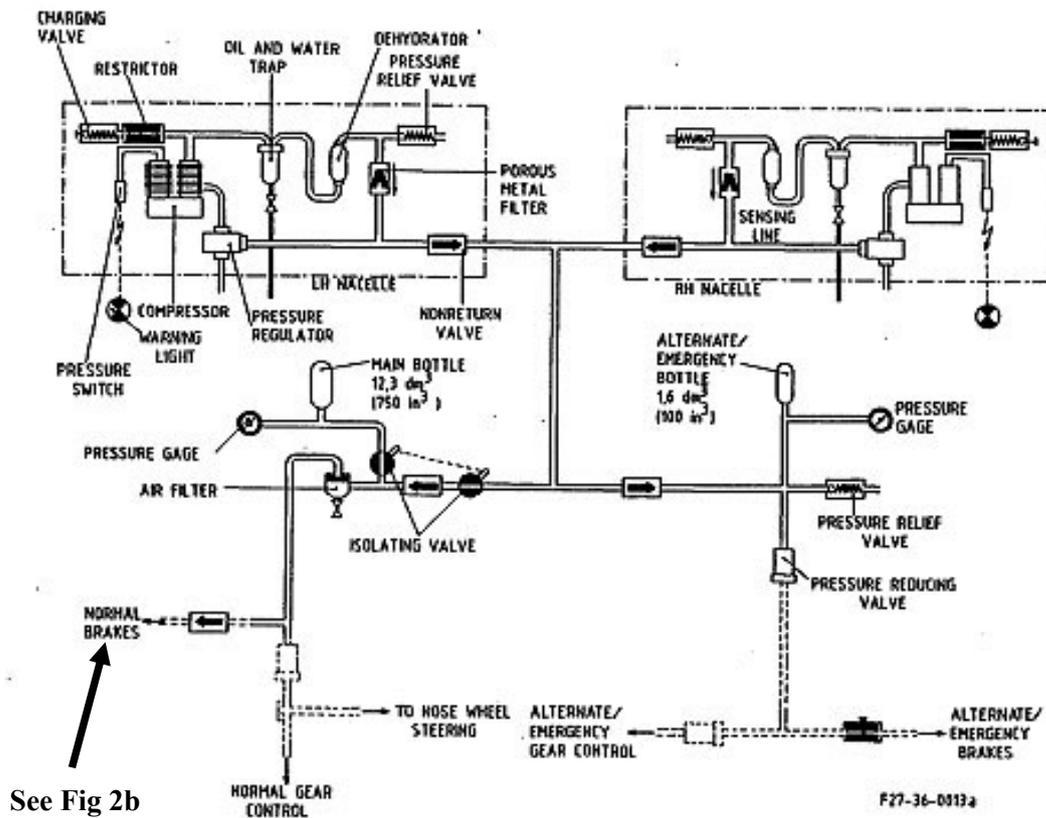
Figure 2a

An isolating valve is incorporated within the system, which, as can be seen in Figure 2a, actually consists of two valves, both operated by a single control rod. The purpose of the valve is to preserve stored pressure in the event of a leak elsewhere in the system.

Pneumatic system schematic diagram

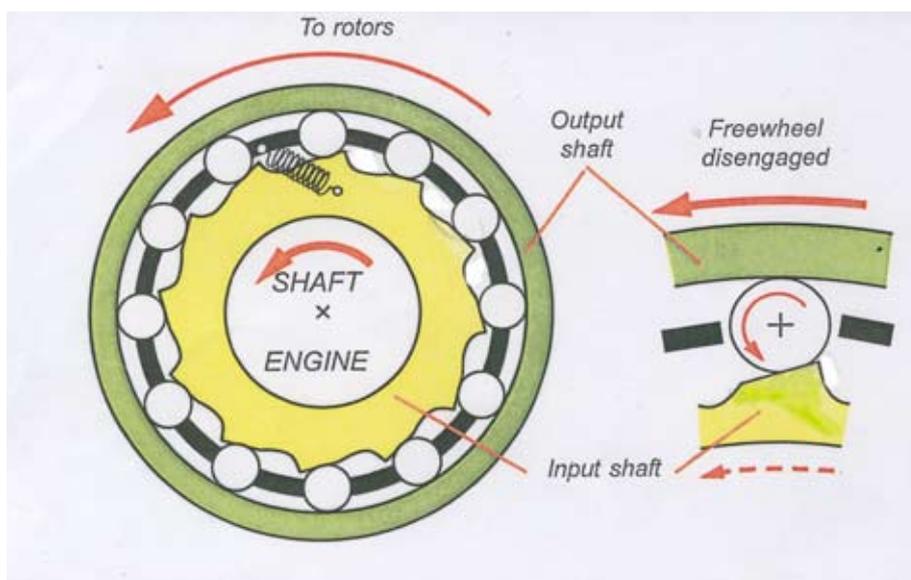
Figure 1

The main rotor gearbox was disassembled at the operator's overhaul facility under AAIB supervision and in the presence of the manufacturer's representative. No mechanical defects were found within the gearbox with the exception of the right engine freewheel unit which had been severely damaged. Examination of the freewheel unit showed that the roller cage had rotated to a point where the rollers had overridden the freewheel ramps, and moved into the adjacent 'trough' in the freewheel shaft disengaging the engine output shaft from the gearbox.

'Ramp and roller' freewheel unit

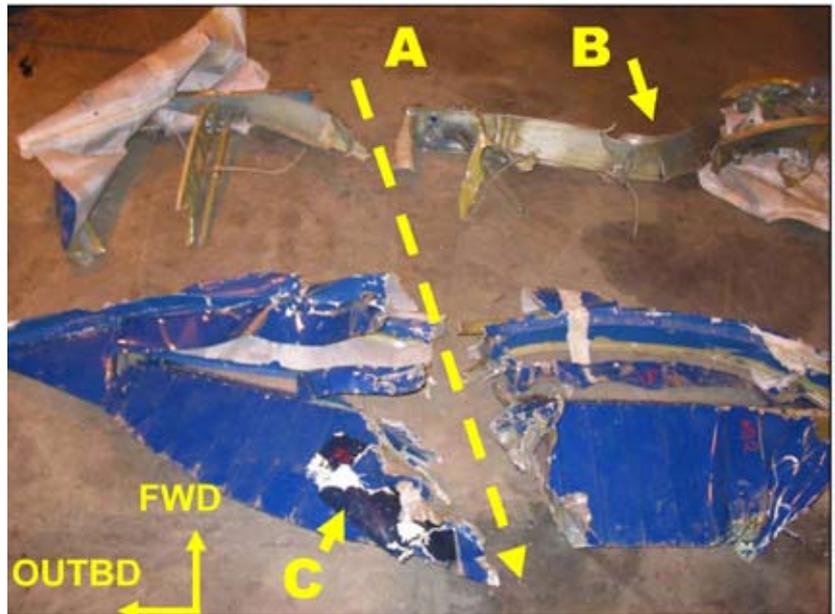
Figure 6

G-AKUI approached from ZK-KAY's right side and that the outer 9 feet of its left wing was in collision with the lower right side of ZK-KAY's fuselage, with G-AKUI in an approximately wings-level attitude and slightly below ZK-KAY. G-AKUI's precise pitch attitude could not be determined, but it was not extreme. Assuming that ZK-KAY was travelling around twice the speed of G-AKUI, the direction of the scrape marks suggests that G-AKUI was tracking approximately at right angles to ZK-KAY at the point of collision.

G-AKUI left outer wing

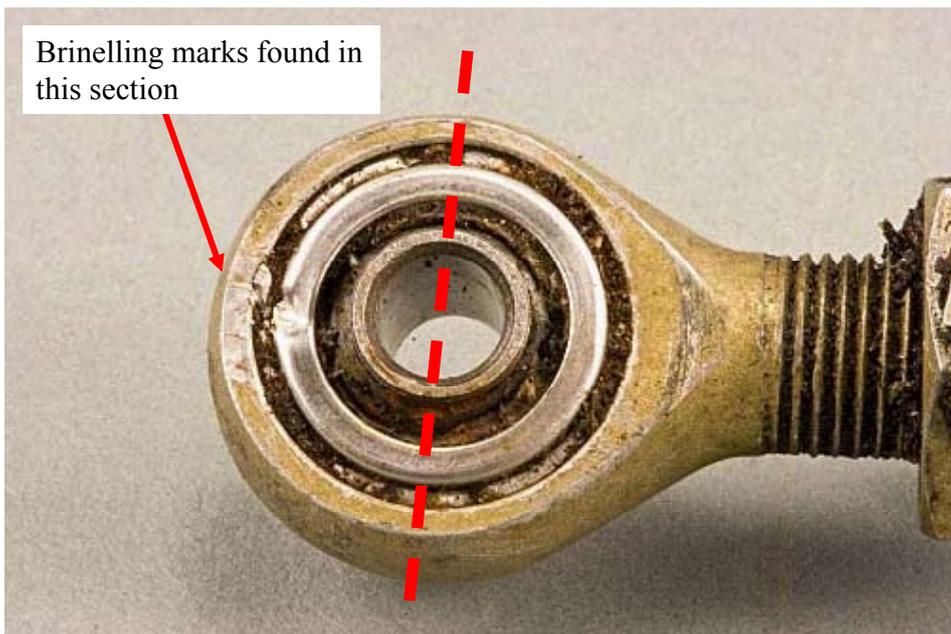
Figure 5

In view of the apparent lack of damage to the servo rod eye end, additional investigation was conducted on this component in order to determine whether a bolt or rivet had been present at the time of the impact.

Forward servo rod eye end from G-CBHL

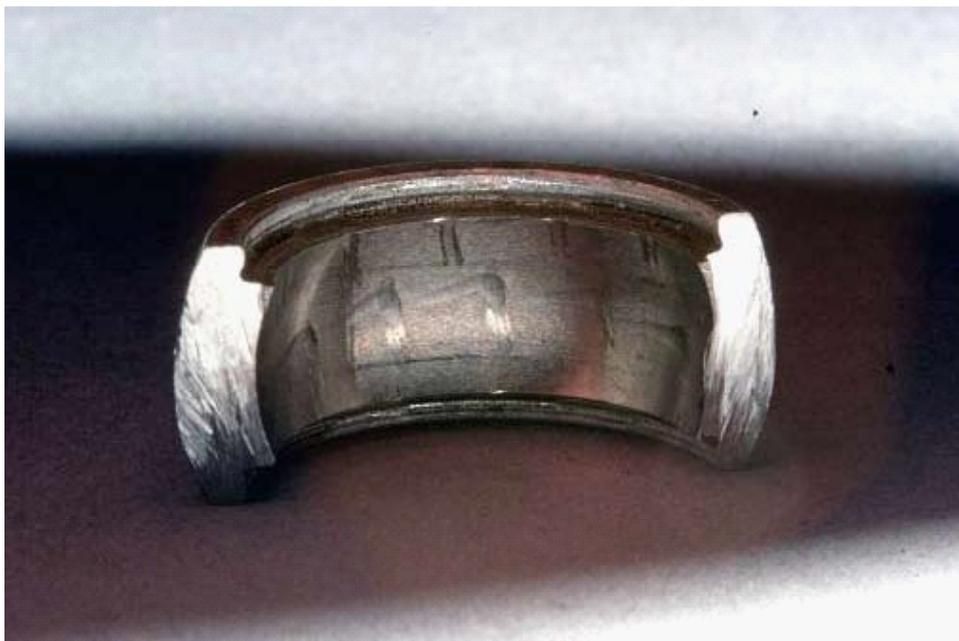
Figure 7

Brinelling marks on the forward servo input rod lower eye end

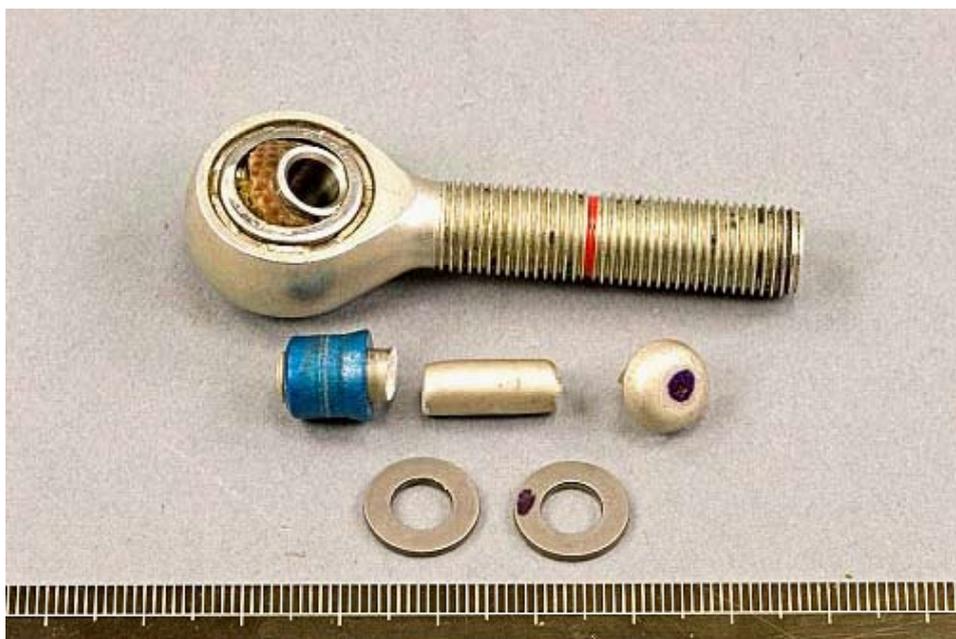
Figure 8

turn had caused the balls to mark the outer race surface in a similar manner to that seen on the accident aircraft. The bore of the central, eye, in which the rivet had been located, was undamaged.

Results of eye end test conducted by the manufacturer. Note failed rivet and undamaged eye

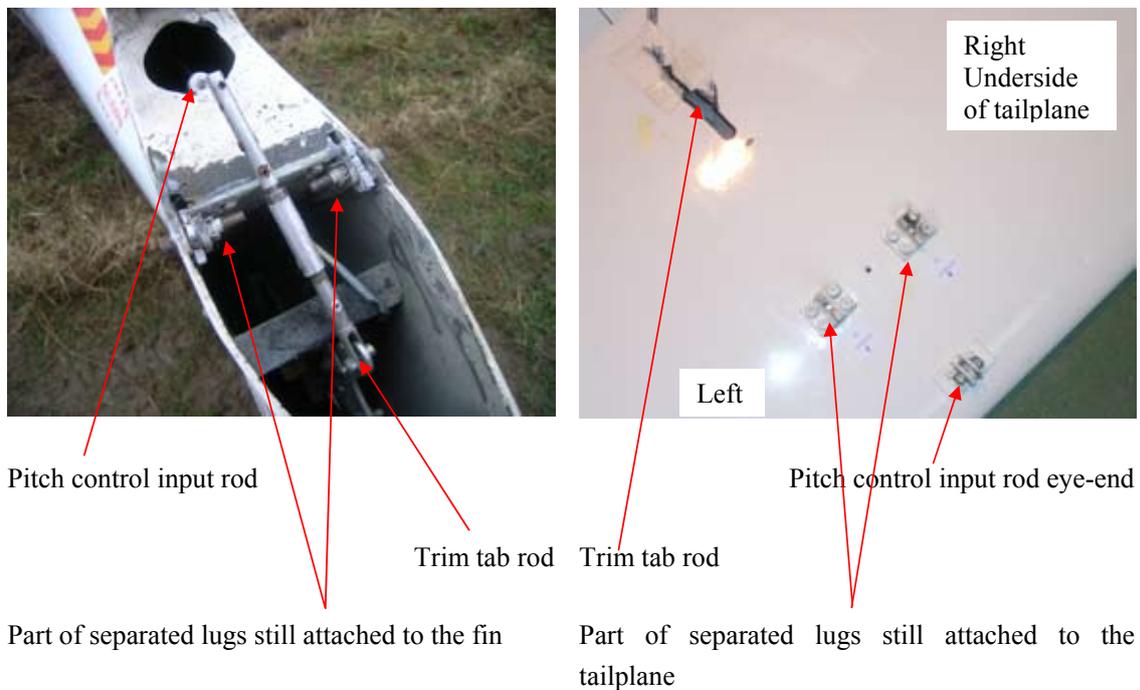
Figure 3

Top of fin (left) and underside of tailplane (right)

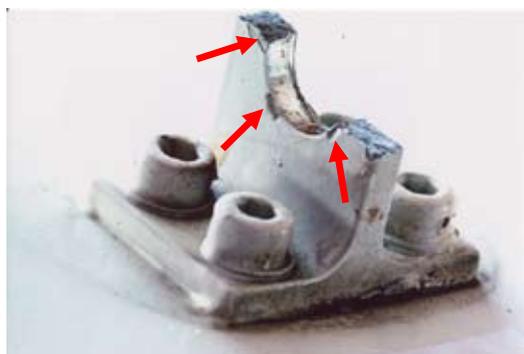
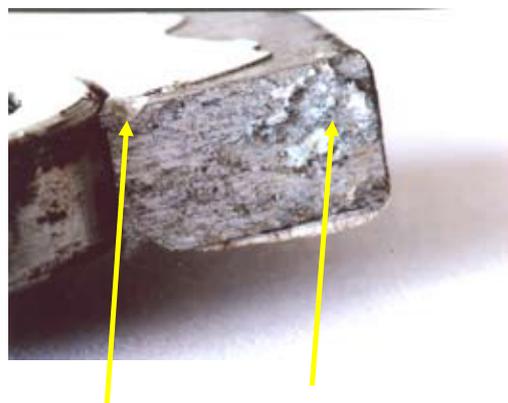
Figure 4

A potential source of pre-existing (ie static) stress in the left hand tailplane lug is a misalignment between

Staking marks (arrowed)

Staking mark Area of stress corrosion

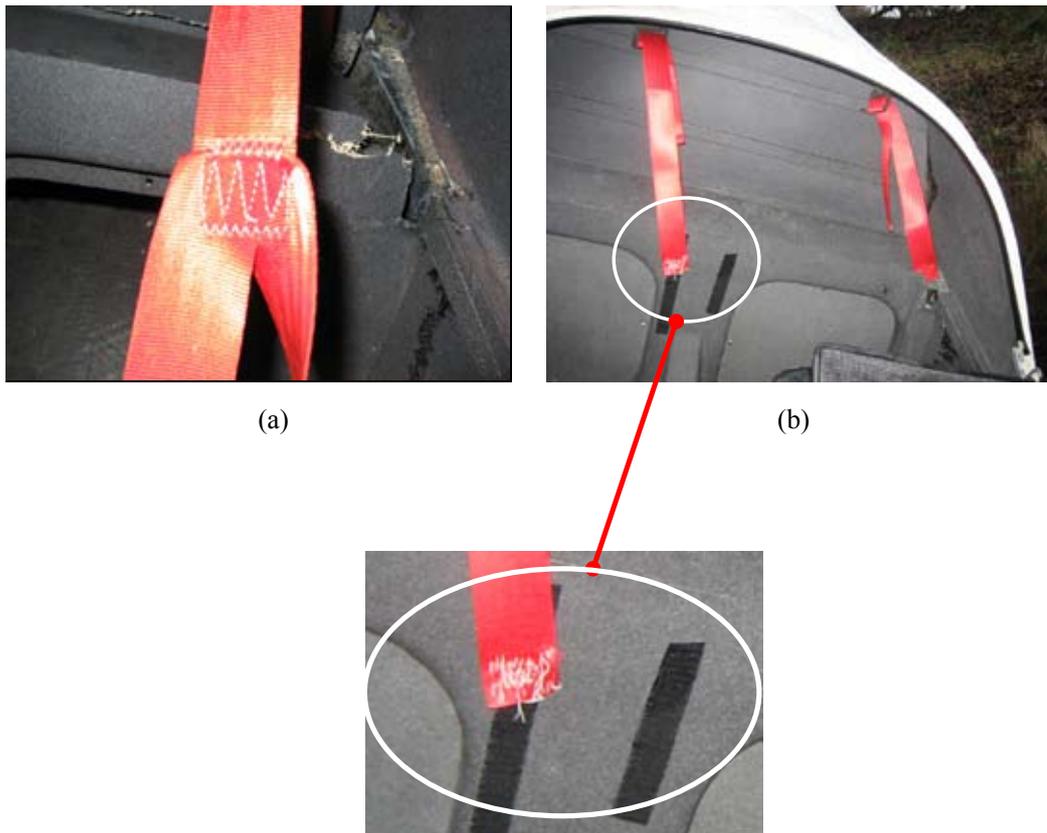
Figure 5

Shoulder straps of pilot's harnesses showing (a) intact stitching from another aircraft and (b) failed stitching from G-BZXG

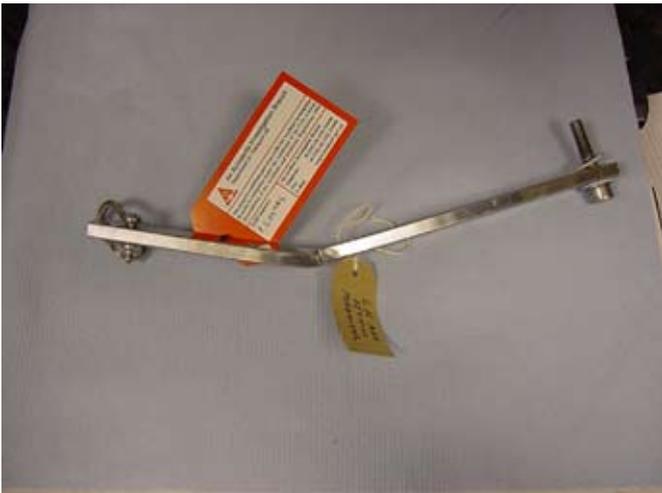
Figure 2

The lift arms attached to this paramotor unit were not those originally fitted to it by the manufacturer and these arms had then been further modified. As noted above, each lift arm was equipped with a row of holes which enabled the lift load attachment position to be varied to take account of different occupant weights, allowing these to be balanced with the fixed weight of the engine, propeller and mounting structure. In this example, the right hand side of the paramotor unit was equipped with a fitting, not forming part of the original structure, which appeared to be positioned to alter the offset of the lift load from the centre line of the box section of the arm. On the left side, the lift shackle was attached in a more conventional way, by means of a shackle pin passing through one of the holes in the corresponding arm (Figures 2 and 3), thus

Left lift arm, from above

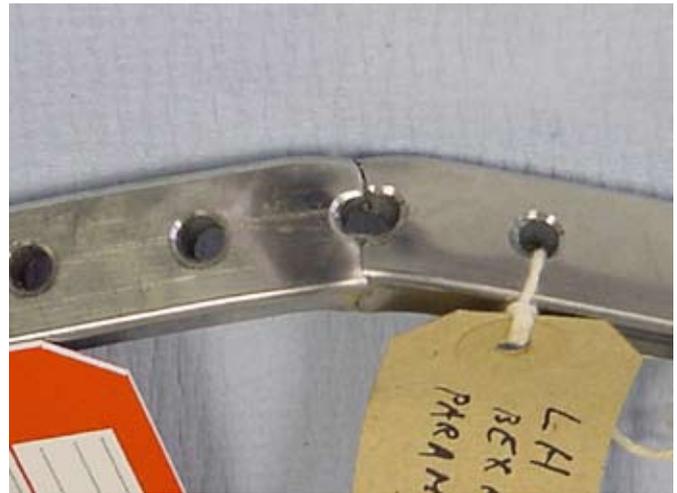
Figure 3

Left lift arm, outboard surface

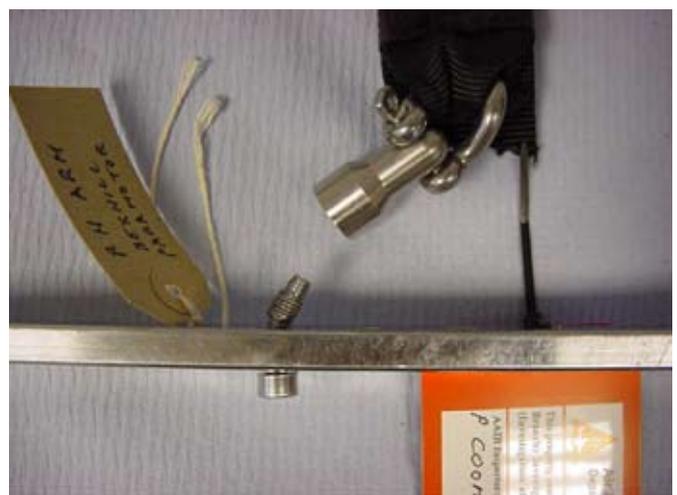
Figure 4

The right arm was not significantly damaged but the additional fitting, described above, had ‘pulled out’

Right lift arm, threaded connection

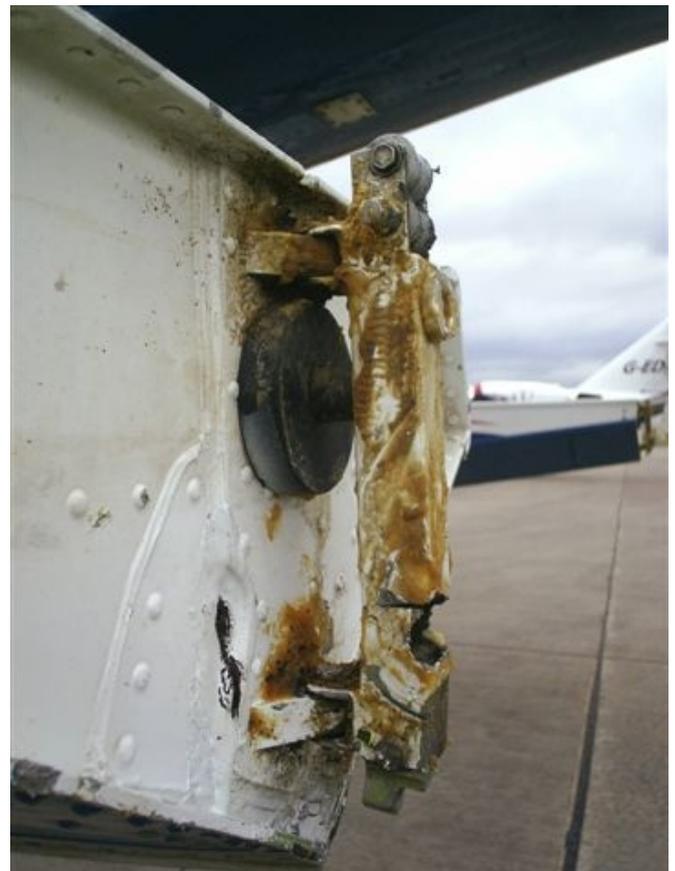
Figure 1
Damaged rudder hinge post

Microscopic examination revealed that the upper and lower failure surfaces, together with the 'tears' in the post sidewall, exhibited characteristics of a failure due to overload. The circumferential welds securing the pivot tube to the rudder post had not completely penetrated the post sidewall, and had also failed in overload, Figure 4. Both of the rudder post sidewalls in the region of the circumferential welds had been distorted by the application of a torsional load in a clockwise sense (viewed from the rear). There was no evidence of corrosion or crack progression by a fatigue mechanism on any of the fracture faces. When operating from water, the water rudder pivot is below the waterline which together with the presence of a liberal

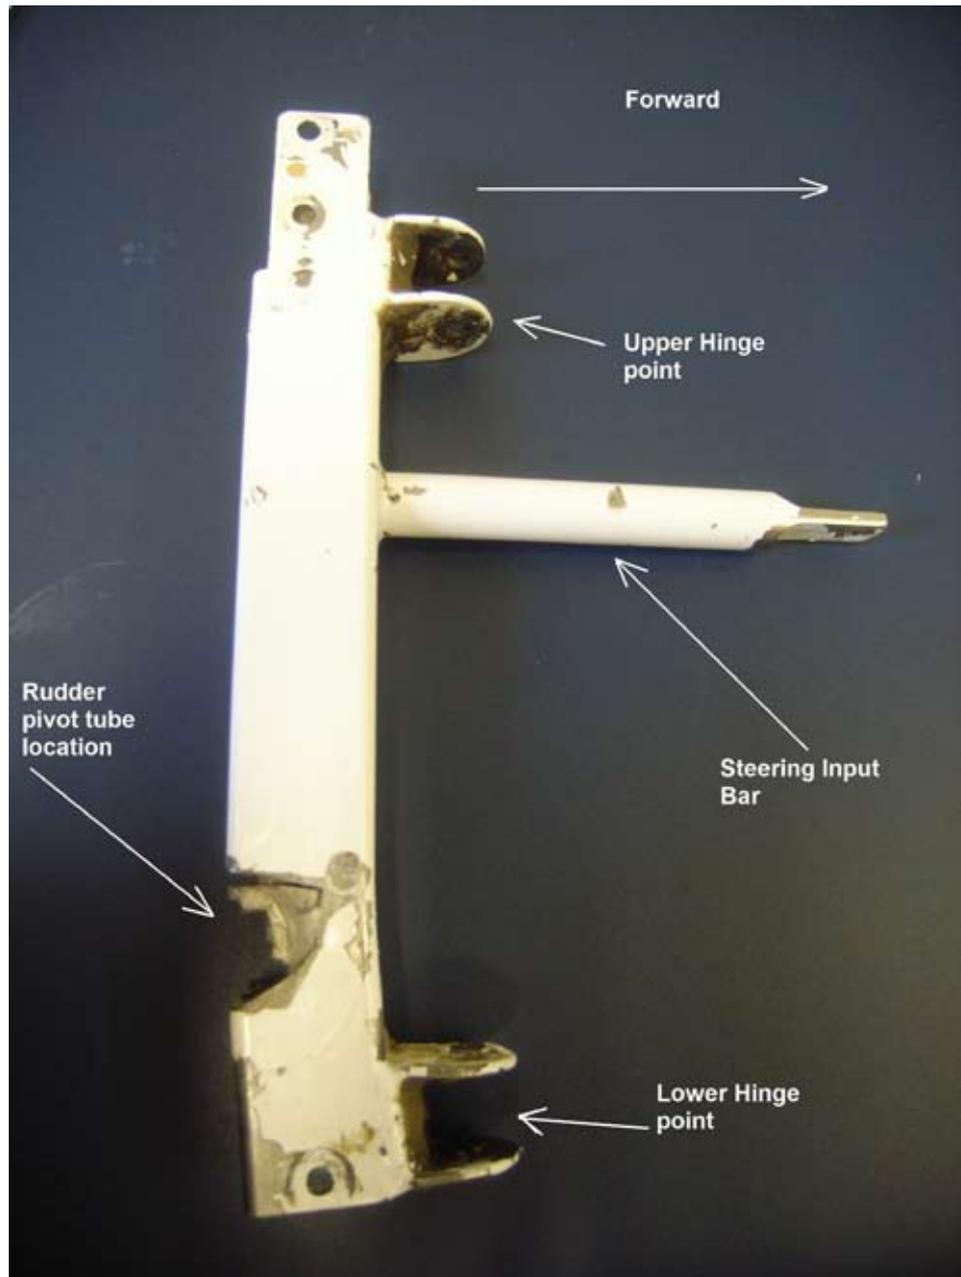
Figure 3

Damaged water rudder hinge post

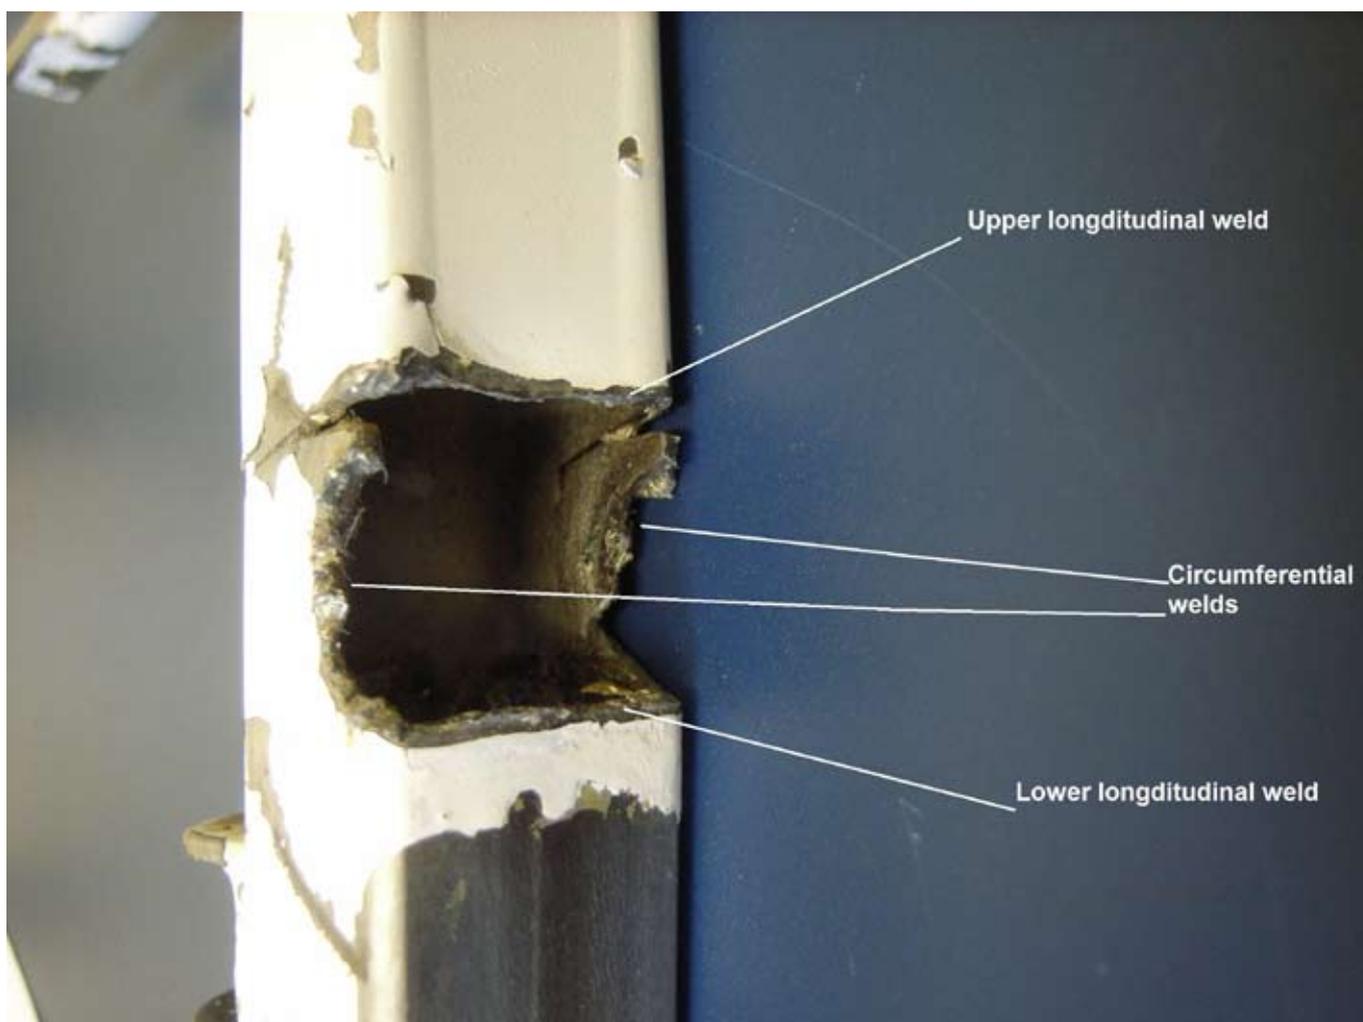
Figure 4
Rudder post weld details

The deformation of the rudder mounting post indicated that the rudder pivot tube had been pulled aft, causing the aft wall of the rudder post to fail where the pivot tube was attached. The ‘tears’ in the post sidewalls illustrate that, despite the welds securing the pivot tube having only partial material penetration, they were able to transmit sufficient load to damage the rudder post sidewalls without failing. The damage observed was consistent with a force being applied to the lower portion of the rudder from the rear whilst deployed. This caused the rudder to ‘pivot’ about the lower mechanical stop, producing the rearward
