### G-REDL - INITIAL REPORTS

### SPECIAL BULLETINS

## **INITIAL REPORT**

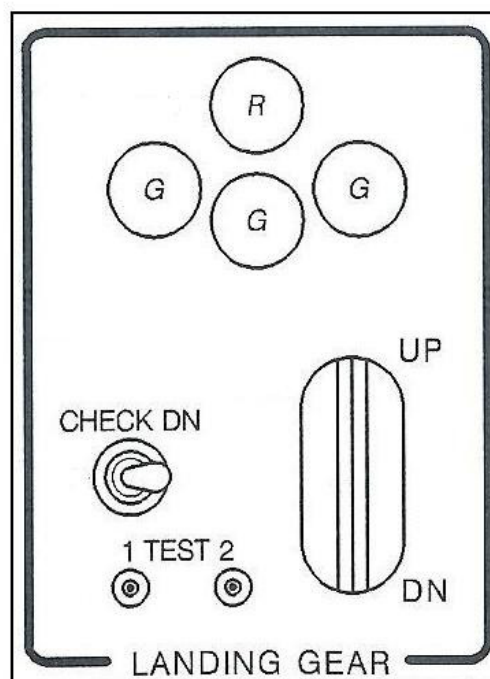
**Figure 1**

TBM 700 - Landing gear control and indication panel

When the actuator was functionally tested on a rig, an anomaly was found. It successfully retracted, giving the correct UP lock indications, but almost simultaneously, the switch indications for DOWN lock were detected. This meant that the actuator would have sent an indication to the landing gear control unit that the nose gear leg was locked both UP and DOWN. This anomaly could have produced the continuous red light reported by the pilot.

It is recommended that EADS Socata amends the TBM 700 Pilot's Operating Handbook, to clarify the need for manual extension of the landing gear if a continuous red light is showing, even if the green gear lights on the landing gear control and indication panel are lit.

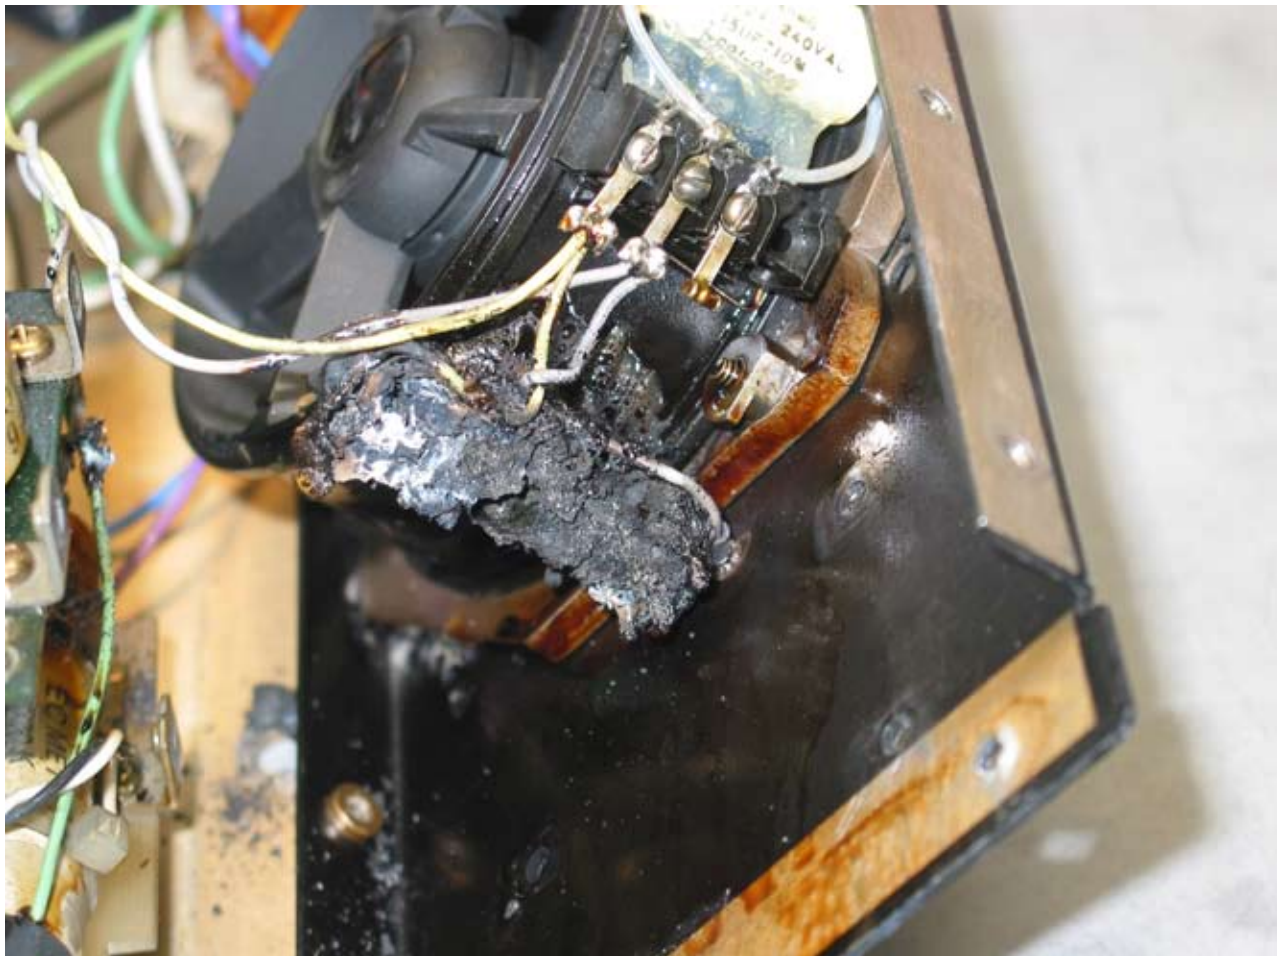
test bench power supply. As soon as electrical power was applied, smoke emanated from the area around the cooling fan. Further disassembly of the unit identified that a capacitor in the cooling fan power supply circuit was completely burnt out. (Figure 1) The capacitor was too badly damaged to allow any further analysis of why it had failed. The inverter was then repaired and tested, with no further anomalies identified.

**Figure 1**  
Burnt out capacitor

It has not been possible to isolate the reason for the capacitor overheating due to the severity of the damage. Previous failures of this component are low in

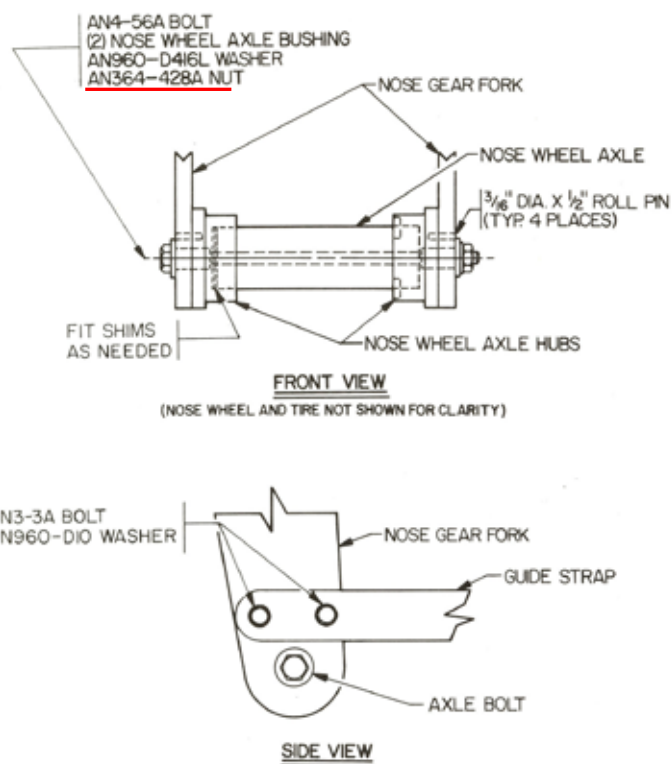
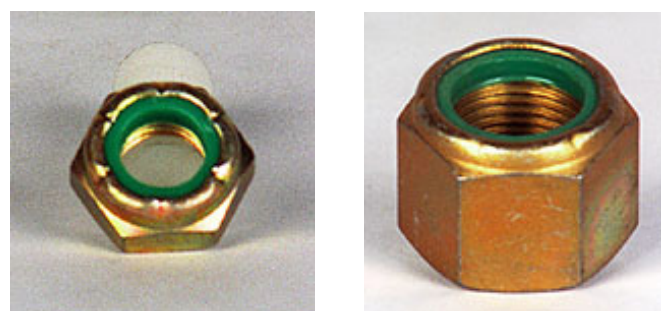
Figure 1

The owner/pilot was unsure as to why the nut had become detached. Thread debris was present on the end of the spindle bolt suggesting that the thread within the nut may have suffered an overload failure in tension.

The tension nut is deeper than the shear nut, which increases the overall width of the fork assembly, although in fact the SB does not specify a longer axle bolt. However it does advise that for retractable gear aircraft, such as G-KSIR, it may not be feasible to use the AN365 tension nut due to width constraints in the nosegear well. In such a case, it advises using a 'lower height' MS21042-4 steel self-locking nut, which offers high tensile strength.

*Notwithstanding, because nose gear shimmy can cause fairly severe side loads to the axle and fork assembly, replacement of the AN364-428A (shear) nut with an A365-428A (tension<sup>1</sup>) nut would be a prudent change.'*
