CONTENTS

G-REDL - INITIAL REPORTS

(ALL TIMES IN THIS BULLETIN ARE UTC)

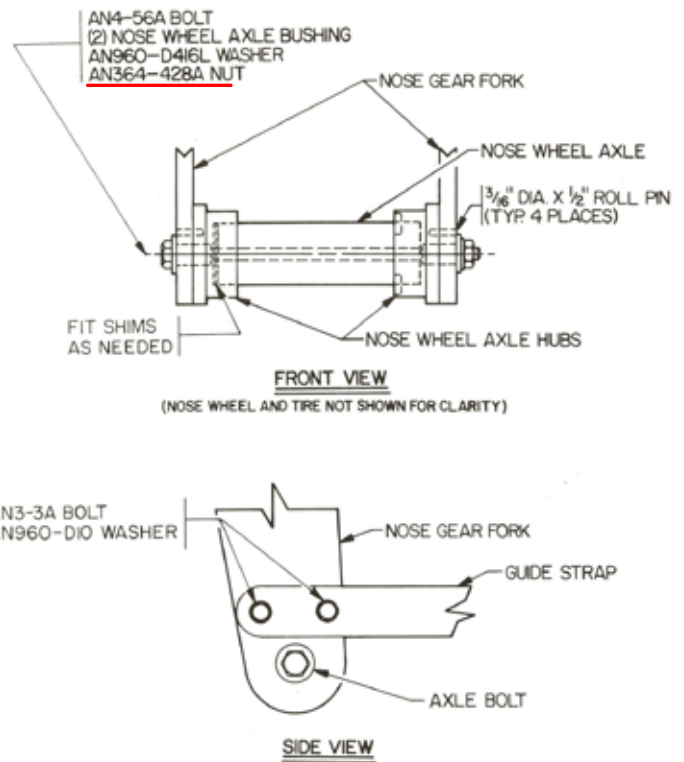
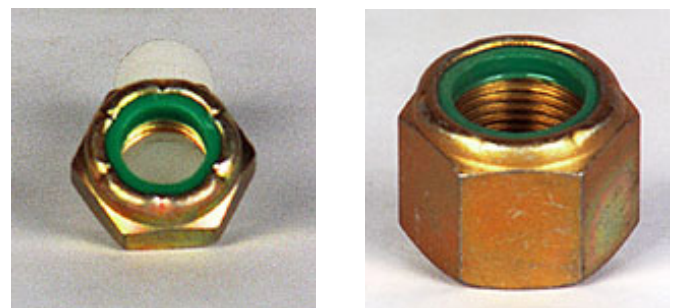
Figure 1

The owner/pilot was unsure as to why the nut had become detached. Thread debris was present on the end of the spindle bolt suggesting that the thread within the nut may have suffered an overload failure in tension.

Notwithstanding, because nose gear shimmy can cause fairly severe side loads to the axle and fork assembly, replacement of the AN364-428A (shear) nut with an A365-428A (tension¹) nut would be a prudent change.'

The tension nut is deeper than the shear nut, which increases the overall width of the fork assembly, although in fact the SB does not specify a longer axle bolt. However it does advise that for retractable gear aircraft, such as G-KSIR, it may not be feasible to use the AN365 tension nut due to width constraints in the nose gear well. In such a case, it advises using a 'lower height' MS21042-4 steel self-locking nut, which offers high tensile strength.
