SPECIAL BULLETINS

INTERIM REPORTS

(ALL TIMES IN THIS BULLETIN ARE UTC)

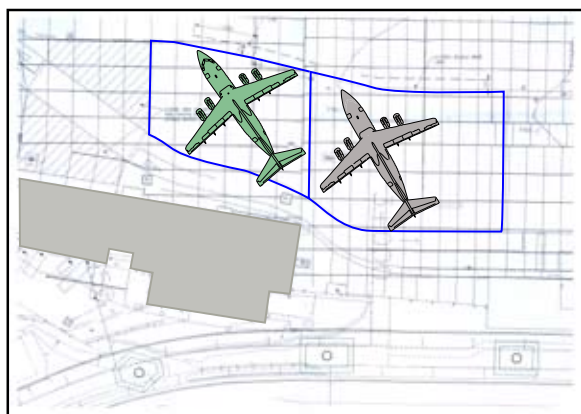
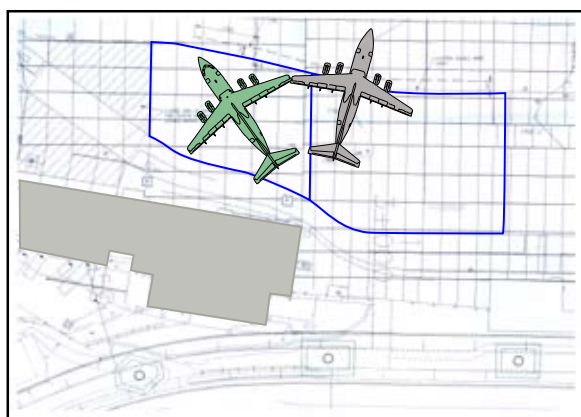
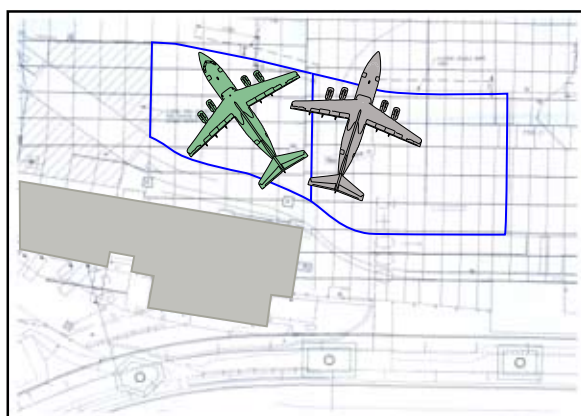
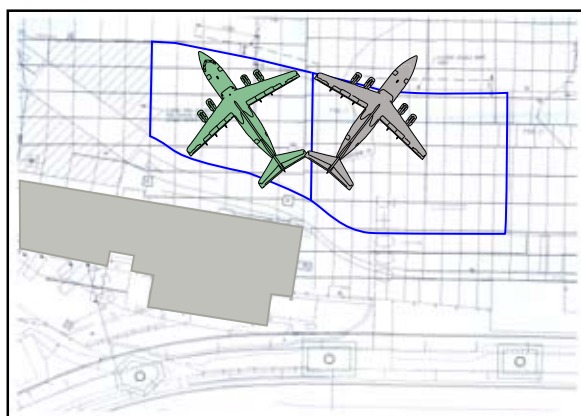
Figure 1

Position of the aircraft after the initial movement of D-AVRJ, which has stopped due to inadequate clearance between the left wing tip of D-AVRJ and the right wing tip of G-BZAT

Position of the aircraft after D-AVRJ has taxied forward and contact has been made between the two horizontal tail planes

Sequence of events leading up to the collision

The collision occurred due to a combination of the RJ100 on Stand 11 being parked 1 m to the right of its stand centreline, D-AVRJ on Stand 10 being pushed back onto a heading which further reduced the tail clearance, and the limited clearance between aircraft of this size when using these stands. The absence of a person monitoring the tail area meant that the inadequate tail clearance was not identified prior to the collision.

The safety actions already taken by the airport operator following this incident should reduce the risk of tail collisions between aircraft operating from Stands 10 and 11 at London City Airport. Therefore no Safety Recommendations are considered necessary.

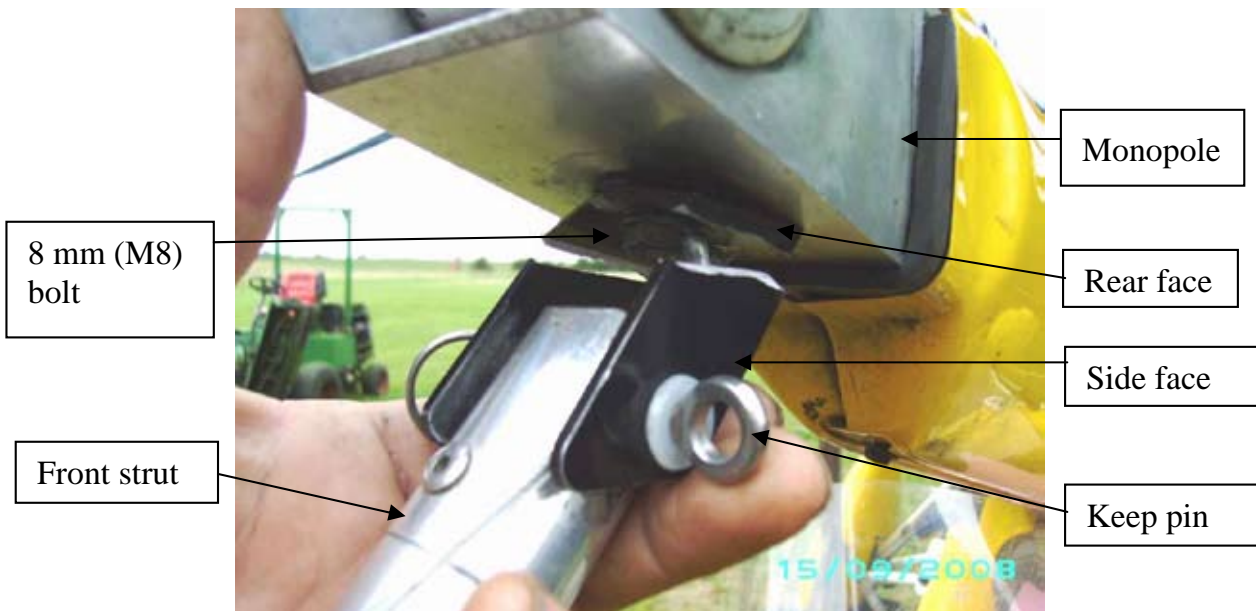
When rigging the aircraft it is possible for the upper bracket to rotate about the M8 securing bolt, such that the bracket is then orientated upside down. During the investigation a bracket on another Quantum aircraft was orientated upside down and an attempt was made to fit the front strut without the wing attached to the monopole. With the bracket in this orientation the distance between the keep pin holes in the bracket and the lower strut assembly was greater than when the bracket was correctly orientated and it was not possible to fit the keep pins. However, the manufacturer has stated that with the wing fitted to the monopole, the

Figure 1
Failed front strut bracket on G-BZMI

structure can flex sufficiently to allow the pins to be fitted with the upper bracket orientated upside down. In this configuration the front strut would then be subject to a tensile preload when the monopole overcentre catch is moved to the engaged position.
