CONTENTS

SPECIAL BULLETINS

INTERIM REPORTS

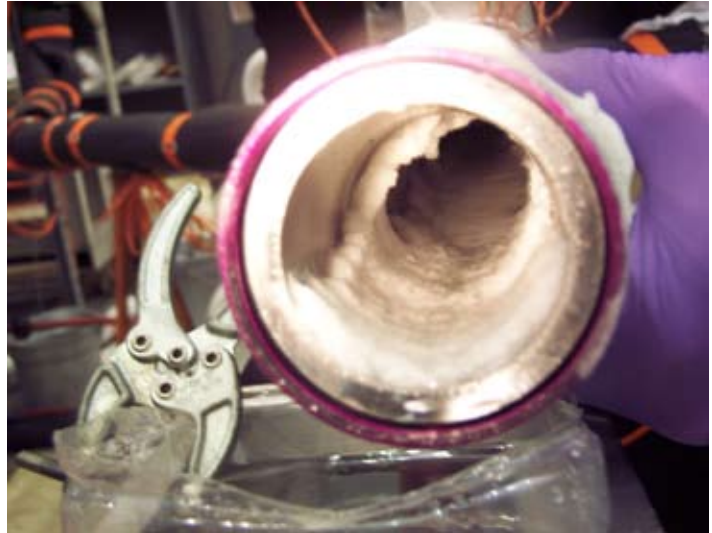
Figure 1

There was less repeatability in the amount of ice found in the fuel pipes at the end of the accumulation runs when the duration was increased from 3 to 6 hours. Several tests were carried out, using the same batch of fuel, at a fuel temperature of -20°C (-4°F) with quite different results. The amount of ice within the system ranged from very little ice to a build up of approximately 6 mm along the bottom of the pipe and 1 to 2 mm around the circumference of the pipe (Figure 1). However, it is possible that on some of the runs, ice might have been released before the end of the test.

Ice in the flexible hose located at the rear of the strut

Examination of the melted ice showed that it consisted of a mixture of water and fuel. The quantity of water in the ice deposited along the inside of the fuel pipes in the strut area was greater than the amount found necessary, in previous tests, to restrict the FOHE.

It is recommended that Boeing and Rolls-Royce jointly review the aircraft and engine fuel system design for the Boeing 777, powered by Rolls-Royce Trent 800 engines, to develop changes which prevent ice from causing a restriction to the fuel flow at the fuel oil heat exchanger.

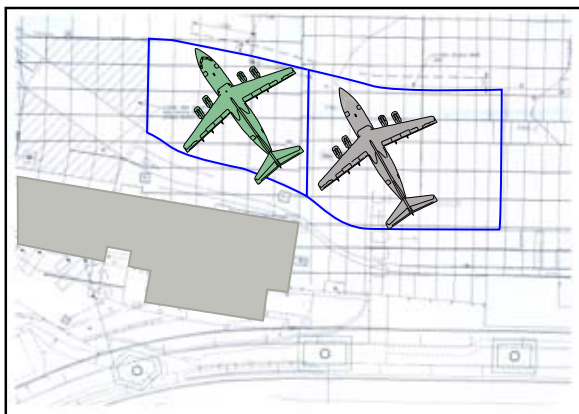
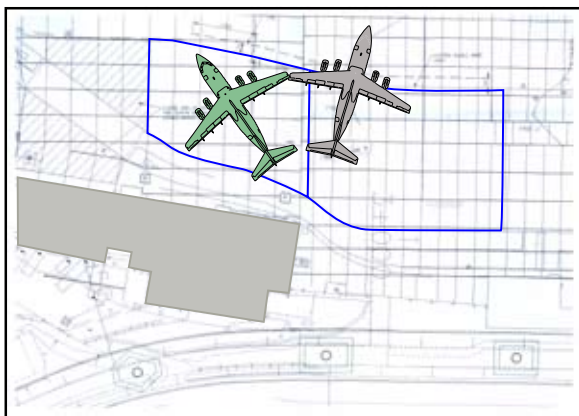
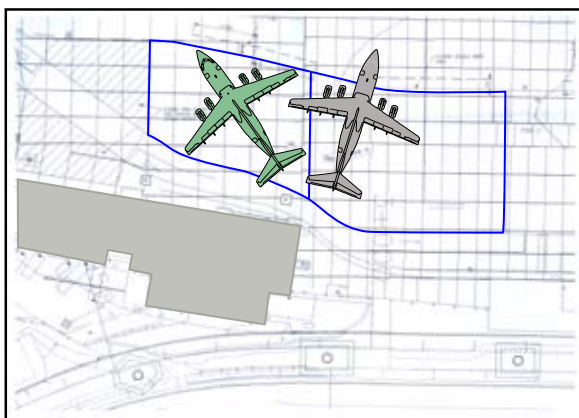
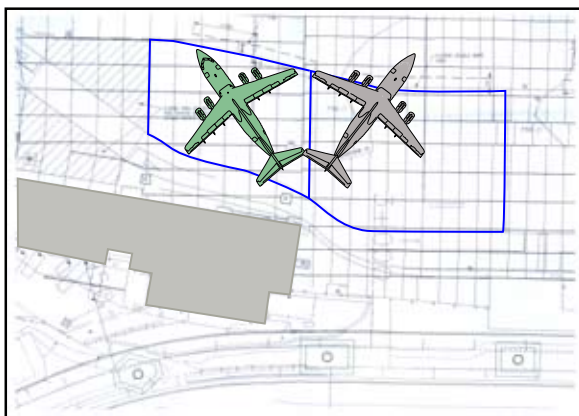
Figure 1
Sequence of events leading up to the collision

Location of the two parked aircraft.
D-AVRJ is the aircraft on the right and is about to taxi off the stand

Position of the aircraft after the initial movement of D-AVRJ, which has stopped due to inadequate clearance between the left wing tip of D-AVRJ and the right wing tip of G-BZAT

Position of the aircraft after D-AVRJ has been pushed backwards by a tug to provide additional wing tip clearance

Position of the aircraft after D-AVRJ has taxied forward and contact has been made between the two horizontal tail planes

The collision occurred due to a combination of the RJ100 on Stand 11 being parked 1 m to the right of its stand centreline, D-AVRJ on Stand 10 being pushed back onto a heading which further reduced the tail clearance, and the limited clearance between aircraft of this size when using these stands. The absence of a person monitoring the tail area meant that the inadequate tail clearance was not identified prior to the collision.

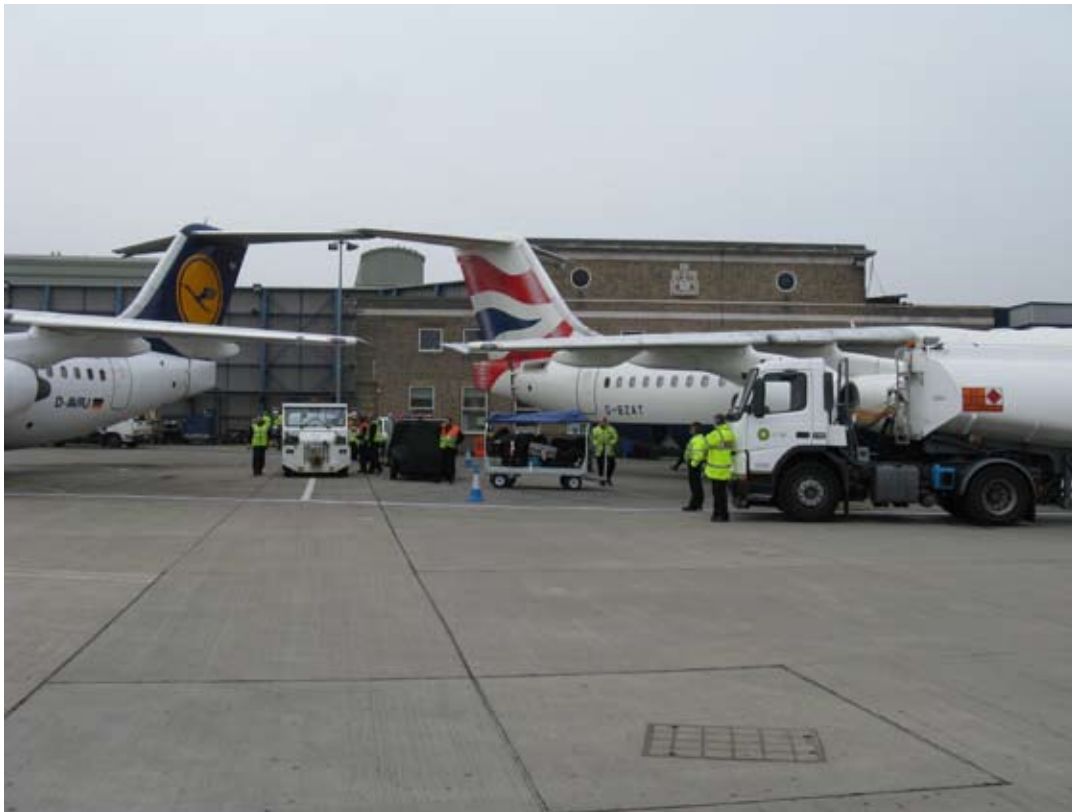
Figure 2

Photograph showing contact between D-AVRJ and G-BZAT

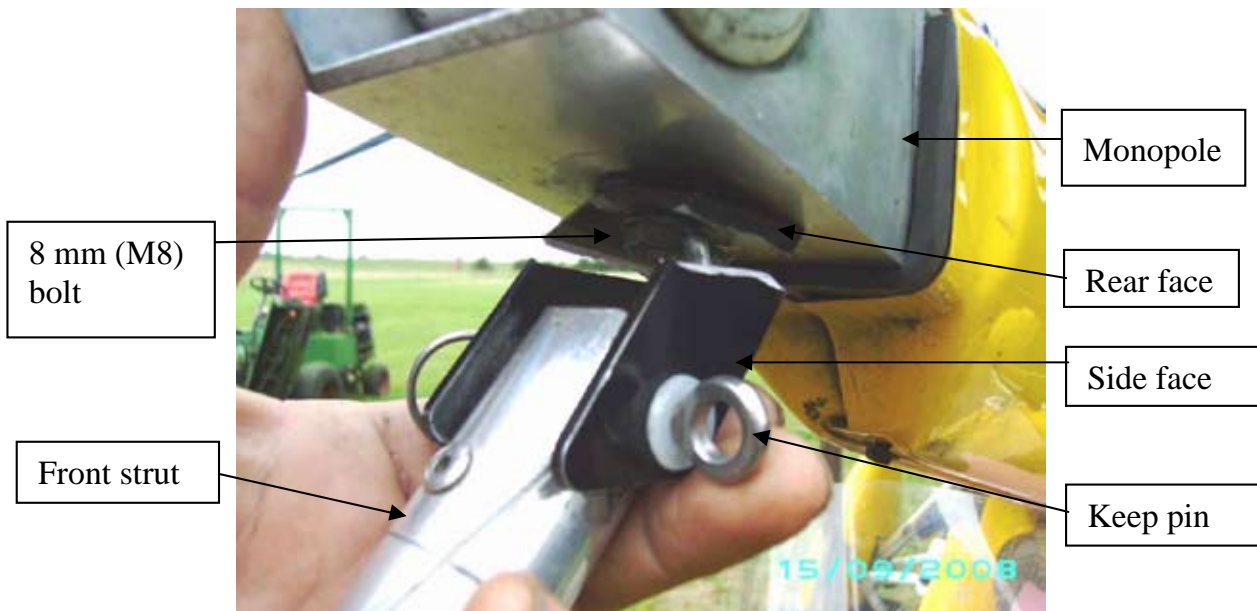
Figure 1
Failed front strut bracket on G-BZMI

When rigging the aircraft it is possible for the upper bracket to rotate about the M8 securing bolt, such that the bracket is then orientated upside down. During the investigation a bracket on another Quantum aircraft was orientated upside down and an attempt was made to fit the front strut without the wing attached to the monopole. With the bracket in this orientation the distance between the keep pin holes in the bracket and the lower strut assembly was greater than when the bracket was correctly orientated and it was not possible to fit the keep pins. However, the manufacturer has stated that with the wing fitted to the monopole, the

structure can flex sufficiently to allow the pins to be fitted with the upper bracket orientated upside down. In this configuration the front strut would then be subject to a tensile preload when the monopole overcentre catch is moved to the engaged position.

The aircraft manufacturer investigated the failure and concluded that the bracket had been fitted upside down. During that investigation, load tests were carried out on two brackets: one was incorrectly fitted and the second was fitted in the correct orientation. On the bracket which had been fitted upside down the rear face started to bow when a load of 310 kgf was applied and there was evidence of cracking along the side faces when the load reached 610 kgf. Both side faces

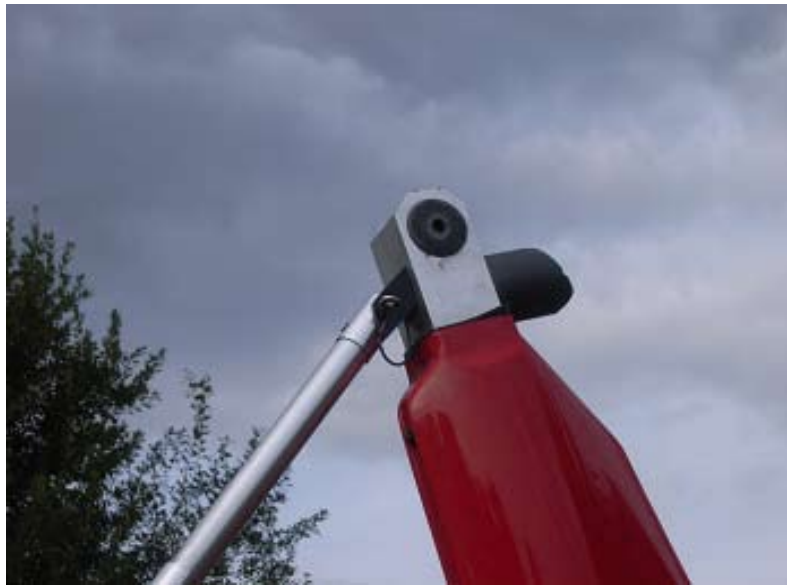
Figure 2

When the microlight is correctly rigged the front strut is aligned with the upper bracket (Figure 2).

Correct orientation of bracket
