CONTENTS

ACCIDENT

Synopsis

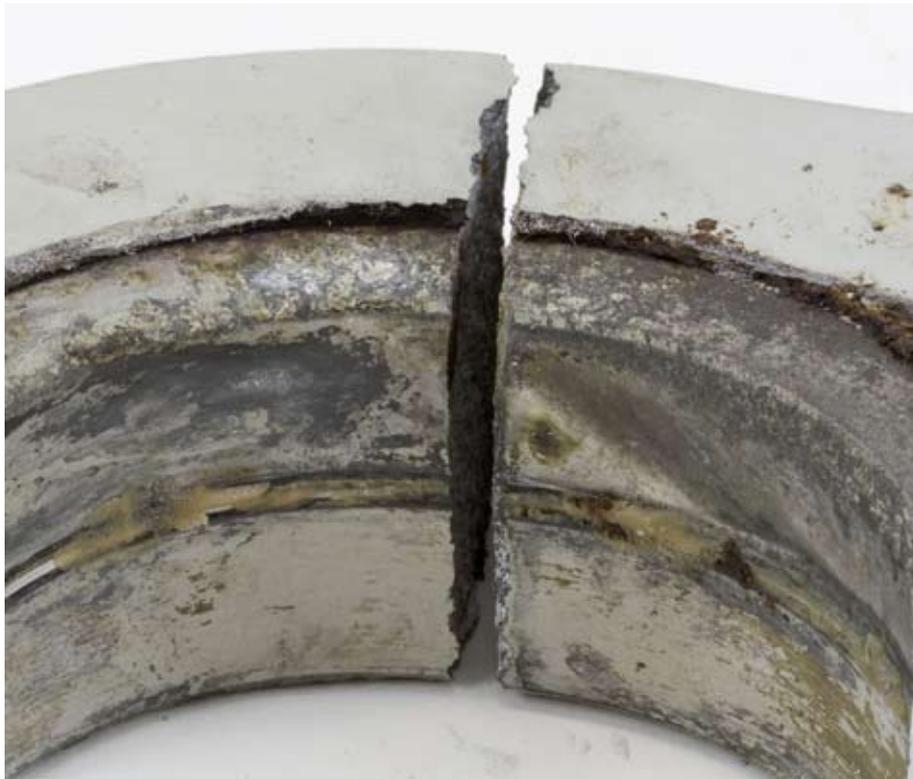
Figure 6

investigation and analysis. The cracked section of the lug was removed (Figure 6), the fracture faces cleaned and then inspected using a scanning electron microscope. This analysis determined that the crack was caused by fatigue growth initiating from surface corrosion pitting around the edge of the bore (Figure 7). From the staining on the surfaces and oxidation/corrosion damage on the fracture surface, it is likely that the fatigue growth had taken place over a considerable period of time before the final fracture occurred. It was not possible to find sufficient detail to determine exactly how long the fatigue crack had been present but the critical crack length was consistent with previous failures. There is no evidence to suggest that the material was in any way deficient as the microstructure, hardness and conductivity all appeared

to be as per specification. The crack was located in the one o'clock position of the lug looking forward. A crack in this location represents a failure of the primary load path for the lug. The secondary load path is via the opposite quadrant of the lug and no cracking was found in this location.

Cracked section of forward lug with the bush removed

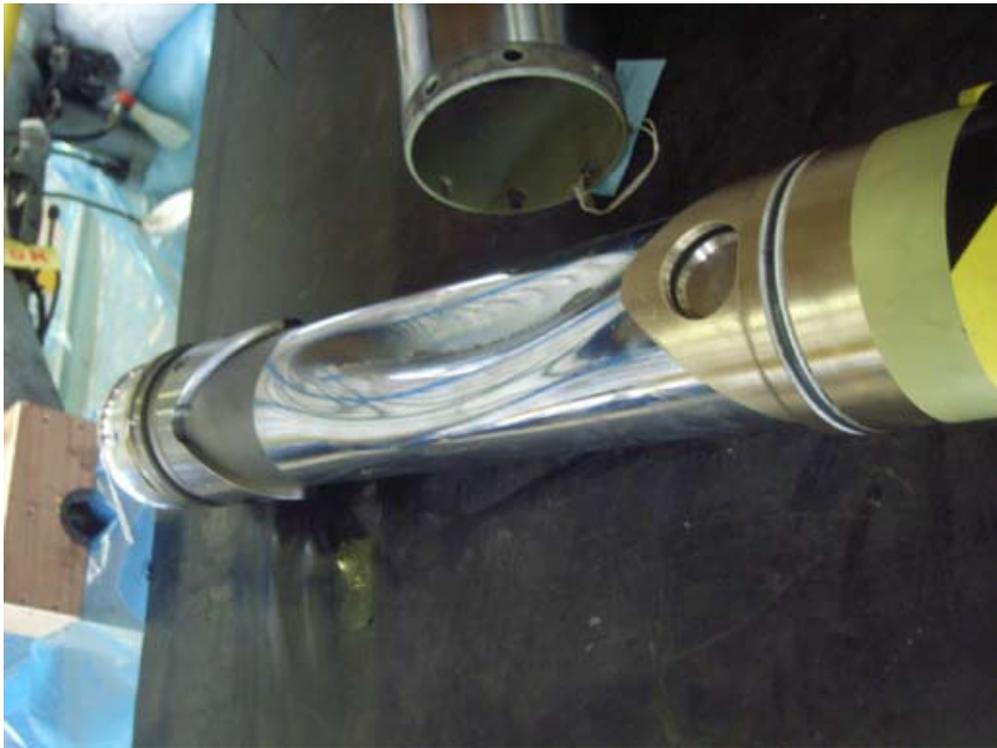
Figure 4

Fault finding of this defect initially concentrated on the nose leg proximity sensors. In order to check their operation, the nose of the aircraft was jacked up, but the nose leg did not extend as expected and fluid started leaking from the assembly. Further examination and disassembly identified that the internal shock absorber assembly was severely distorted and a link rod, which connects the upper arm of the torque link to the moving proximity sensor target mounting, was bent.

View of damaged inner cylinder

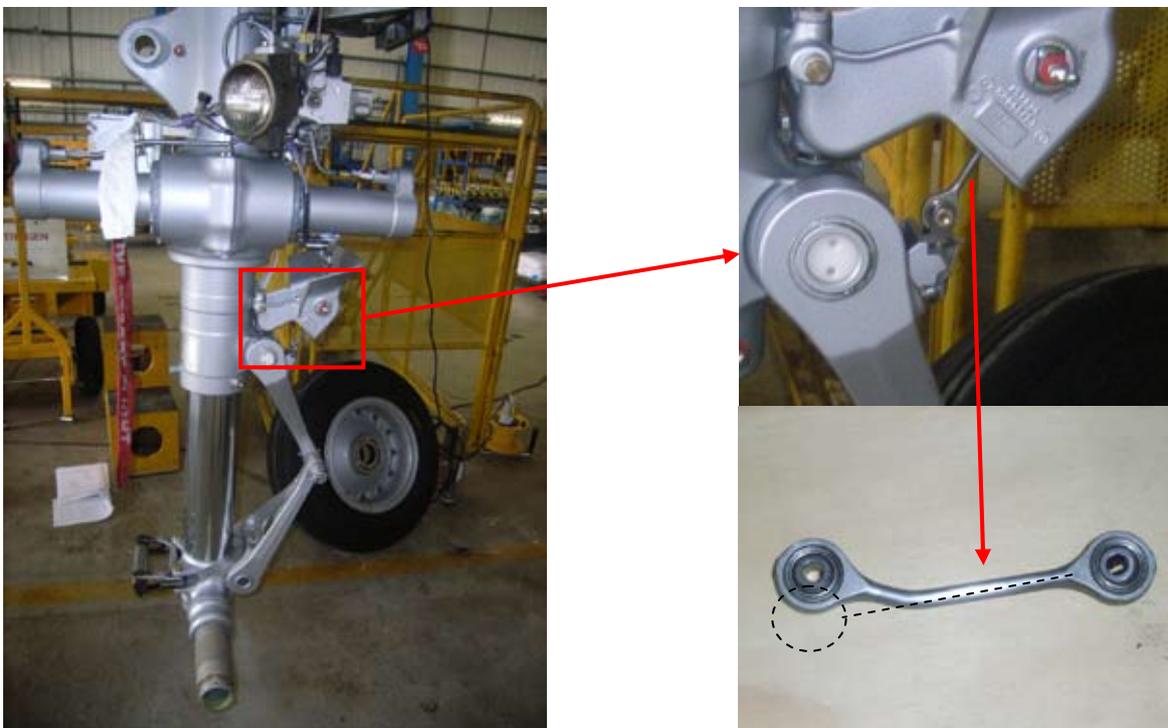
Figure 5

View of replacement nose gear leg showing location of link rod and bent link rod from incident leg
