CONTENTS

COMMERCIAL AIR TRANSPORT

SERIOUS INCIDENT

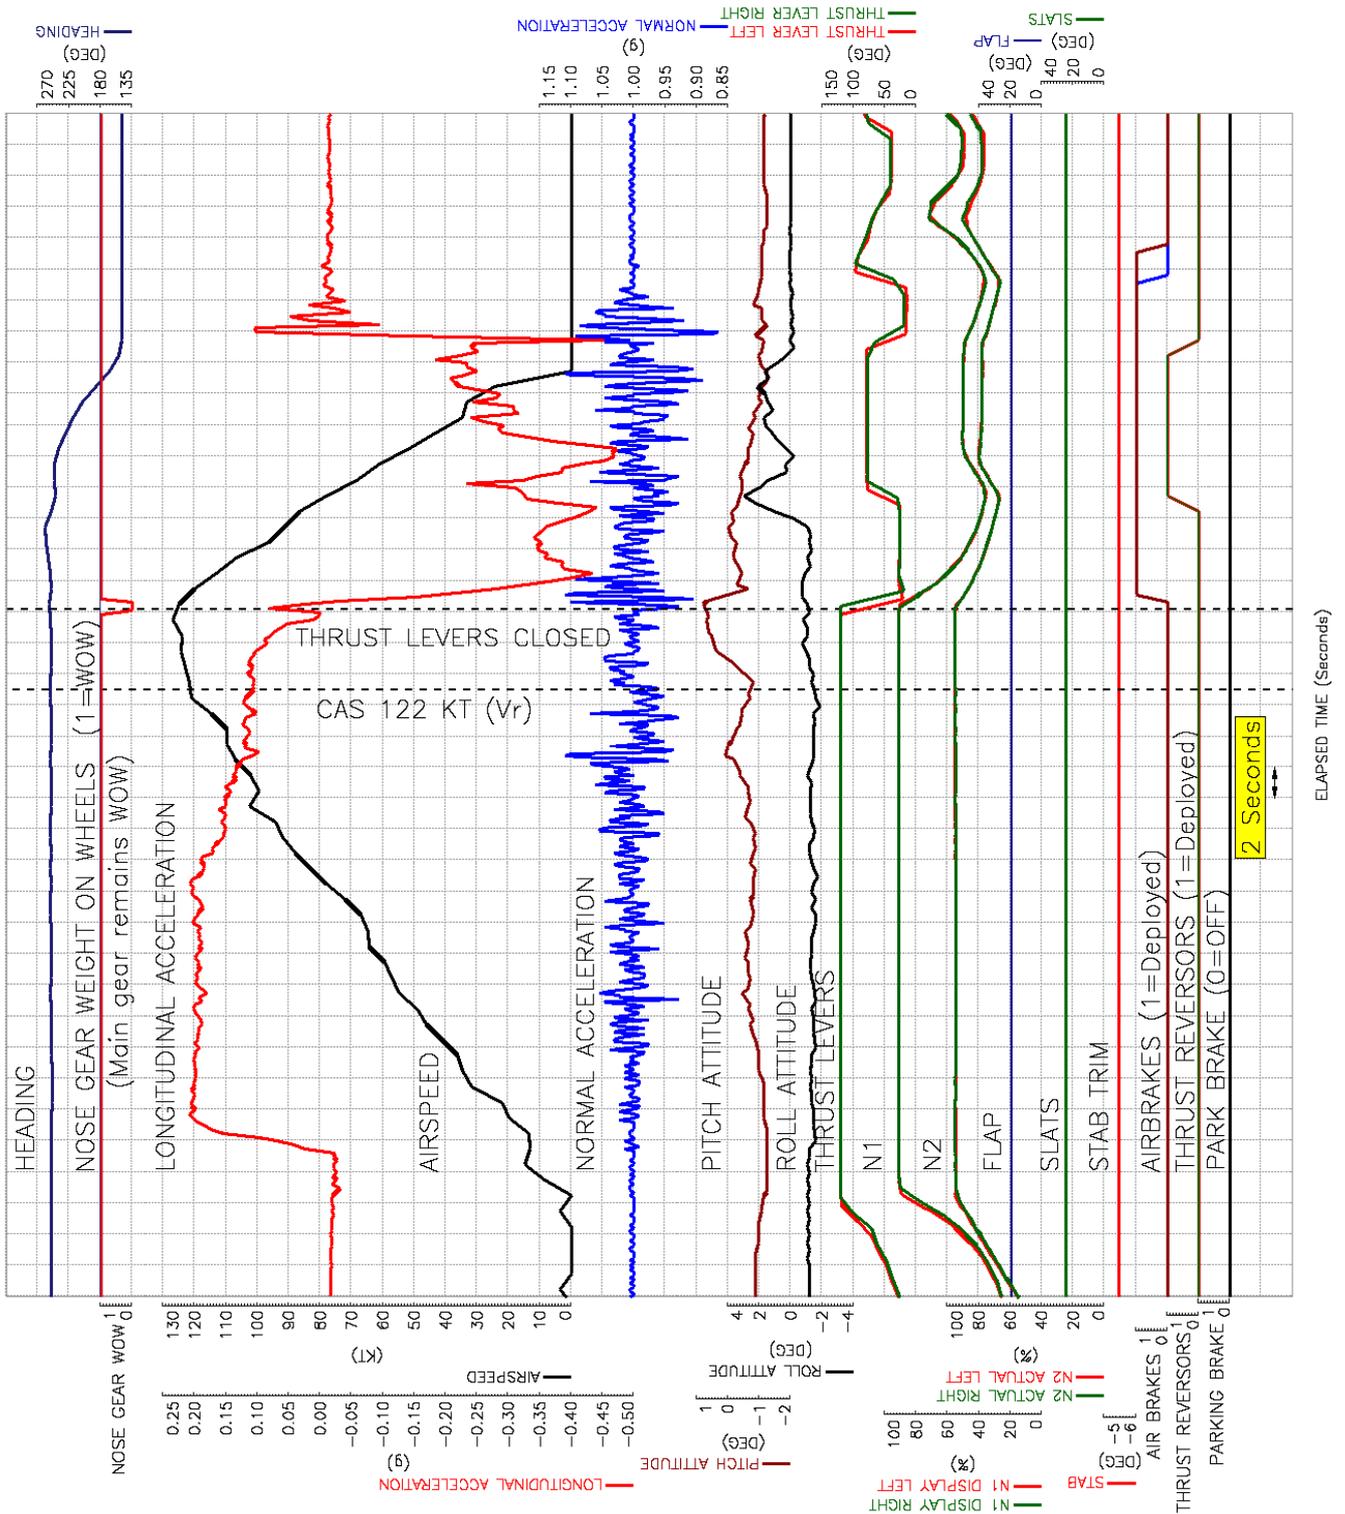
both engines to the maximum takeoff power of 91% N1 (Figure 4). Having confirmed that the engine power was set and the co-pilot was holding the control column, the commander advised “BRAKE RELEASE” and the aircraft started to accelerate. During the initial acceleration phase, the longitudinal acceleration remained predominantly stable at about 0.2 g, and as the airspeed reached 80 kt, the commander took over the control column. At about the same time, the longitudinal acceleration started to reduce, and at 119 kt (V_1), it had stabilised at just greater than 0.1 g. The aircraft was about 860 m from the end of the runway at this time. Approximately one second later, at an airspeed of 122 kt, the co-pilot called “ROTATE”. Three seconds later, the commander confirmed that the aircraft was not responding to his control column input and two seconds later the thrust levers were closed, which was shortly followed by deployment of the airbrakes and the rapid deceleration of the aircraft. The flight crew stated that they had applied heavy manual braking at this time. During the five seconds between the rotate command and the rejection of the takeoff, the pitch attitude of the aircraft had increased by less than 2°, from about 1° nose-down to just less than 1° nose-up, and the airspeed had reached a maximum of 128 kt. About two seconds prior to closing of the thrust levers, the longitudinal acceleration had further reduced to nearly 0 g. The aircraft was about 570 m (± 40 m) from the end of the runway at this time.

Figure 4
D-CKDM - Rejected takeoff at Northolt

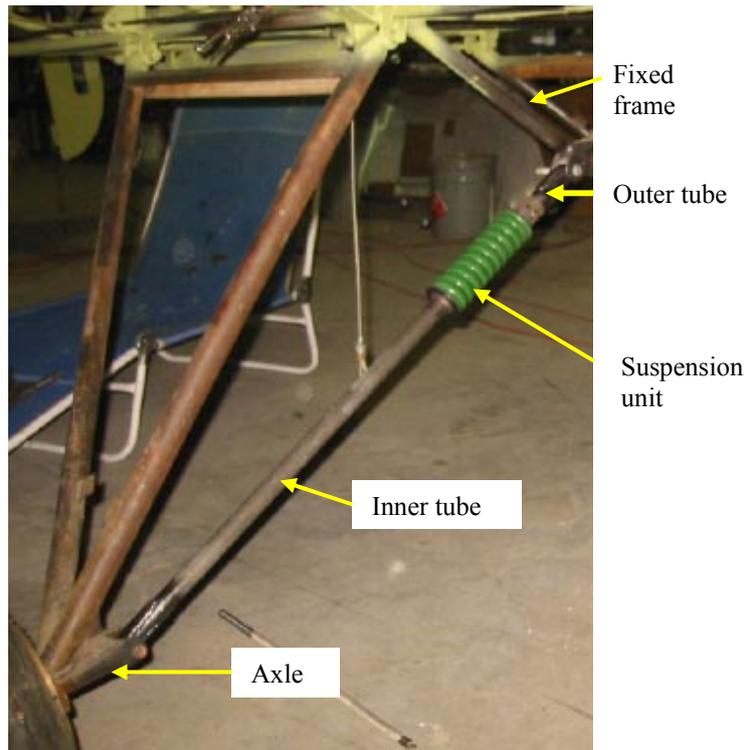
Figure 1

Right landing gear cross-strut

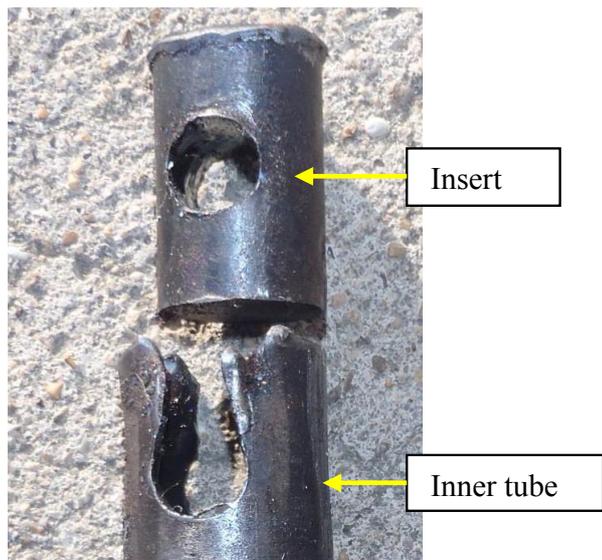
**Figure 3**

The damage to left and right inner tubes was consistent with the aircraft having landed heavily with Bolt 'A' on the right strut bottoming on the end of the slot in the outer tube. This damage could not have been sustained in the firm landing that occurred in March 2011 as it is unlikely that the right cross-strut would have remained intact during the subsequent flights.

Right inner tube

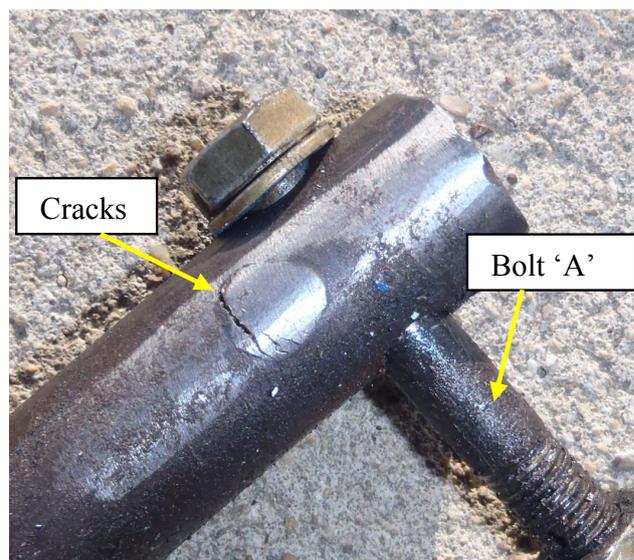
**Figure 4**

Left inner tube

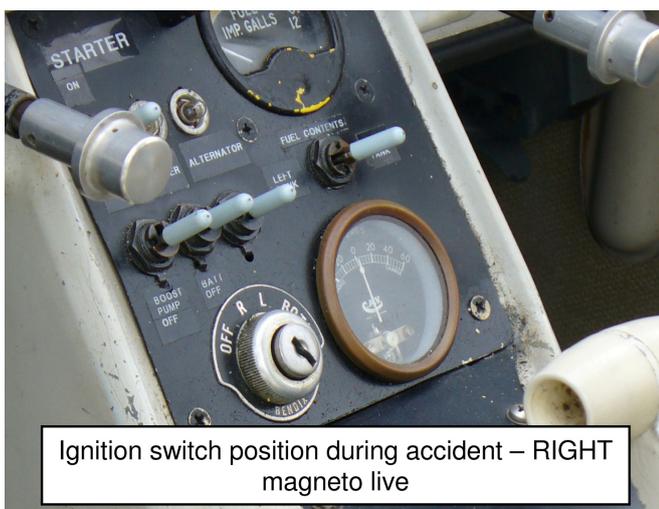
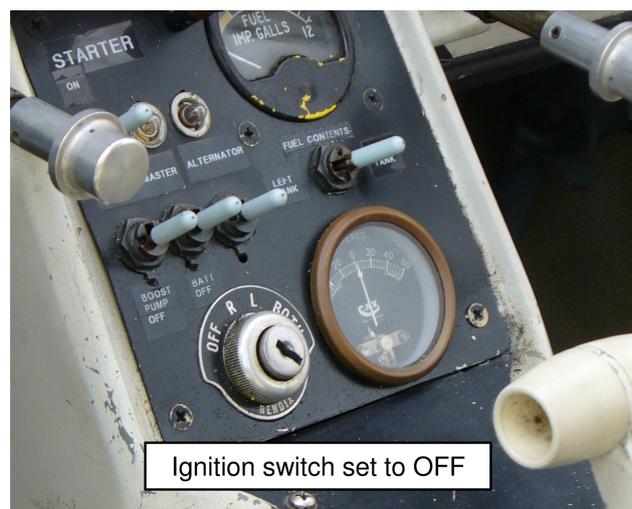
Figure 2
Ignition switch positions during and after the accident

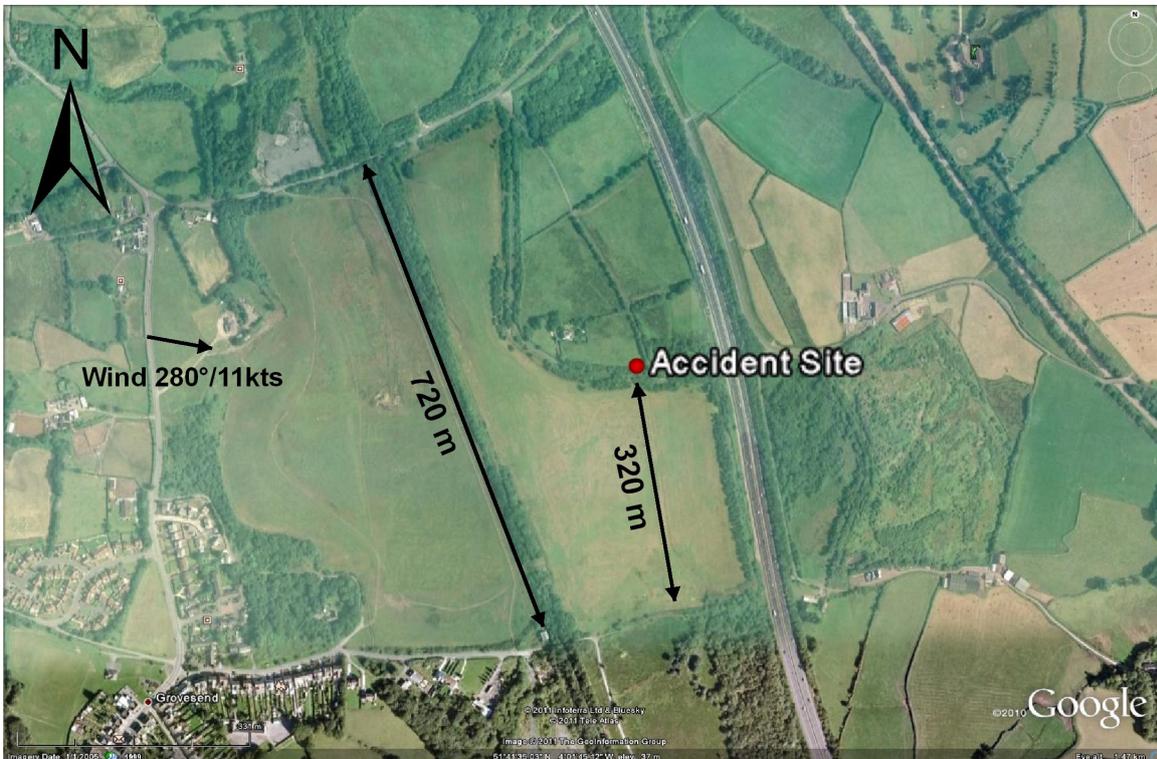
Figure 2
Fields adjacent to the accident site

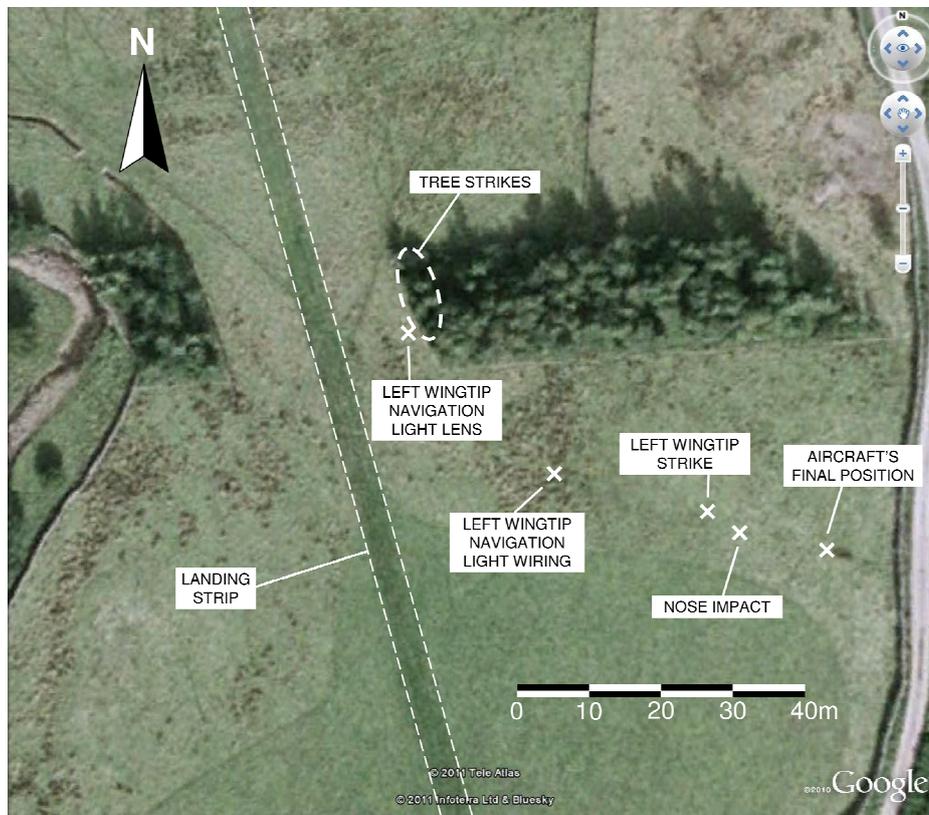
Fresh damage to trees in the wooded area adjacent to the landing strip indicated that the aircraft had struck the trees before impacting the ground beyond. Five individual tree strikes were observed, varying in height between 4 and 6 m above ground level, along a line inclined approximately 14° to the horizontal, in the direction of landing. Damage to the trees indicated that the outer 2 m of the aircraft’s left wing had been in contact with the trees. The red lens from the aircraft’s left wingtip navigation light was recovered on the ground between the wooded area and the runway, close to broken branches from the tree strikes (Figure 1).

Figure 1
Wreckage plot

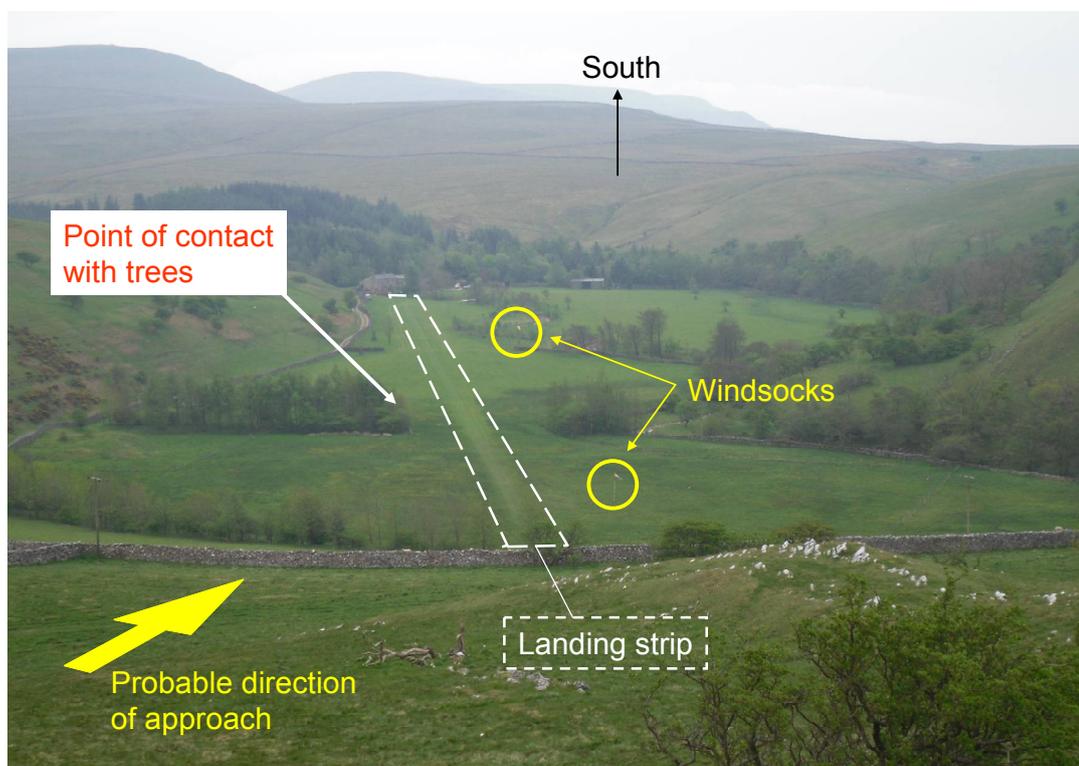
Figure 2

View of the airstrip from high ground to the north
