CONTENTS

SPECIAL BULLETINS

Eurocopter EC225 LP Super Puma	G-REDU	18-Feb-09	1
Eurocopter AS332L2 Super Puma	G-REDL	01-Apr-09	5

ACCIDENT

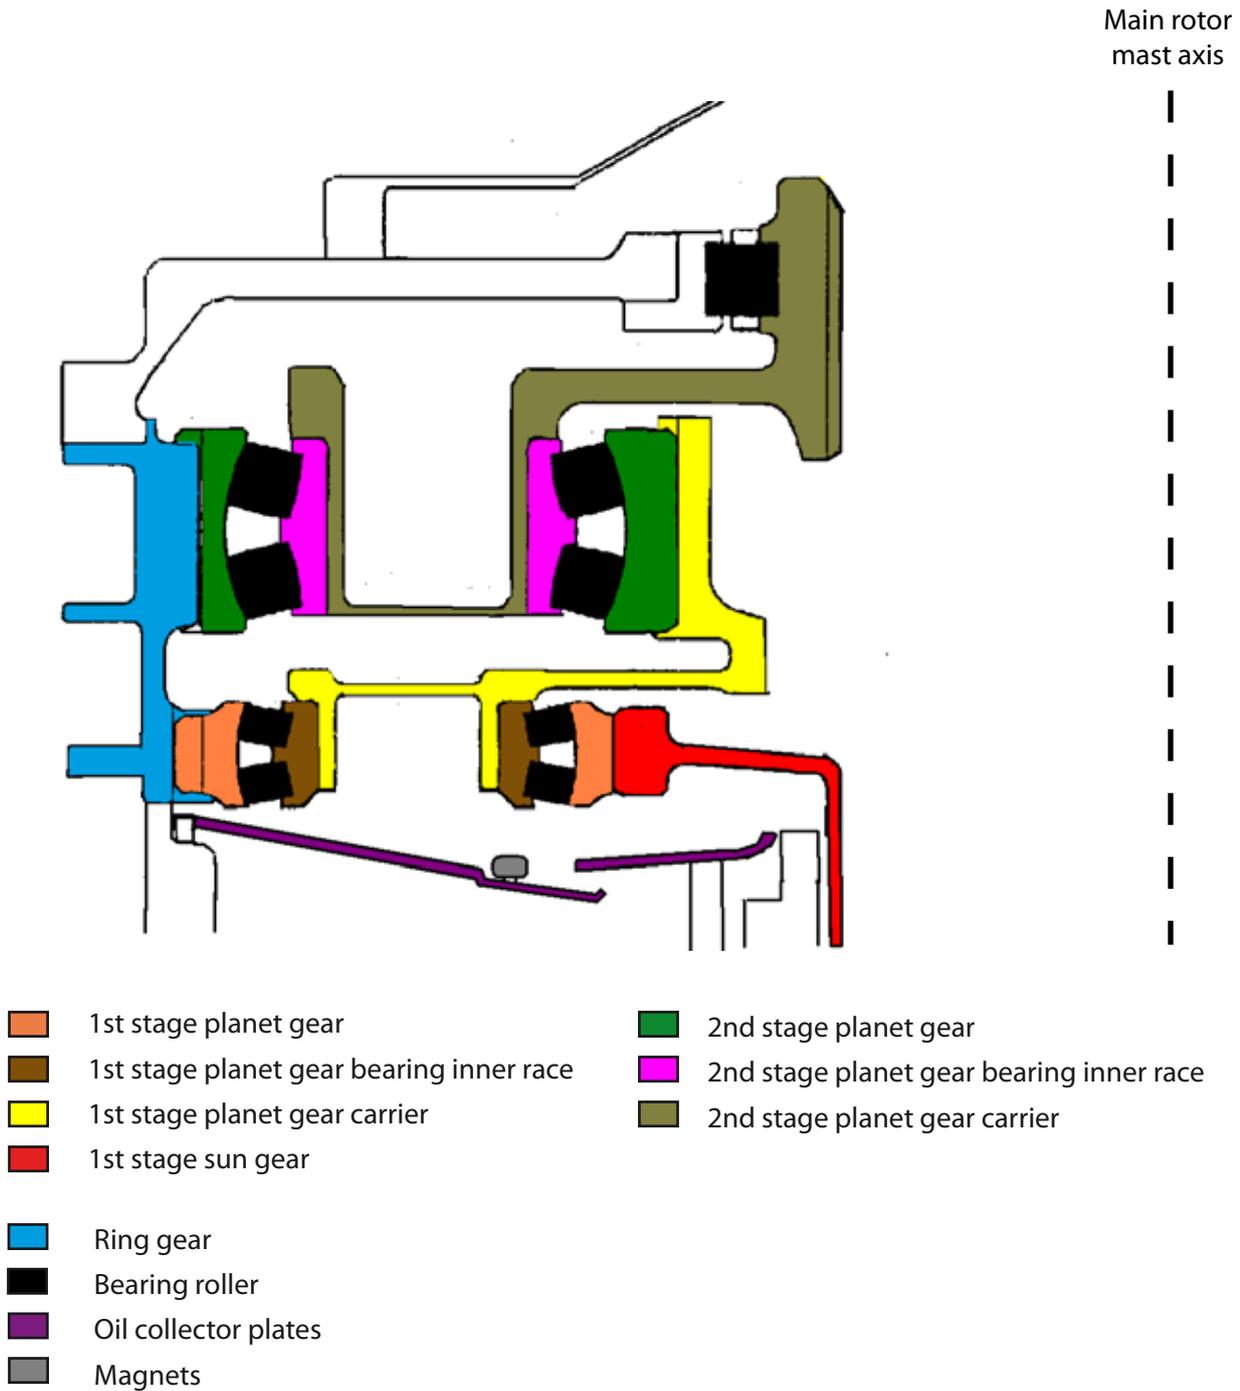
Figure 2
Schematic cross-section of epicyclic module

There is evidence of damage throughout the epicyclic module, consistent with it operating for a period whilst contaminated with sizeable debris. Several imprints of rollers from the first stage planet gear bearings are evident on second stage gears.

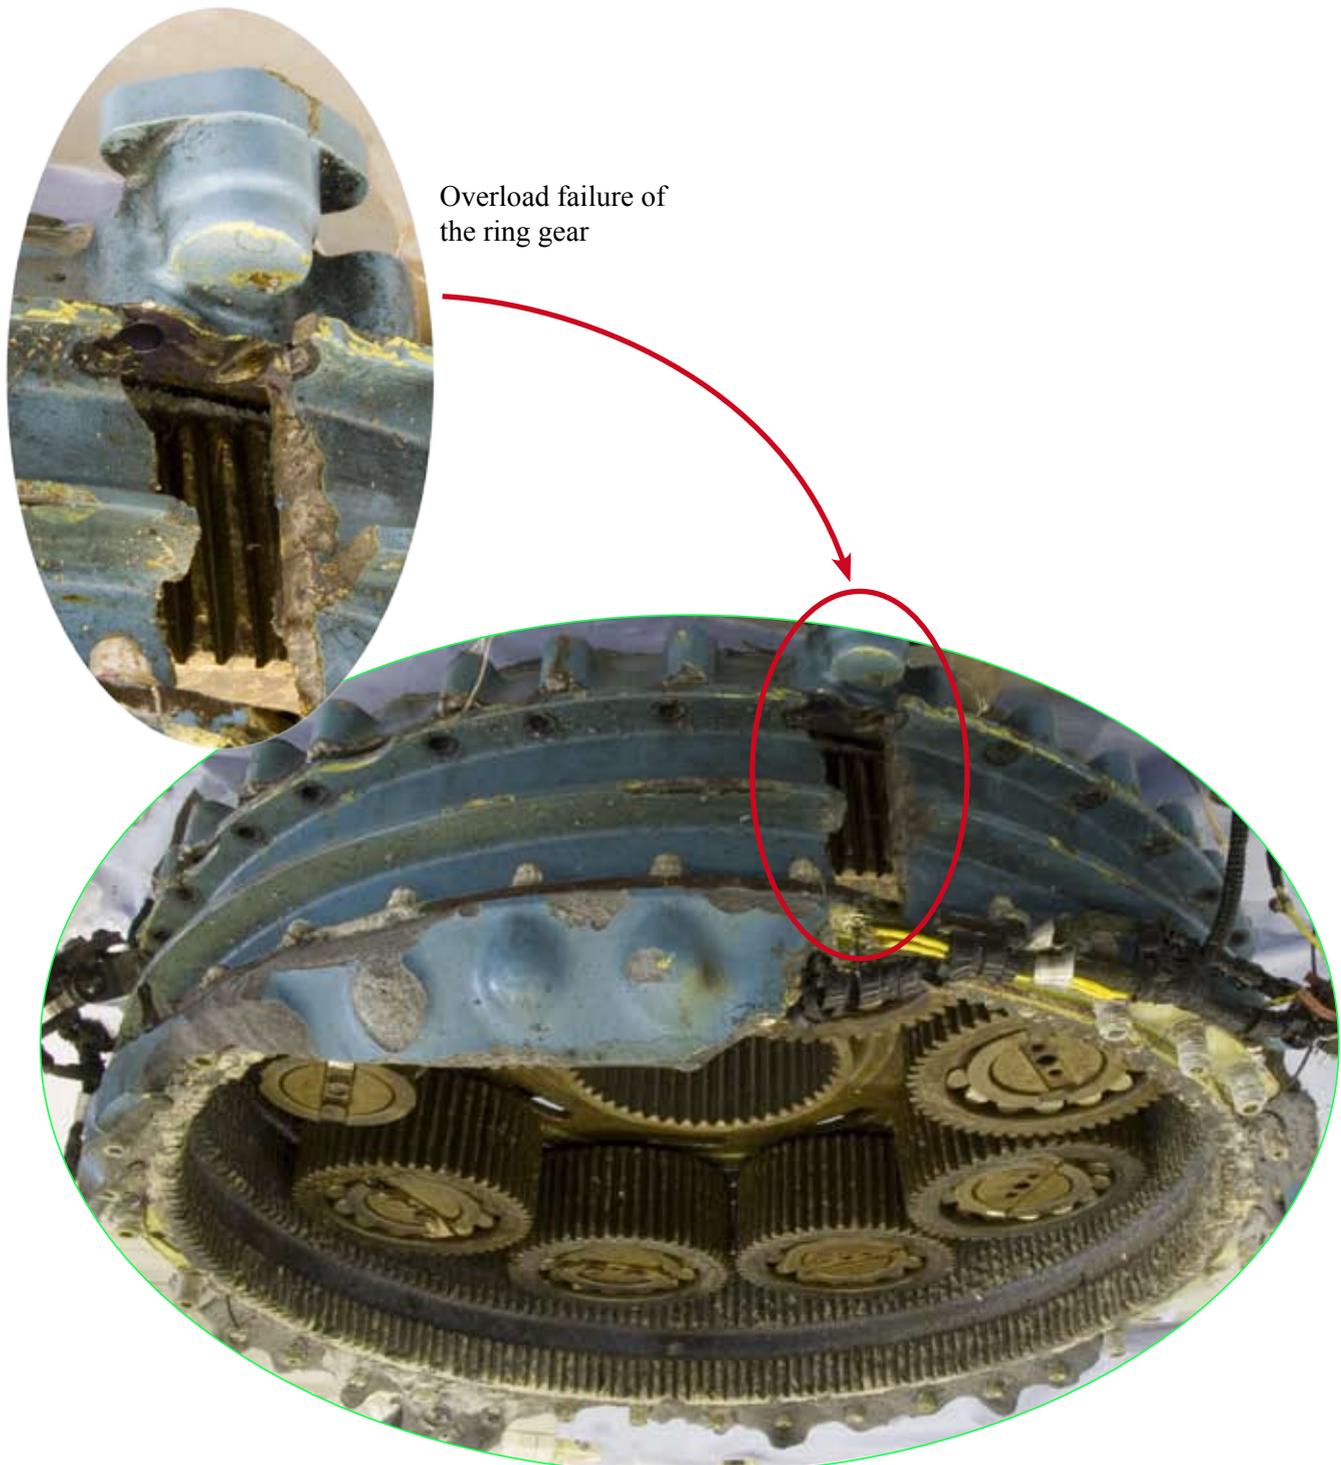
Figure 4

The ring gear (which had burst open), both sun gears, all eight of the planet gears in both stages, together with the planet gear carriers, were recovered, with the exception of approximately 33% of one planet gear from the second stage. This was the only gear in that stage to have failed.

It is considered that a section of the failed second stage planet gear became jammed between the ring gear and a planet gear, precipitating the ring gear failure, (Figure 4). There is evidence on all gear teeth of damage caused by debris being present, consistent with the gearbox running in an abnormal condition prior to the separation of the main rotor head. However, no evidence has indicated that the flight crew were aware of any problem with the MRG until shortly before the accident, when the loss of MRG oil pressure occurred, and a noise became evident on the CVR. This was likely to have been at the time the ring gear burst open.

Failed ring gear details with second epicyclic stage reinstalled - viewed from below.

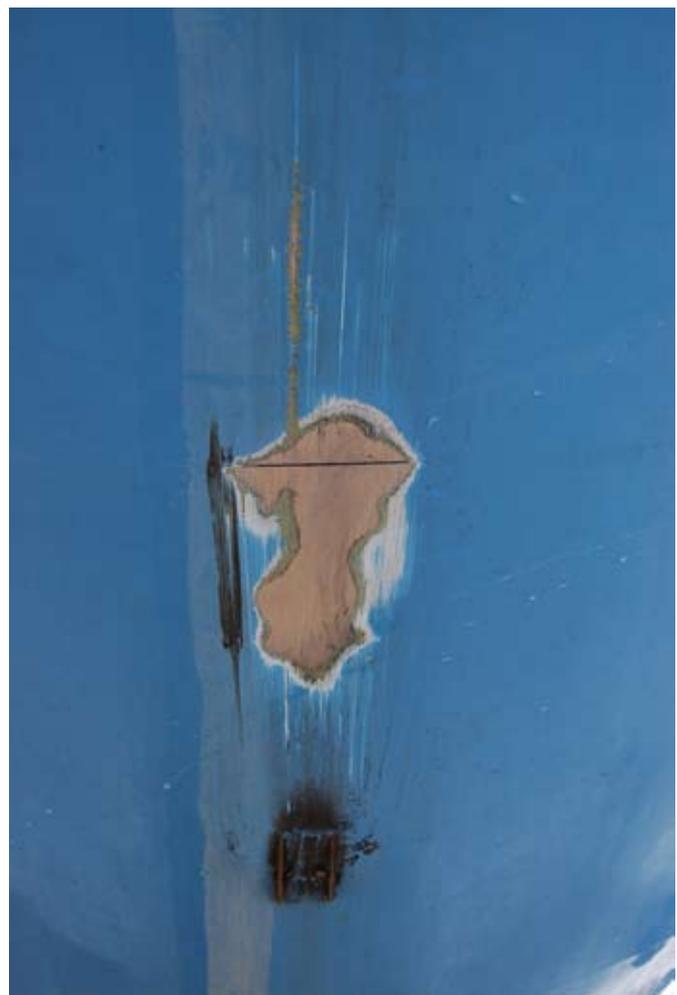
Figure 1

Damage to the underside of the aircraft tail

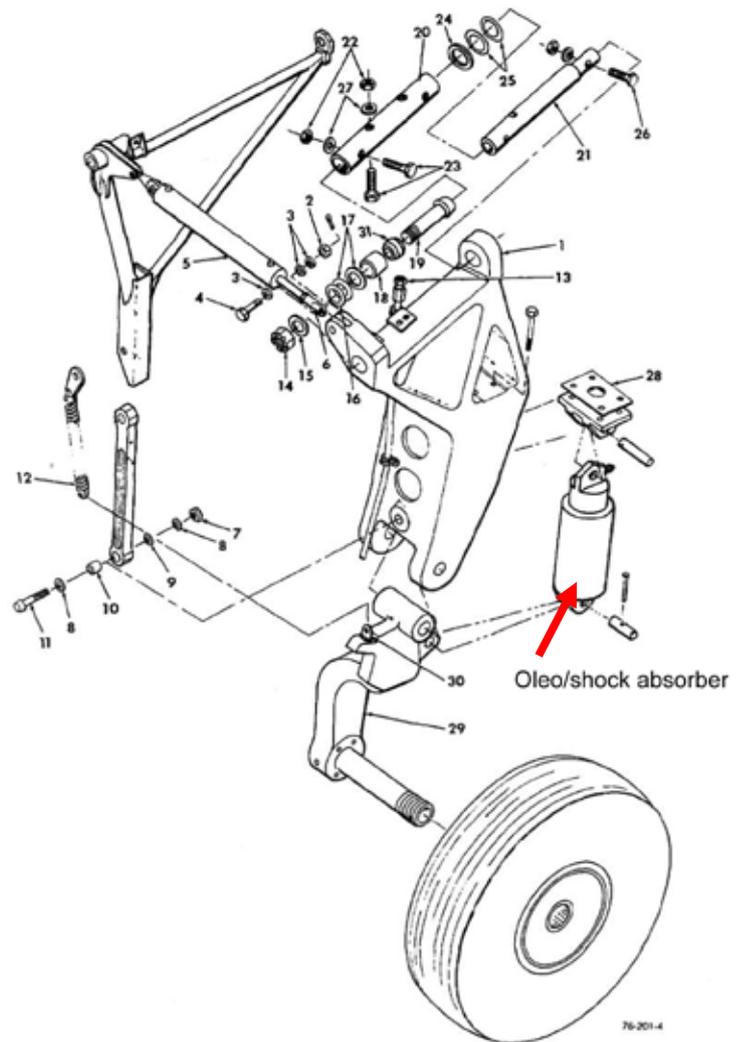
The landing gear on this type of aircraft is operated by a hydraulic system powered by an electric motor. Figure 1 is an illustration of the trailing link main landing gear where vertical movement of the wheel is controlled by an oleo strut/shock absorber. Disassembly of this strut revealed internal corrosion that had inhibited movement of its internal piston. This had had the effect of preventing the strut from fully extending, such that following the previous takeoff, it was probably no more than around three quarters of its maximum length. This in turn would have caused the wheel to trail aft of its normal weight-off-wheels position and it was found that, in this position, the wheel fouled the edge of the wheel-well. Although this had not prevented gear retraction, it had ‘hung up’ during the subsequent attempts at gear extension.

The oleo is maintained ‘on condition’, meaning it is not subjected to periodic internal inspections. Following this event, the maintenance organisation commented that they were unaware of any previous occurrences of this type of problem. The company has subsequently instigated a maintenance action at the 150 hour inspection, whereby the range of travel of the oleo struts is checked whilst the aircraft is jacked up.
