CONTENTS

COMMERCIAL AIR TRANSPORT

(ALL TIMES IN THIS BULLETIN ARE UTC)

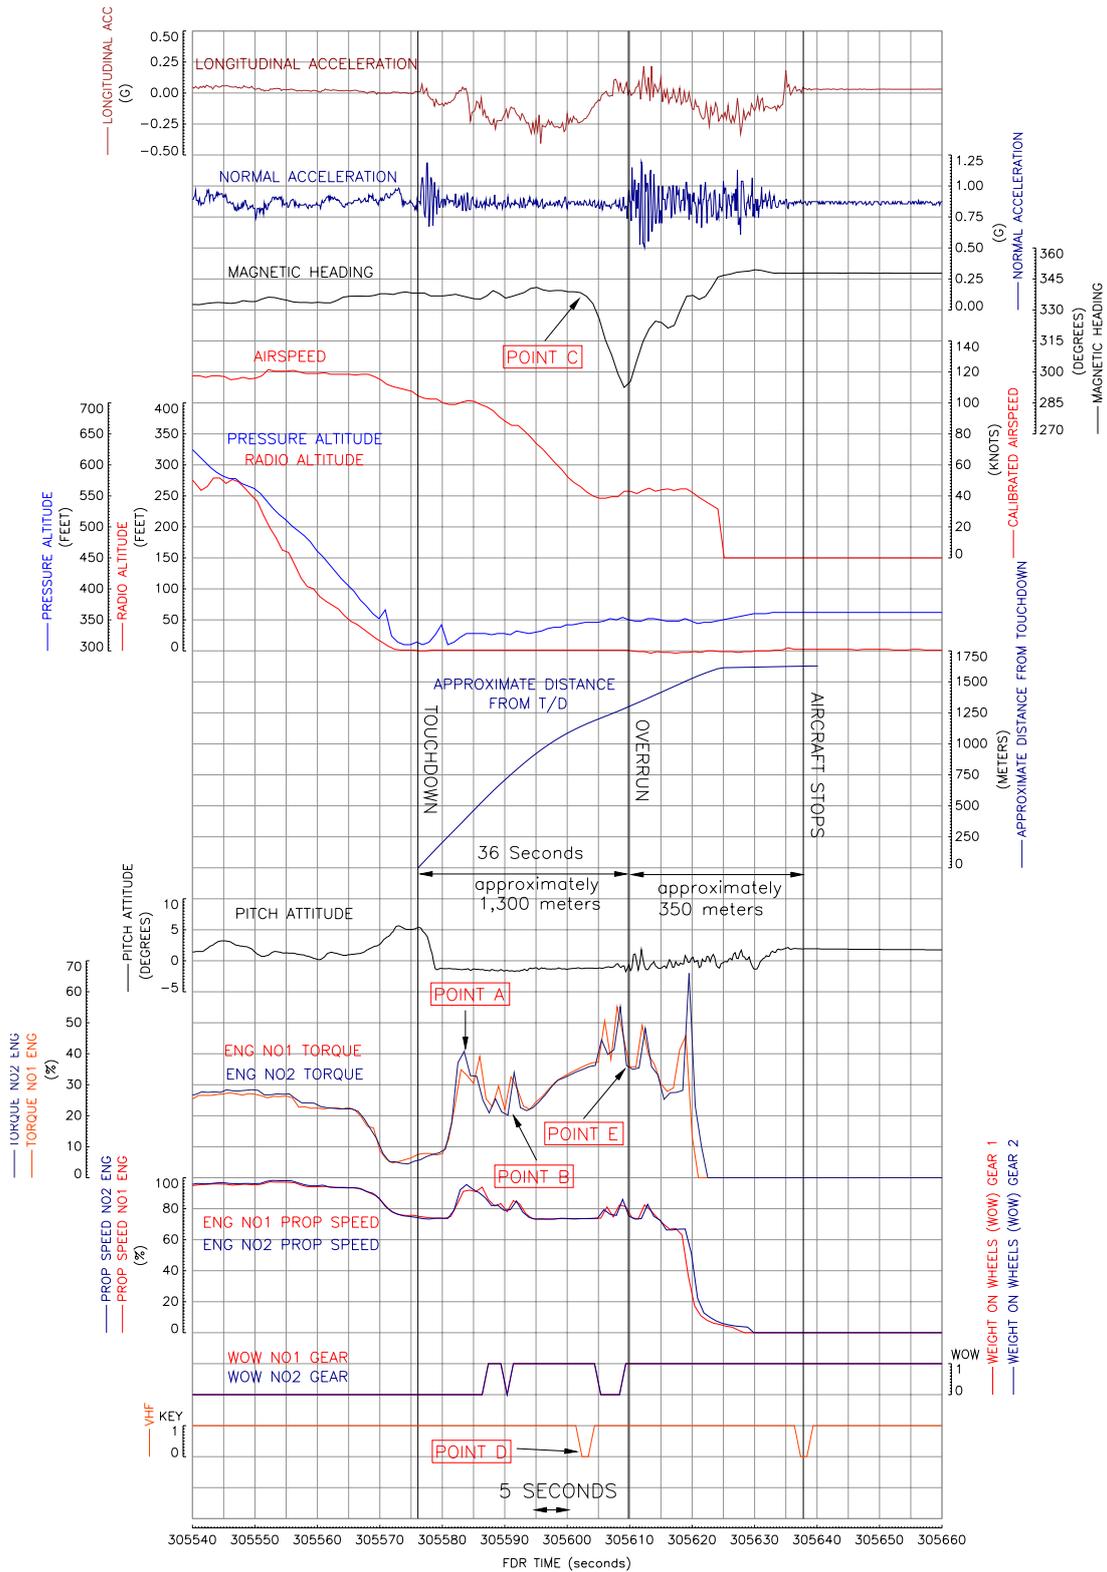
Figure 1
Salient FDR Parameters

Figure 1 provides the salient parameters of the final approach and landing. As the aircraft passed through 50 ft radio altitude, the power levers were retarded and the aircraft started to flare; airspeed was 119 kt. The aircraft touched down approximately 530 metres from the threshold of Runway 34 (approximately 1,300 metres from the end of the runway), at an airspeed of about 105 kt (a ground speed of 109 kt). Almost immediately the engine torque started to increase (from about 5% to 40%) before rapidly decreasing (Figure 1, point A), at which point the aircraft started to settle on to its wheels and the ground speed started to reduce. The engine torque then rapidly increased and decreased twice in quick succession (Figure 1, point B) and the aircraft momentarily became light on both main gears. During the second engine torque increase the co-pilot said "WE DON'T HAVE BETAS" to which the commander acknowledged "NO"; the aircraft was about 600 metres from the end of the runway and ground speed was about 92 kt.

approximately 190 metres from the end of the runway it started to deviate from the runway centre line (Figure 1, point C), turning to the left, almost coincidentally the commander advised the tower “WE GOT A PROBLEM” (Figure 1, point D) ; ground speed was about 40 kt and engine torque was at 37%.

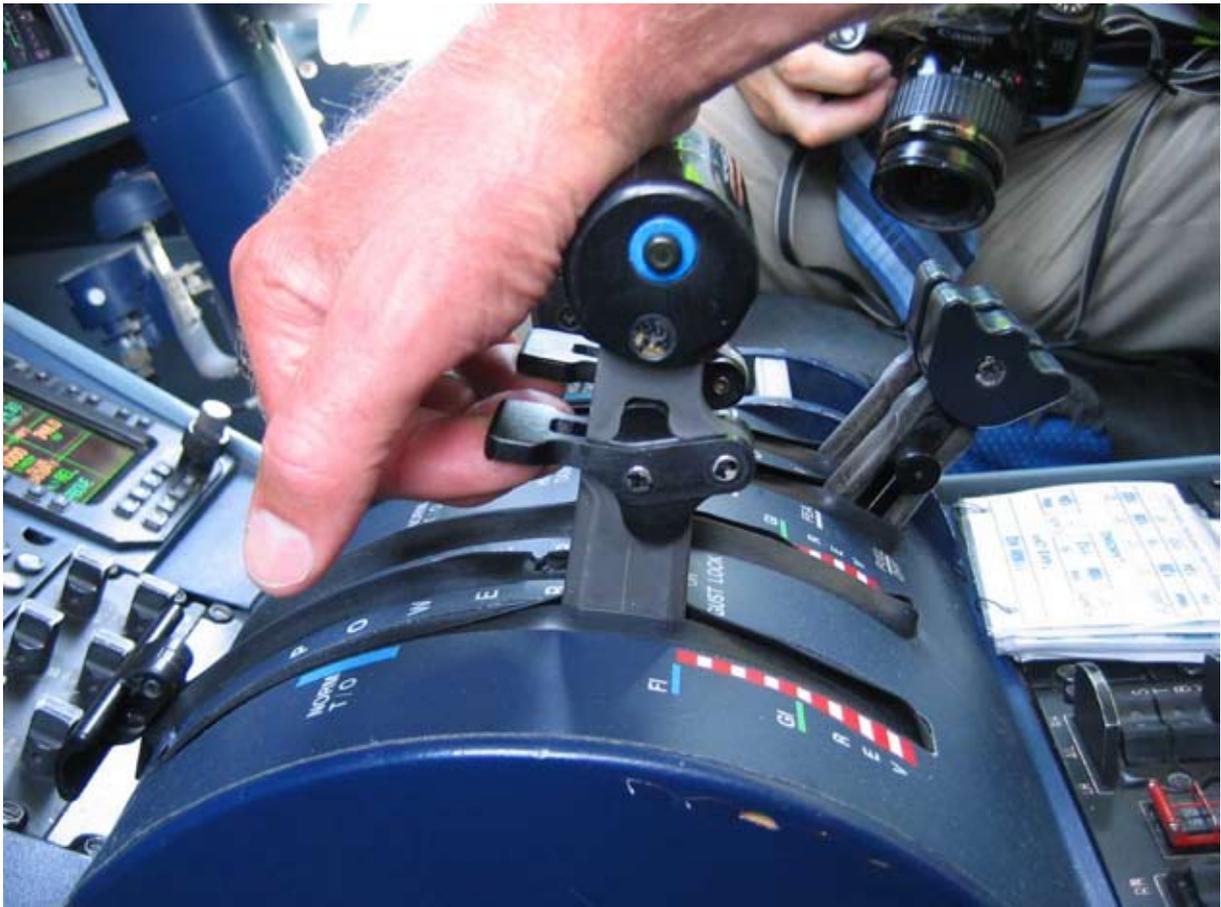
Figure 2

The aircraft’s power levers are fitted with mechanical baulks to prevent inappropriate selections. One baulk prevents selection of settings below flight idle unless certain conditions are met. To select settings below flight idle (after landing or in the event of a rejected takeoff), the pilot must first ensure that the power levers are at the flight idle position, and then pull two latches (one on each power lever) upwards to disengage the locks, before retarding the power levers below flight idle into the beta range. Further rearward movement of the power levers causes selection of increasing amounts of reverse thrust. The latches are operated with the tips of the fingers, whilst the palm of the hand rests on (or grasps) the power lever itself (see Figure 2).

Power levers and latches

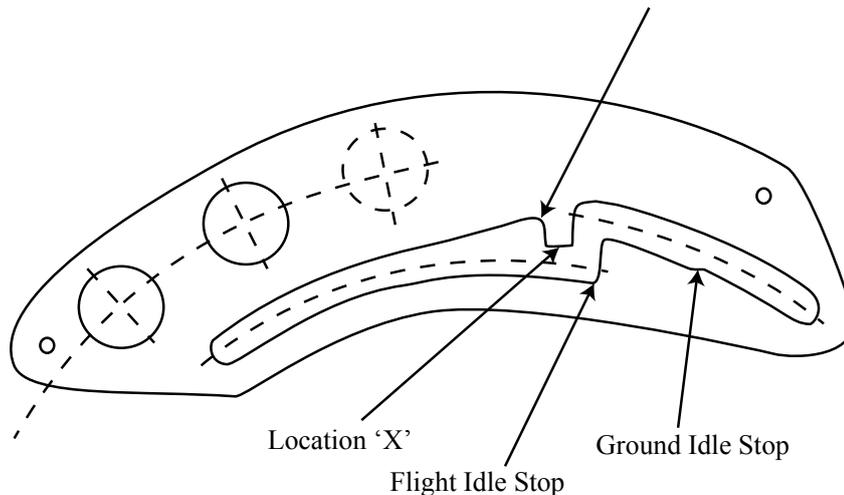
Figure 3
Power Lever Gate

Stop prevents pilot from inadvertent selection of a position below Flight Idle during flight when retarding Power Lever with latch lifted

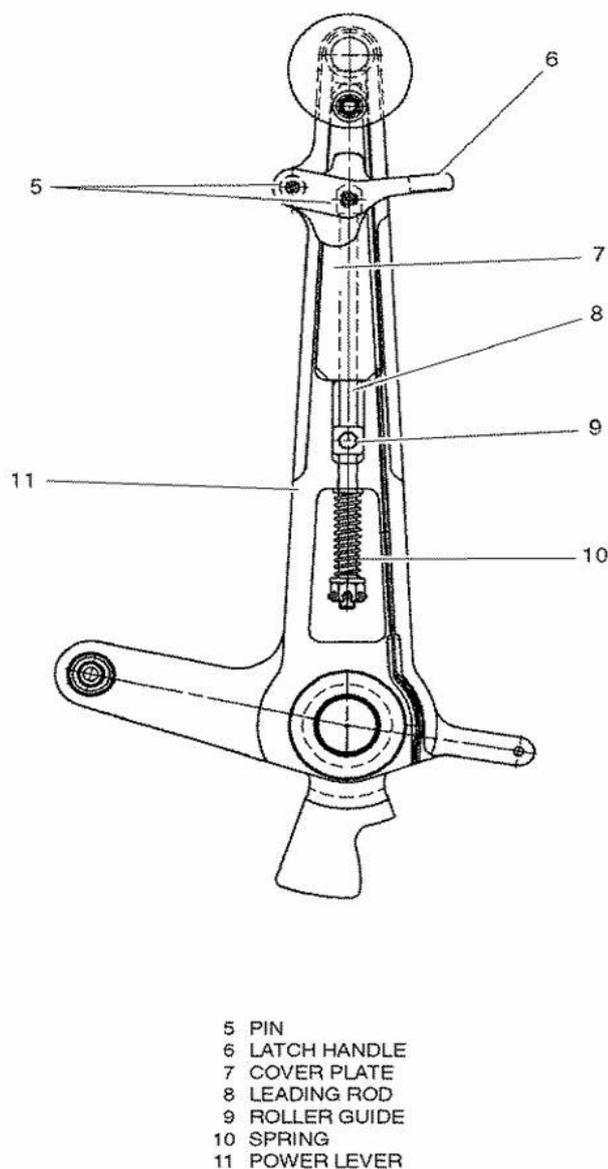
Figure 5

geometric flight idle position and maximum power position. Latch levers on the forward face of each power lever must be raised to enable selection of the beta (ground idle) propeller range. Once these latches are raised, the power levers are free to move further aft, commanding a progressively lower blade pitch angle. Further movement aft causes the levers to reach the ground idle position. Aft movement beyond the ground idle position increases power, providing reverse thrust. This movement into the reverse thrust range compresses a spring within the quadrant which provides tactile information to the pilot.

Power lever assembly

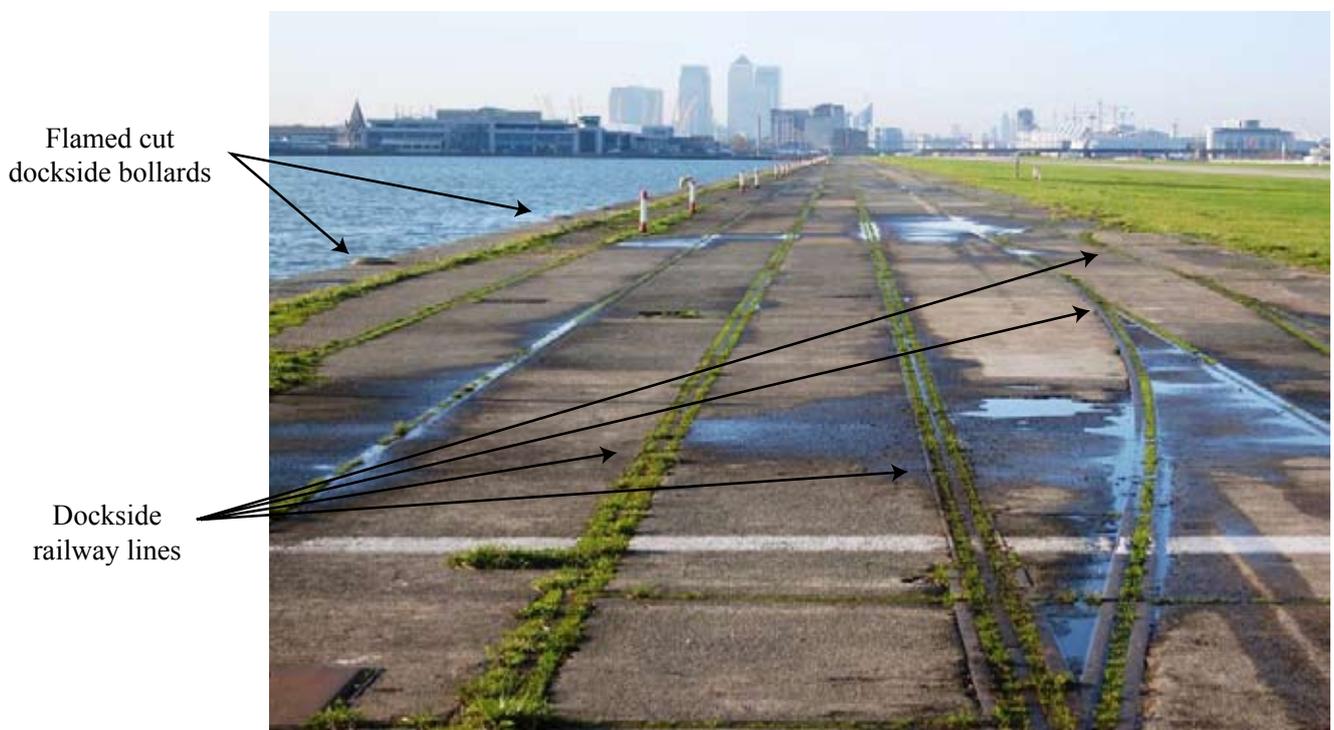
Figure 2

The airport, opened in 1987, was built on the site of a disused ship's loading and unloading dock. Prior to being made into an airport the dock consisted of two rows of warehouses along the northern and southern sides of the dock that were accessed by a central road and railway that ran in an east-west direction down the middle of the dock (now the airport's runway). These railway lines were removed prior to the construction of the runway. Between each row of warehouses and the waters' edge ran two sets of railway lines on which ran the ship loading/unloading cranes and rail freight wagons. These railway lines were not removed when the airport was constructed and remain in place today (Figure 2).

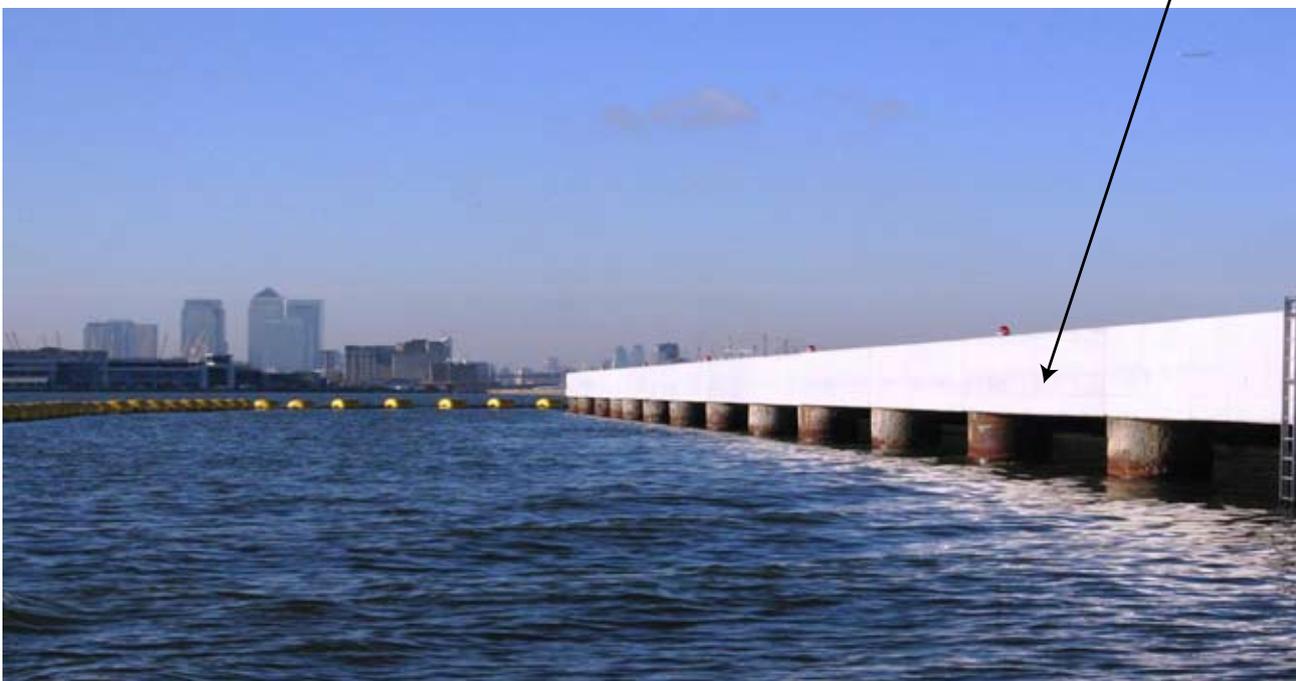
Figure 3
View looking west along southern edge of Runway 28 Hold Area

A walk around the Runway 28 holding area with a hand-held magnetic compass by an AAIB Inspector showed that there were some large and strong magnetic anomalies that made the compass needle deviate by up to $\pm 60^\circ$. Engineers from the magnetic survey team based at QinetiQ, Portland Bill, Dorset were contracted to conduct magnetic signature and compass deviation surveys of the Runway 28 aircraft holding area. Figure 4 shows the results of the compass deviation survey observed at various points in the holding area. The numbers annotated at each point in Figure 4 indicate the number of degrees that a magnetic compass will deviate from magnetic north when placed in that position. These readings were taken 1.4 metres above the holding area surface. The areas where readings

Pre-cast steel clad piled beams
(estimated total = 56)

'It is QinetiQ's considered opinion based upon the results obtained during the magnetic and compass surveys that aircraft flux gate compass deviation problems experienced at London City Airport are caused by several ferrous magnetic signature anomalies (MA), primarily emitted as a vertical component from the 68 piled beam structures situated under Runway 28 Holding Area in excess of 60,000nT¹. The second source of MA is emitted from remains of flame cut bollards spaced a regular intervals under Runway 28 Holding Area with a magnetic signature in excess of 30,000Nt. The third source comes from the reinforced concrete in Runway 28 Holding Area, which appears to interact with the signature from both prime and second source signature emitters. The fourth source, albeit not quite so large as the previous sources, is the railway lines below Runway 28 Holding Area.'

In order to mitigate the problem the airport operator attempted to degauss the runway. The process was partially successful and the magnetic anomaly was found to dissipate over time. The airport did not institute special ATC procedures to address the problem and found that pilot awareness of the potential problem reduced the incidence of related occurrences, of which there have been no further reports for “several years”.

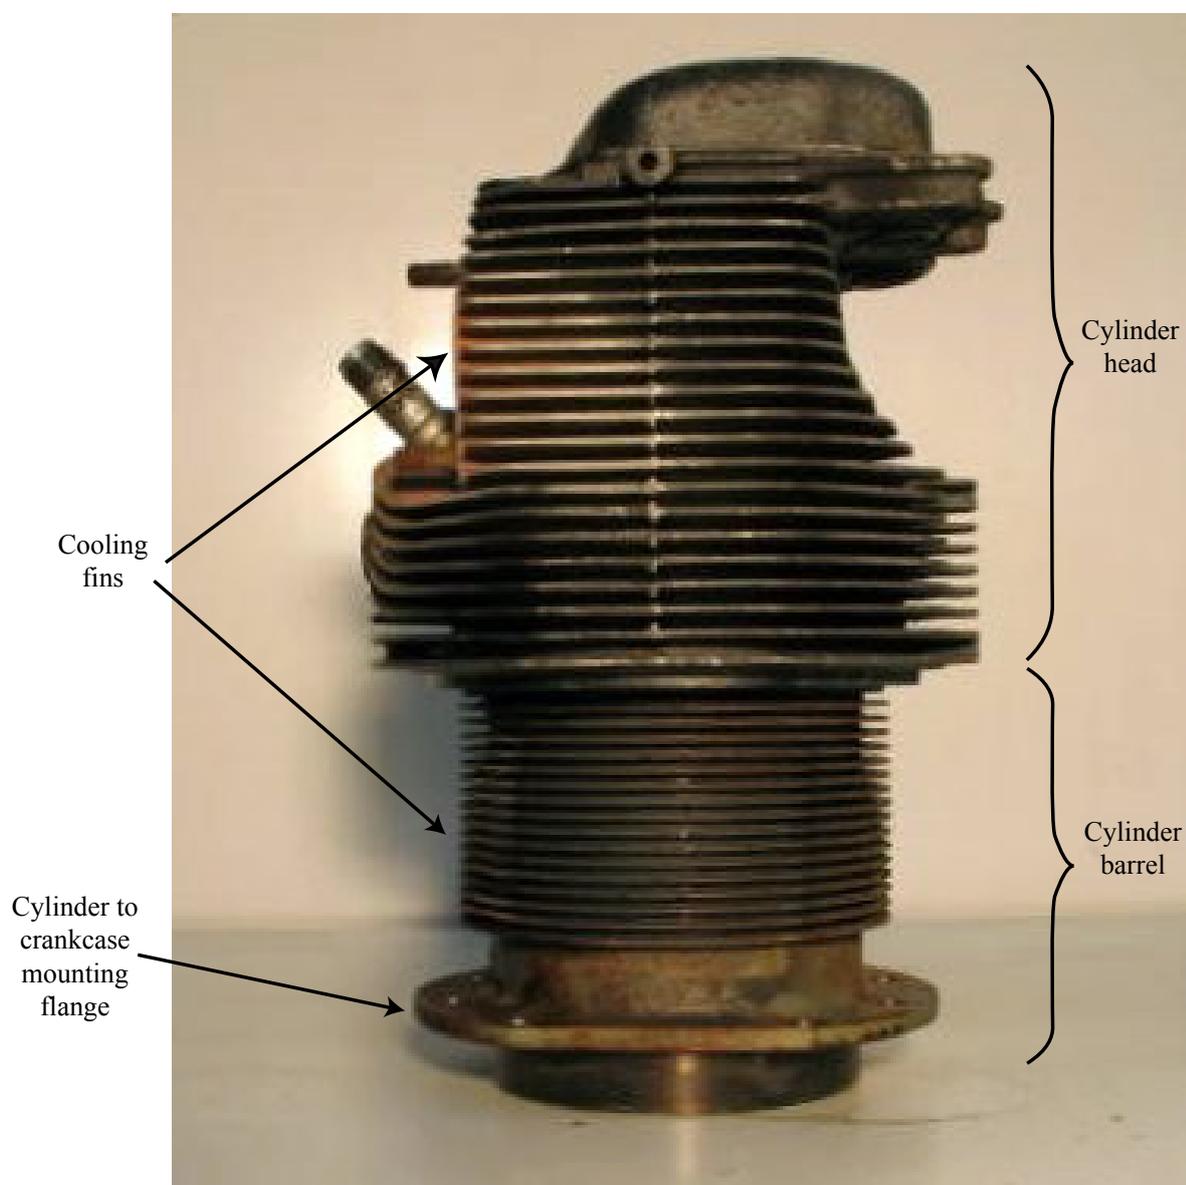
Figure 1

Inspection by the maintenance organisation revealed that the No 4 cylinder had completely separated from the engine in the area between the cooling fins and the cylinder-to-crankcase mounting flange (Figure 1). The pieces of the cylinder were sent to AAIB for

detailed metallurgical examination. The metallurgical examination showed that corrosion had occurred on the outer surface of the cylinder which, over a period of time, had reduced the wall thickness and produced corrosion pits. These corrosion pits acted as stress raisers which, combined with the reduced cylinder wall thickness, allowed fatigue initiation and propagation. A fatigue crack initiated and propagated around approximately 36% of the cylinder's circumference prior to the final overload failure.

Lycoming 0-235 Series Engine Cylinder

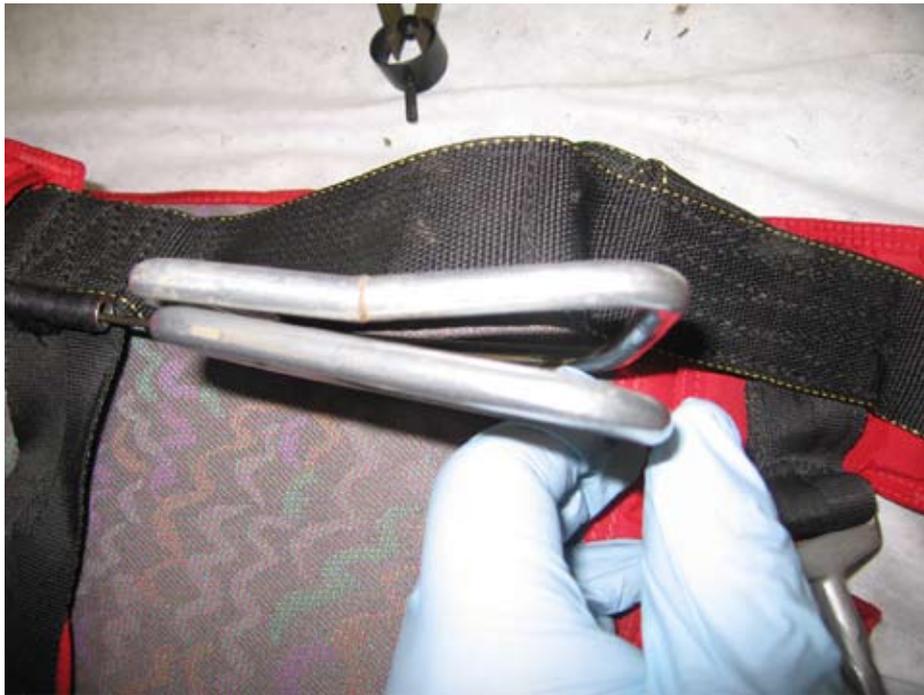
Figure 2

The parachute's deployment lanyard, consisting of a multi-strand cable, had 'unwound' and its end was bent, indicating the application of a significant side load. The 'D' ring was compared to that of a sample TSE28 and found to be deformed, see Figure 2. Tests carried out on a sample parachute showed that this damage was consistent with a high side load applied in the ground impact and, when pulled using the recommended method, the sample parachute and the parachute from the ASW 19 deployed with a steady force of about 6 kg .

'D' ring distortion

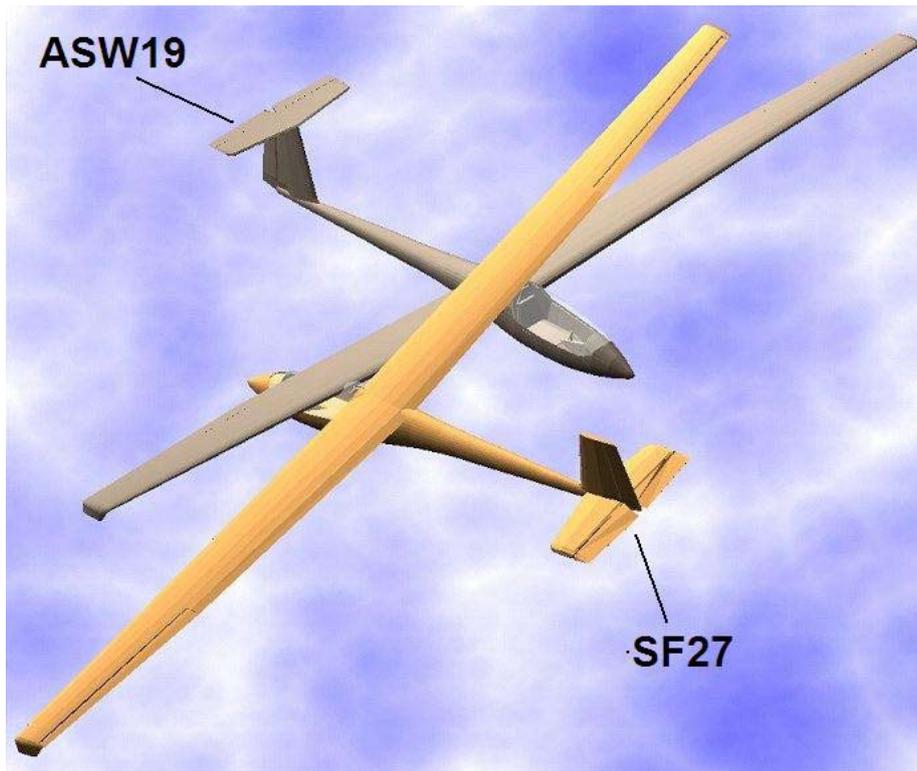
Figure 3

determine the sequence of these additional impacts. At some point after the initial impact the outboard right wing of the SF27 failed, approximately 4.5 metres from the wing root, which would have made this glider incapable of flight.

The pilot of the SF27 stated that the collision occurred at approximately 1,500 ft above Sutton Bank. Calculations by the AAIB indicated that the time taken for both gliders to descend to the ground would have been approximately 14 seconds and they would have descended below the minimum height (500 ft) for a full parachute deployment within about 10 seconds. The evidence at the site indicated clearly that the pilot of the ASW 19 had managed to unfasten his seat harness but had not managed to leave the cockpit of the glider before it hit the ground; the damage to the parachute 'D' ring was further indication of this.

Collision reconstruction
