CONTENTS

SPECIAL BULLETINS

COMMERCIAL AIR TRANSPORT

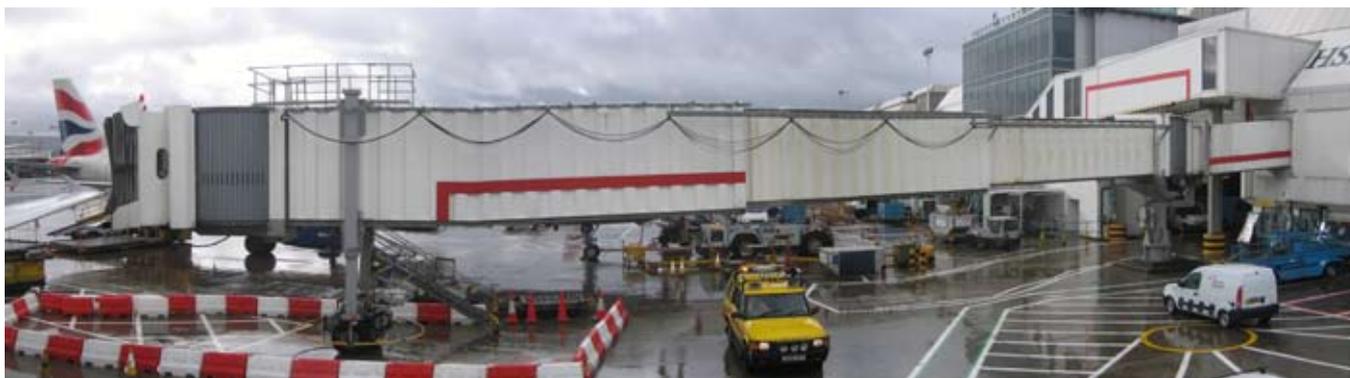
Figure 1

The AWI also stated that during the night of 11 February the jetty would be extended parallel to Stand 415's clearway, that worksite protection would be put in place and that, on completion of this activity, the contractor

Extended airbridge at Stand 415

It is recommended that the airport operator, Heathrow Airport Limited, should implement a policy to disable the Stand Entry Guidance system on any stand which has restrictions placed on its use.

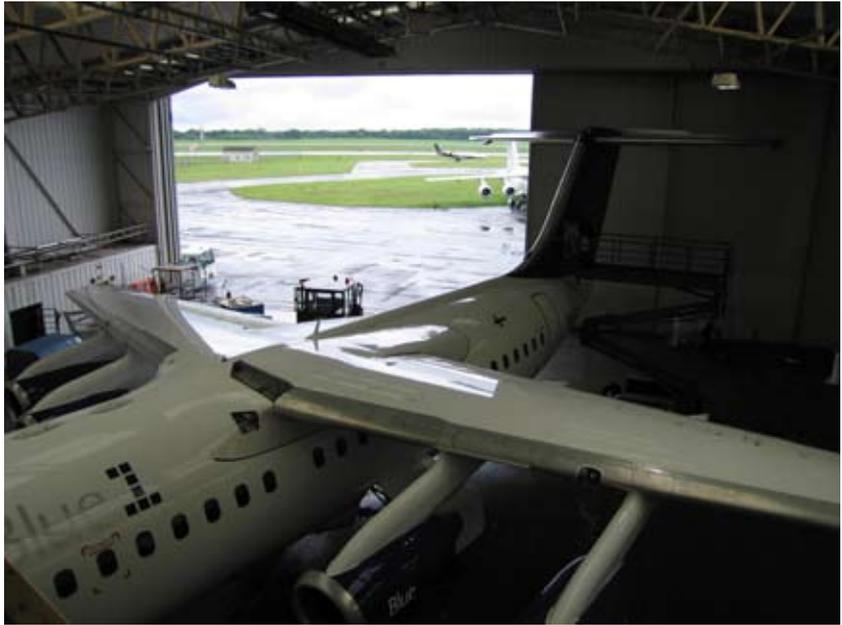
Figure 1

After parking the aircraft, the crew noticed that a panel was missing from the wing-to-fuselage fairing and there was minor damage to the fin (Figure 1).

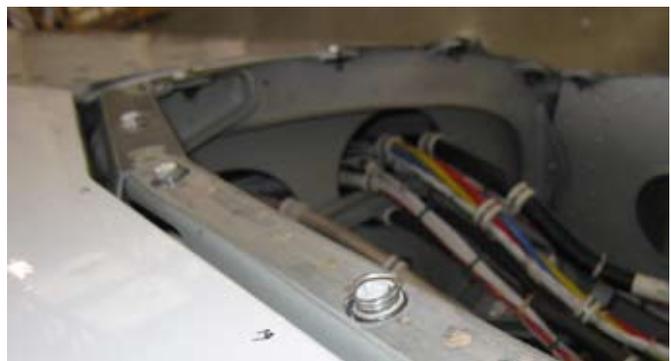
Figure 2

The aircraft was inspected at Stansted and the 25 bolts that secure this panel to the aircraft were all still on the aircraft located in their respective grommets (Figure 2 shows an example). The bolts and grommets were then removed and in all cases the grommets were found to have failed (Figure 3 shows several failed grommets). The failure of the grommets differed in detail but the upper flange in all 25 had failed, and there was evidence that the flanges in the region of the failures were of reduced thickness. There was also evidence of paint on the grommet flanges.

All the retaining bolts were intact and found on the aircraft located in their respective damaged grommets. There was no evidence of the panel having failed in the region of the grommets. It was therefore concluded that the panel became detached because the grommet flanges had failed. The grommet flanges were of reduced

The manufacturer halted the Inspection Service Bulletin ISB 53-202, which was in the Airworthiness Directive consultation process with the EASA, so they could update it to include paint removal from a sample of grommets prior to grommet inspection. In view of this response no recommendation has been made. This is a known problem that applies to all aircraft types when being repainted.

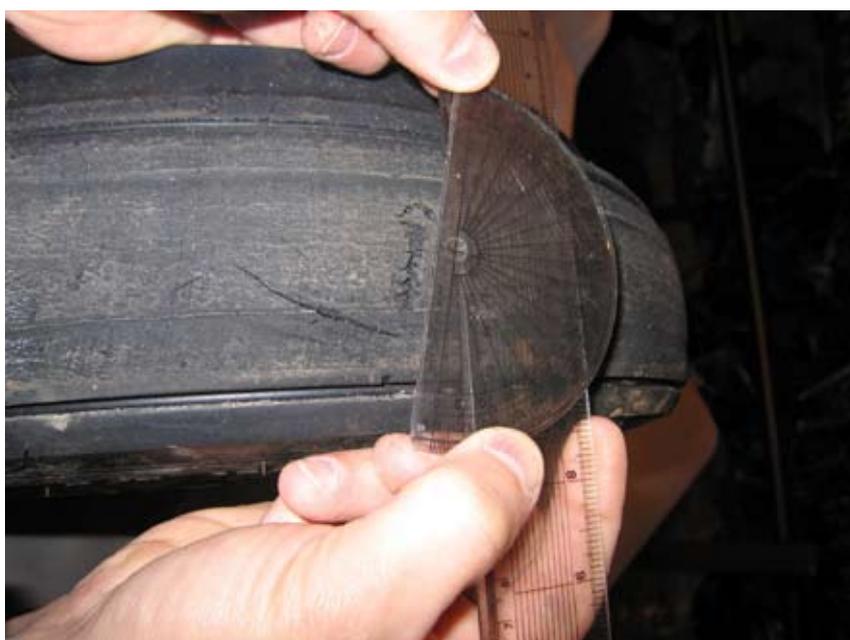
- a. The left nosewheel tyre was found to have regular transverse marks at approximately 12° to the wheel axis, and the tyre chine, which usually shows no signs of wear, had signs of heavy loading, see Figures 9 and 10. The orientation of the marks is consistent with both nosewheel tyres being highly loaded and ‘scrubbed’ to the right, opposing the aircraft’s motion. There were no significant marks on the chine on the right nose tyre.
- b. The nose gear leg and associated structure was inspected and no damage was seen.
- c. With the aircraft on jacks the nose gear steering system was functioned and the rigging values were checked, with nothing abnormal being

Figure 10 (right)
Tyre tread, left nosewheel

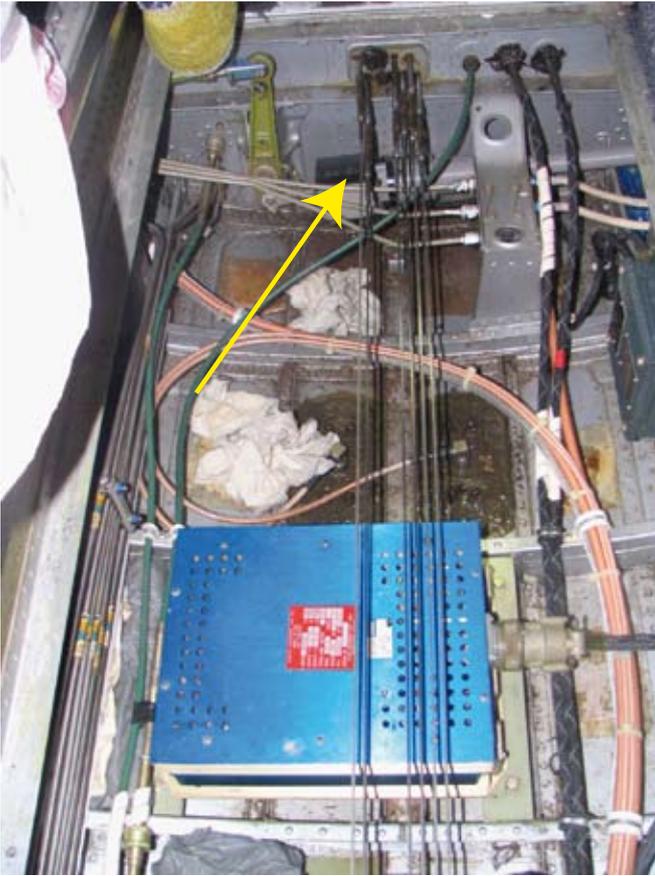
Figure 3

View of lower fuselage skin of N757CX with floor panels removed. Note the location of aileron trim actuator (arrowed)

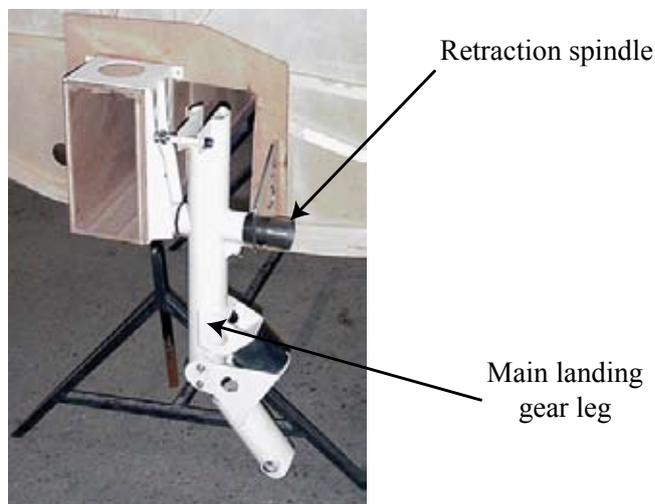
Figure 1

The owner of the aircraft, who was also the pilot on the incident flight, reported that the right main landing gear screw jack and nose leg locking rod had buckled, which had caused the nose and right landing gear to collapse. The owner removed the right landing gear screw jack and retraction mechanism and attempted to rotate the right main leg about the retraction spindle (see Figure 1). However the leg could not be easily rotated about the spindle and remained jammed at an angle of approximately 50°.

Main landing gear leg

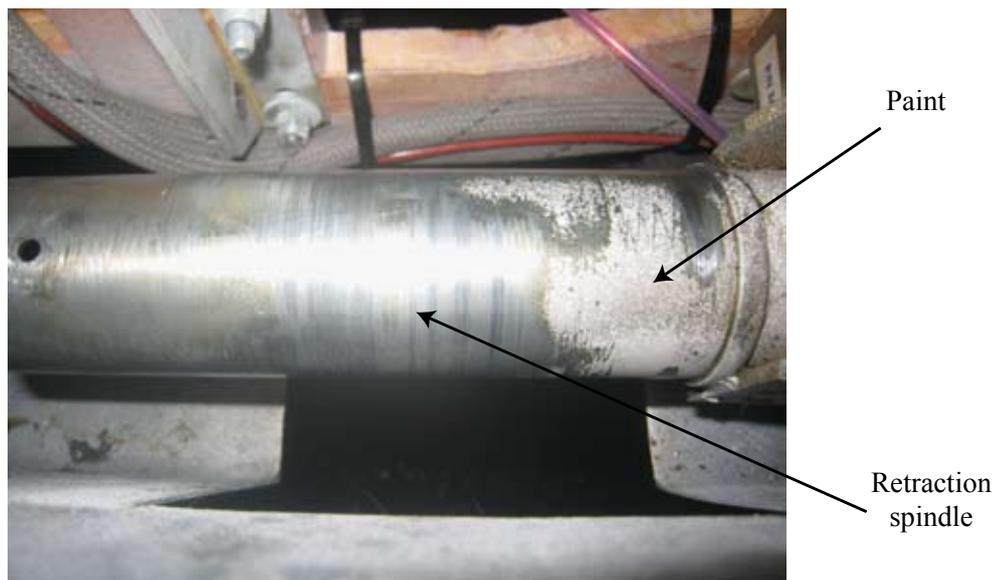
Figure 2

On removing the right leg from the retraction spindle, the owner noticed that there was paint on the inner portion of the spindle and that there did not appear to be much grease on the painted portion of the shaft (see Figure 2). There should not be any paint on the spindle.

Paint on right spindle

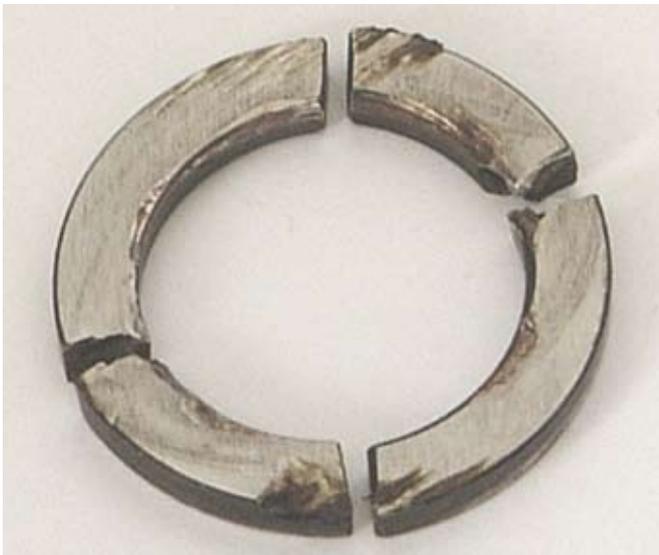
The half-rings had recently been replaced by an experienced engineer and hence incorrect installation would seem unlikely. This would appear to be an unusual failure and hence the components have been sent to the manufacturer for further analysis. This may take some time. Should further significant and relevant information be obtained by AAIB, a supplementary report will be published.

Figure 2
Half rings

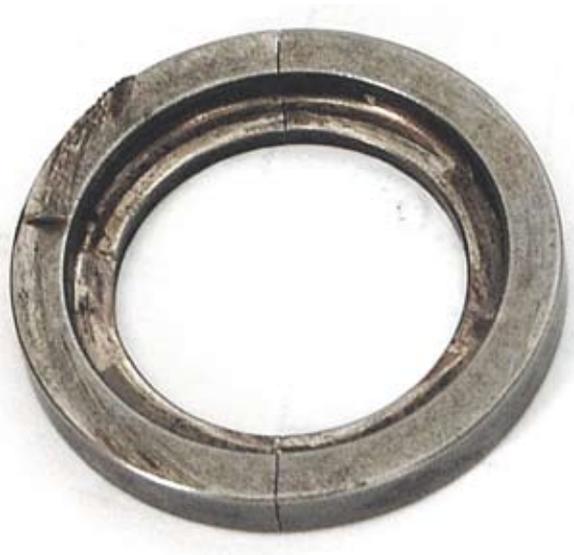
Figure 3
Collar
