SPECIAL BULLETINS

Boeing 777-236 ER	G-YMMM	17-Jan-08	1
-------------------	--------	-----------	---

COMMERCIAL AIR TRANSPORT

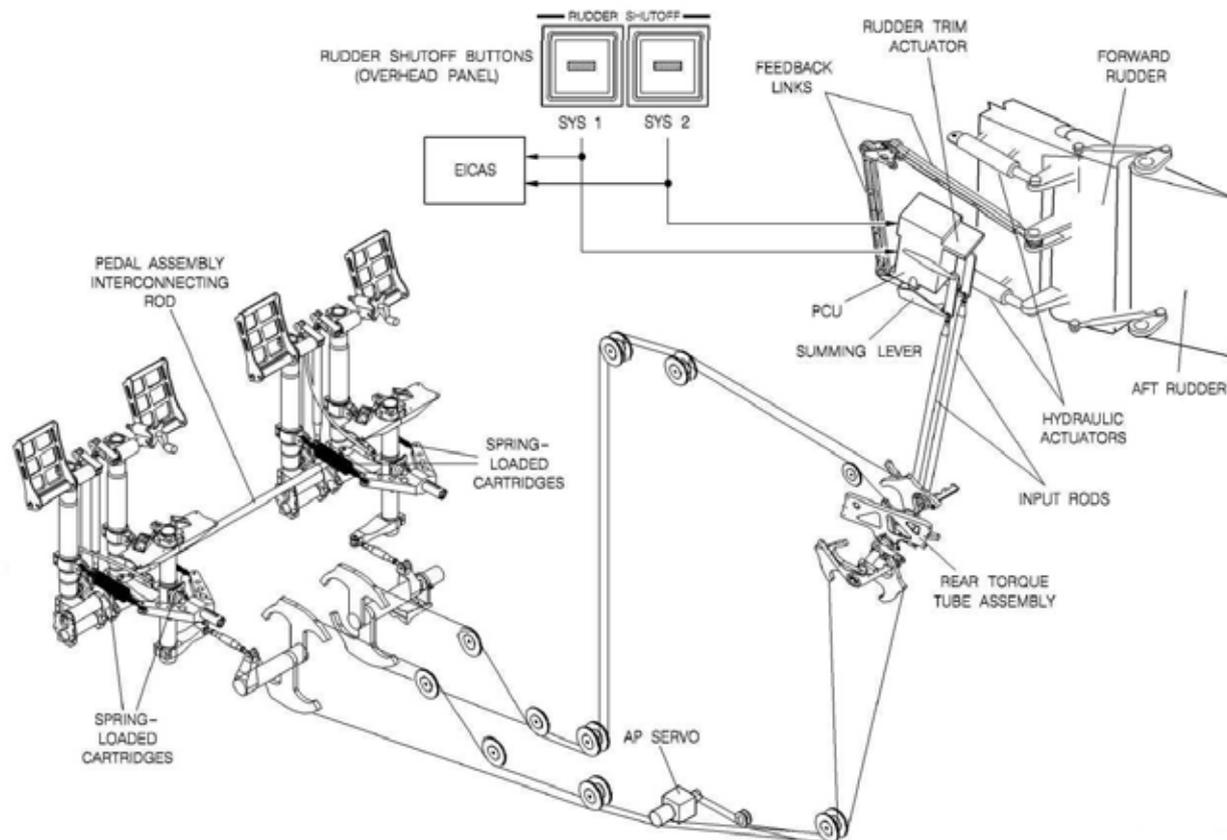
Figure 1

Embraer 145 Rudder System Schematic

The rudder hardover protection system is designed to remove hydraulic power to the rudder PCU in the event of a rudder runaway (ie uncommanded rudder deflection). RHPS will automatically shut off both Rudder System 1 and 2 if the following three conditions are met simultaneously:

Condition 3 ensures that RHPS is disabled in the event of an engine failure. RHPS will indirectly trigger the 'RUDDER SYS 1-2 INOP' message on the EICAS once the pressure switches sense the loss of pressure.

Safety Recommendation 2007-112

It is recommended that Embraer SA should review and modify the design of the RHPS (rudder hardover protection system) in the EMB-145, to prevent unnecessary RHPS triggering.

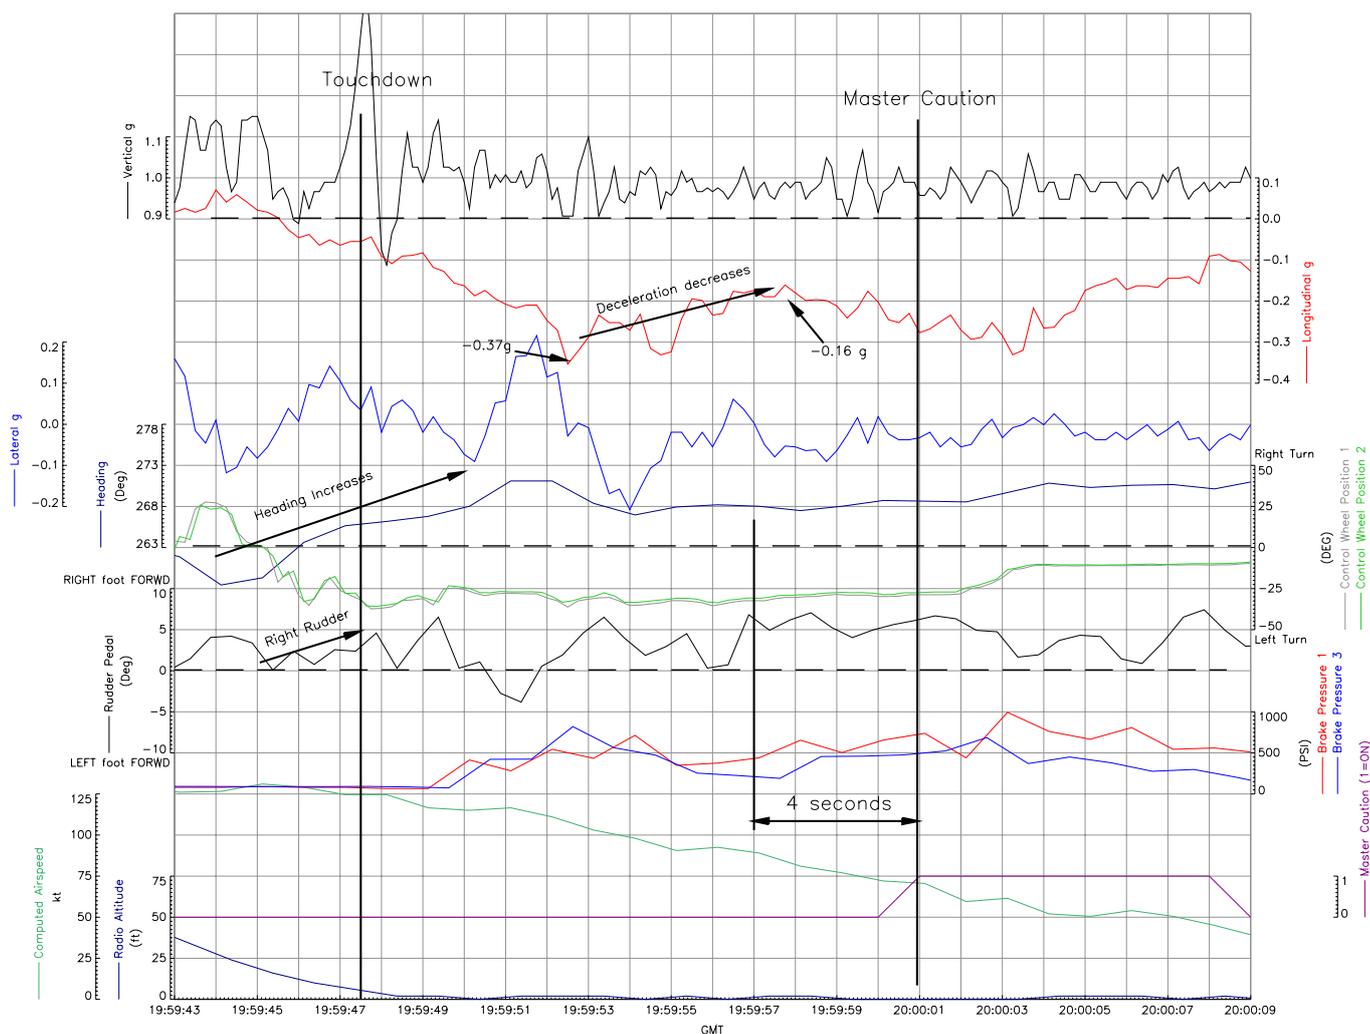
At 20:00:01, a master caution was triggered with the aircraft at a groundspeed of 79 kt. Based on the pilot's report, this master caution was probably triggered by the RHPS. According to the manufacturer, the 'RUDDER SYS 1-2 INOP' message requires a 3 second confirmation time. The message should appear at the same time as the master caution. The master caution is recorded by the FDR every second so, in this case, the event which triggered it would be between three and four seconds before 20:00:01.

Figure 2 confirms that, during this 4 second period, the minimum rudder pedal deflection was 4°, corresponding to 6.7° of right rudder deflection.

G-EMBT FDR Parameters

Of the three conditions required to trigger RHPS, two conditions were apparent most of the time. First, the N_2 on both engines was above 56% during the entire ground roll. Second, the rudder pedal deflection was 3° or greater for a large portion of the ground roll which corresponds to 5°, or greater, of rudder deflection. The third condition, pedal force, is not known because it was not recorded by the FDR.

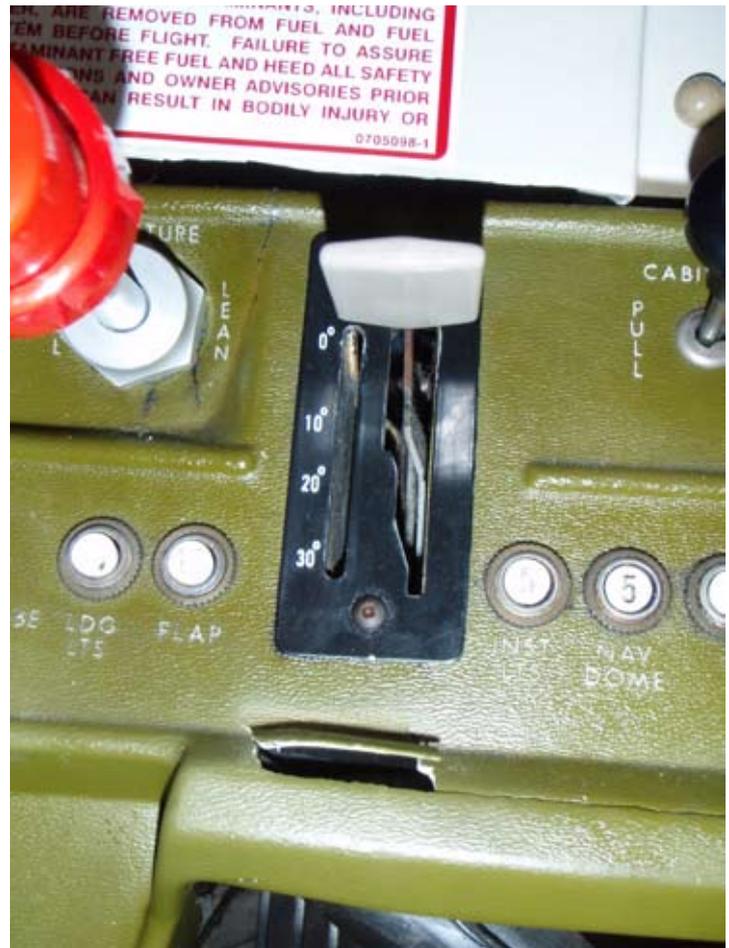
Figure 1

The flap actuation lever and indication assembly were inspected on the aircraft, and the indicator was found to be bent upwards such that it did not protrude from its slot on the console, (Figure 1), and could potentially have offered some mechanical resistance. The flap actuation lever and indicator assembly was removed along with the associated wiring and circuit breaker. There was evidence of mechanical scoring by the position indicator on the mounting plate, see Figure 2, although it was not possible to determine when this took place. The wiring was checked and found to be correct, however there was significant heat damage to

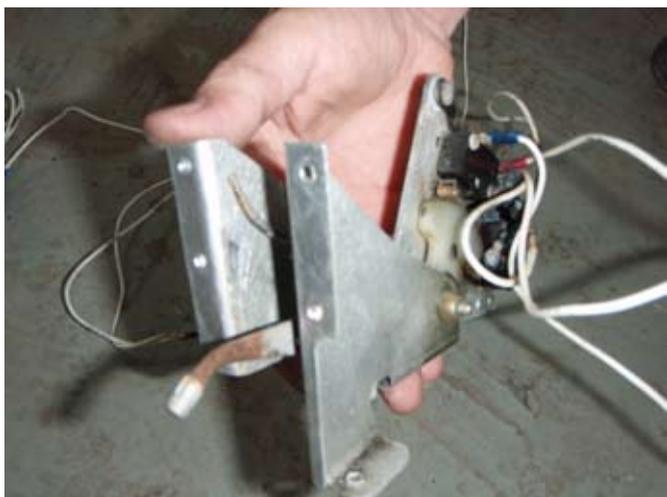
Figure 2

The 'flaps up' switch was disassembled and examined. The damage appeared to have been caused by arcing inside the switch, although it was not clear from the

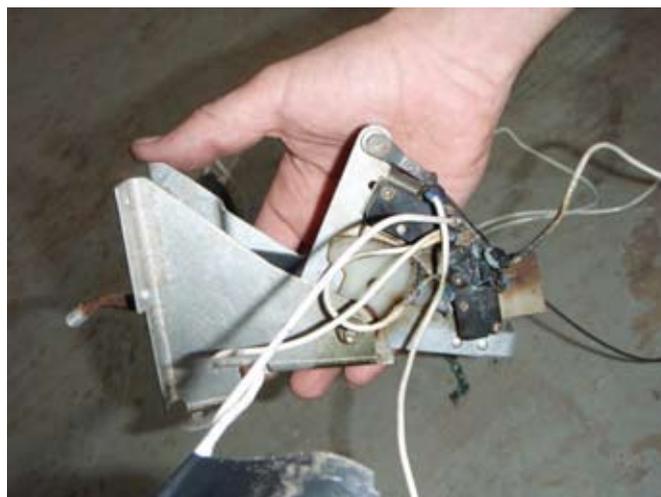
Figure 3

the 'flaps up' switch, see Figure 3. The circuit breaker had not tripped.

damaged components why the arcing had occurred. It was not possible to determine when the switch was made, although it may well have been at the time of the aircraft, around 30 years ago.

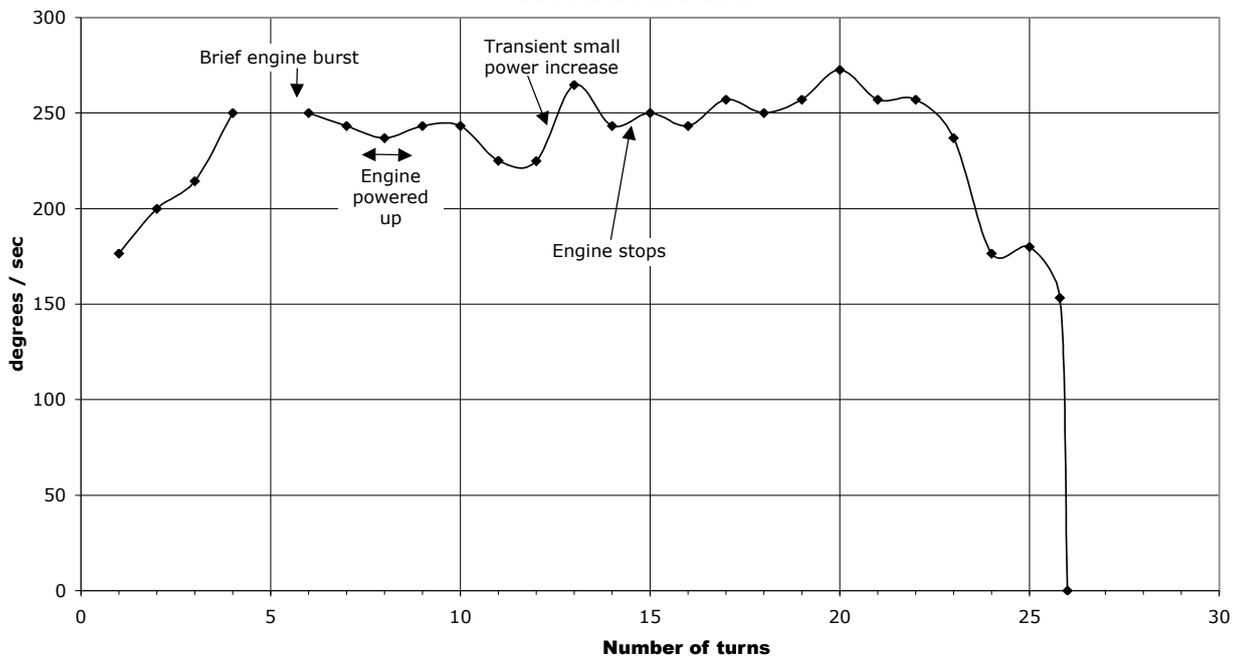
The plot at Figure 2 shows an initial rotation rate of the order of 175° per second, increasing progressively to around 250° per second by turn four or five. The actual rotation rate for turn five could not be established as there was no common reference feature in the video from which to determine the relevant time interval. Thereafter, the rotation rate varies between 225° and 275° per second until turn 22 or 23, after which it decays briefly to its initial rate of around 175° per second. The spin ceased altogether some 26 turns, and 40 seconds, after spin entry.
