CONTENTS

ACCIDENT

Aircraft Type and Registration:	Beech B200 Super King Air, G-BYCP	
No & Type of Engines:	2 Pratt & Whitney PT6A-42 turboprop engines	
Year of Manufacture:	1981	
Date & Time (UTC):	24 March 2007 at 1635 hrs	
Location:	Southend Airport, Essex	
Type of Flight:	Commercial Air Transport (Passenger)	
Persons on Board:	Crew - 2	Passengers - 5
Injuries:	Crew - None	Passengers - None
Nature of Damage:	Damage to nose fuselage, the nose landing gear and doors, and propeller tips	
Commander's Licence:	Commercial Pilot's Licence	
Commander's Age:	44 years	
Commander's Flying Experience:	3,800 hours (of which 2,200 hrs were on type) Last 90 days - 137 hours Last 28 days - 30 hours	
Information Source:	AAIB Field Investigation

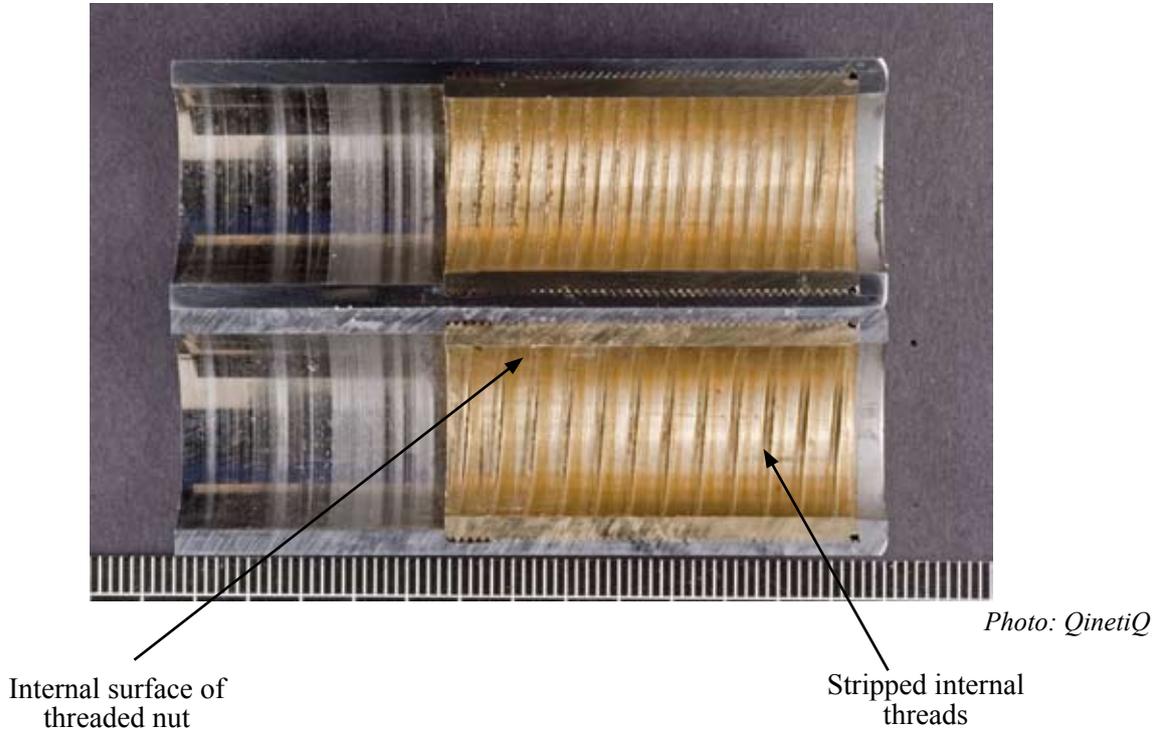
Figure 2
Internal surface of threaded nut (screw insert) assembly showing stripped internal threads

Examination of the nose landing gear actuator revealed that a complete failure of the internal threads in the aluminium bronze nut had occurred. The threads had stripped and, hence, the input from the landing gear motor/gearbox could not cause the nut assembly to traverse the screw. A considerable amount of aluminium bronze wear debris was present in the grease on the screw thread, which suggested that the nut had been wearing over a period of time prior to failure. Examination of the grease showed that it was contaminated with water, which is likely to have reduced its lubrication properties, leading to increased wear and corrosion damage of the screw. Also, the corrosion pits formed were likely to have increased the roughness of the screw and accelerated wear of the nut. This wear would have progressively reduced the load bearing capacity of the thread to a point when it could no longer support normal operating loads, leading to a failure of the remaining thread profiles. As the problem with the nose landing gear actuator was downstream of the emergency system input, it was not possible to lock the nose landing gear down.

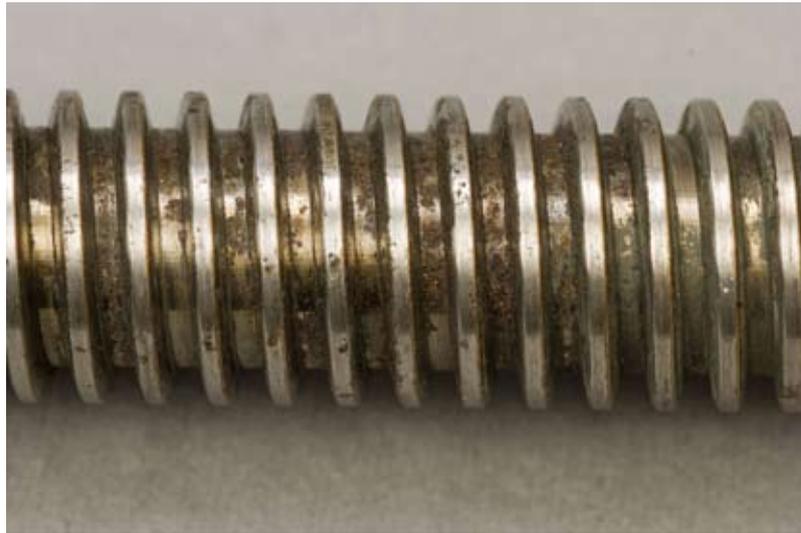
Figure 3

Corrosion observed on upper end of screw.

Other incidents on B200 aircraft also showed corrosion and increased wear, due to lack of lubrication. Although the nose landing gear actuator in G-BYCP was a PMA part, the corrosion and lack of lubrication could equally have occurred to an OEM part since the only difference in design is the method of attaching the plug (nut) insert. The presence of excessive play at the 1,000 cycle end play check would indicate increased wear and, as such, an actuator would normally be returned for overhaul. However, the actuator from C-GISH 'failed' only 89

Safety Recommendation 2007-126

It is recommended that the Federal Aviation Administration require Raytheon (Beechcraft) to review the maintenance requirements of the nose landing gear actuator fitted to the Beech B200 King Air series of aircraft, and any other model using a similar design of actuator, with regard to the requirement of periodic lubrication and the periodicity of inspections.

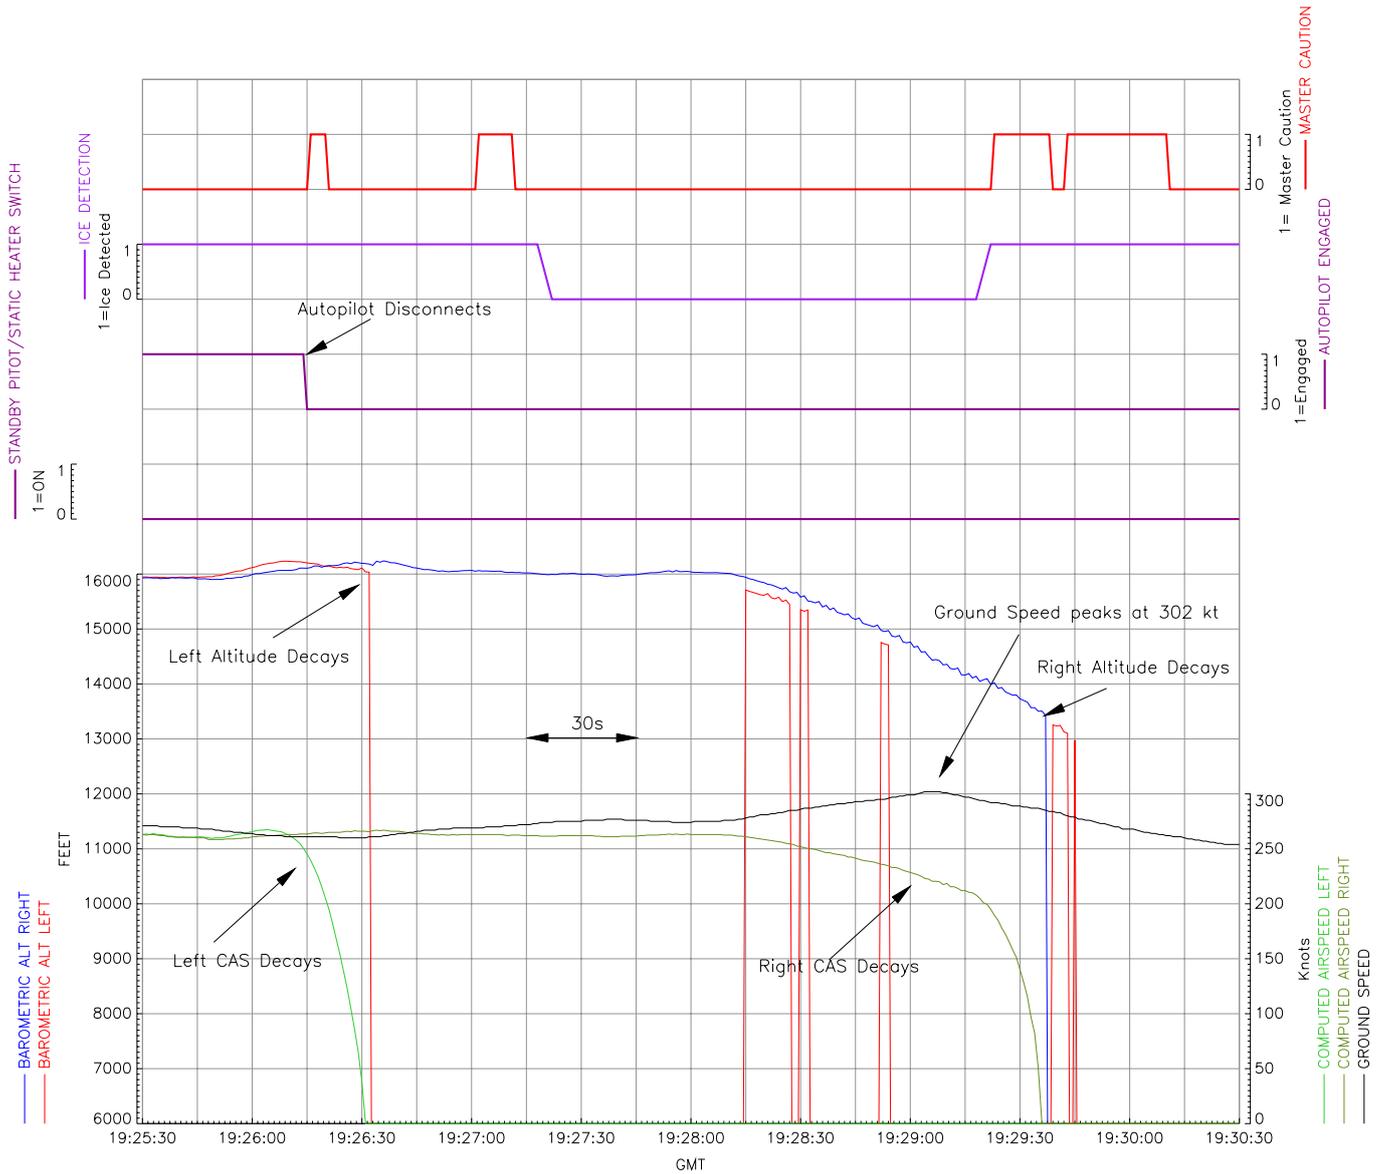
Figure 1

Just under four minutes after levelling off, the ice detection system again detected the presence of ice. Around 30 seconds later, both left and right ADC altitudes began to fluctuate again. As this occurred, the left ADC calibrated airspeed (CAS) dropped to zero and the autopilot disengaged. About 20 seconds after this, the recorded altitude data from the left ADC dropped to zero ft (Figure 1). The remaining altitude information from the right ADC indicated that the fluctuations then ceased and the altitude recovered to 16,000 ft.

Loss of flight data and aircraft descent

further, over a period of 16 seconds, to read zero kt. Two seconds after this, altitude data from the right ADC recovered briefly to read 13,428 ft, but dropped to zero immediately afterwards. Two further recoveries of the left ADC altitude were noted, but again were only temporary.

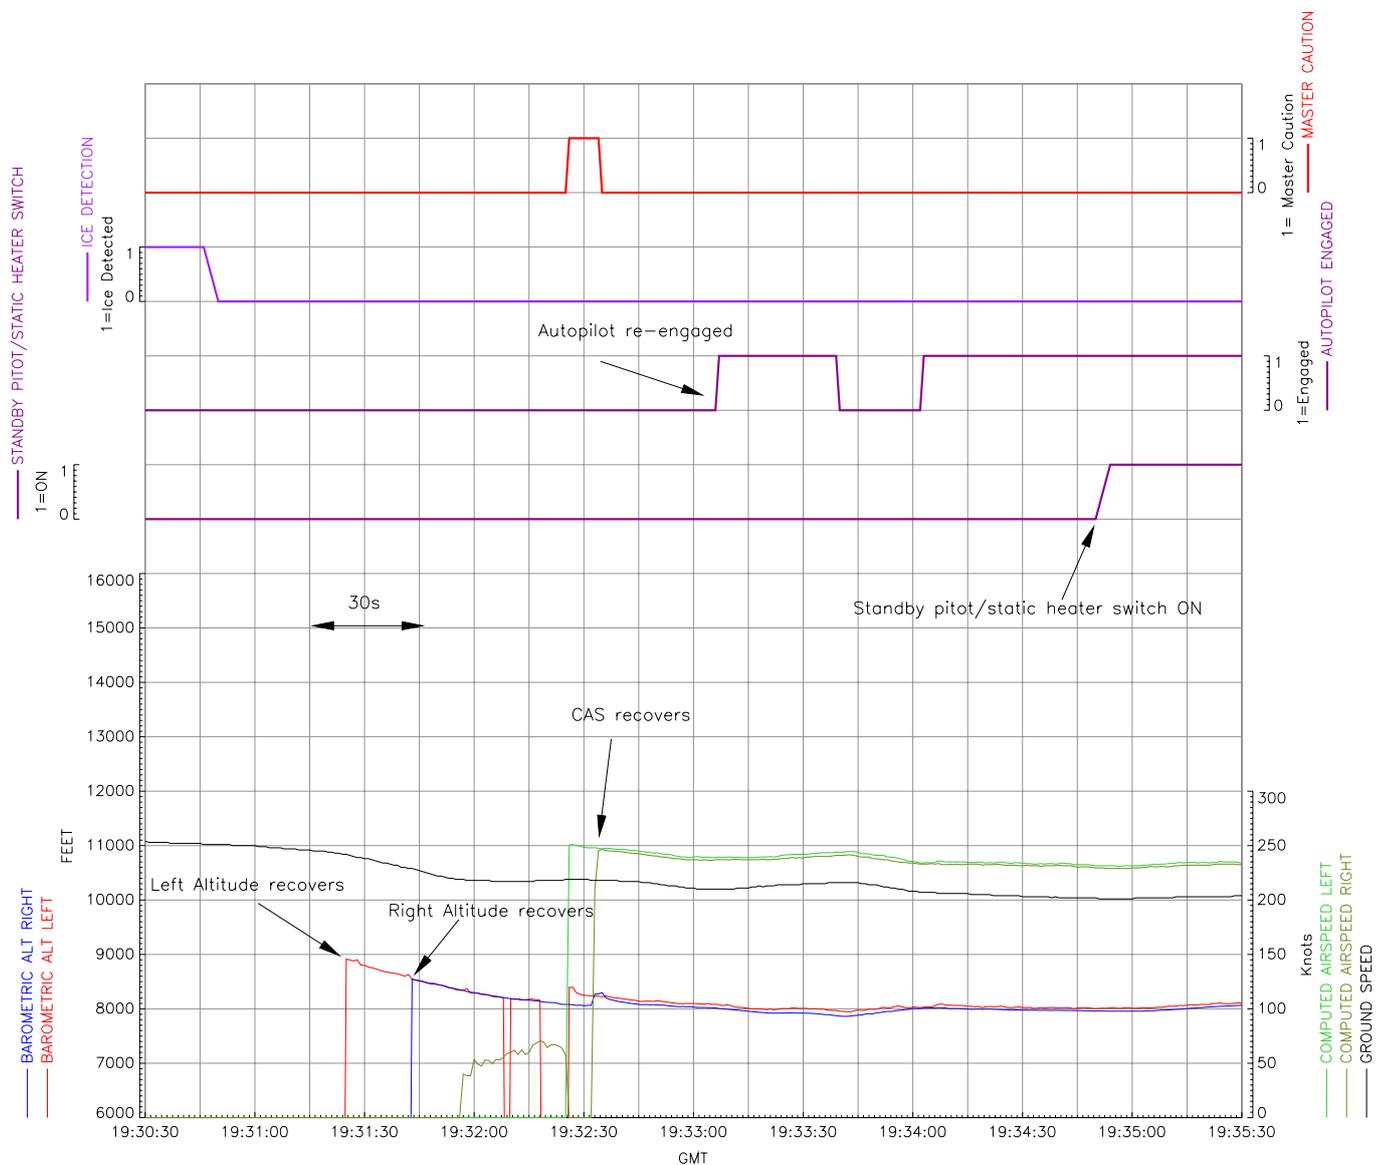
Figure 2

ADC altitude data returned at 8,914 ft and, 17 seconds later, the right ADC altitude also returned at the same value as the left ADC (Figure 2). CAS did not recover until nearly three minutes after being lost, as the aircraft was levelling at FL80, with an SAT of 2.75°C. Both CAS values recovered to within 3 kt of each other and within 30 kt of the ground speed. No further anomalous behaviour was observed with altitude or airspeed for the remainder of the flight.

At 1935 hrs, about 2 minutes after levelling at FL 80, the standby pitot heat switch was selected ON (Figure 2). No parameters from the standby instrumentation were recorded. Stall system outputs remained valid, with no stick shaker or stick push events recorded during the flight. Output from both Angle of Attack (AOA) vanes continued to vary within expected values for the flight conditions.

Aircraft level-off, flight data recovery and standby pitot heat switch position

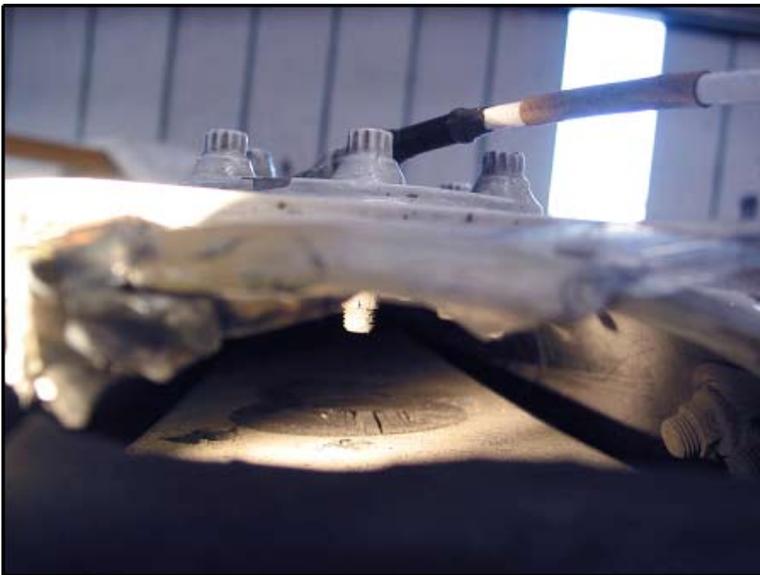
Figure 3 (left)

It was evident that the larger part of the outboard pivot bearing and its retainer had detached (Figure 3) and migrated outwards inside the torque tube under centrifugal loading, becoming jammed between the torque tube and the flexible spar (Figure 4). The inboard bearing retainer had also detached from the flexible spar and travelled

View inside G-CHCK tail rotor blade torque tube showing missing pivot bearing

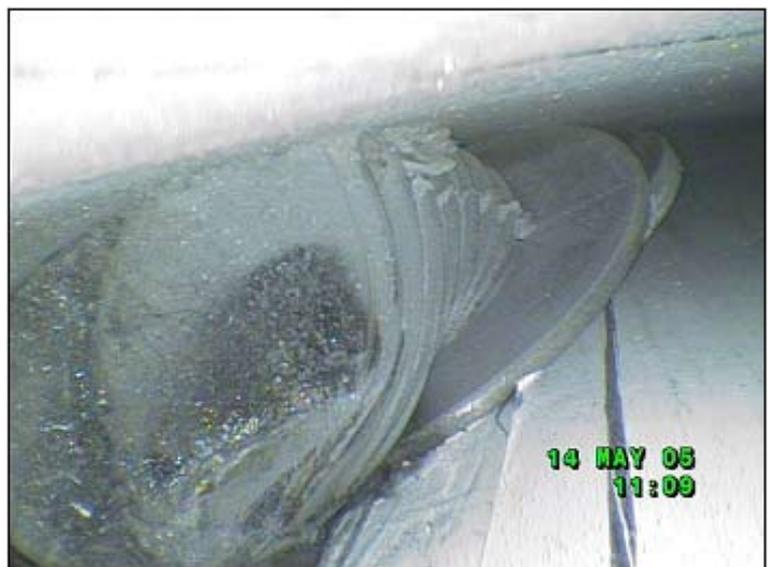
Figure 4 (right)

View inside torque tube of G-CHCK tail rotor blade showing detached outboard pivot bearing trapped between torque tube and flexible spar

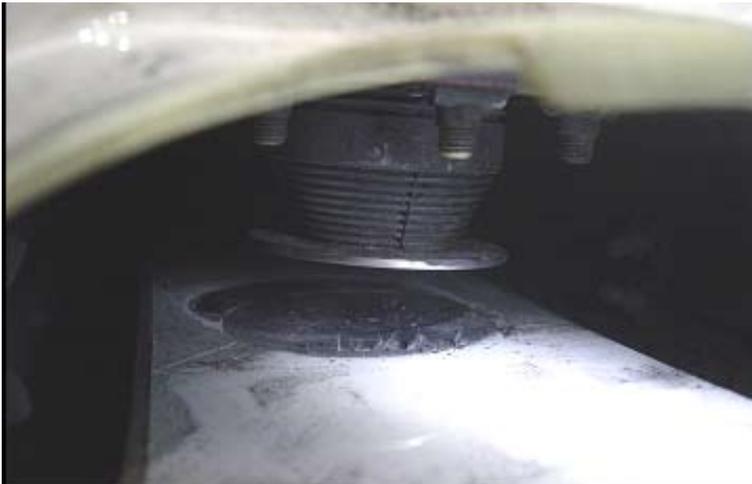
Figure 5 (left)

up inside the torque tube, but the inboard bearing was undamaged (Figure 5). Overlapping circular witness marks were visible on both sides of the flexible spar (Figures 5 and 6), corresponding to the original position of each bearing retainer and the newly adopted positions after the retainers had disbonded from the flexible spar. Similar witness marks were found on the flexible spar of another of the operator's S-92 helicopter, serial number 920013, which had also suffered a disbond of a bearing retainer. This blade was also removed and sent to the helicopter manufacturer for examination.

G-CHCK tail rotor inboard pivot bearing showing missing bearing retainer and overlapping circular witness marks

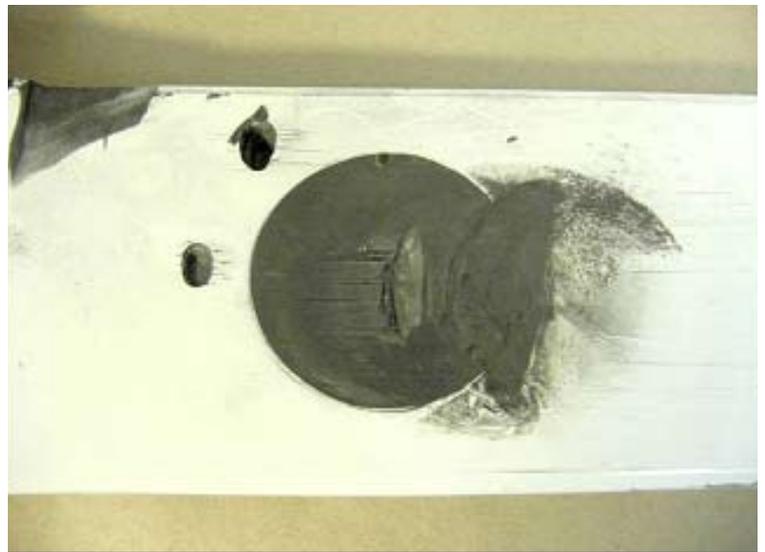
Figure 6 (right)

G-CHCK flexible beam outboard side showing witness marks produced by bearing retainer

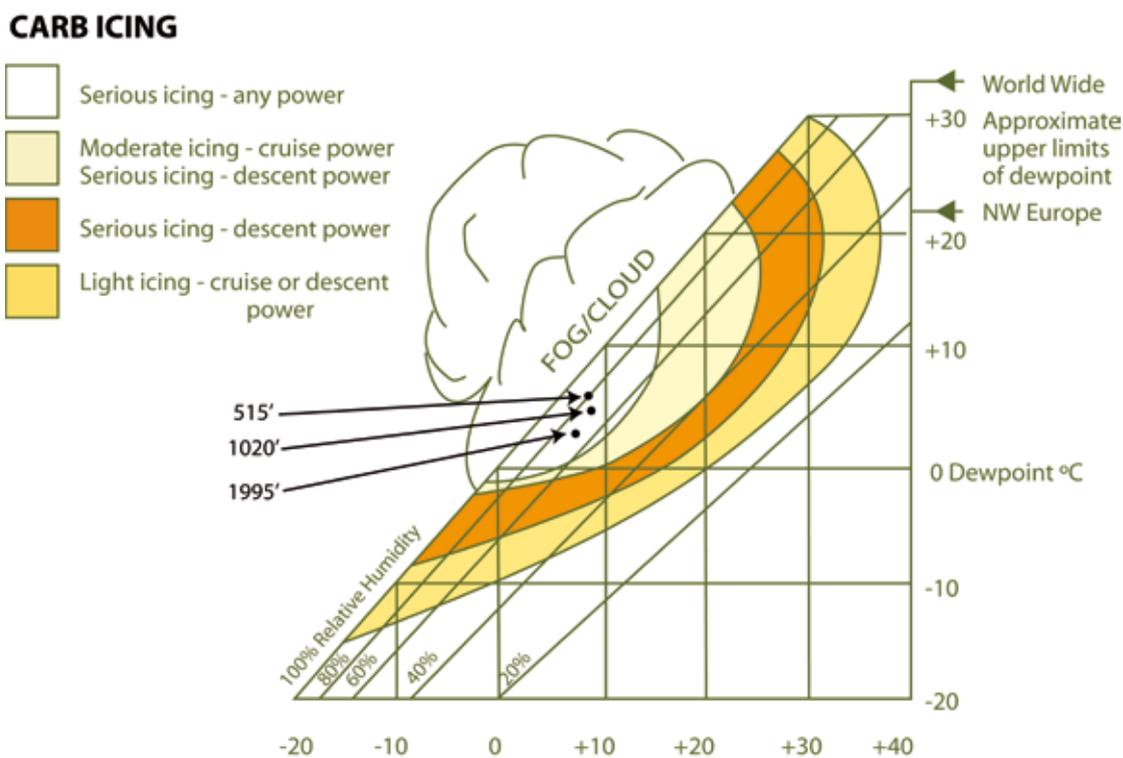
These temperature and humidity readings were plotted on a carburettor icing probability chart and the result, shown at Figure 1, indicates that there was a possibility of serious icing at any power.

Figure 1
Carburettor Icing Probability Chart
