CONTENTS

SPECIAL BULLETINS

COMMERCIAL AIR TRANSPORT

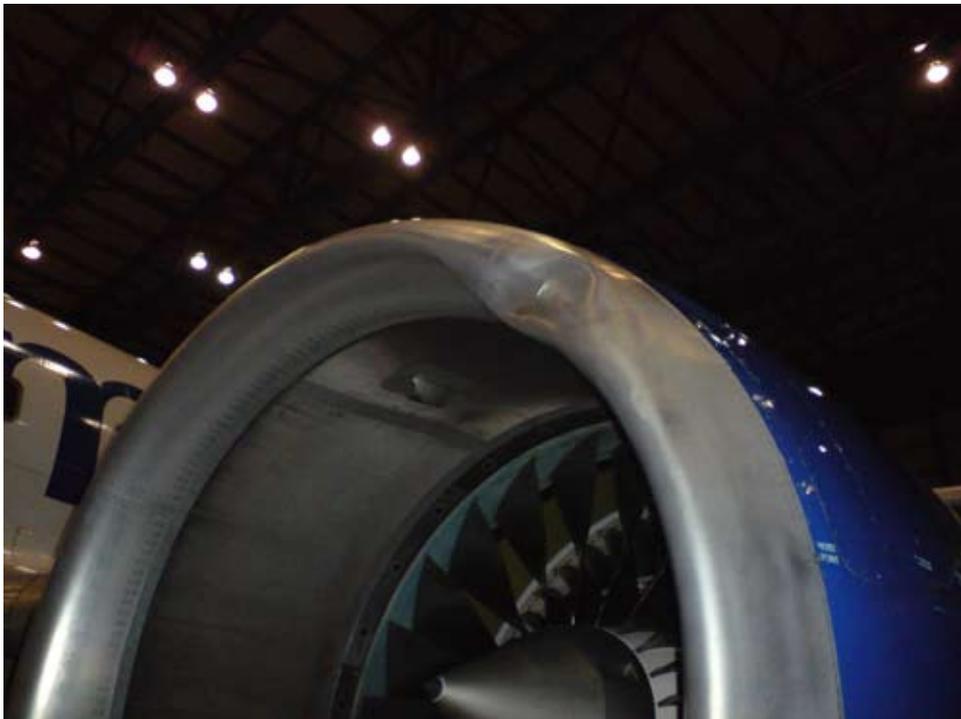
Figure 1

Maintenance personnel assessed the damage to the front upper intake lip of the intake cowl of the left engine as beyond allowable limits and replaced the cowling in accordance with the Aircraft Maintenance Manual. The engine strut, fairings, structure, mounts and fittings were also inspected but found to be undamaged.

Damage to engine cowling

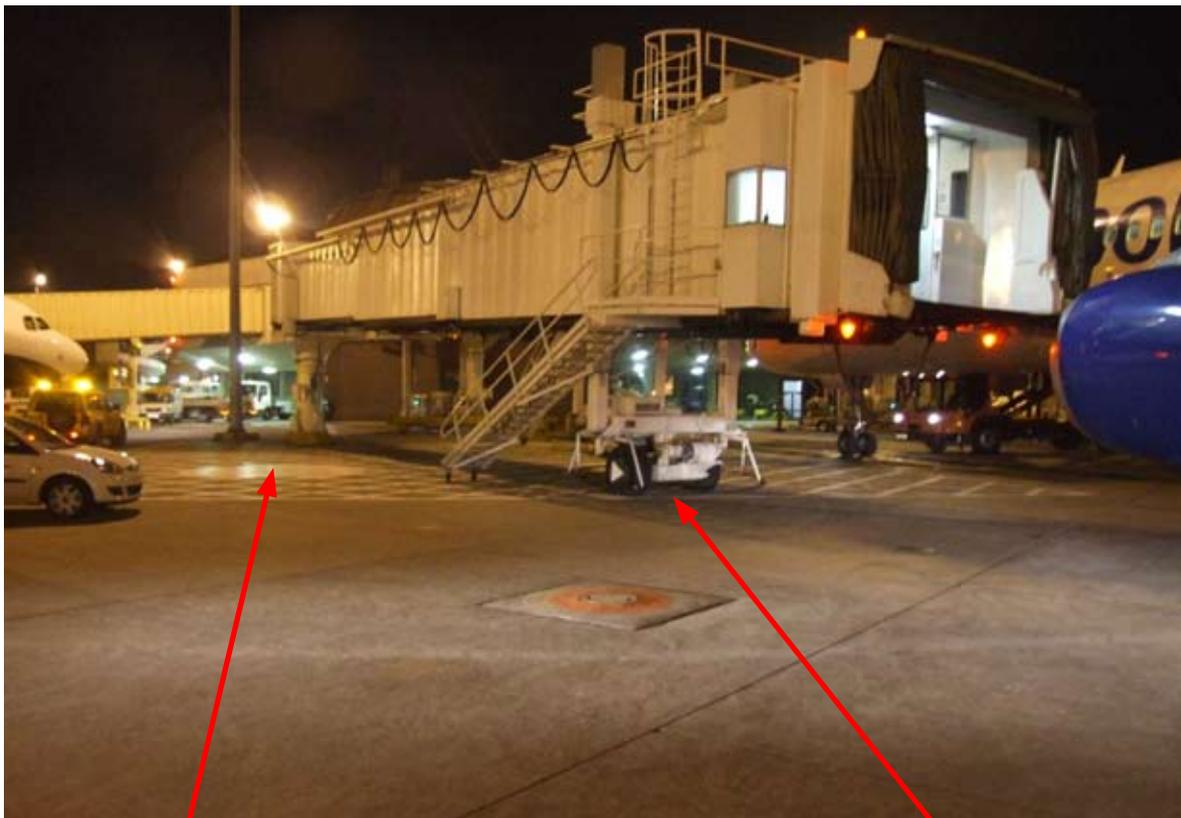
Correct position of airbridge wheels

Actual position of airbridge wheels

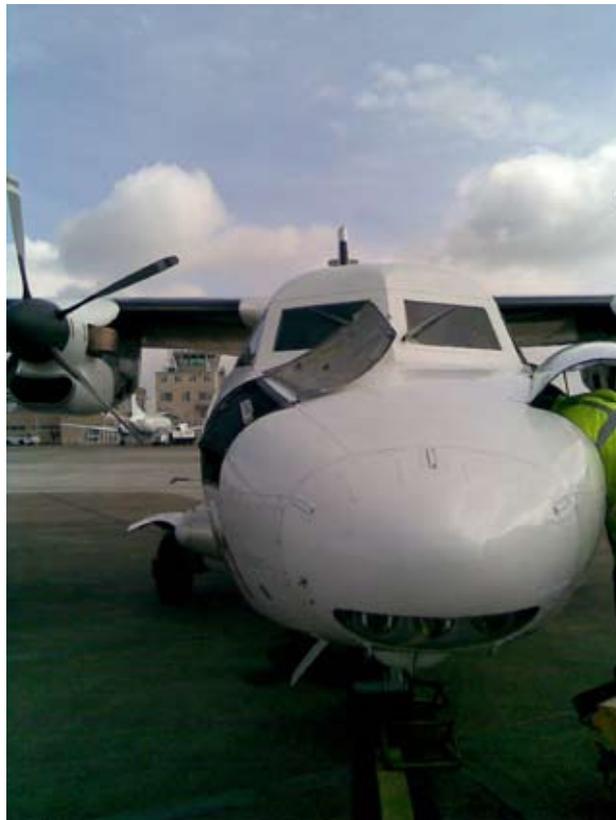
Figure 1

Nose baggage door after arrival at Ronaldsway

The operator's maintenance engineer inspected the baggage door and reported that there were no defects with either the door or its locking device that would have prevented the door from locking. From photographs taken by the Airport Manager at Ronaldsway, it can be seen that whilst the locking device appeared to be locked from the outside, the hook on the mechanism had not engaged with the catch (Figure 2).

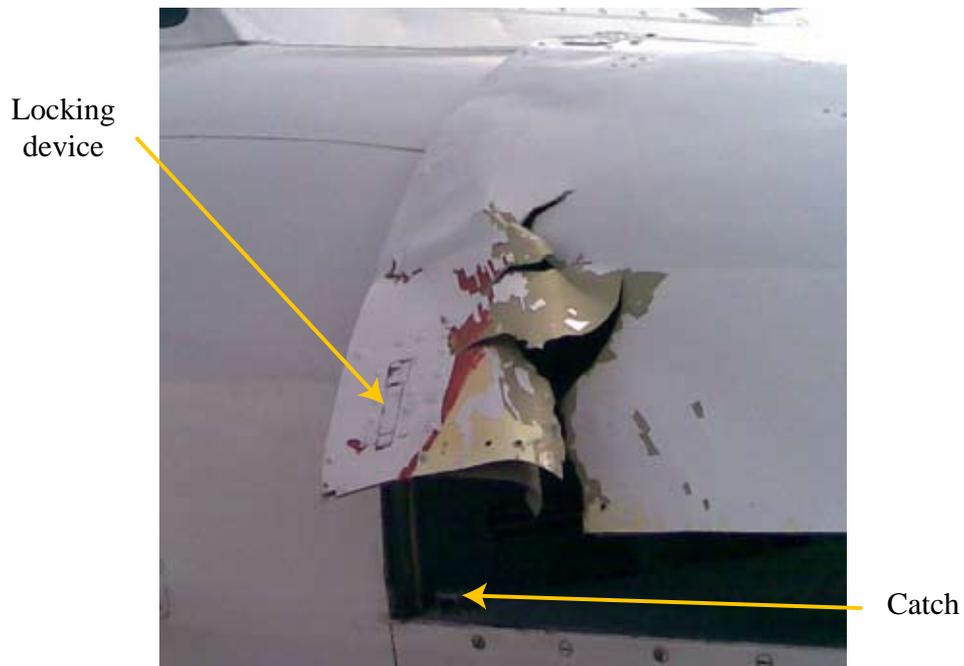
did not open during the outbound journey suggests that it was probably opened at Belfast City Airport. Whilst the door locking mechanism appeared from the outside to have been locked, it is apparent, from the lack of damage, that the hook did not engage in the catch when

the locking mechanism was closed. A modification is available to fit a physical indicator to the front door locking mechanism, but the modification had not been incorporated on this aircraft.

Figure 2
Door locking mechanism

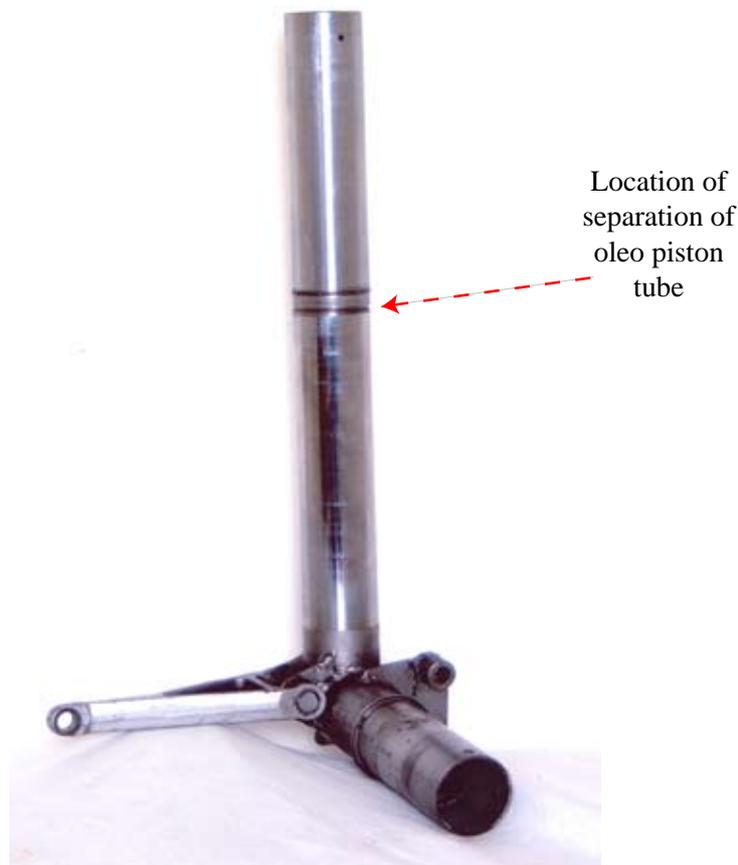
Metallurgical examination of the fractured oleo piston tube showed that it had failed along the lower of two grooves, where a circlip and seal are normally located, Figure 2. The piston tube had been separated for some time, as evidenced by debris recovered from within the unit and damage to the fracture surfaces. This damage meant it was difficult to determine the cause of the failure, other than that it had been associated with a fatigue cracking mechanism. No previous occurrences of this type of failure have reportedly occurred.

It is likely that the piston tube, having been failed at this location for some time, had continued to operate normally within the shock strut, with the torque links just being

able to retain the lower section within the outer cylinder when in flight. As such, when on the ground, the landing gear would have had a normal appearance. However, on the subject flight it is possible that the piston tube may have exited the outer cylinder on takeoff or, more likely, that the heavier than normal touchdown loads allowed the tube to defect rearwards and separate from the leg, before sliding back in to the outer casing and operate apparently normally. The failure of the torque link bolt and brake hose appeared to have occurred after the separation of the piston tube from the outer cylinder.

The origin of the fatigue cracking and/or the initiating event could not be established due to damage to the fracture surfaces brought about by the gear remaining in service after the piston tube had completely failed.

Figure 2
Right Main Landing Gear oleo piston tube

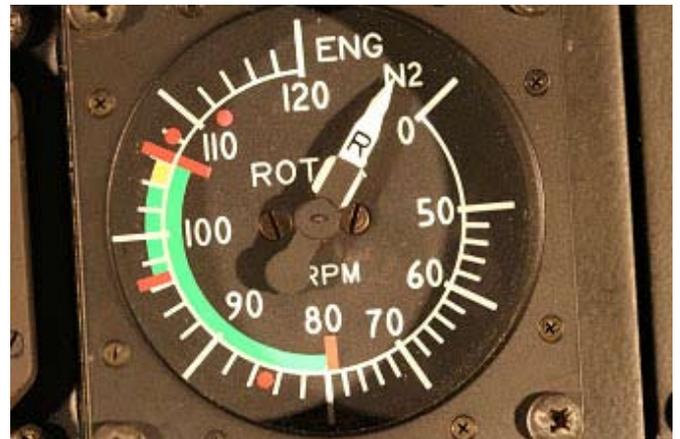
The pilot would have been naturally concerned about rotor rpm, and did interrogate the triple tachometer gauge (see Figure 2). However, controlling the helicopter attitude and selecting a suitable landing site would have demanded most of his visual attention during the short time available and so it is likely that he only gave the gauge a brief glance.

The two N2 pointers are below the NR pointer in this photograph of the gauge at rest.

Note the tail of the NR pointer.

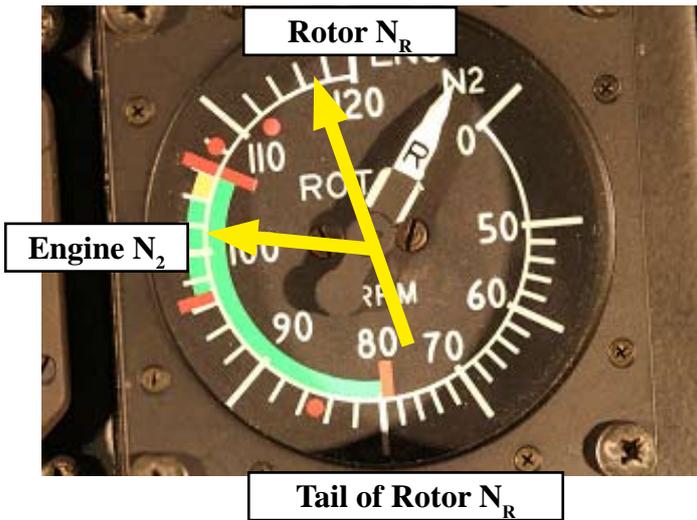
Figure 3

The Triple tachometer gauge with the positions of the pointers, as determined by the investigation, superimposed in yellow. The N2 pointers are not visible as, in this photo, they are hidden by the NR pointer
