## CONTENTS

### COMMERCIAL AIR TRANSPORT

| Boeing 757-3CQ | G-JMAB | 12-Dec-07 | 1 |

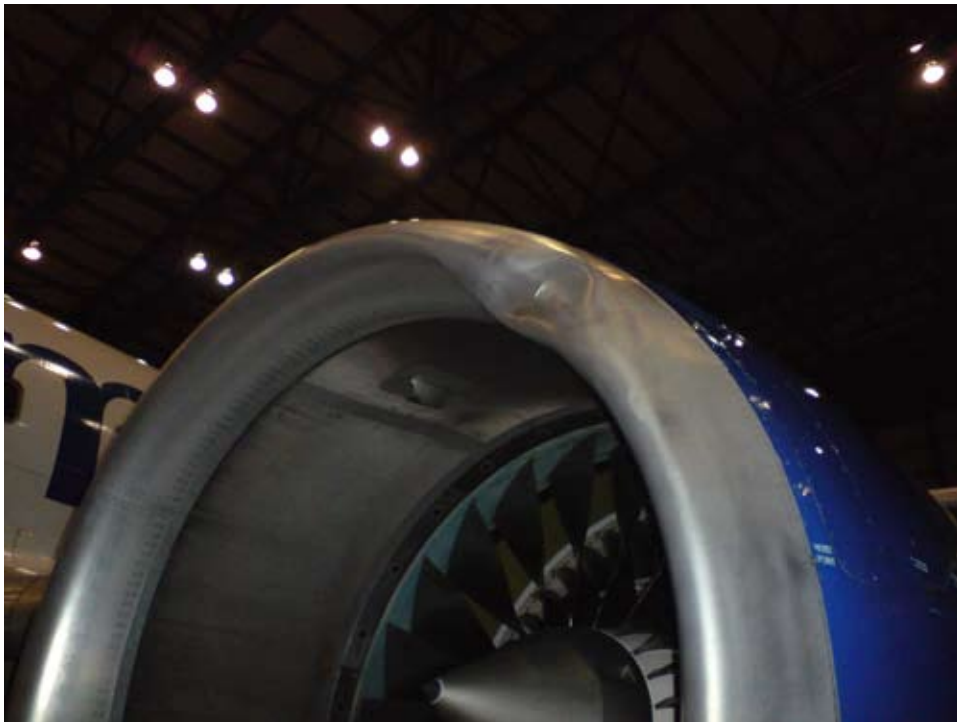
**Figure 1**

Maintenance personnel assessed the damage to the front upper intake lip of the intake cowl of the left engine as beyond allowable limits and replaced the cowling in accordance with the Aircraft Maintenance Manual. The engine strut, fairings, structure, mounts and fittings were also inspected but found to be undamaged.

Damage to engine cowling

The operator stated that the aircraft was fully serviceable prior to the accident. Following replacement of the damaged engine cowl, the aircraft was declared serviceable and returned to normal operations.

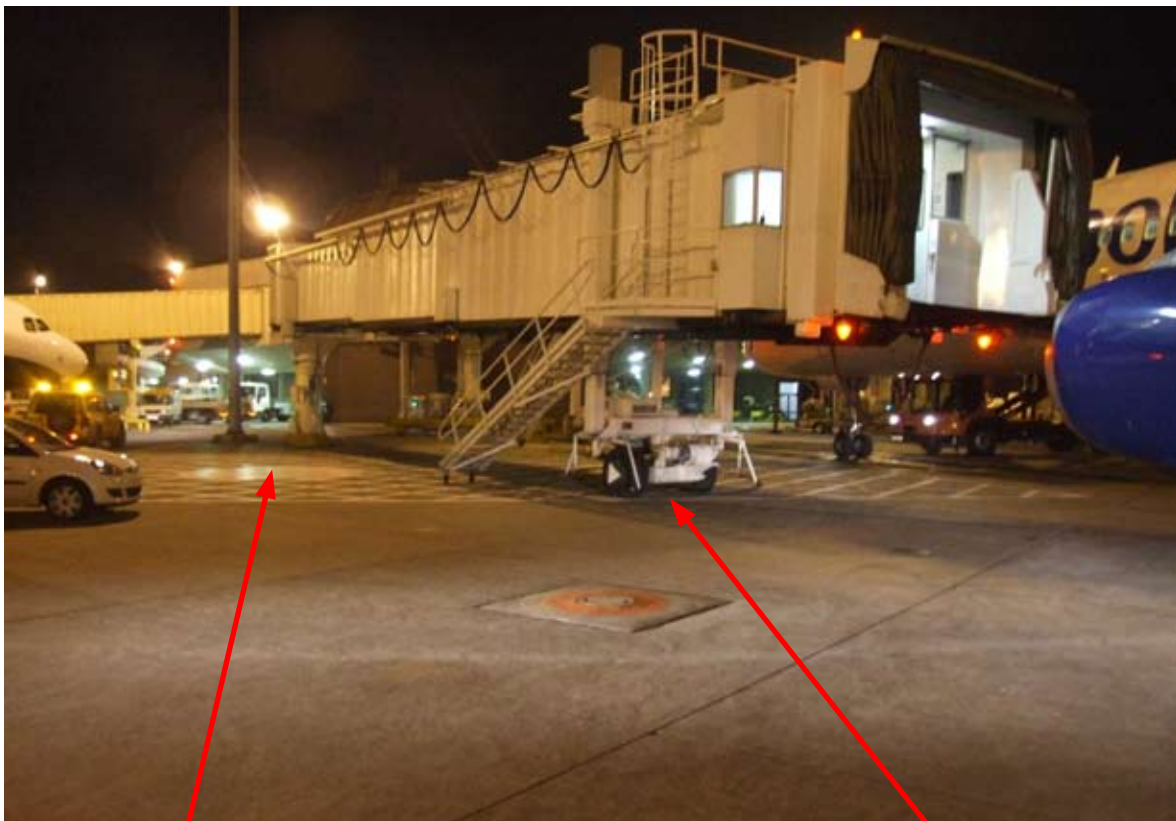
In its own investigation, the airport operator stated that there was no written procedure for the management of stand closures but noted that the handling agent did not check the position of the outer airbridge though required to do so by local procedures. It was also concerned that the AFRS had not been called to attend.

Correct position of airbridge wheels

Actual position of airbridge wheels

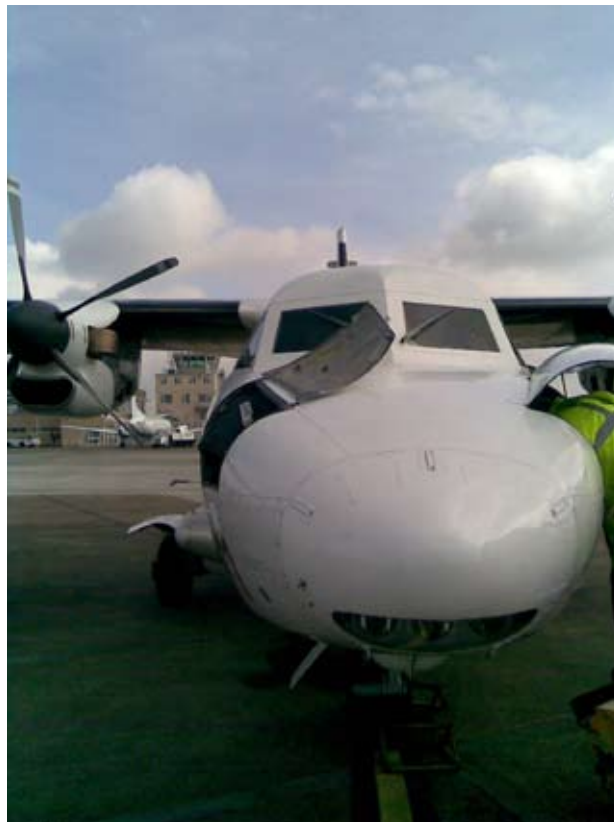
**Figure 1**

The airport Duty Manager at Ronaldsway was notified at 0950 hrs that the aircraft was landing with an open baggage door. From his position in the control tower, he could see that the door was open and a holdall was hanging out of the aircraft. One piece of baggage was subsequently found to be missing, which the commander believed might have been mislaid by the ground handling agency at Belfast City Airport. Figure 1 shows the position of the right nose baggage door after arrival at Ronaldsway.

Nose baggage door after arrival at Ronaldsway

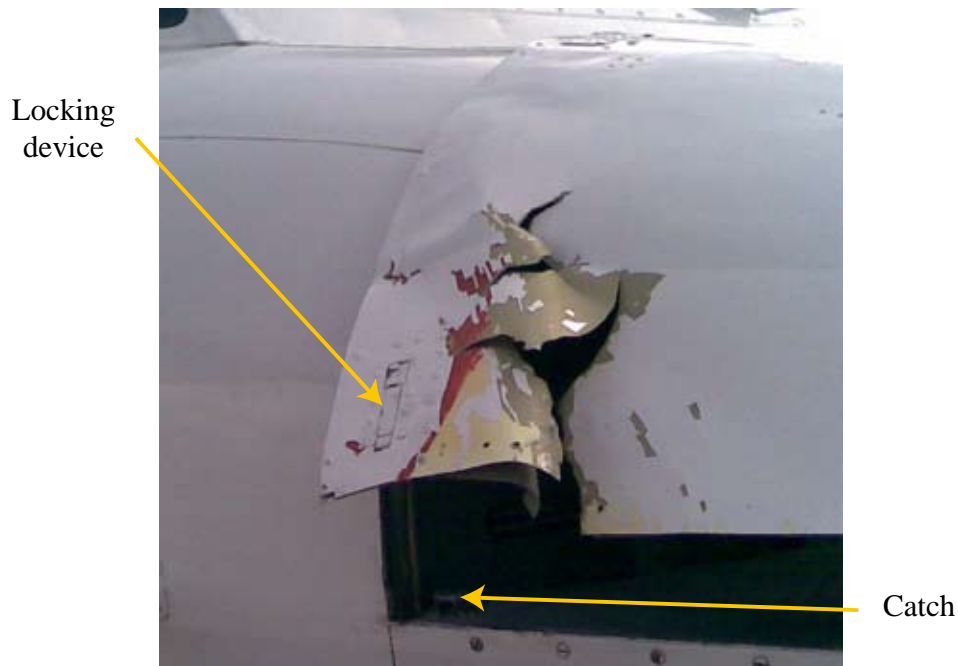
**Figure 2**  
Door locking mechanism

The operator's maintenance engineer inspected the baggage door and reported that there were no defects with either the door or its locking device that would have prevented the door from locking. From photographs taken by the Airport Manager at Ronaldsway, it can be seen that whilst the locking device appeared to be locked from the outside, the hook on the mechanism had not engaged with the catch (Figure 2).

did not open during the outbound journey suggests that it was probably opened at Belfast City Airport. Whilst the door locking mechanism appeared from the outside to have been locked, it is apparent, from the lack of damage, that the hook did not engage in the catch when

the locking mechanism was closed. A modification is available to fit a physical indicator to the front door locking mechanism, but the modification had not been incorporated on this aircraft.

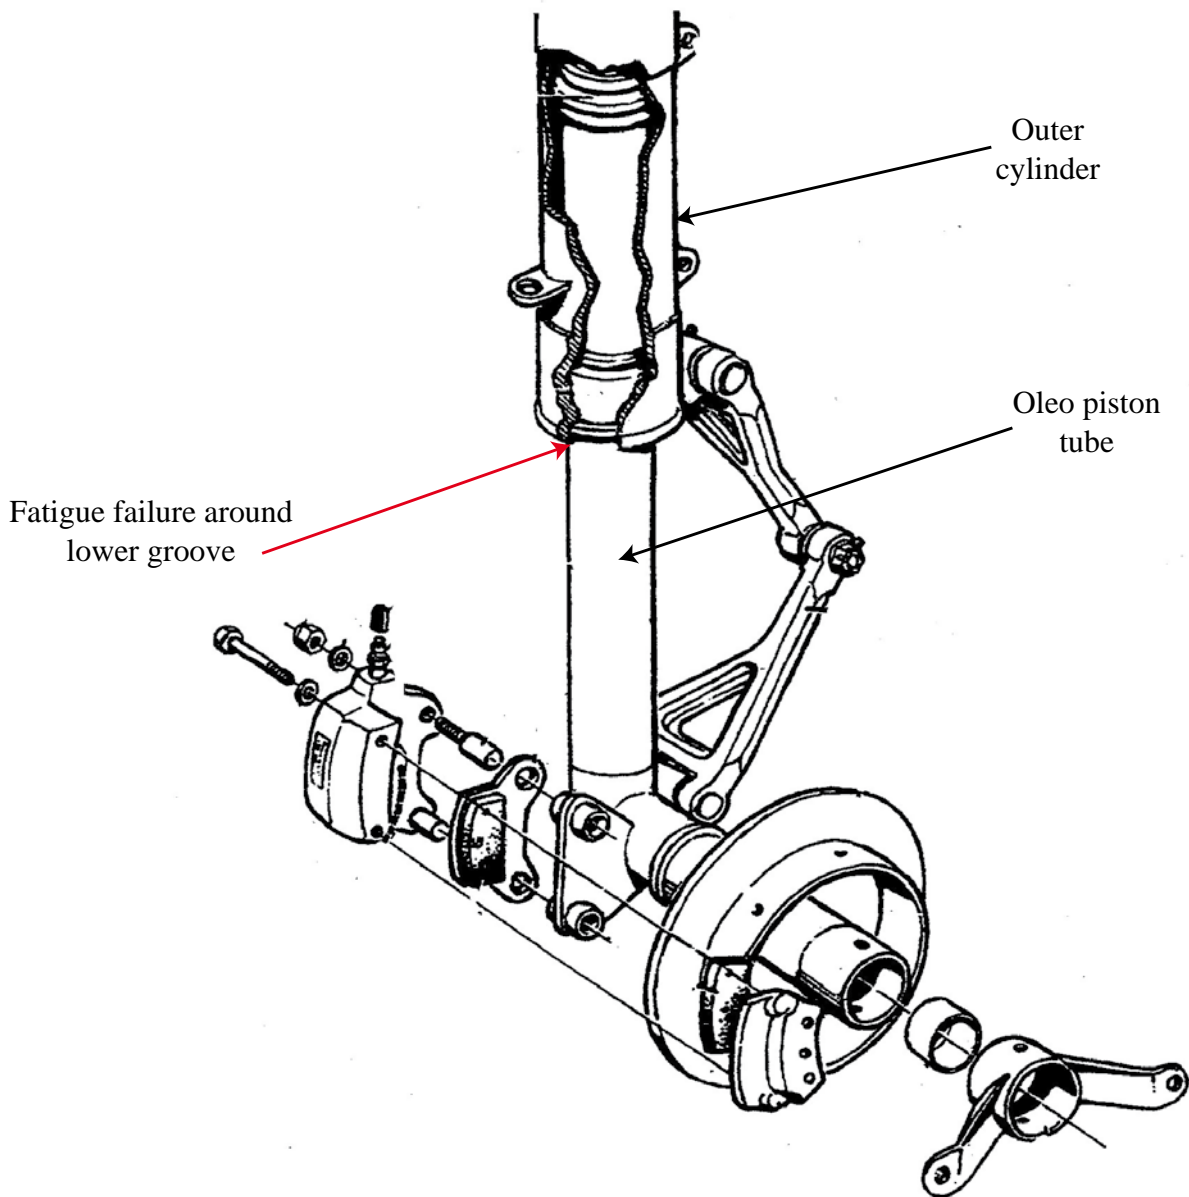
**Figure 1**

oleo piston tube, integral with the wheel axle, which operates within the outer cylinder to attenuate loads from the landing gear to the airframe on touchdown (Figure 1). The cylinder is connected to the axle via a torque linkage. The landing gear is maintained 'on condition' and there had been no history of loss in oleo pressure, or fluid leaks from the seals on the subject leg. It was not possible to establish the service history of the failed unit.

Diagram of the Robin HR200 Main Landing Gear unit

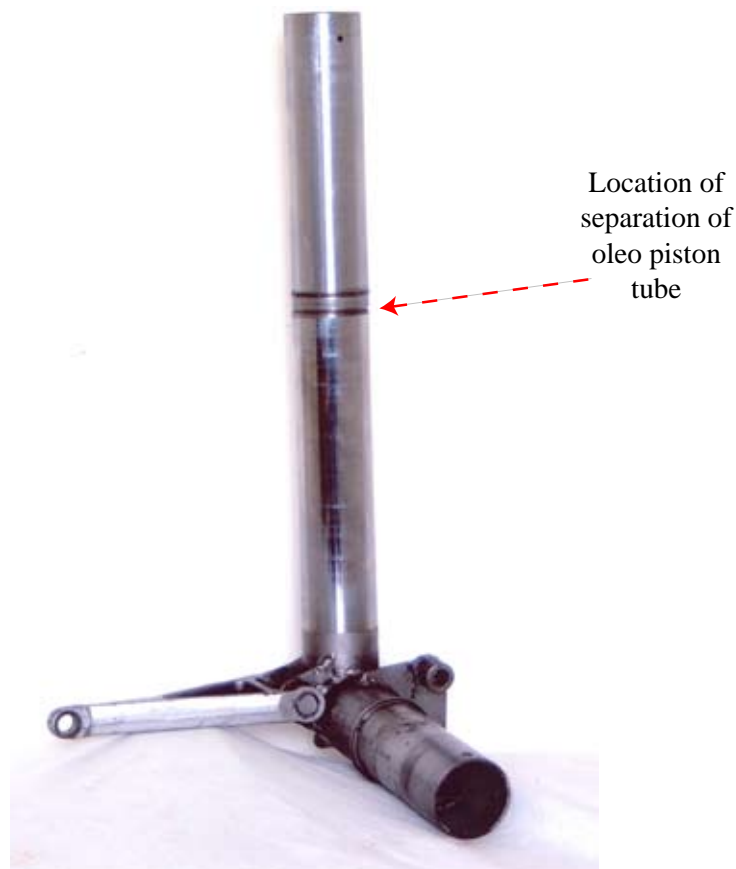
**Figure 2**

Metallurgical examination of the fractured oleo piston tube showed that it had failed along the lower of two grooves, where a circlip and seal are normally located, Figure 2. The piston tube had been separated for some time, as evidenced by debris recovered from within the unit and damage to the fracture surfaces. This damage meant it was difficult to determine the cause of the failure, other than that it had been associated with a fatigue cracking mechanism. No previous occurrences of this type of failure have reportedly occurred.

It is likely that the piston tube, having been failed at this location for some time, had continued to operate normally within the shock strut, with the torque links just being

able to retain the lower section within the outer cylinder when in flight. As such, when on the ground, the landing gear would have had a normal appearance. However, on the subject flight it is possible that the piston tube may have exited the outer cylinder on takeoff or, more likely, that the heavier than normal touchdown loads allowed the tube to defect rearwards and separate from the leg, before sliding back in to the outer casing and operate apparently normally. The failure of the torque link bolt and brake hose appeared to have occurred after the separation of the piston tube from the outer cylinder.

The origin of the fatigue cracking and/or the initiating event could not be established due to damage to the fracture surfaces brought about by the gear remaining in service after the piston tube had completely failed.

Right Main Landing Gear oleo piston tube

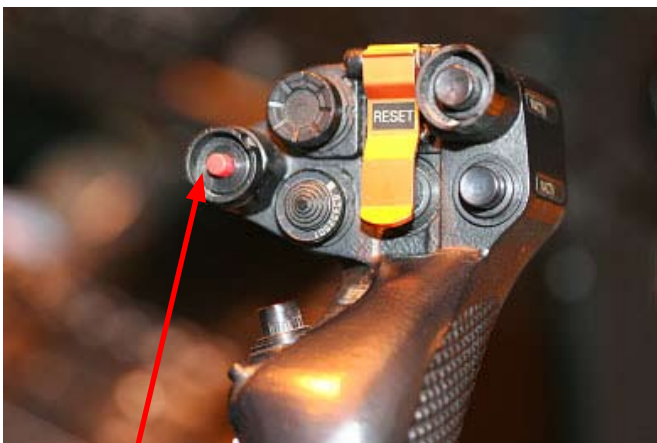
**Figure 1**

A SAS DCPL switch is mounted on top of each cyclic grip and, whilst it is protected from inadvertent operation by an annular guard, the switch sits about 1 mm proud of the guard (see Figure 1). Tests were undertaken, on the ground, to establish if either of the front seat occupants could have inadvertently operated this switch. In the first test the corner of the magazine which the passenger had been reading was knocked against the switch. The test proved that it is possible for the corner of a heavy magazine to operate the switch. The second test simulated the pilot turning to place a book in the right door stowage. This test proved that it is possible for an elbow to operate the switch. On both tests the pressure to operate the switch also caused the cyclic stick to move forwards.

SAS DCPL SWITCH

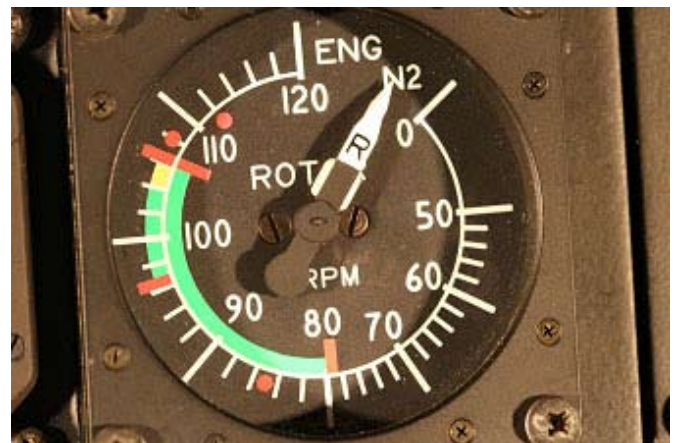
The pilot would have been naturally concerned about rotor rpm, and did interrogate the triple tachometer gauge (see Figure 2). However, controlling the helicopter attitude and selecting a suitable landing site would have demanded most of his visual attention during the short time available and so it is likely that he only gave the gauge a brief glance.

The two N2 pointers are below the NR pointer in this photograph of the gauge at rest.

Note the tail of the NR pointer.

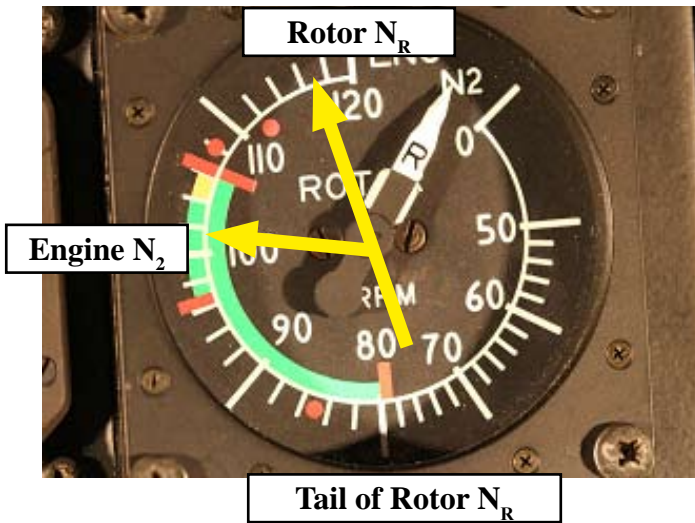
**Figure 3**

From the information in the warning unit it was established that in the early part of the accident sequence the AP A TRIM warning light illuminated and a gong sounded every three seconds for 10 seconds. The Master Caution light would also have illuminated and messages informing the pilot of the loss of the AFS systems would have been displayed on the CAD and PD. However, the pilot believed that he had an engine problem and therefore entered an autorotation, which would have required him to pitch the helicopter nose up initially to reduce speed. This would have caused the rotor rpm to increase, and the engine power to decrease. The engine N2 would have remained at 100%. From the warning unit it is known that the rotor rpm exceeded 112%, which would have caused the ROTOR RPM warning light to flash and a constant tone to be generated in the pilot's headset. It is possible that in glancing down at the triple tachometer gauge the pilot mistook the tail of the rotor NR pointer as being one of the engine N2 pointers, thereby reinforcing his belief that he had an engine problem (see Figure 3). However the engine and torque indications on the upper VEMD screen would have shown that both engines were still operating normally.

The AP A TRIM warning light and gong would self-cancel ten seconds after they had been activated and the flashing red messages on the PD would change to amber OFF messages. The descent took approximately 42 seconds, during which the pilot's workload would have been very high. In addition to flying the helicopter,

The Triple tachometer gauge with the positions of the pointers, as determined by the investigation, superimposed in yellow. The N2 pointers are not visible as, in this photo, they are hidden by the NR pointer

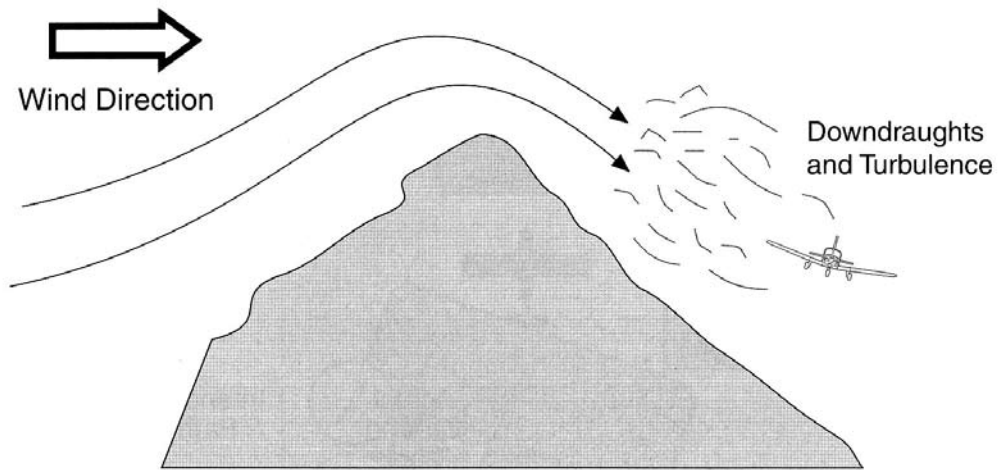
**Figure 2**

turbulence would be expected at low level (Figure 2). The ridge to the east may also have influenced the local airflow. The combined effect of the two ridges is difficult to assess, although a scenario in which marked changes in vertical and horizontal wind strength for the approach could readily be envisaged.

The pilot attributed the accident to the downdraught created by the adjacent hills. This is a well known phenomenon and pilots are advised against flying at low level downwind of high ground, particularly in strong wind conditions, or in aircraft with low wing loadings that are susceptible to gusts.

Dangers of flying at low level downwind of high ground  
(Figure copyright AFE and Jeremy M Pratt)
