ACCIDENT

Aircraft Type and Registration:	Bombardier BD700 Global Express, VP-CRC	
No & Type of Engines:	2 Rolls Royce BR 710 series turbofans	
Year of Manufacture:	2007	
Date & Time (UTC):	29 January 2008 at 0808 hrs	
Location:	London Luton Airport	
Type of Flight:	Private	
Persons on Board:	Crew - 3	Passengers - 1
Injuries:	Crew - None	Passengers - None
Nature of Damage:	Left inboard main landing gear tyre burst, flap drive shaft and two hydraulic pipes fractured, wiring loom damaged and localised wing structural damage	
Commander's Licence:	Airline Transport Pilot's Licence	
Commander's Age:	36 years	
Commander's Flying Experience:	3,759 hours (of which 92 hrs were on type) Last 90 days - 78 hours Last 28 days - 38 hours	
Information Source:	AAIB Field Investigation

Synopsis

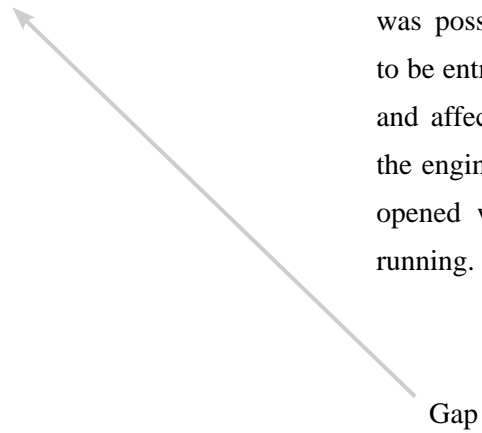
Figure 2

Hand pressure was sufficient to open up a significant gap between the hose and duct, Figure 2. It was possible, therefore, for air to be entrained through the joint and affect the mixture entering the engine, should the gap have opened whilst the engine was running.

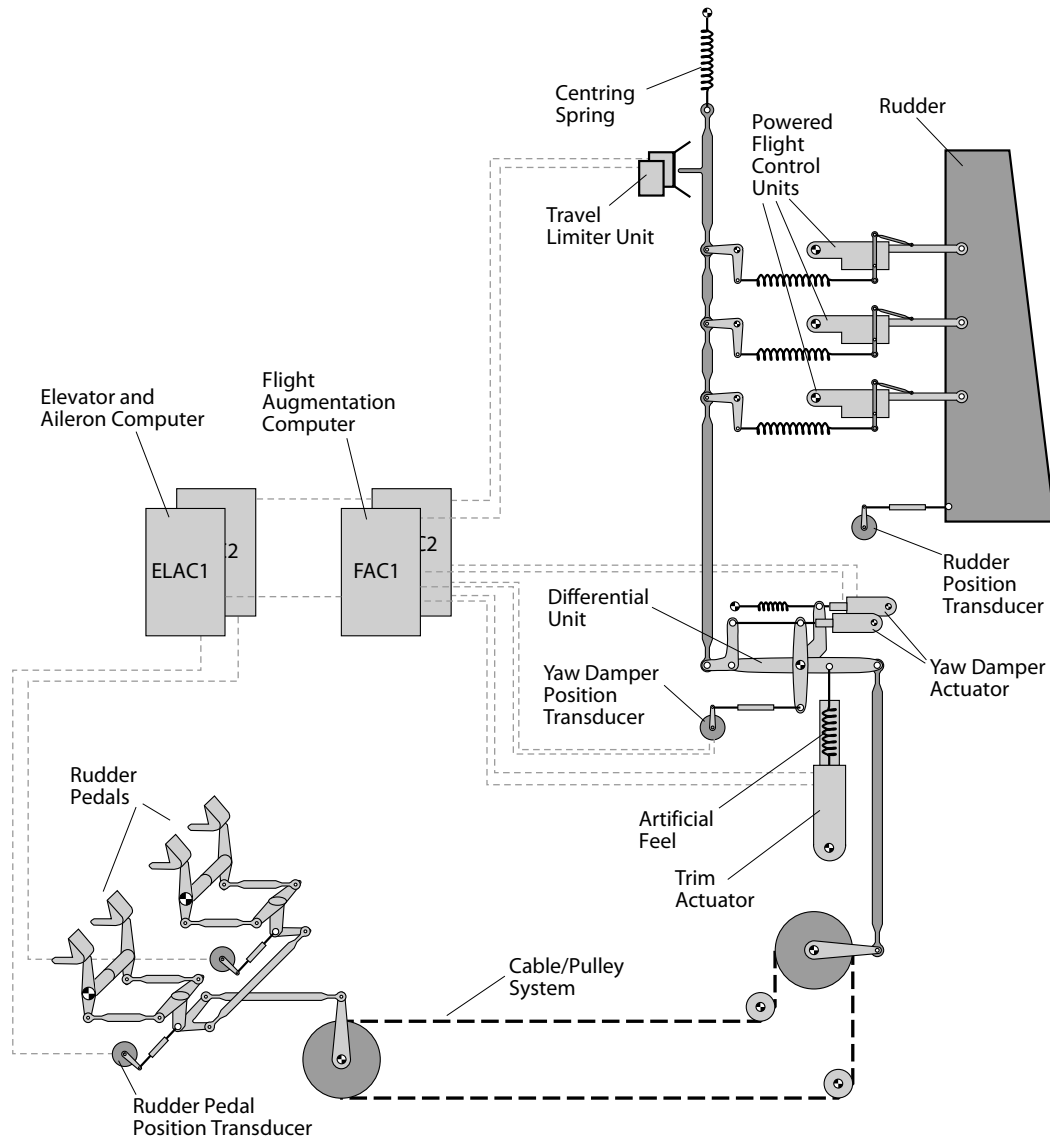
Figure 1

A319 Rudder Control System Schematic

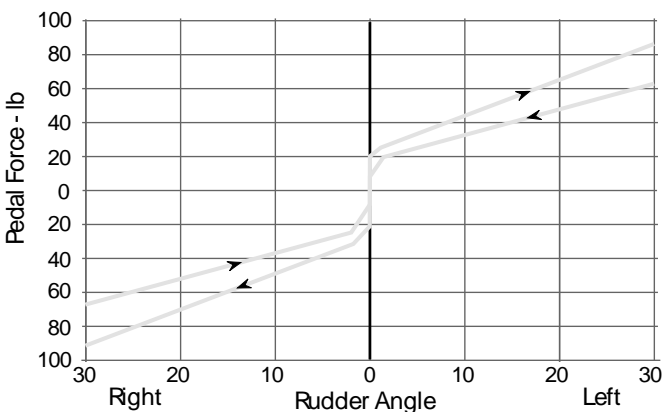
Figure 2

A319 Normal Rudder Pedal Force vs Rudder Deflection

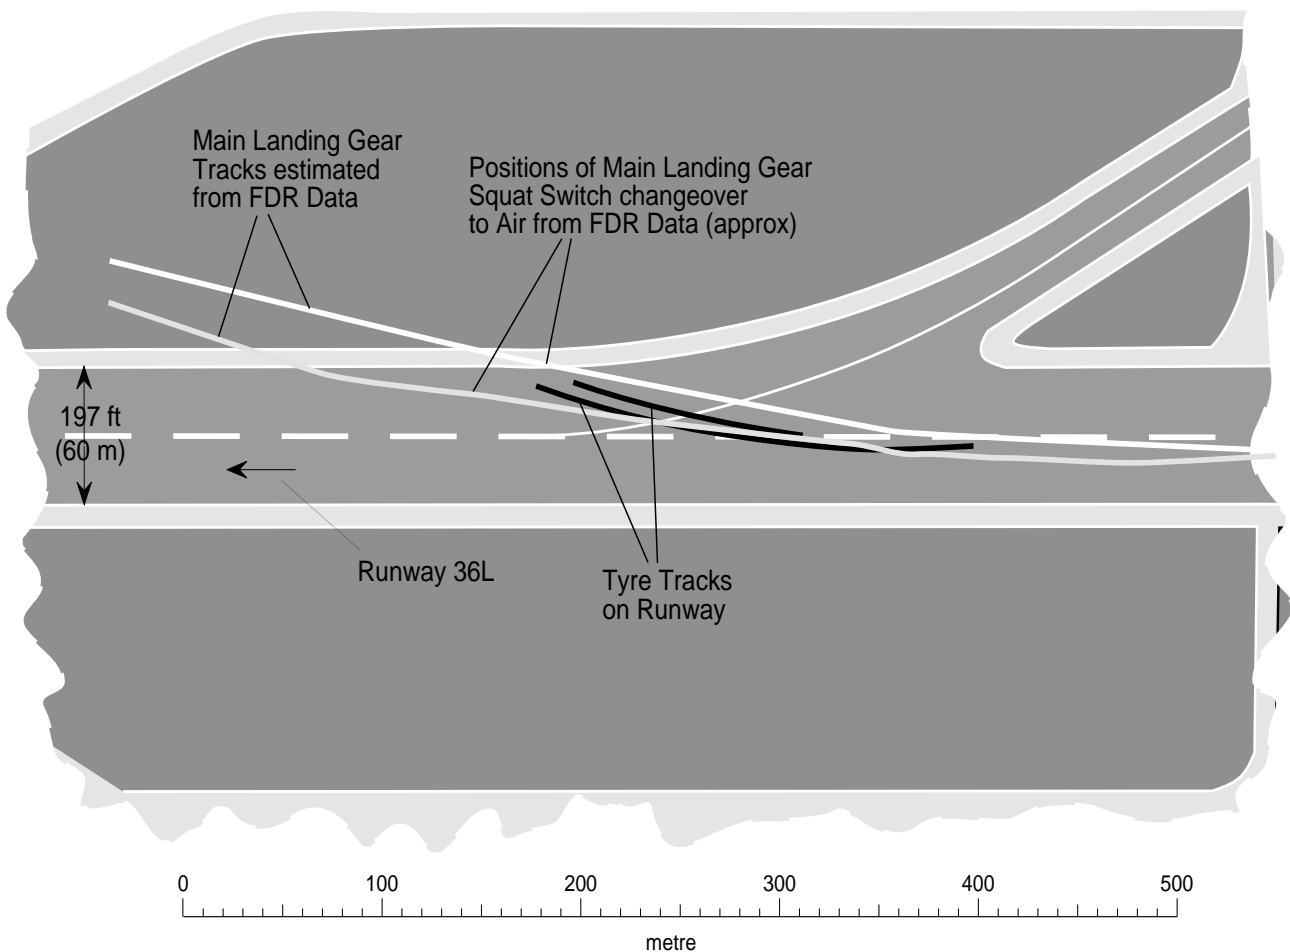
Figure 3

Plan View of Runway Tyre Marks and Main Landing Gear Tracks estimated from FDR Data

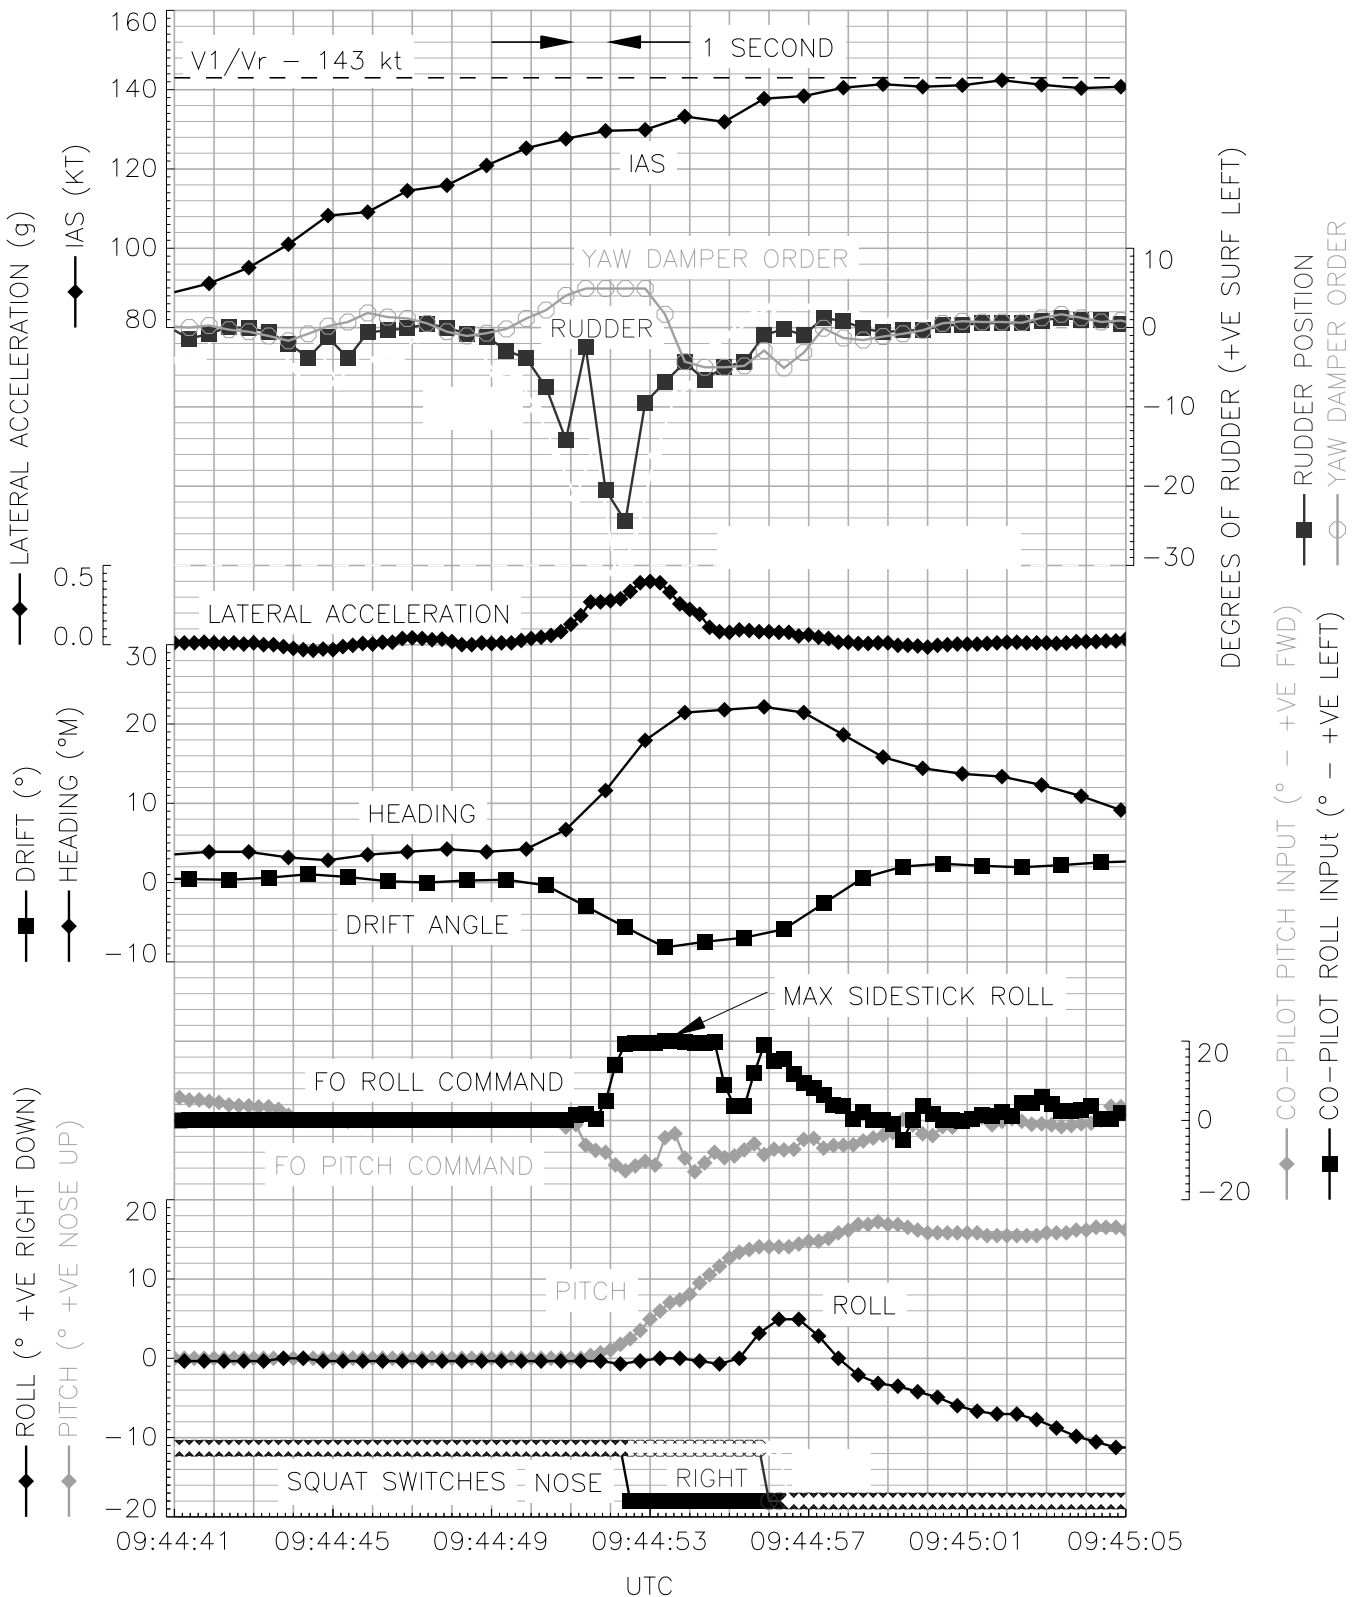
Figure 4

FDR Parameters showing control inputs and aircraft motion.
(Incident to G-DBCI on 18 April 2007)

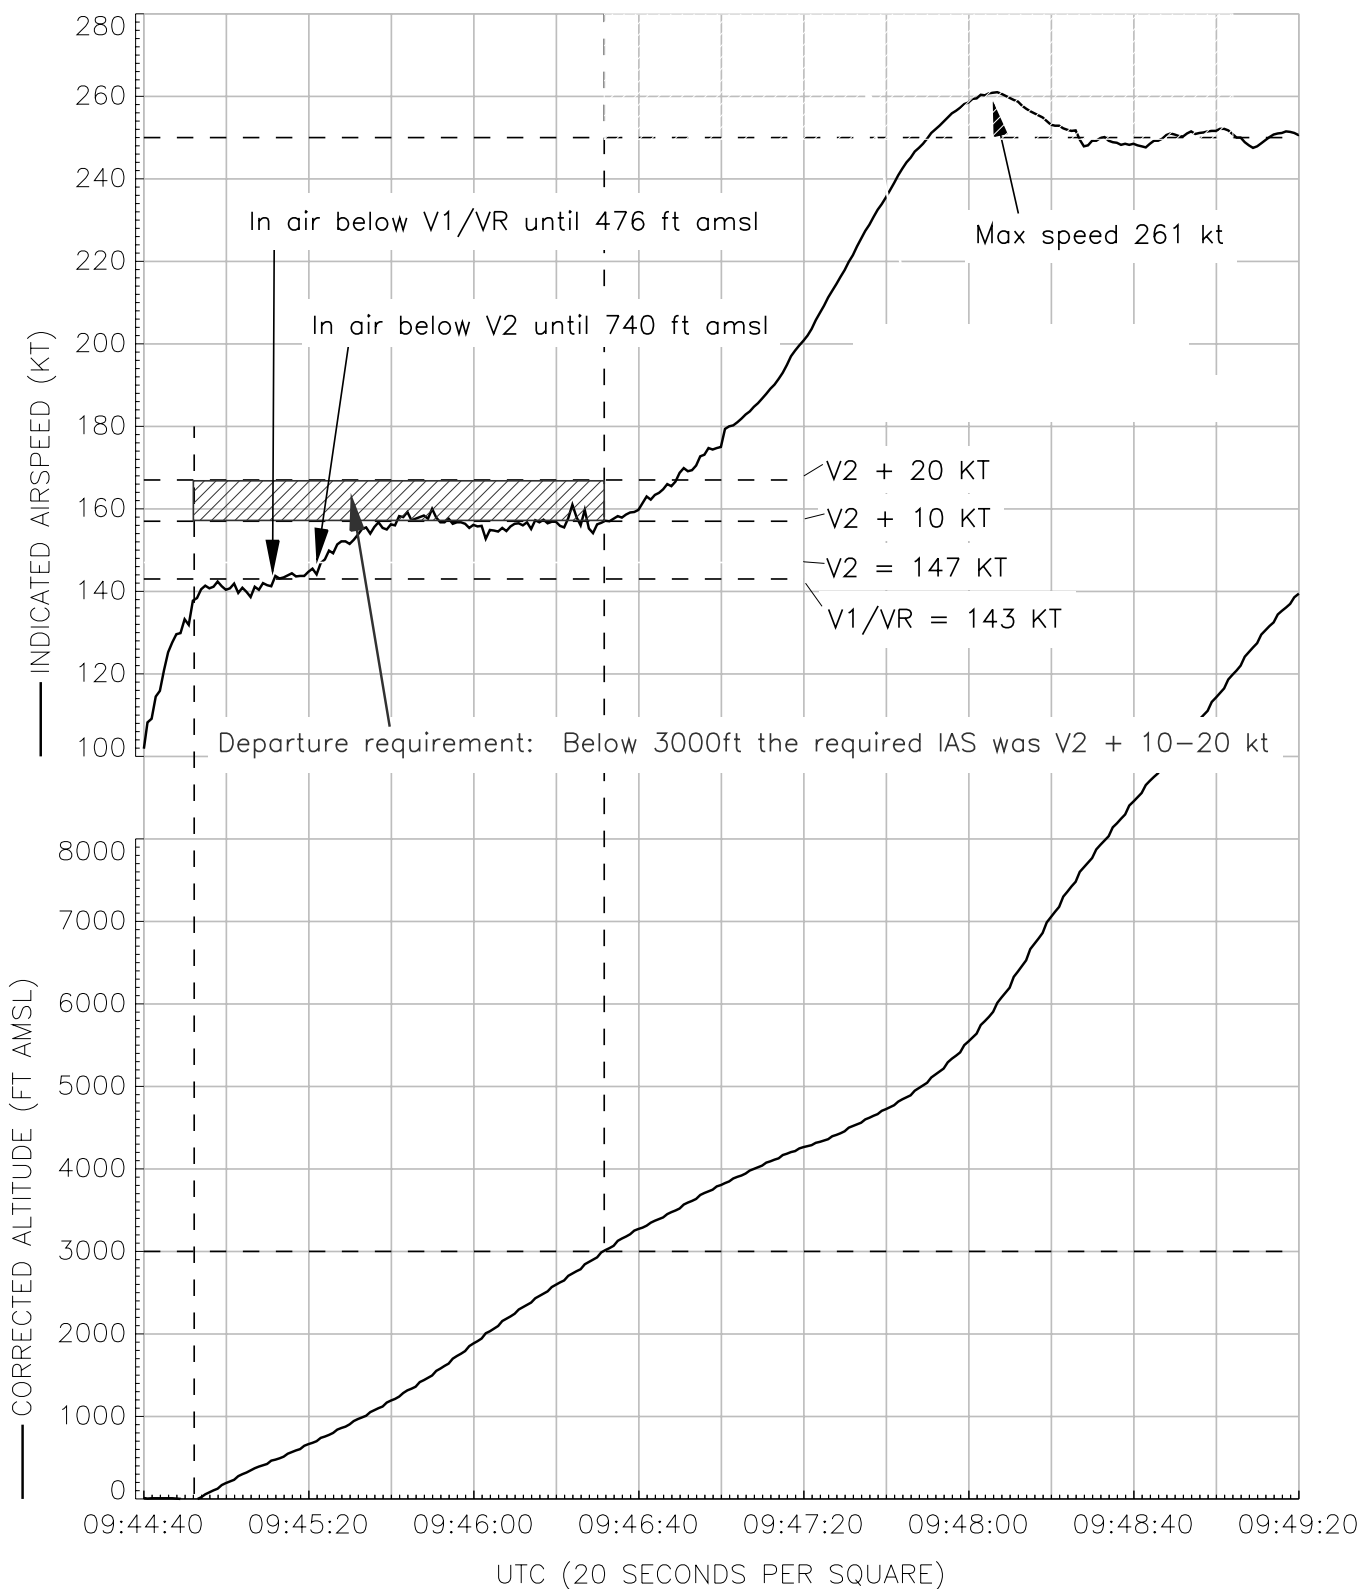
Figure 5

FDR parameters showing recorded airspeed relative to required airspeed after takeoff
(Incident to G-DBCI on 18 April 2007)
