(ALL TIMES IN THIS BULLETIN ARE UTC)

SERIOUS INCIDENT

Aircraft Type and Registration:	Airbus A320, G-DHJZ
No & Type of Engines:	2 CFM56-5B4/P turbofan engines
Year of Manufacture:	2003
Date & Time (UTC):	5 July 2007 at 1205 hrs
Location:	Kos Airport, Greece
Type of Flight:	Commercial Air Transport (Passenger)
Persons on Board:	Crew - 6 Passengers - 180
Injuries:	Crew - None Passengers - None
Nature of Damage:	Severe damage to main landing gear
Commander's Licence:	Air Transport Pilot's Licence
Commander's Age:	47 years
Commander's Flying Experience:	12,100 hours (of which 950 were on type) Last 90 days - 174 hours Last 28 days - 38 hours
Co-pilot's Age	34 years
Co-pilot's Flying Experience	381 hours (of which 147 were on type) Last 90 days - 154 hours Last 28 days - 49 hours
Information Source:	AAIB Field Investigation, at the request of the Greek Air Accident Investigation & Aviation Safety Board

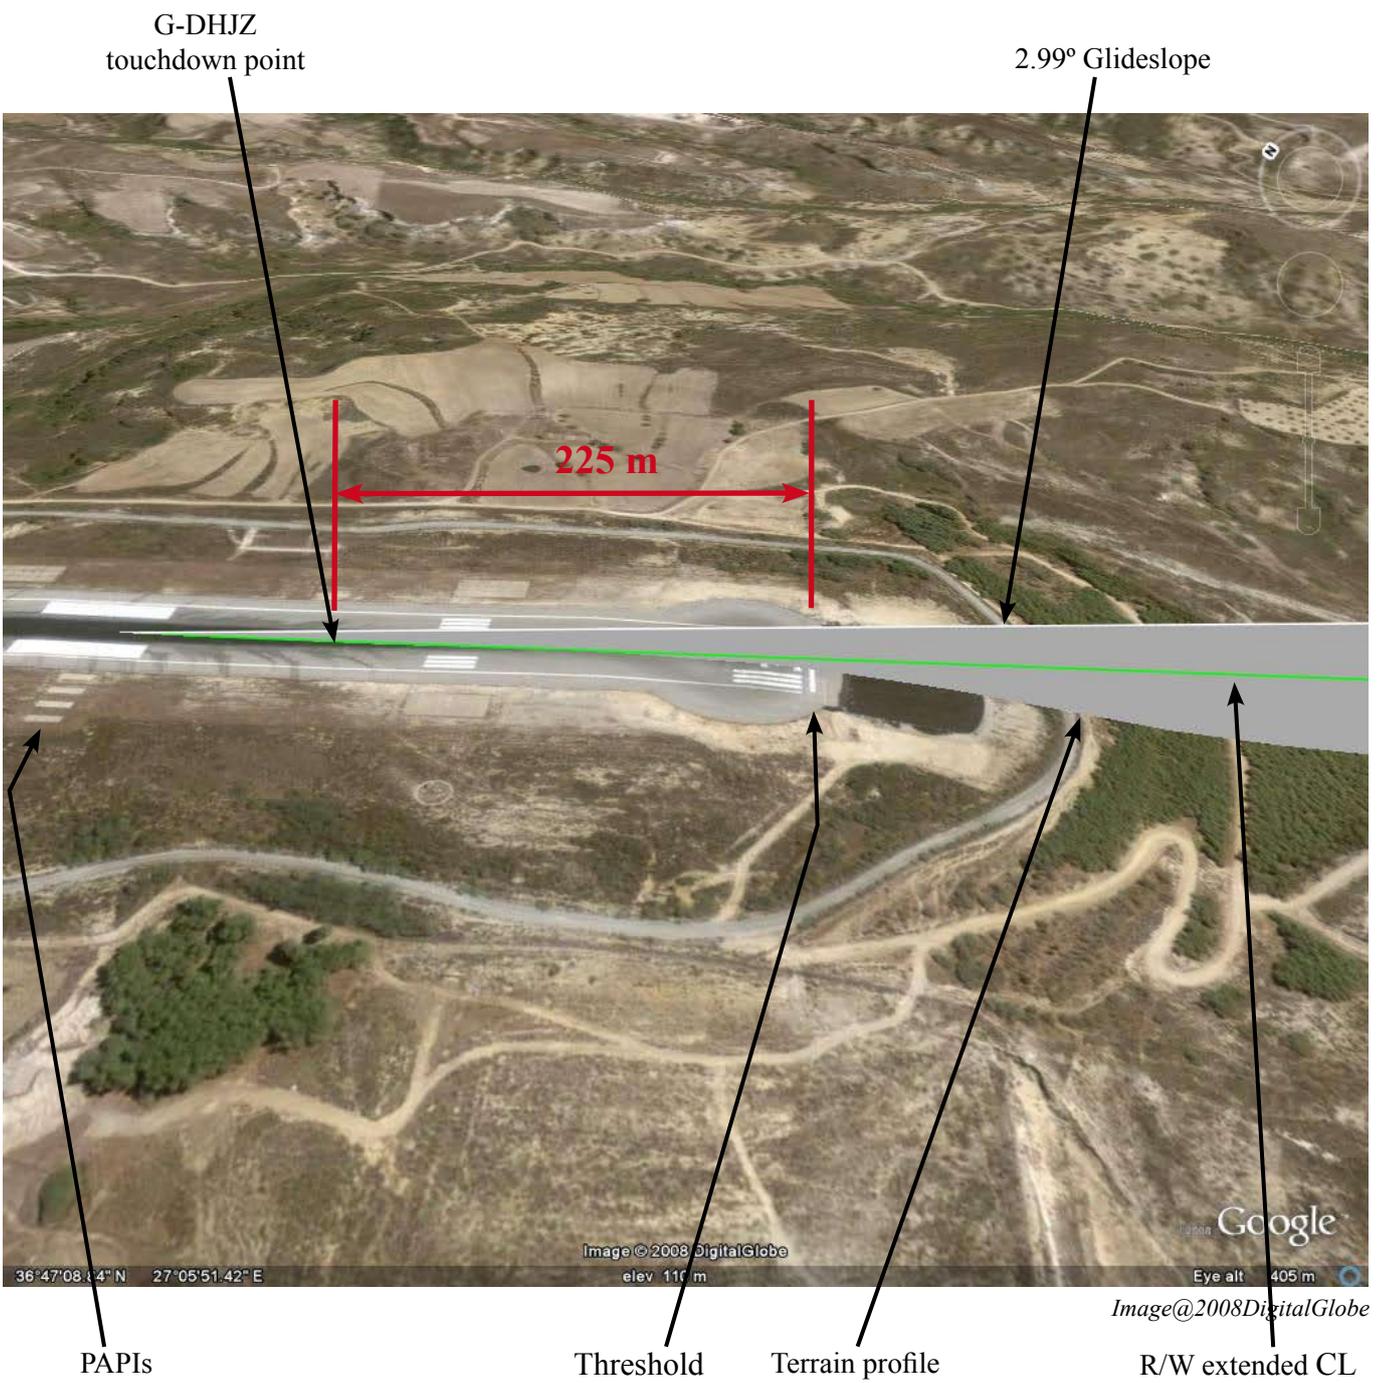
Figure 2
Threshold region of Runway 32 at Kos

The steeply rising terrain under the approach to Runway 32 at Kos, can result in a pilot gaining a false perspective of an approach and has the potential to cause pilots to perceive the rate of descent to be greater than it is. This, and the accompanying 'ground-rush', may result in an early and excessive flare. However, this did not occur in this case as the co-pilot used the RA callout of FIFTY as the trigger to begin to flare.

It is recommended that the Greek Civil Aviation Authority should review the performance of the PAPI installation of Runway 32 at Kos, to ensure that flight crews are able to acquire them visually in time to stabilise their aircraft on the correct glideslope before landing.

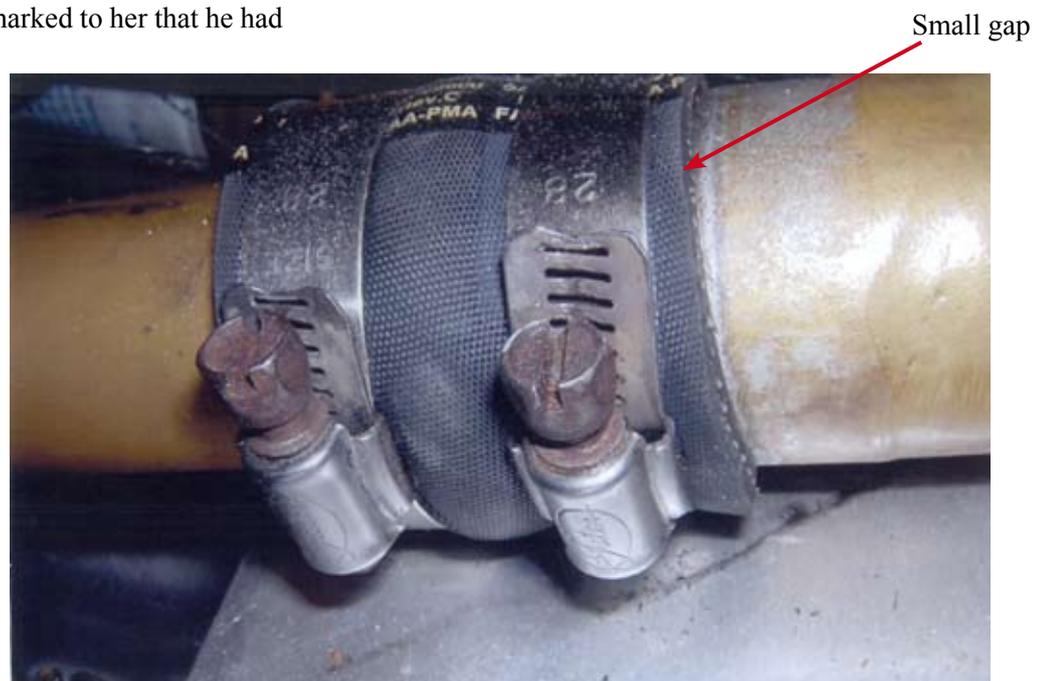
Figure 1

Subsequent examination of the engine by the owner revealed evidence from the exhaust stacks and spark plugs that the engine had been running with a very lean fuel/air mixture, although she reported that there had been no indication in flight of abnormally high oil temperature. Further inspection of the engine showed that the hose connecting the air intake duct to the No 3 cylinder to the inlet manifold, did not properly cover the end of one of the ducts, Figure 1.

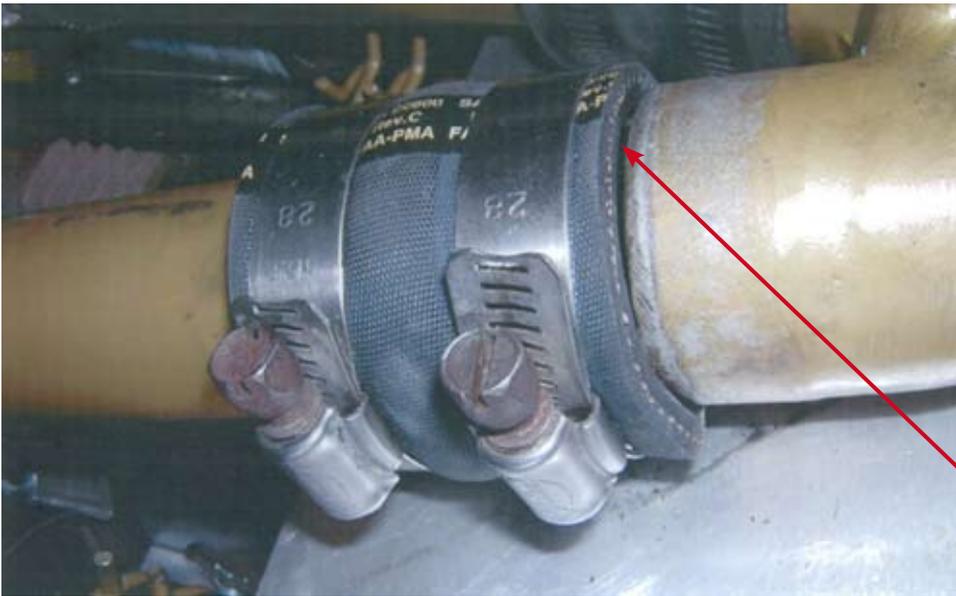
Gap

Hand pressure was sufficient to open up a significant gap between the hose and duct, Figure 2. It was possible, therefore, for air to be entrained through the joint and affect the mixture entering the engine, should the gap have opened whilst the engine was running.

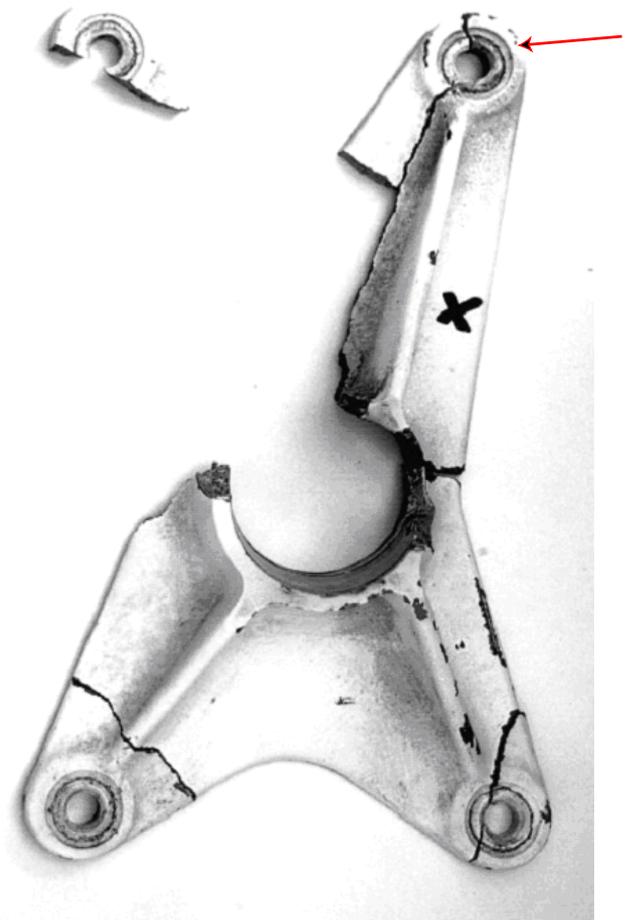
Figure 2

The aircraft was recovered to the maintenance organisation's hangar, where an inspection revealed that the left landing gear forward trunnion fitting had broken into several pieces. Parts of the component were missing, although one piece was later recovered from the runway at Tatenhill. Figure 1 shows an illustration from the Illustrated Parts Catalogue, which shows details of the installation.

The fragments from the trunnion fitting were removed from the aircraft, Figure 2, and subjected to a metallurgical examination.

Recovered trunnion pieces. Fragment marked 'X' was found at Tatenhill. Note damage around bolt hole (arrowed)

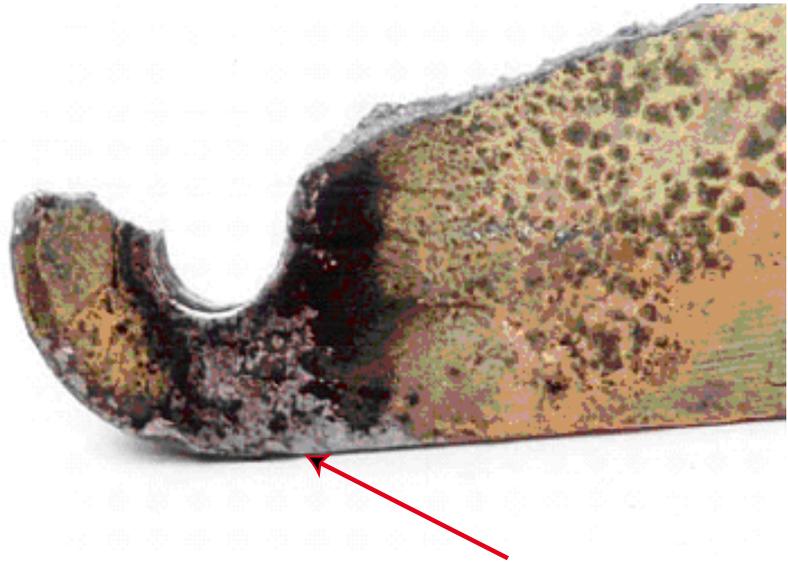
Figure 3

Fretting damage area on reverse side of fragment X (arrowed)

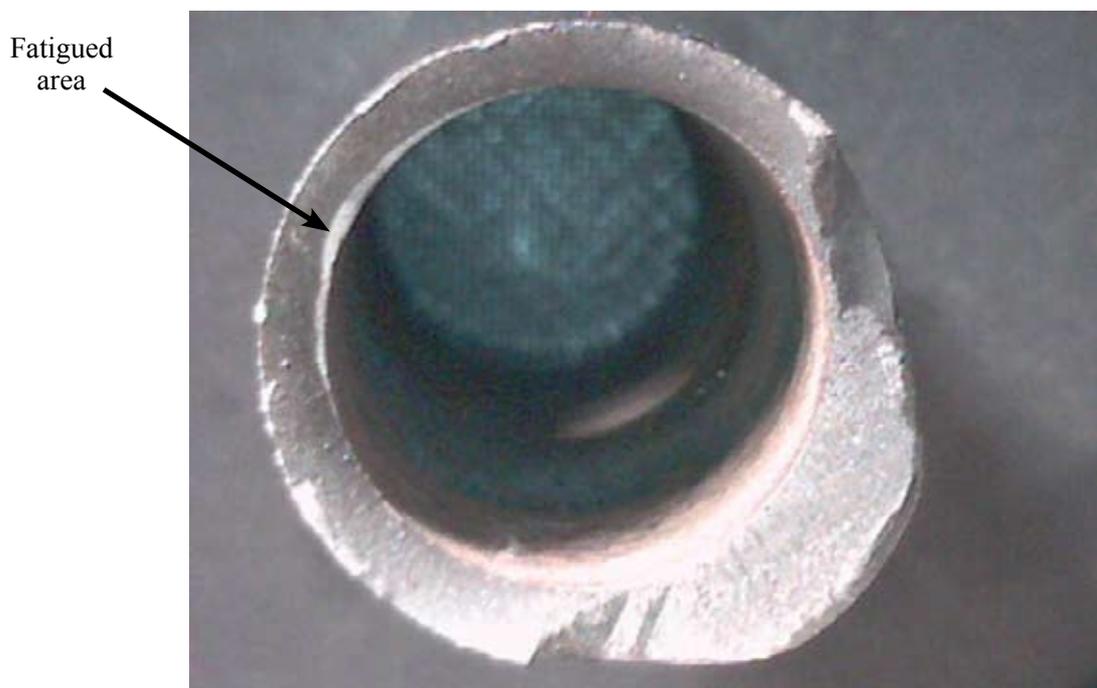
Figure 1

The aircraft had experienced a nose-over during a soft-field landing in about 1999. The current repairer noted the contemporary repairs but also noted additional significant damage which had apparently not been spotted at the time. He is cataloguing this damage and will submit a report to the LAA, who have also been advised of the discovery of the fatigue crack in the strut.
