SPECIAL BULLETINS

Airbus A340-313	G-VAIR	27-Apr-08	1
-----------------	--------	-----------	---

(ALL TIMES IN THIS BULLETIN ARE UTC)

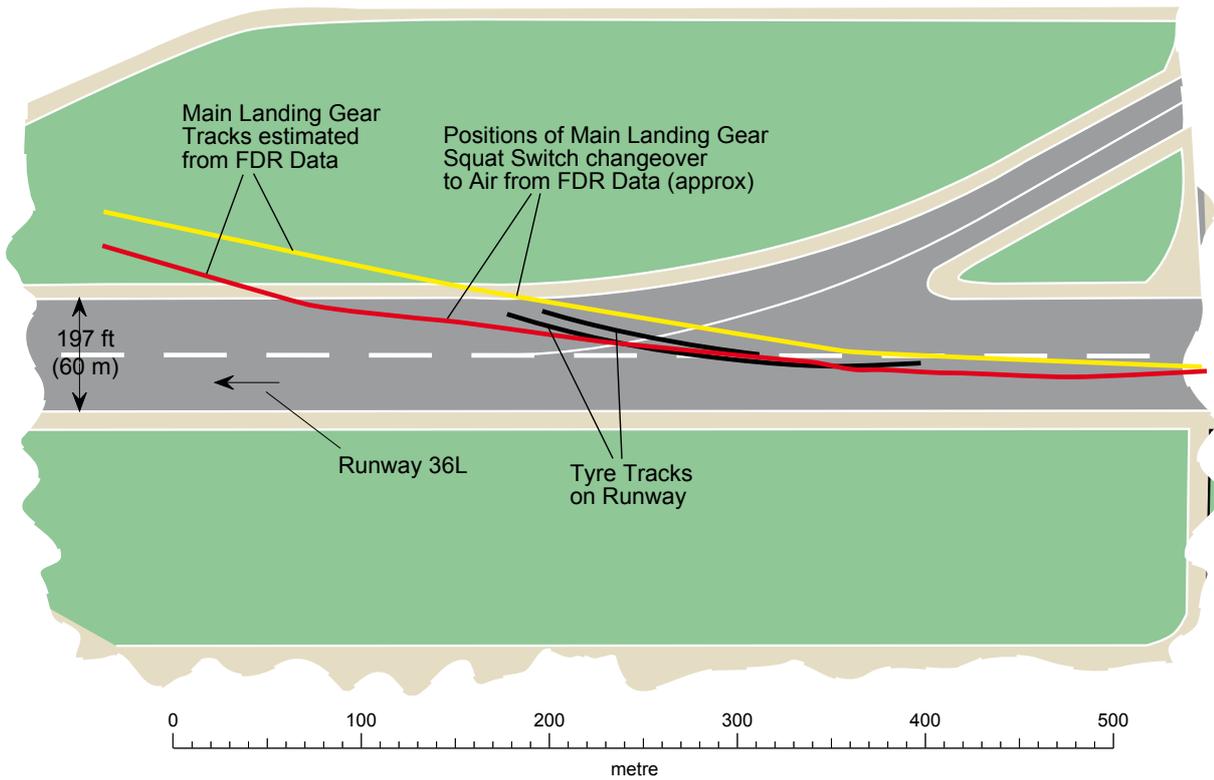
Figure 3

Inspection of Runway 36L at Amsterdam by the Dutch authorities shortly after the incident identified two pairs of tyre track marks that appeared likely to be associated with G-DBCI's takeoff ground roll deviation. The Dutch Safety Board supplied photographs of the marks and their approximate dimensions and AAIB subsequently examined the runway. The marks were found to consist of pronounced black rubber deposits on the light-coloured asphalt surface of the runway. Their lateral spacing corresponded to the A319 main landing gear wheeltrack and their position (Figure 3) corresponded closely to the aircraft track estimated from FDR data. It was therefore concluded that G-DBCI's mainwheel tyres had made the marks during the takeoff ground run.

The track marks from the left main wheel tyres commenced approximately 1,035 m from the start of Runway 36L, adjacent to a turnoff (V2 turnoff) from the reciprocal Runway 18R, with the aircraft near to the centreline. The marks indicated a brief slight turn to the left, followed by a sustained right turn, during which track marks from the right mainwheel tyres became evident. After turning approximately 20° right of the runway heading, both the left and right track marks ceased, at points respectively 9 m and 6 m from the runway edge. No signs were found to indicate that any of the tyres had run on the runway shoulder or the grass surround.

Plan view of runway tyre marks and main landing gear tracks estimated from FDR

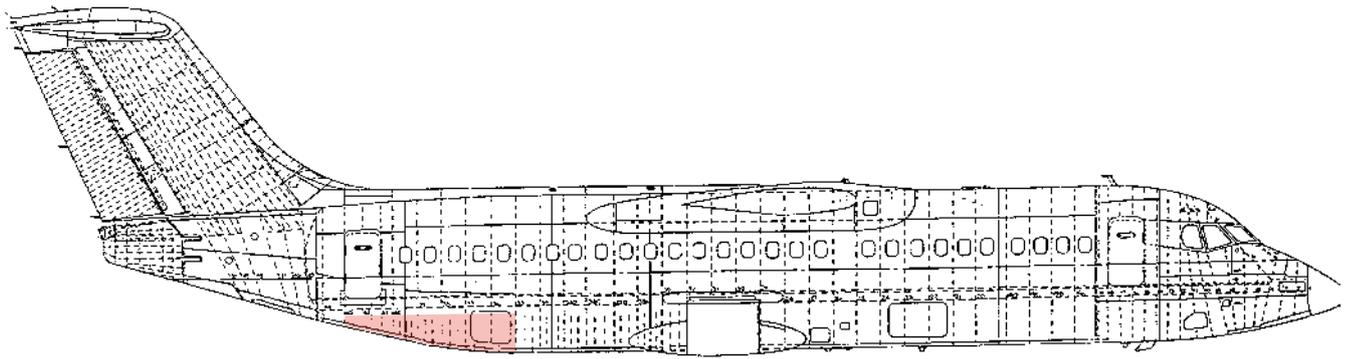
Figure 2

Area of damage to the lower fuselage

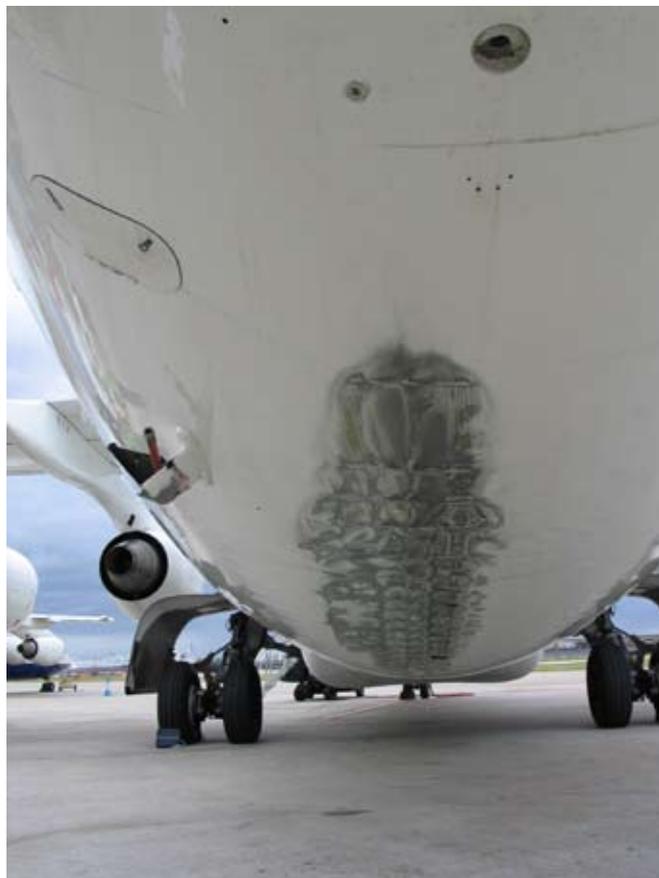
Figure 3

Damage to the rear of the aircraft

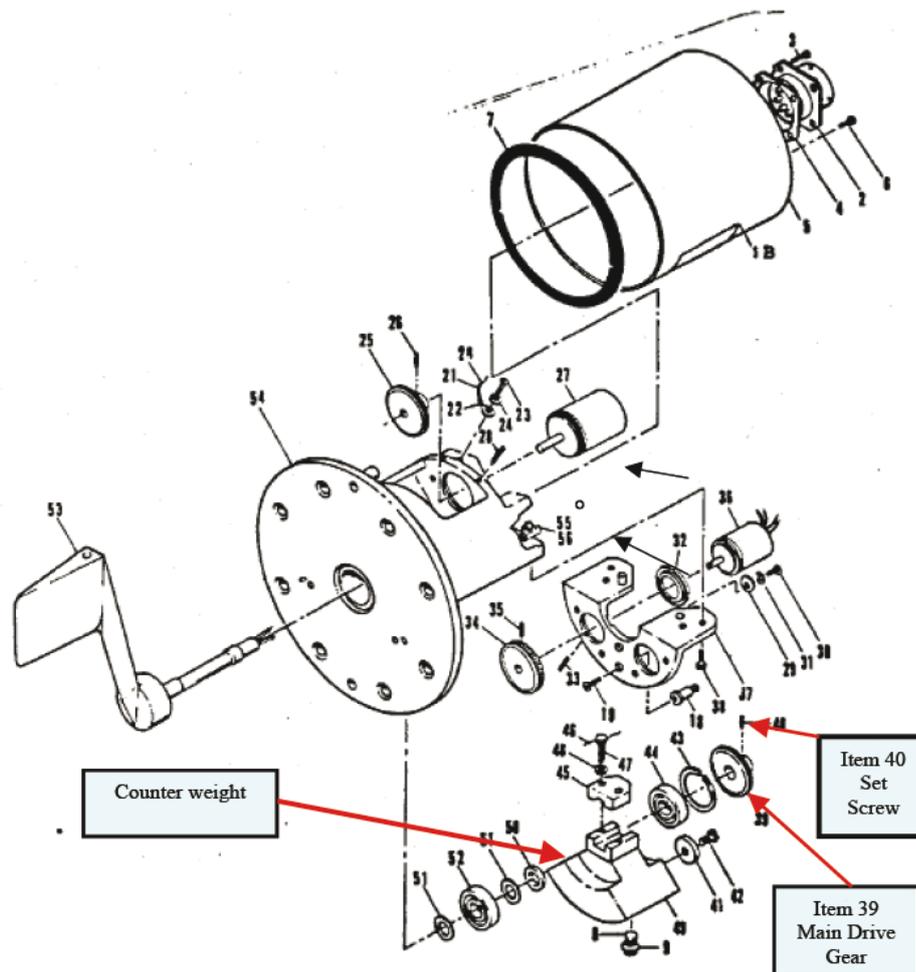
Figure 3
AOA sensor

The workshop report from 2005 contained no detail as to the nature of the repair; however, during the AAIB supervised examination, it was apparent, from its pristine condition, that the vane had been renewed. An internal examination revealed that a slight seepage had occurred from an oil-filled damper. When the unit was placed on test, with the resolver outputs being displayed on an oscilloscope and a digital voltmeter, a small calibration error was noted. The vane was rotated over its full range of movement and although the test initially appeared satisfactory, it was found that a slow rate of vane rotation revealed an 'open spot' for resolver No 2 at the approximate 29° position, possibly as a result of a contaminant particle in the brush-type resolver pick-off. In the opinion of the overhaul agent, this feature almost certainly accounted for the intermittent failure

messages. The almost immediate reappearance of the fault messages following its reinstallation on the aircraft on 8 December, suggested that the original defect had not been rectified following its shop visit in 2005.

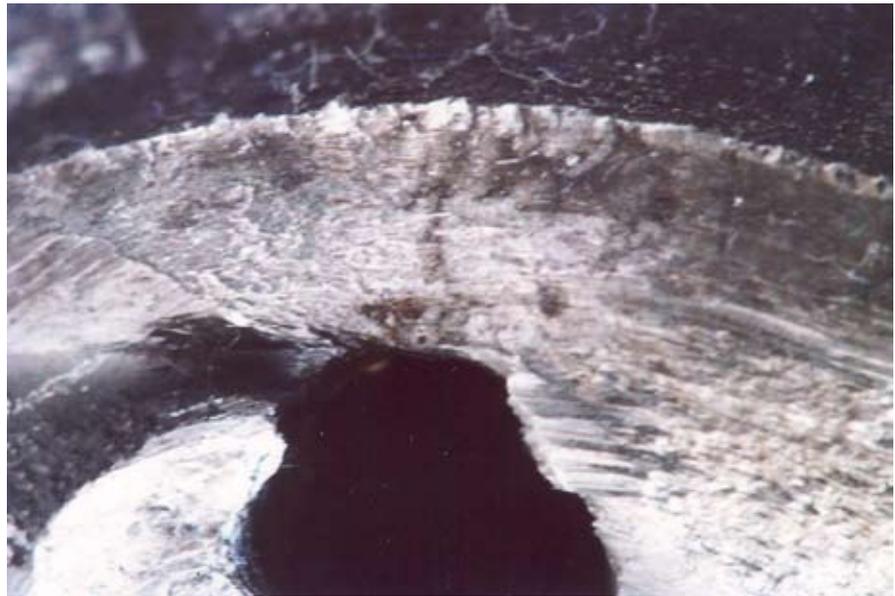
Figure 2

The detached pivot assembly was returned to AAIB for metallurgical examination. The pivot assembly had separated in the area of the splined shaft. The fracture surface had been partially damaged by smearing during rotational movement, most likely caused during the repeated attempts to operate the gear prior to the landing. A number of fatigue fracture initiation sites were found at the edge of the fracture face, adjacent to a lubricating hole (see Figure 2). The examination concluded that the separation of the pivot assembly had resulted from a cyclic fatigue mechanism during normal functioning of the landing gear in service.

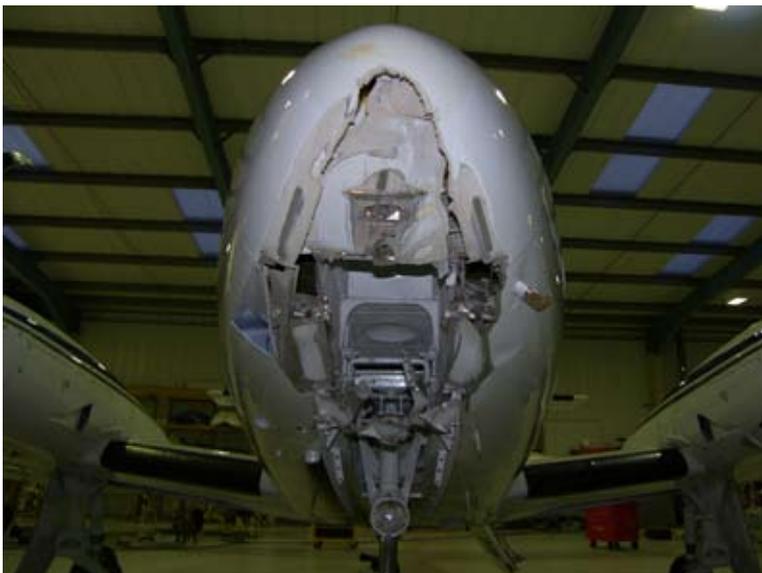
Figure 1

Photograph of G-CYLS showing damage to nose of aircraft

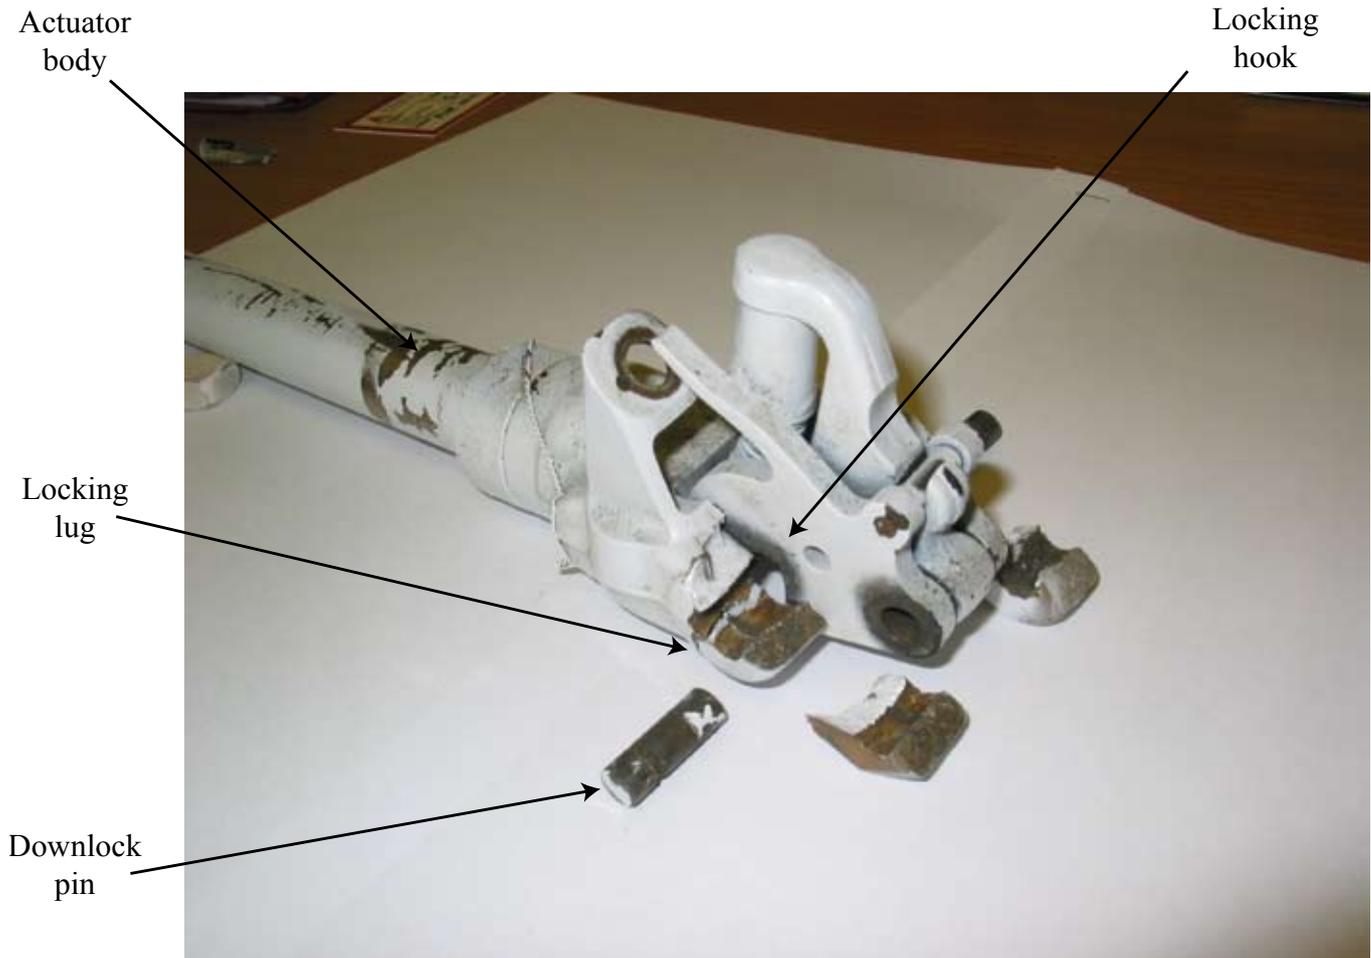
Figure 2

Of the two fractures on each lug, one was solely the result of ductile overload and thus secondary to the initial failure; the other exhibited much less deformation. One of the two 'primary' fractures was very flat in appearance with no obvious signs of ductile overload and was also

G-CYLS nose gear actuator showing fractured locking lugs (actuator ram in fully retracted position)

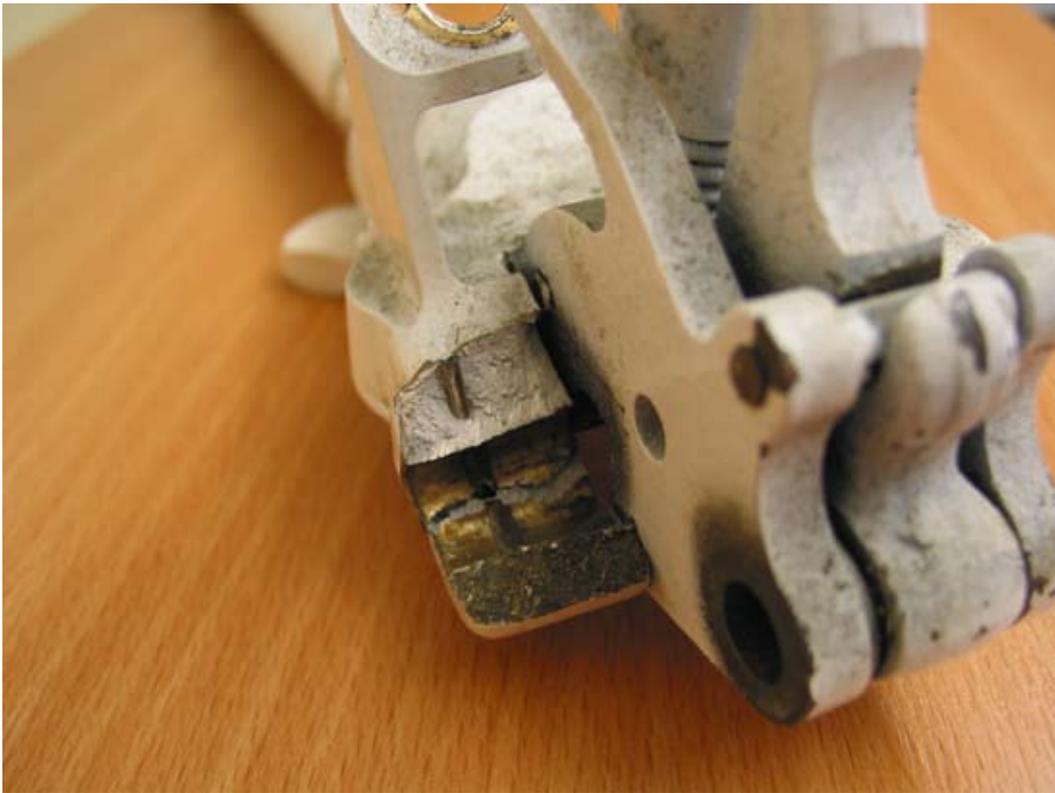
Figure 3

The discoloration of the primary fractures of the actuator locking lugs is indicative that these had been present for some time, in contrast to the fresh appearance of the final ductile overload failures that resulted in the nose gear collapse. The cracks had therefore occurred over a period of time, but it was not clear what mechanism had caused the primary fractures. It is conceivable that

Photograph showing primary (A) and secondary (B) fractures of nose gear actuator locking lug

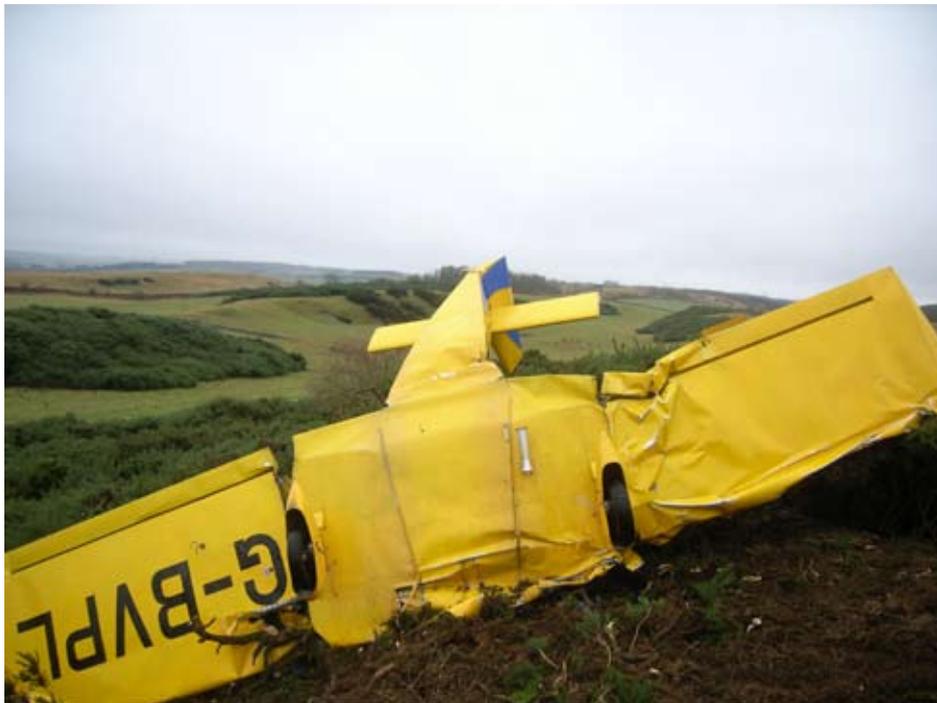
Figure 1

The aircraft had come to rest nose-down in a gorse thicket on the summit of a small hillock. There were no witness marks on the land surrounding the thicket to indicate that the aircraft had touched down prior to the thicket. The gorse bushes surrounding the aircraft were undamaged. After clearing the gorse to allow access, examination revealed that the right wing had been subject to a relatively uniform load which had crushed the leading edge, Figure 1; its inboard trailing edge section and aileron had been buckled under a compressive load. The left wing exhibited two areas of damage to the leading edge, one just outboard of the left main landing gear, caused by impact with a large gorse bush, the other the left wingtip, which had been subject to a significant impact. The rear section of the left wing, outboard of the landing gear, had been

Photograph illustrating impact damage to the wings and forward fuselage

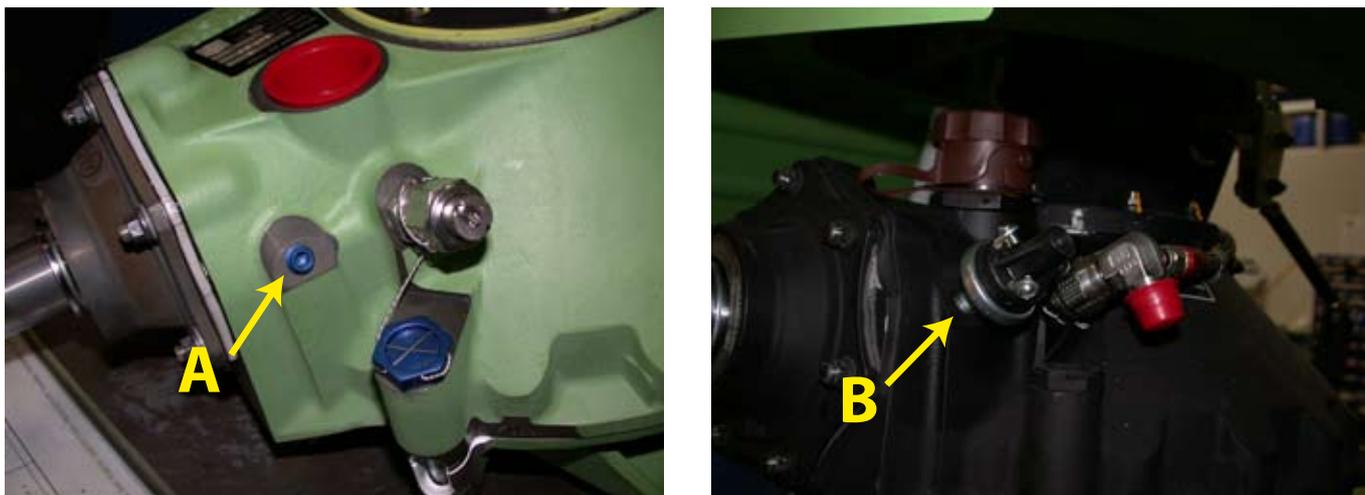
Figure 2

The plug must be replaced with a pressure switch before installing the gearbox in the helicopter, although this is not mentioned in the maintenance manual procedure for MRGB removal and installation.

Photographs showing MRGB with blanking plug ('A') and low oil pressure switch ('B') installed

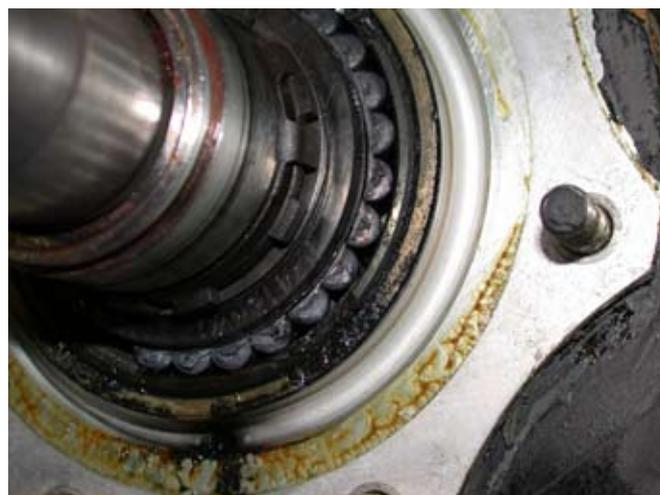
Figure 3

Photograph showing damage to MRGB pinion outer bearing

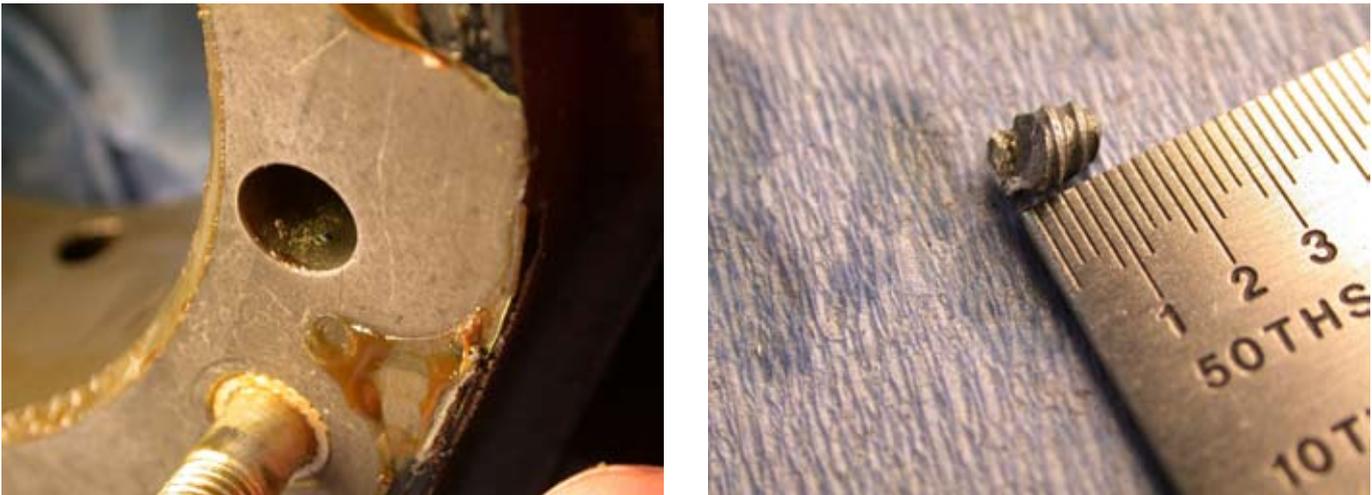
Figure 4

Examination of the bearing oil supply gallery revealed the presence of oil, small shiny chips of non-ferrous debris and a single fragment of ferrous debris (Figure 4). This fragment, which measured approximately 3 mm in length with a diameter tapering from approximately 0.8 mm to 2.5 mm at its widest, was found to have a machined threaded/spiral finish closely resembling the tip of a stud extractor bit.

Photographs showing metallic debris in pinion bearing oil gallery (left) and close-up view of ferrous fragment (right)
