CONTENTS

SPECIAL BULLETINS

Summary of:	Aircraft Accident Report No: 2/2007	62
	Report on the serious incident to Boeing 777-236, G-YMME on departure from London Heathrow Airport on 10 June 2004

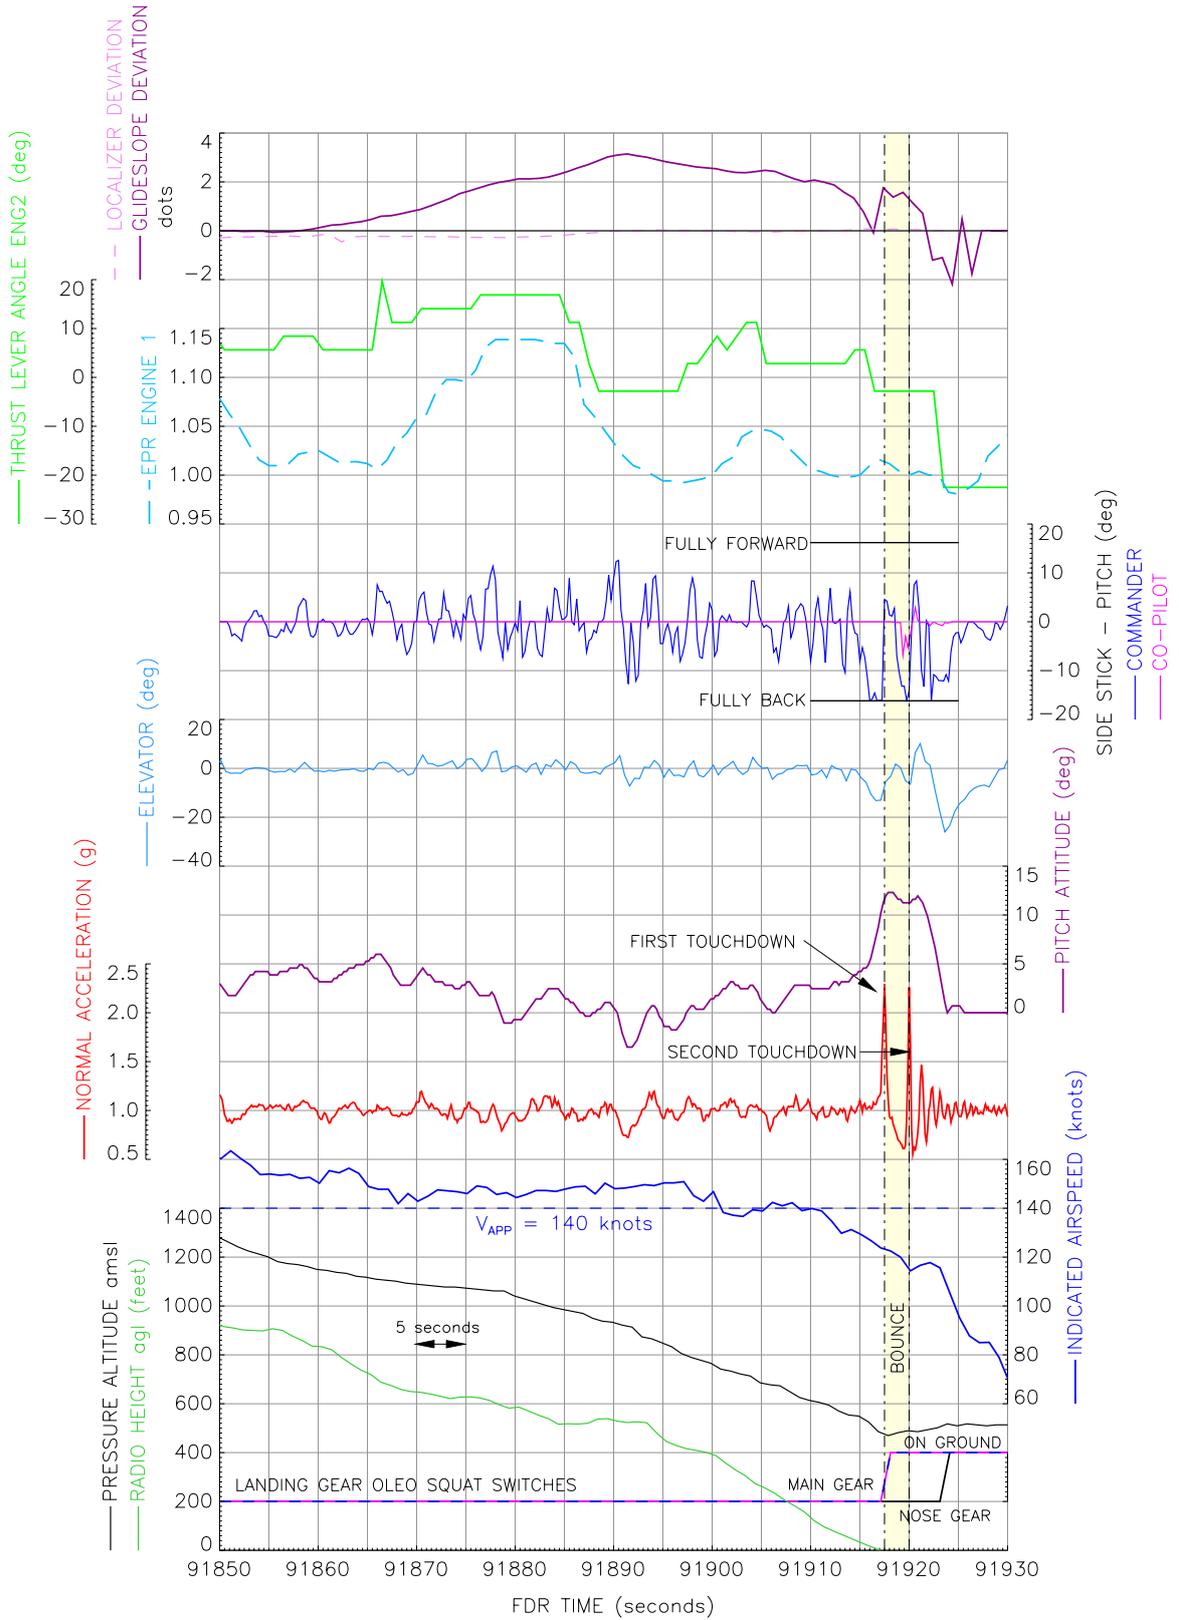
Figure 1
Salient FDR Parameters
(Accident to HA-LPB on 1 October 2006)

The aircraft touched down with +2° of roll attitude (right main landing gear first) with a vertical load factor of +2.3g and at an indicated airspeed of 125 kt. The aircraft reached a maximum pitch attitude of 12.3° nose-up. The spoilers deployed just as the aircraft bounced⁴, and the pitch attitude started to reduce. The commander then made a nose-down sidestick input (+4.6° then +2.7°) before again applying full aft sidestick, and just as the first officer applied -7° aft sidestick. As neither of the priority takeover pushbuttons were pressed, the sidestick inputs from both crew would have been additive in effect.

The damage to the aircraft (manufacturer's serial number 1635) consisted of abrasion marks approximately 70 inches long on the lower fuselage skin in the area of frames 65 to 68. At frames 65 and 66, the skin had worn away and there were light abrasion marks on both frames. There was no other damage to the aircraft structure. The damage indicated that there had been a brief, relatively light contact between the rear of the aircraft and the surface of the runway. Marks on the runway indicated a single ground contact within the normal touchdown zone.

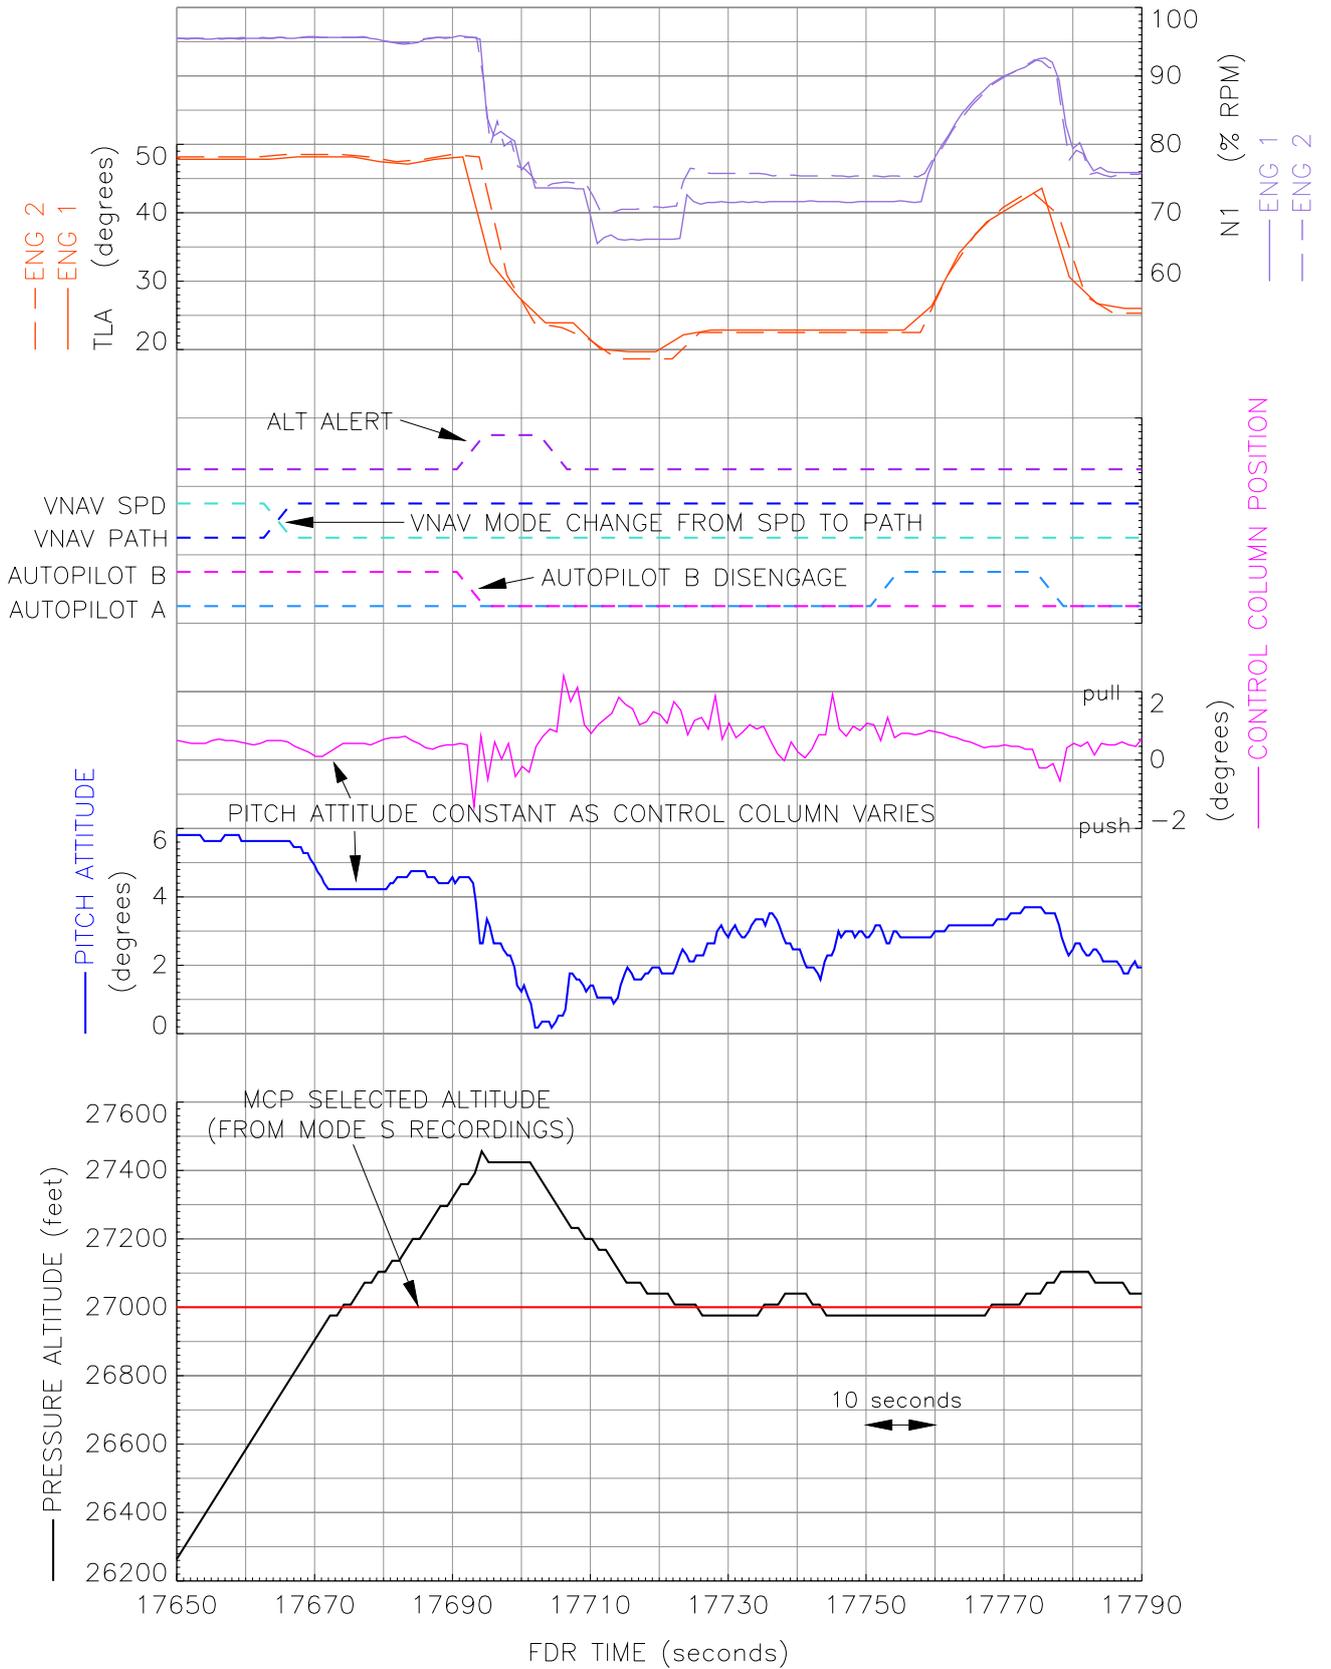
Figure 1

Descent to Stansted

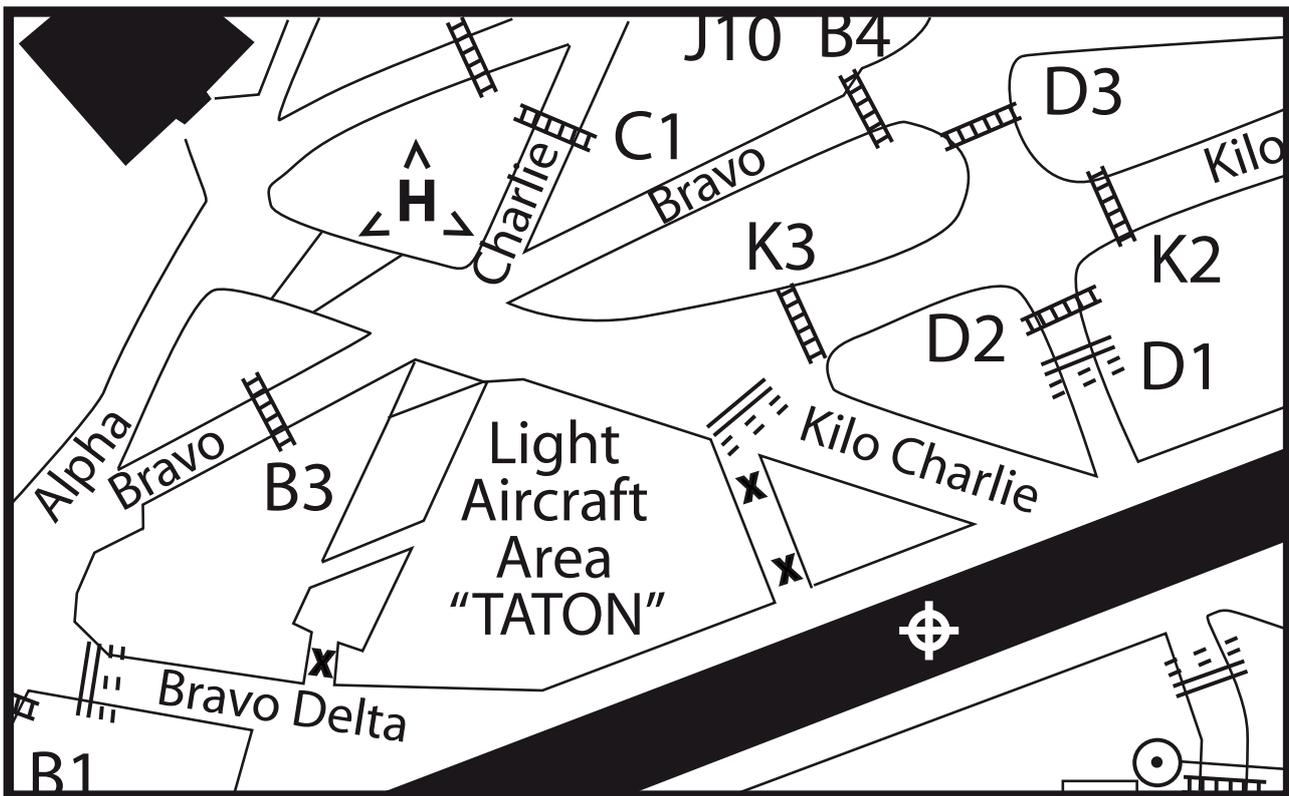
Figure 1

runway exit: KC, B (23m wide), C (23m wide), KC and B (See Figure 1).

The commander had some knowledge of the airport and knew that Taxiway A was beyond Taxiway C. Confused by the sign board, and believing he had somehow passed Taxiway C, the commander advised the co-pilot that he had missed the taxiway and turned hard right to get back to where he thought it to be. While he was turning ATC issued further taxi instructions, which the co-pilot needed to write down, thus taking his attention away from monitoring the aircraft's position. The commander estimated that in the turn the nose gear had cleared the edge of the paved

Taxiway intersection KC,C,B

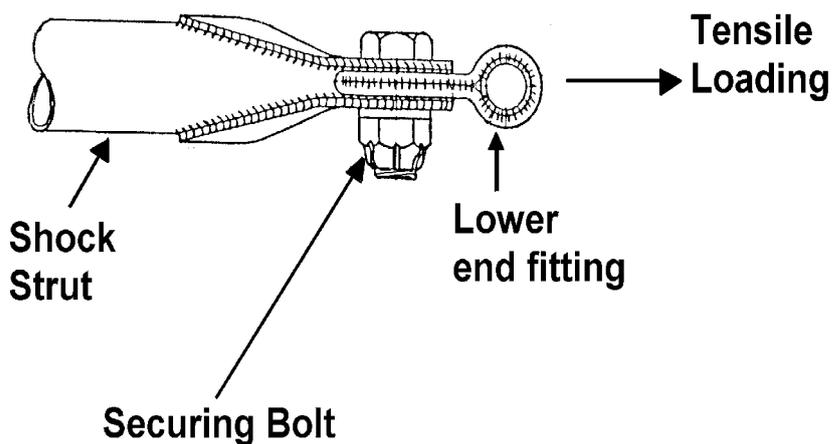
Figure 1

Examination of the aircraft revealed that the collapse of the left landing gear was caused by the shock strut lower end fitting 'pulling' from the strut. The lower end

fitting, see Figure 1, fits into the strut and is secured by a bolt. While the aircraft is on the ground the fitting is under a tensile load. The hole for the securing bolt had become elongated in the direction of the load before failing in overload. A review of the aircraft log book failed to identify when this component was fitted, but its general condition indicated that it had been installed for a considerable time. The damage to the bolt hole could not have been seen with the fitting attached to the strut and there is no requirement to remove the fitting from the shock strut for inspection.
