CONTENTS

List of recent aircraft accident reports issued by the AAIB

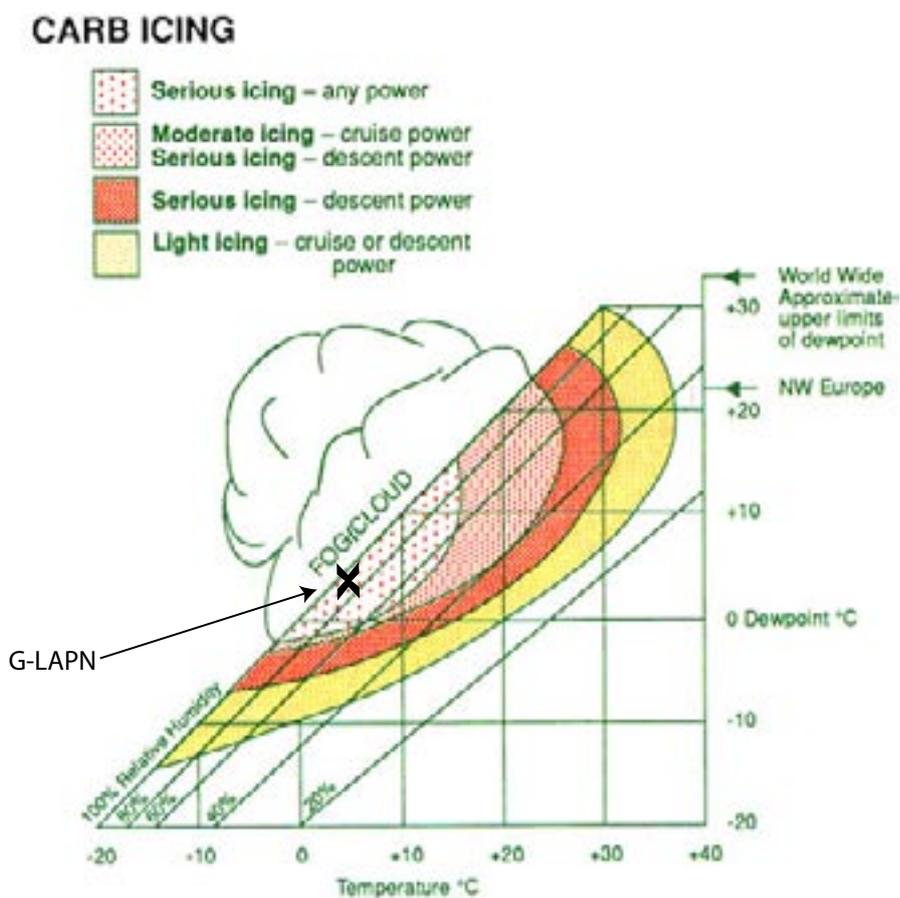
Figure 1
Carburettor icing probability chart

The surface temperature and humidity figures were plotted on the carburettor icing probability chart (Figure 1) as shown in the CAA General Aviation Safety Sense Leaflet 3A titled ‘Winter Flying’ and Leaflet 14 titled ‘Piston Engine Icing’. The chart showed a probability of serious carburettor icing at any engine power setting.

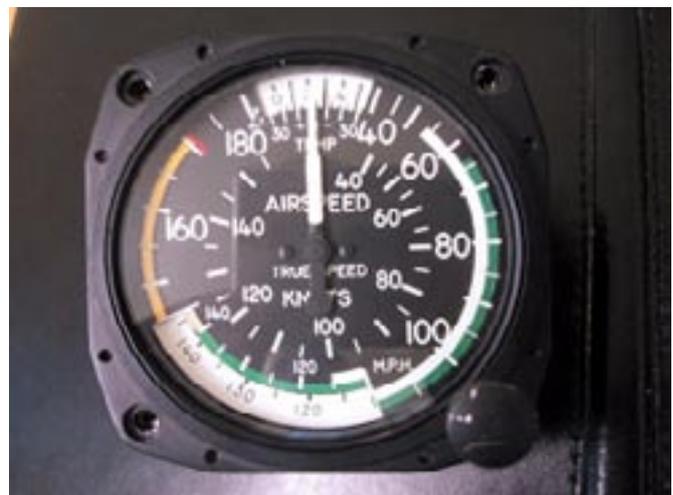
Figure 2

G-AZWE's air speed indicator. The larger figures are mph, the smaller figures are knots. Note that the legend 'KNOTS' is larger than that for 'MPH'.
