CONTENTS

(ALL TIMES IN THIS BULLETIN ARE UTC)

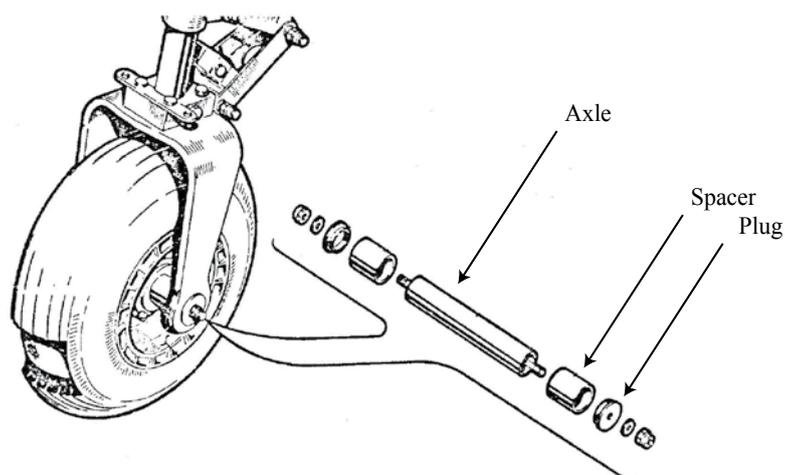
Figure 1

Examination of the aircraft by the maintenance organisation revealed that one of the axle plugs on the nose landing gear axle rod assembly had failed causing the nose wheel to detach.

This contains a through-bolt, a spacer and an axle plug on each end, which are fastened with a washer and nut (see Figure 1). The aircraft maintenance manual contains information for the assembly and installation of the nose wheel. It states '*tighten nuts until no side play is felt (allow wheel to rotate freely)*'. It is necessary to remove the axle rod assembly whenever the wheel is removed.

PA-28-181 Nose wheel axle assembly

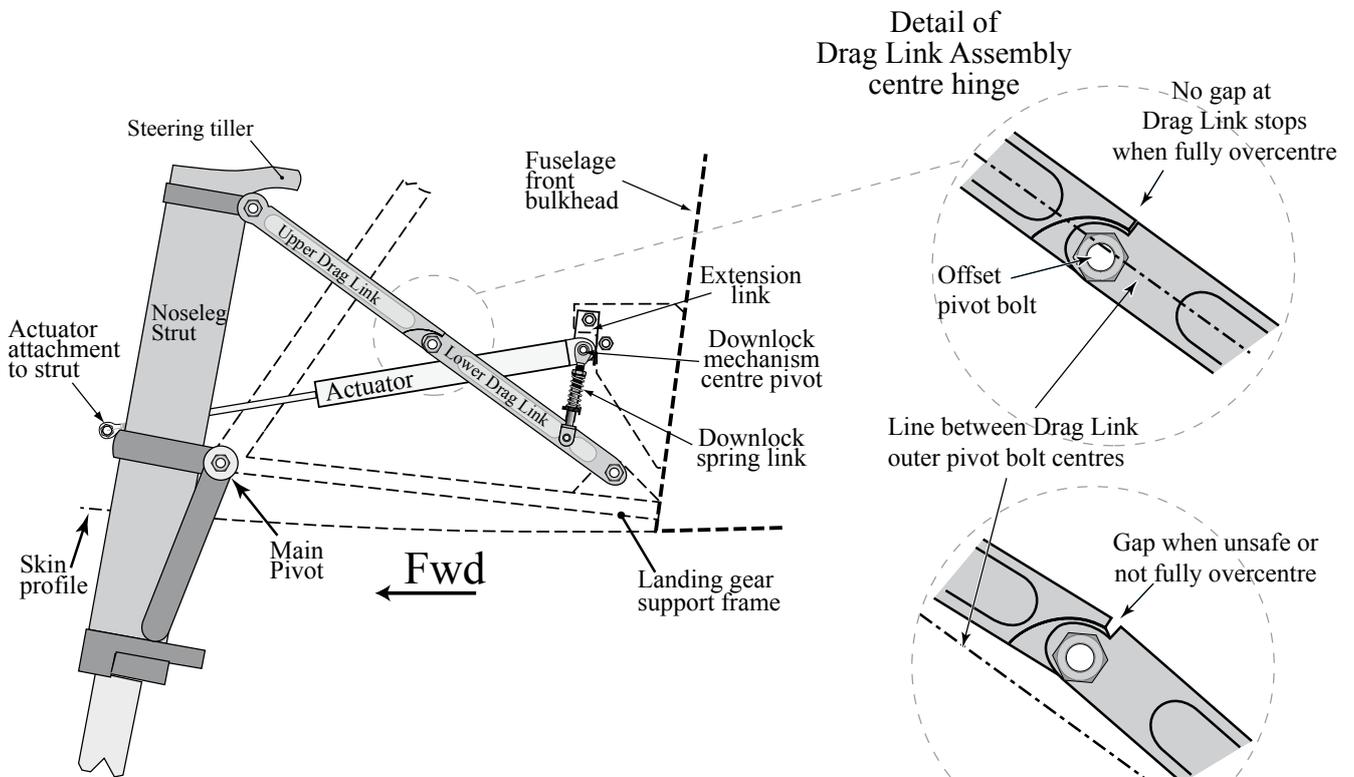
Figure 1

The NLG of the Piper Seneca is of the forward retracting type which, when extended, has the wheel axle forward of the oleo strut pivot. When retracted, the gear is held up by hydraulic pressure in the actuator and, when extended, it is held in the down position by a geometric downlock mechanism. There are no locking hooks for either position. When the NLG is extended and under load it is prevented from collapsing by the drag link assembly (see Figure 1). When the NLG is fully extended, the offset drag link centre pivot is below the centre line of the two end pivots preventing the drag link assembly collapsing when the landing gear is under load.

The geometry of the NLG is such that the aircraft's weight on the nose-wheel applies a compressive load to the drag link assembly which tends to drive it more

PA-34 nose landing gear side view showing main components in extended position
(Steering mechanism & downlock spring omitted for clarity)

firmly into the safe over centre condition when the gear is properly extended. Conversely, it will tend to cause the drag link to fold, and the gear to retract, if the load is applied when the drag link assembly is in an under centre condition.

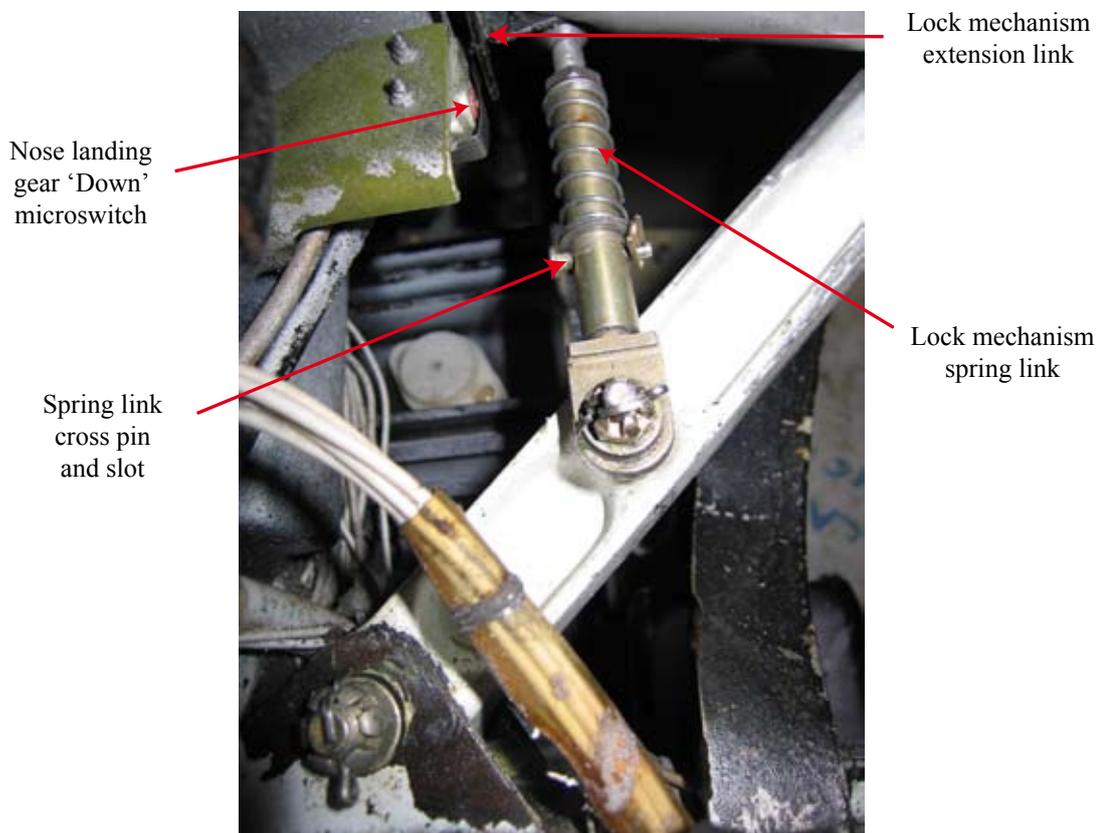
Figure 2

The aircraft was examined at Humberside Airport with the NLG secured in the down position by strops. Facilities were not available to carry out a functional test of the landing gear. The NLG extension link (see Figure 2) was found in a position corresponding to the down and locked position and the NLG micro switch had been activated, producing a 'down and locked' indication in the cockpit. The drag link assembly however was in an unlocked, under centre, condition. The downlock spring link showed some ovality in the pin slot, it was not possible to determine if this was the result of in service wear or as a result of an overload event. The central pivot pin, which secures the spring lock to the extension link and acts as the retraction jack input point, was severely distorted (see Figure 3). The retraction jack appeared to be in good condition with no evidence of external leaks or damage.

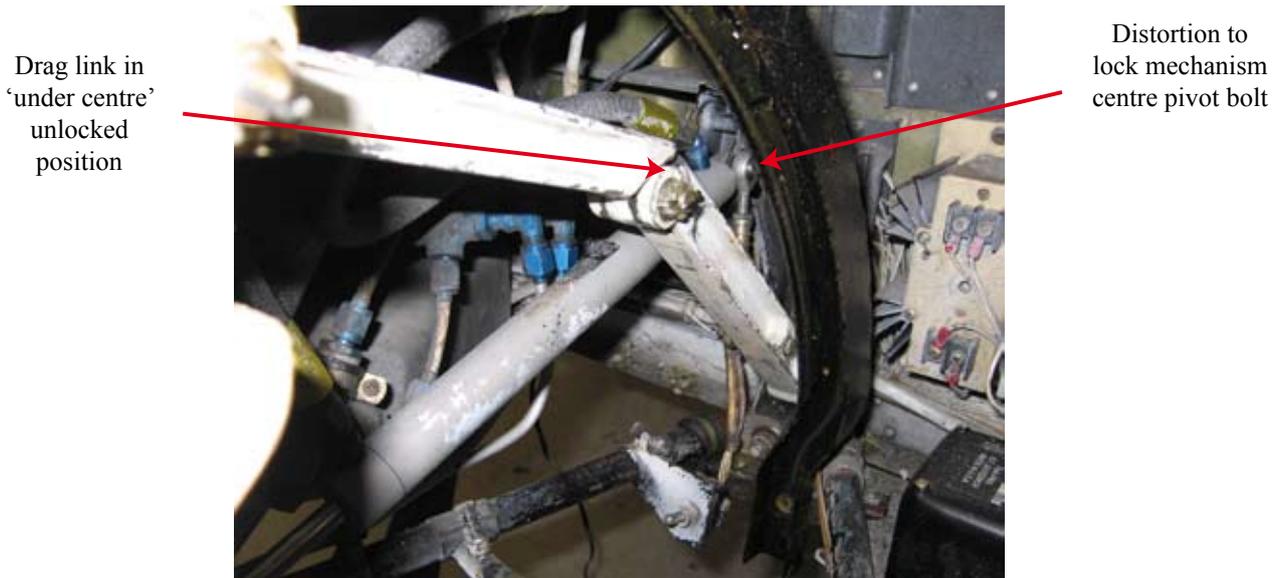
Figure 3

Given the reportedly smooth collapse of the NLG, it appears probable that the NLG, although indicating 'down and locked' had not achieved a locked condition, leading to the 'retraction' of the NLG as weight was applied to it. In order for the NLG to remain unlocked, the ability of the downlock spring link to force the drag link into a locked position must have been compromised. The sensitivity of the Seneca NLG to small changes to the compressed length of the downlock spring link has been covered in some detail in previous Seneca landing gear collapse reports. (See AAIB Bulletin 11/2005).

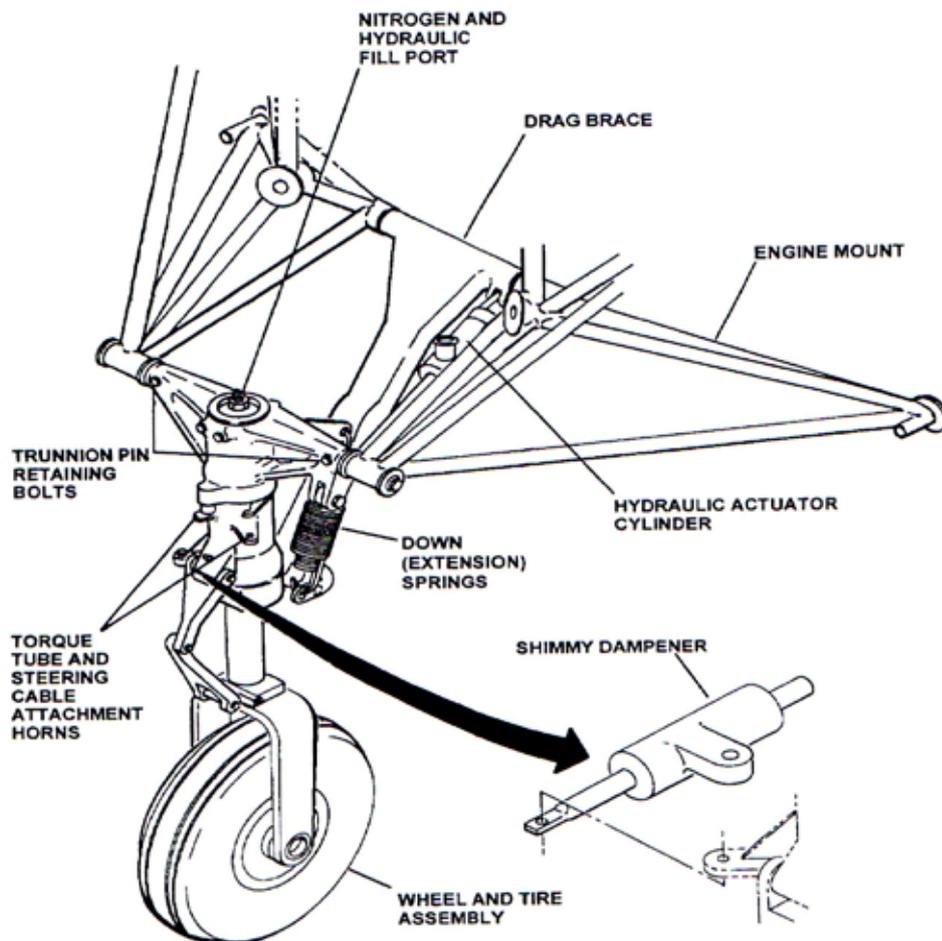
The aircraft is fitted with a tricycle landing gear which is retracted by an electrically driven hydraulic power pack actuated by the landing gear selector switch. When the landing gear selector switch is placed in the UP position, the landing gear retracts and, when all three gears are retracted, the pump is shut off and the gear held up by hydraulic fluid lock. A hydraulic

pressure switch controls the pump by removing power when the pressure reaches a preset limit. A loss in hydraulic pressure is sensed by pressure switches which actuate the power pack to build up additional hydraulic pressure. When the landing gear selector switch is placed in the DOWN position, the hydraulic fluid lock is released and hydraulic fluid directed to the down side of the landing gear actuator cylinders. When all three landing gear are down, each drag brace moves into an over centre position so that the gear is down and locked (see Figure 1). There is no electrical indication of gear retraction other than all indicator lights being extinguished. When the landing gear extends to the down position, the three landing gear microswitches are actuated, causing the three green lights to illuminate, indicating that the gear is down and locked.

Figure 1
Nose landing gear assembly
