## CONTENTS

**(ALL TIMES IN THIS BULLETIN ARE UTC)**

## ACCIDENT

<b>Aircraft Type and Registration:</b>	ATR 72-212A, D-ANFH	
<b>No &amp; Type of Engines:</b>	2 Pratt and Whitney PW127F turboprop engines	
<b>Year of Manufacture:</b>	2001	
<b>Date &amp; Time (UTC):</b>	17 September 2005 at 1202 hrs	
<b>Location:</b>	Guernsey Airport	
<b>Type of Flight:</b>	Public Transport (Passenger)	
<b>Persons on Board:</b>	Crew - 4	Passengers - 63
<b>Injuries:</b>	Crew - None	Passengers - None
<b>Nature of Damage:</b>	Damage to lower rear fuselage	
<b>Commander's Licence:</b>	Airline Transport Pilot's Licence	
<b>Commander's Age:</b>	54 years	
<b>Commander's Flying Experience:</b>	10,000 hours (of which 517 were on type) Last 90 days - 110 hours Last 28 days - 41 hours	
<b>Information Source:</b>	AAIB Field Investigation

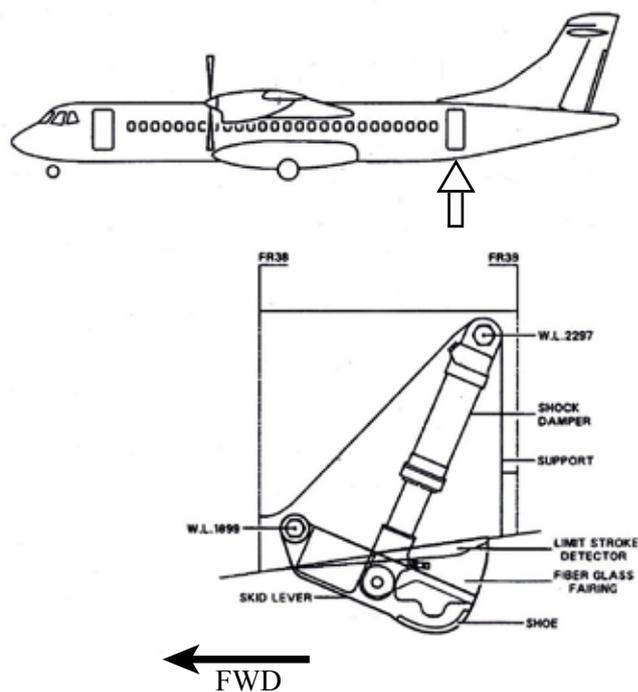
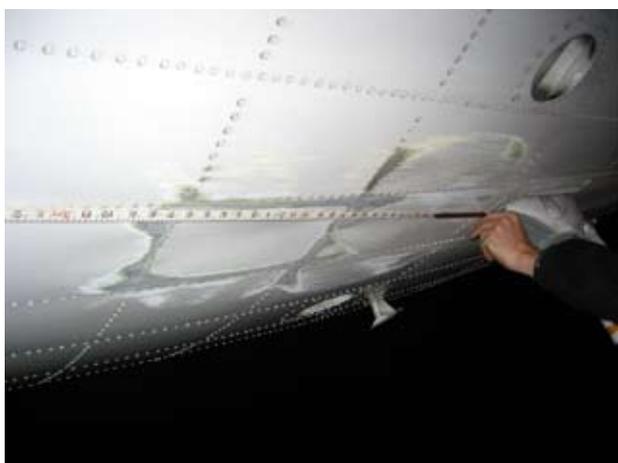
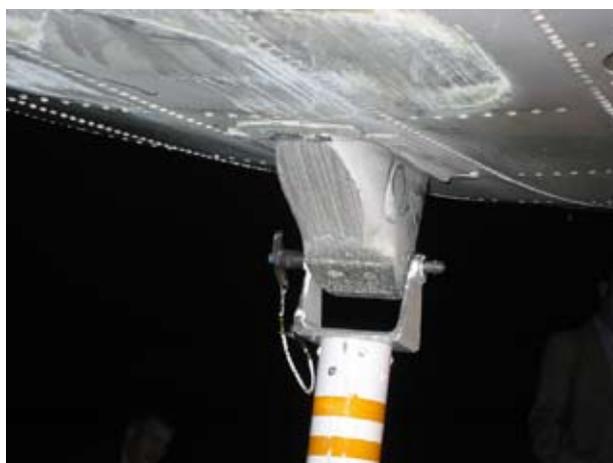
**Figure 1**

a width of some 0.5 m. This had affected fuselage Frame Nos 36 to 38, with the skin having worn through to the extent that the flanges of Frames 36 and 37 were exposed. The damage was symmetrical about the aircraft centre line, indicating that the aircraft was in a wings level attitude at the time it initially touched down.

ATR 72 Tail skid detail

Abrasion damage on fuselage underside

There was no doubt that the damage to the aircraft was consistent with the fuselage making contact with the runway, heavy enough to cause the tail skid damper to compress to its full limit of travel. The loss of material from the skid's shoe allowed the fuselage structure to contact the runway surface and be abraded. This was as a direct result of an excessive pitch attitude during the landing.

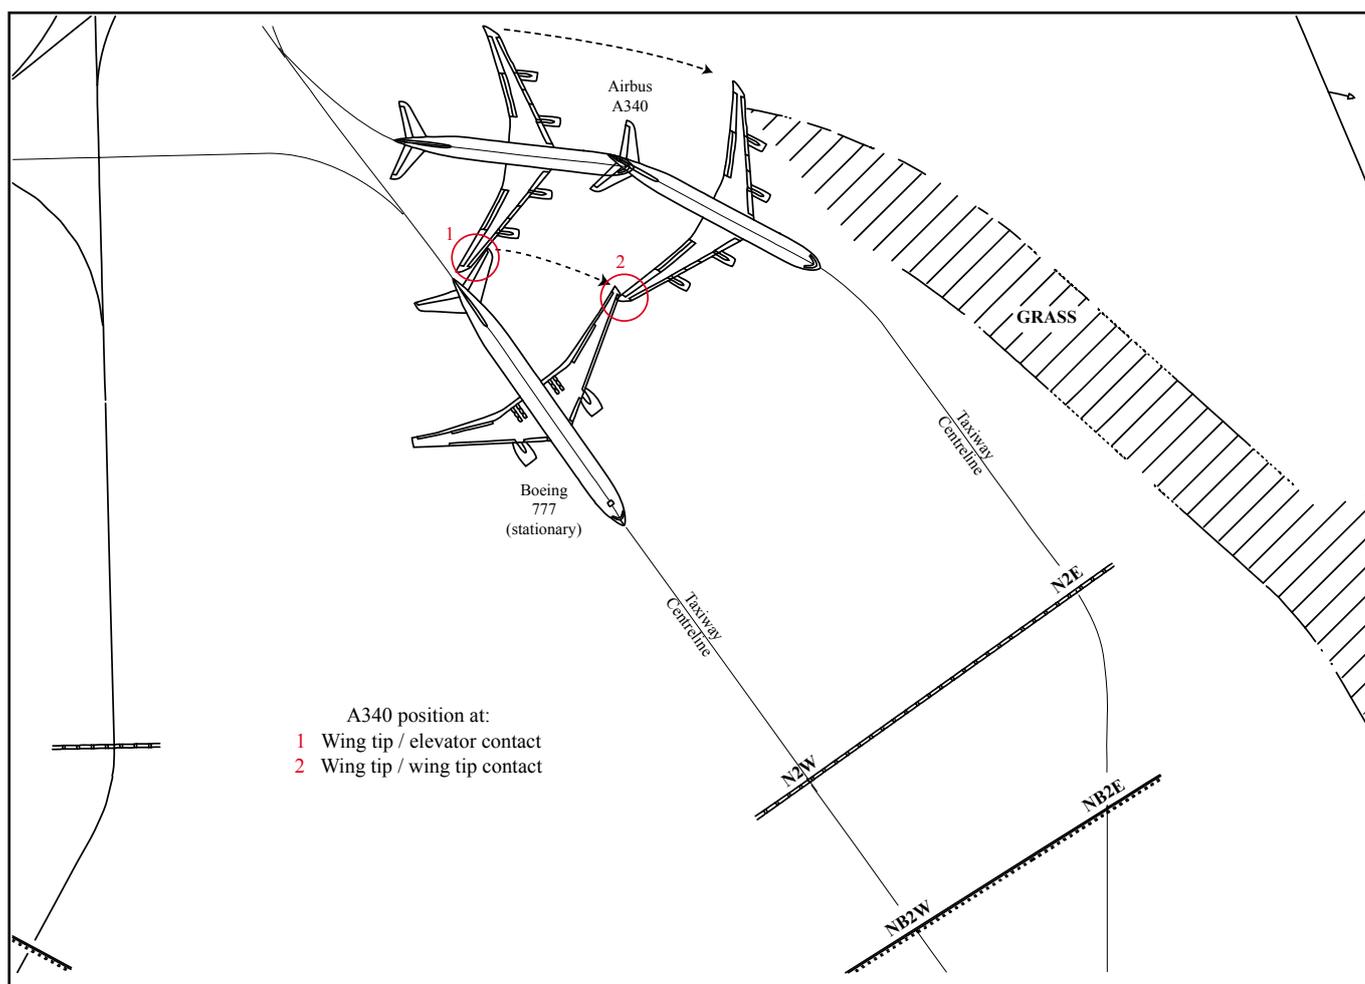
**Figure 2**

Damage to the B777's left elevator and left wing tip appeared to have been inflicted by the upper part of the winglet of the A340. Damage to the A340 was temporarily repaired and the aircraft was dispatched. The B777 had been equipped with a replacement wing-tip fairing and was still awaiting delivery of a replacement elevator when examined by the AAIB.

Relative aircraft positions at points of contact

It is recommended that Heathrow Airport Limited review the current layout/design of the Holding Areas for departing aircraft, to ensure that wingtip clearance is maintained between manoeuvring aircraft.

It is recommended that Heathrow Airport Limited, in co-operation with National Air Traffic Services, review the current Air Traffic Control procedures applicable to the Holding Areas for departing aircraft, and any future layout of these Holding Areas, to ensure that adequate wingtip clearance is maintained between manoeuvring aircraft.

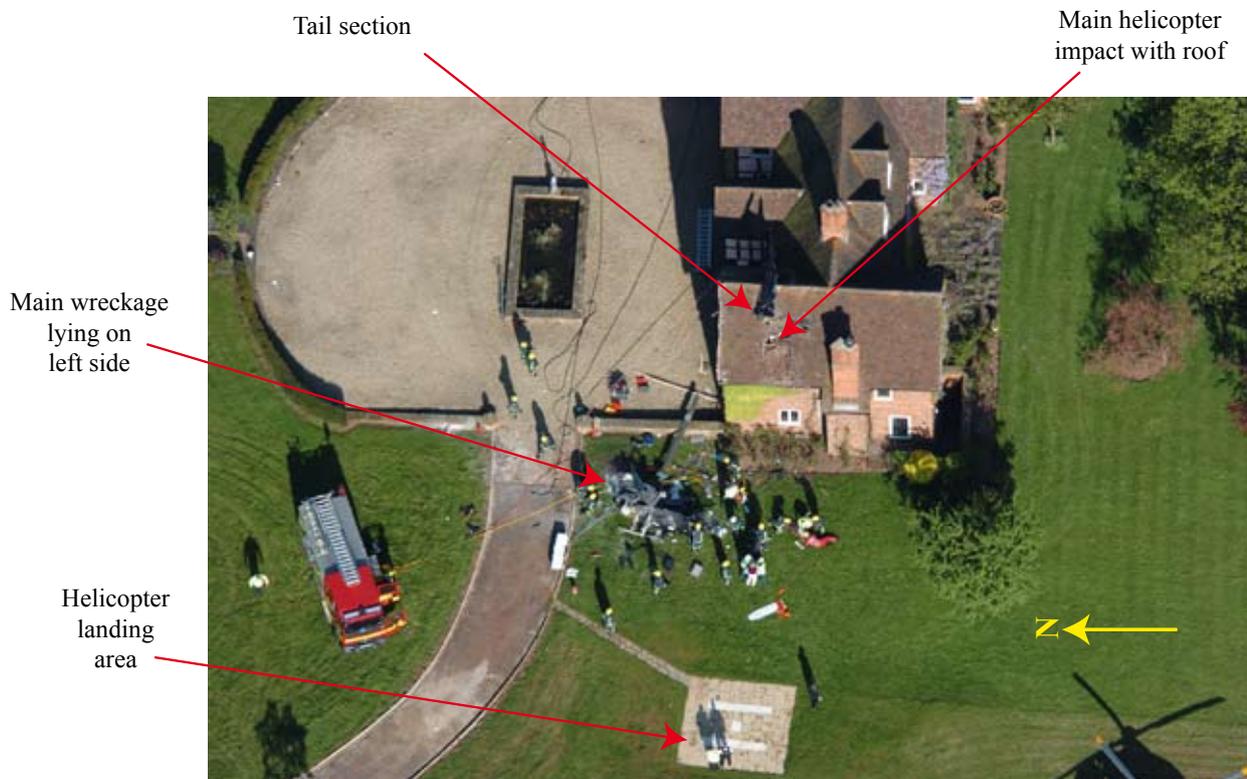
**Figure 1**

The helicopter crashed onto the roof of the pilot's house approximately 16 m to the north of the designated landing area. It struck the pitched roof (Figure 1) with a high rate of descent, whilst in an approximate 30° nose down and right side low attitude, on a westerly heading. The impact had severed the rear structure of the helicopter, comprising the tail boom and fin, which had remained straddled across the apex of the roof. The severity of the vertical impact had caused the rear right skid attachment to be forced up into the fuselage structure. Pieces of the right skid then
