(ALL TIMES IN THIS BULLETIN ARE UTC)

ACCIDENT

Aircraft Type and Registration:	Airbus A319-111, G-EZEU	
No & Type of Engines:	2 CFM CFM56-5B5/P turbofan engines	
Year of Manufacture:	2004	
Date & Time (UTC):	24 November 2005 at 0835 hrs	
Location:	Nottingham East Midlands Airport	
Type of Flight:	Public Transport (Passenger)	
Persons on Board:	Crew - 6	Passengers - 110
Injuries:	Crew - None	Passengers - None
Nature of Damage:	Damage to left wing tip and left wing tip of a neighbouring aircraft	
Commander's Licence:	Airline Transport Pilot's Licence	
Commander's Age:	45 years	
Commander's Flying Experience:	10,670 hours (of which 756 were on type) Last 90 days - 93 hours Last 28 days - 35 hours	
Information Source:	AAIB Field Investigation

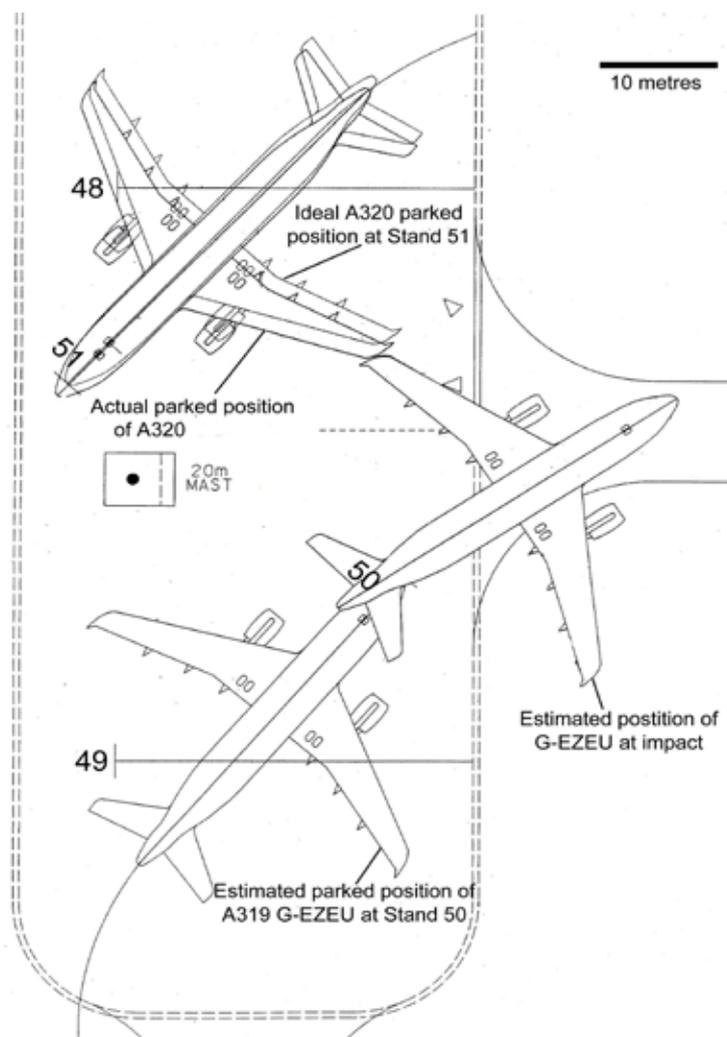
Figure 2

The estimated relative positions of both aircraft at impact is shown in Figure 2. G-EZEU suffered damage to its left wing tip assembly and winglet. The upper section of the winglet had bent aft and a small section of the top of the winglet (approximately 20 cm by 15 cm) had separated and become embedded in the left wing tip leading edge of the A320. The navigation lights in the A320's left wingtip were damaged and the wing lower surface in this area exhibited scrape marks. Neither aircraft sustained any internal structural damage as a result of the impact.

Estimated relative positions of the aircraft at impact

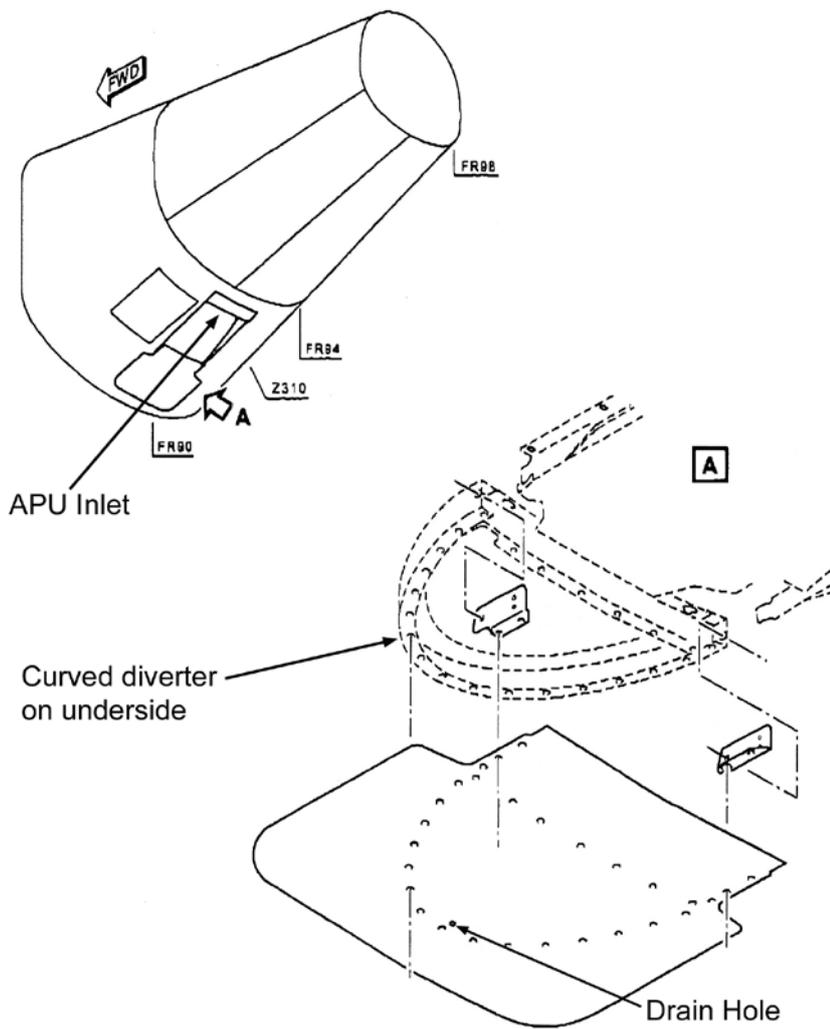
Figure 1

A week later, during a routine inspection of the APU, an engineer noticed a small drain hole (approximately 1/8 inch in diameter) located aft of the curved APU diverter¹ (see Figure 1). He reported that it was very difficult to spot. When he attempted to check if the hole was clear almost a litre of an oil-water mixture drained out. The panel containing the drain hole was removed and the area inside was found to be wet and contaminated. The operator suspected that a build-up of dirt and dried oil had blocked the hole.

Location of drain hole relative to diverter and APU inlet

A build-up of dirt and oil in the drain hole aft of the diverter had caused a blockage which prevented oil

and other fluid contaminants draining overboard. If this blockage were to unblock suddenly, for example due to the vibration during a takeoff, then the released fluid could easily be ingested by a running APU. Once ingested this contaminant could pass into the bleed air duct and subsequently into the cabin air conditioning system. This scenario probably explains the oily smell and mist observed in the cabin during takeoff.

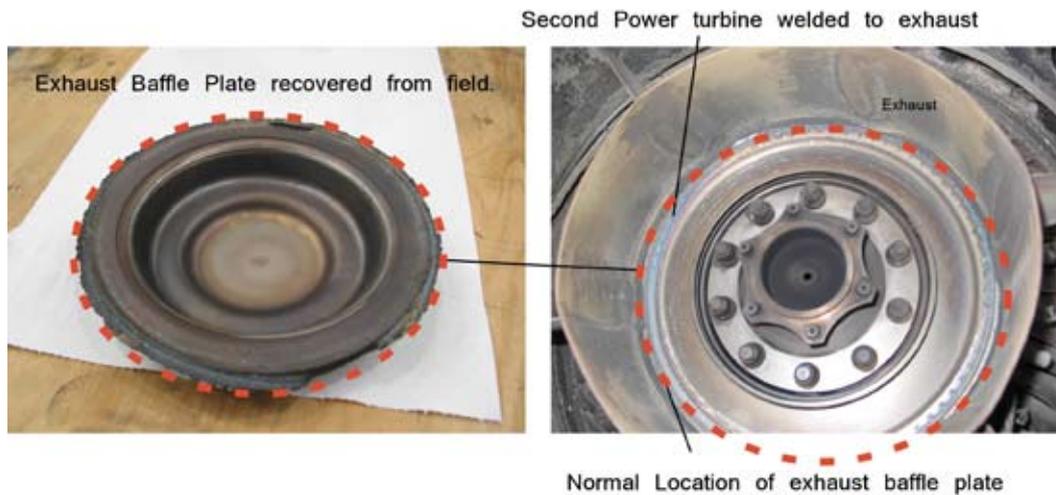
Figure 5

Additional inspection of the No 2 engine revealed that the PT had been damaged significantly, with most of the turbine blades on the first and second stage missing. A large section of the rear exhaust baffle was also missing. There was no evidence of an uncontained engine failure, all debris having exited the engine through the exhaust duct.

Damage to the exhaust components

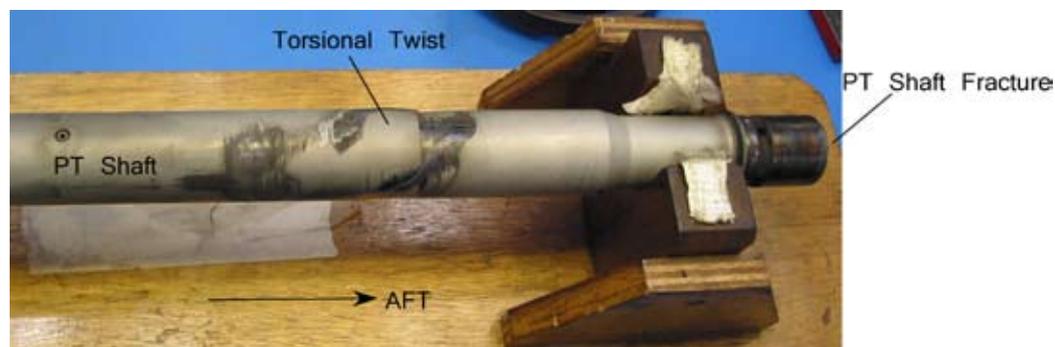
Figure 6

The engine was strip examined at the manufacturer’s UK overhaul workshops and from this it was clear that the PT shaft had become disconnected. The two PT discs had been severely damaged and had lost all of their blades. Also, the second stage PT disc had

Power Turbine shaft damage

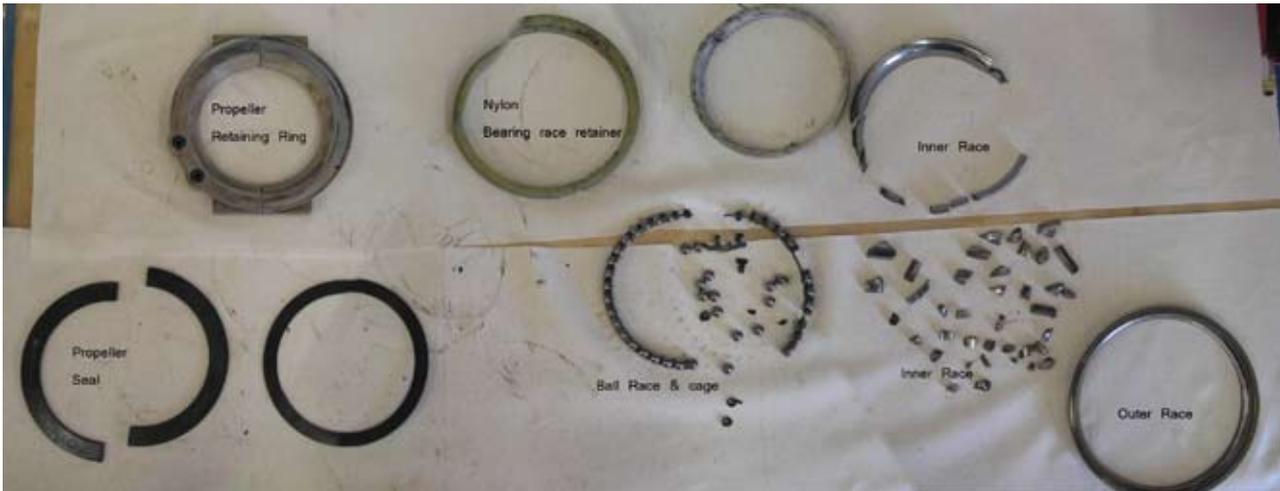
Figure 7

removed, it was evident that the inner race, ball race and ball retainer of the blade support bearing had all been significantly damaged and were in many pieces, Figure 7. The outer race remained in one piece in the hub, although it exhibited signs of

Damaged components of the No 1 propeller blasé support bearing

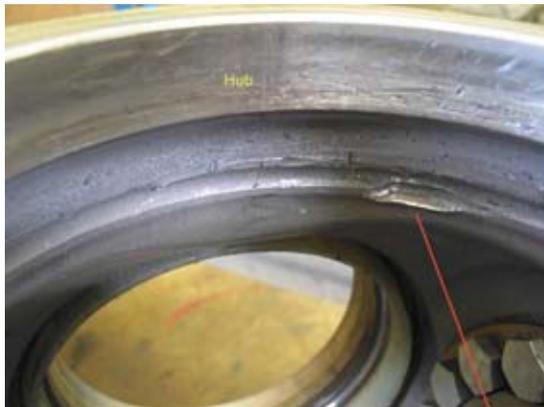
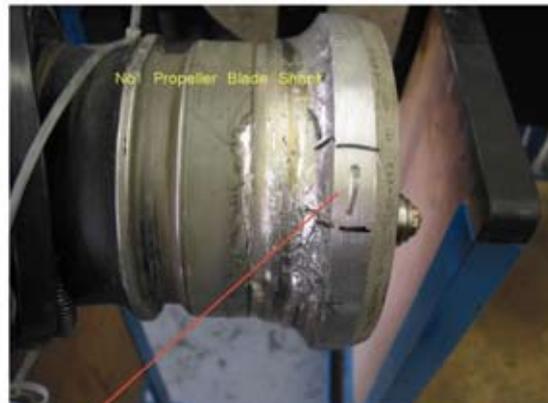
Figure 8

Smear from ball bearing becoming jammed between hub and shank

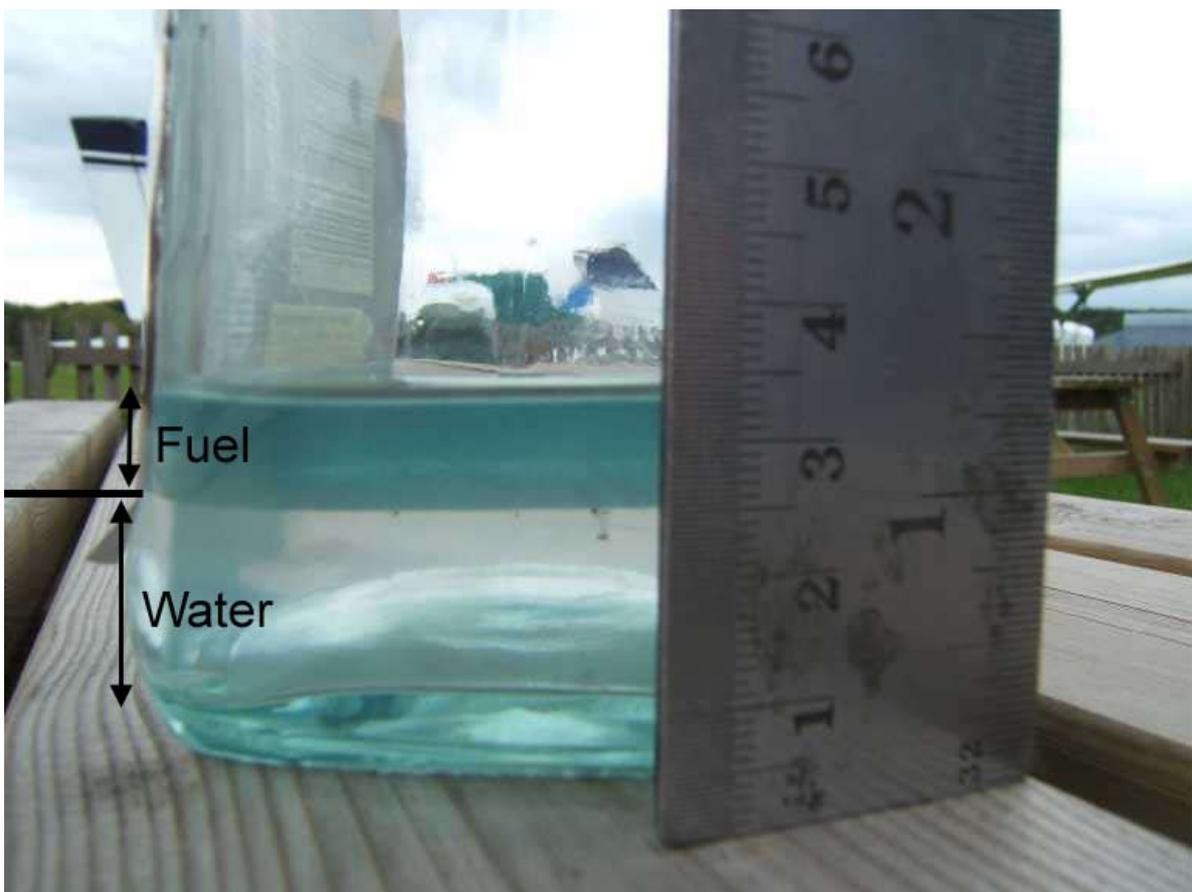
Figure 1

Contents of the fuel gascolator bowl

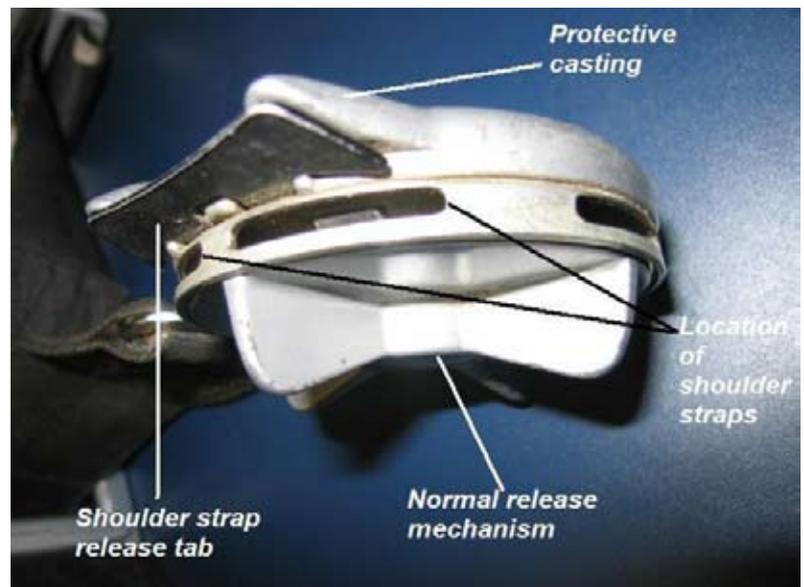
Figure 4

The glider was fitted with a four-point nylon harness consisting of two shoulder straps and two lap straps. The harness buckle was attached to the right lap strap. The shoulder and left lap straps were released from the buckle by turning the release mechanism on the front of the buckle through 45° in either a clockwise or anticlockwise direction. The buckle was also fitted with a shoulder strap release tab behind the shoulder strap slots (see Figure 4),

Pushing the tab forward would release both shoulder straps but leave the lap straps secure. The tab requires a force of 19.6 Newtons to operate it and is protected from inadvertent operation by two projections on the rear of the buckle casing. During the impact, the seat

BGA 3445 Seat harness buckle
