## CONTENTS

### SPECIAL BULLETINS

### COMMERCIAL AIR TRANSPORT

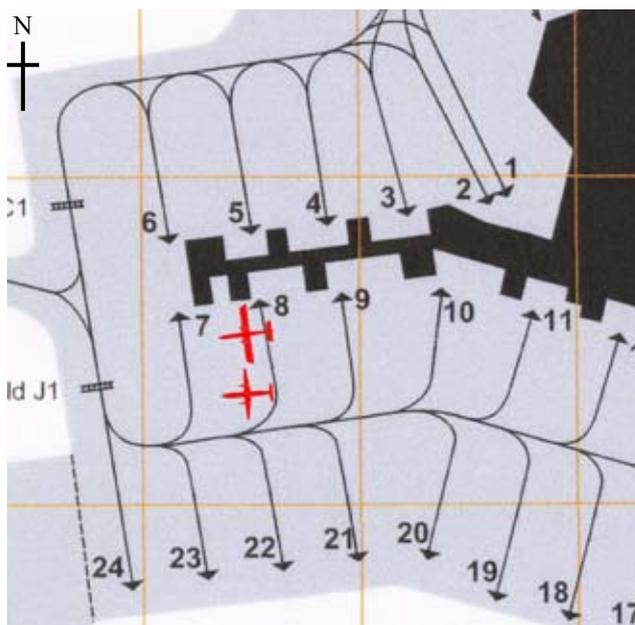
Figure 1

The evening before the incident, G-BEDP was parked on Stand 8 facing west close to the terminal. Later that evening a company Jetstream also parked on Stand 8, just to the left of G-BEDP. G-BEDP was scheduled to depart before the Jetstream the following morning.

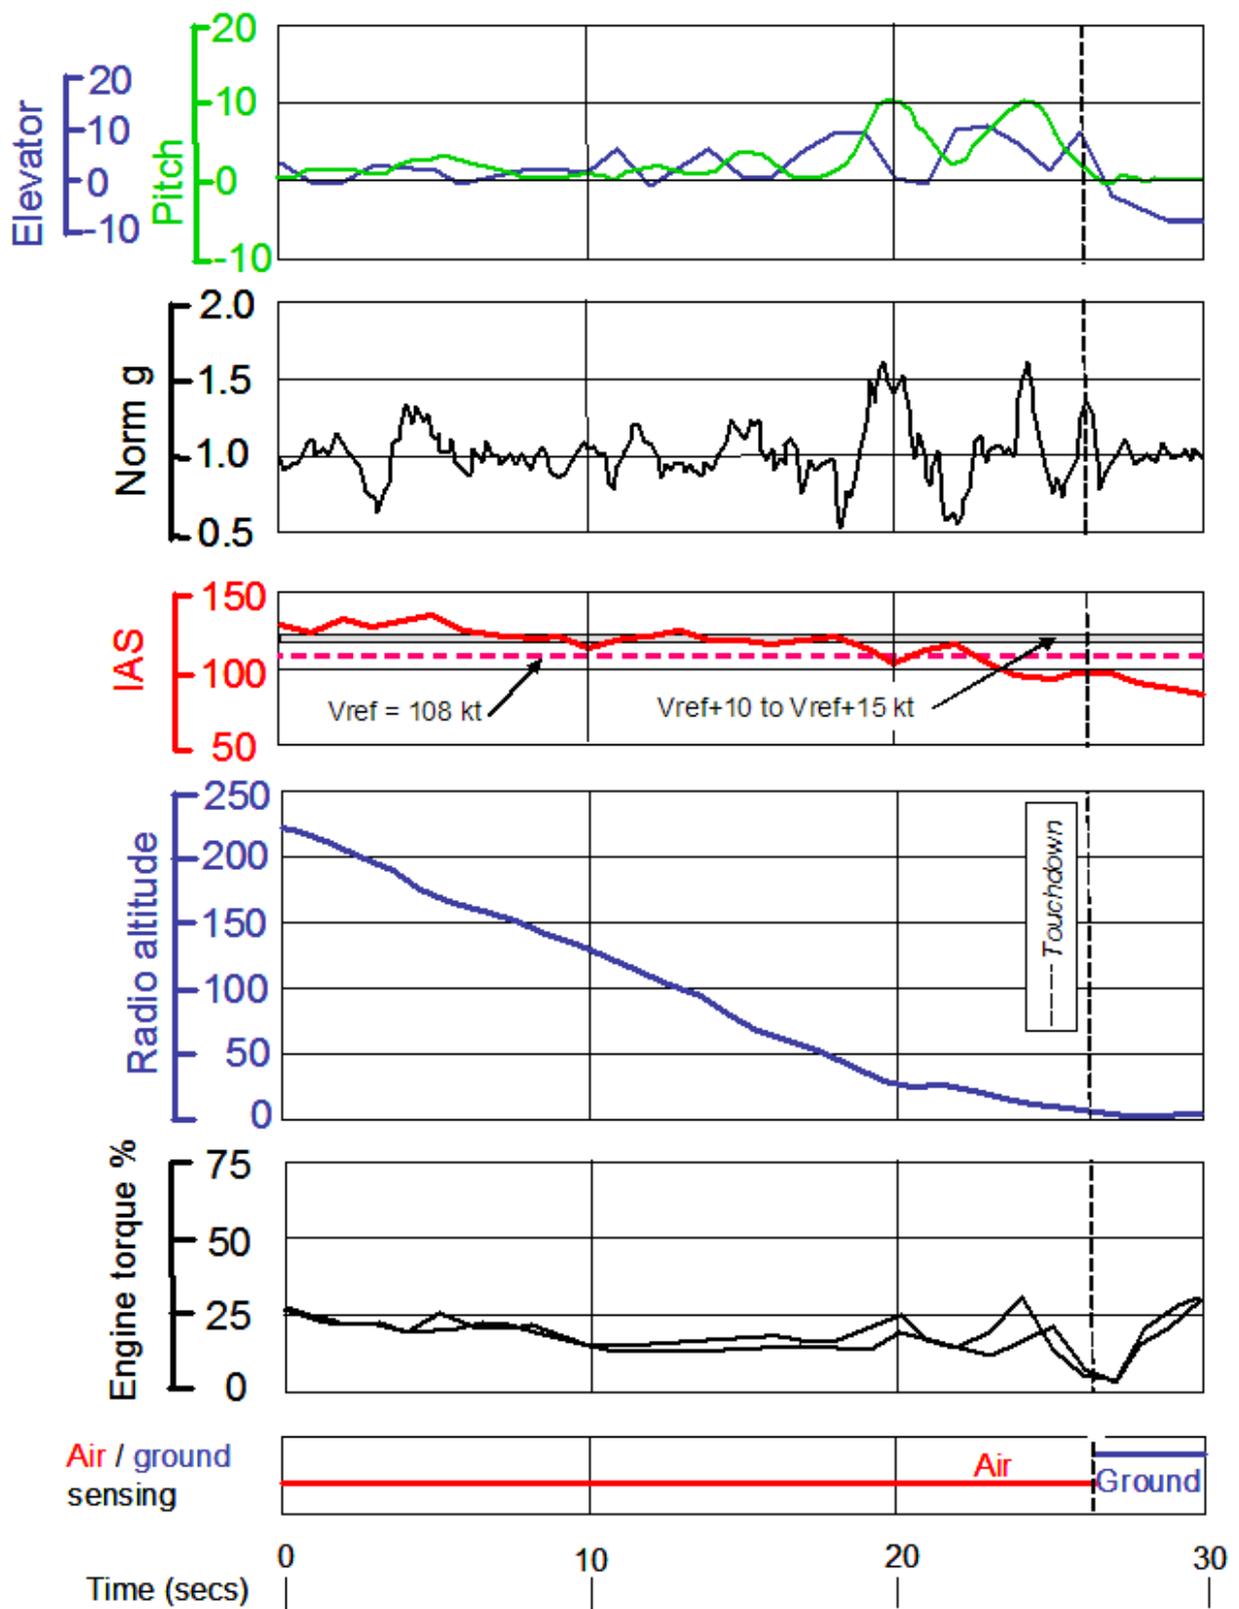
**Figure 1**  
Relevant flight data parameters

The relevant recorded parameters for the latter stages of the approach are shown at Figure 1. As the aircraft descended on final approach, the speed remained at or above the 118 to 123 kt band ( $V_{REF}+10$  to  $V_{REF}+15$  kt) with a pitch attitude of between 2° and 3°. From about 16 seconds before touchdown, the flight data showed increasing pitch excursions which were countered by elevator input. The recorded pitch and elevator signals became out of phase, and both increased in amplitude as the aircraft continued its descent. This divergence culminated in two significant pitch excursions, at 6 and 2 seconds before touchdown. In the first case, the pitch attitude reached a maximum of 10.5° at a radio altitude of 24 ft, even after a significant corrective nose-down elevator input had been made. The pitch attitude then reduced to between 2° and 3° momentarily, before increasing again to reach 10.6°, at a recorded radio altitude of 11 ft.

During the first significant pitch excursion, the airspeed dropped to 105 kt ( $V_{REF} - 3$  kt), before recovering somewhat as the pitch attitude reduced. The airspeed then showed an overall downward trend for the remainder of the landing phase, reducing to 94 kt ( $V_{REF} - 14$  kt) at the peak of the second pitch excursion, just prior to the landing. The touchdown itself was recorded with a pitch attitude of  $2^\circ$  to  $3^\circ$  and an airspeed of 98 kt, and the pitch attitude at the point of touchdown was decreasing at a rate of about  $5^\circ$  per second. The peak normal acceleration at touchdown was 1.2 g, which was less than that associated with the two previous pitch excursions (about 1.4 g).

The flight data showed that a stable approach was achieved initially, but that this became unstable at a late stage, probably due to a combination of the gusty conditions and the associated large control inputs. During the final stage of the approach the airspeed decayed to 94 kt, significantly below both  $V_{REF}$  and the target approach speed.

The significant downdraught reported by the commander below 100 ft is likely to be associated with the observed pitch excursion at about 24 ft, and the consequent loss of airspeed. Although some engine thrust was added to counter the speed loss, this was not effective and, after a brief recovery, the speed continued to decay until touchdown. It was during the second pitch excursion, shortly before main wheel touchdown, that the tail most probably contacted the runway. The flight data supports the commander's recollection that the touchdown itself was not at an exaggerated pitch attitude.

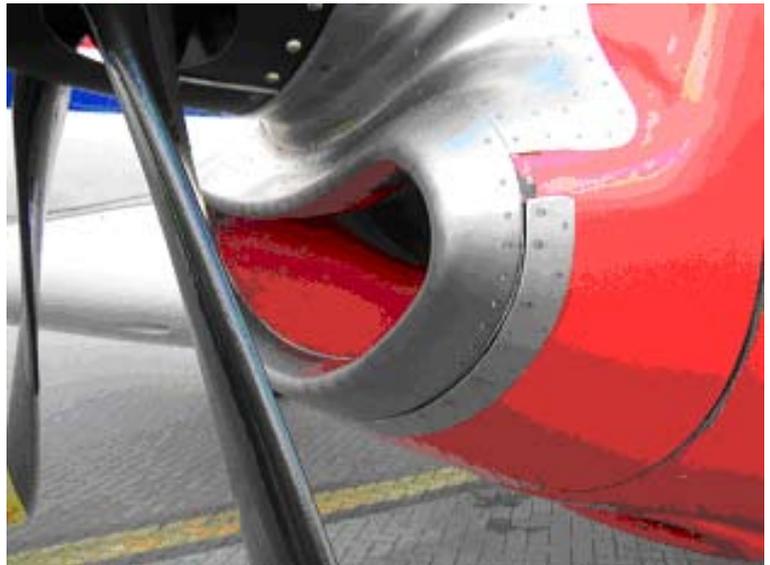
**Figure 2**

de-iced using hot air bled from the engine compressor, under certain icing conditions, it is known that ice may build up in the region between the intake upper lip and the spinner. Tests conducted by the manufacturer, following a number of in-flight flameout events soon after entry into service, identified that an airflow reversal occurs above the lip. This can allow accumulated ice to ‘slip’ down into the engine air intake, when the aircraft flies

into warmer conditions. As a result, a number of design changes were introduced in 1993/94 to improve the intake heating capability and the intake lip profile to reduce its susceptibility to accrete ice. These changes returned the intake to the required airworthiness standard (Service Bulletin J41-A72-001) and, at that time, the AFM was amended to include the requirement of selecting ‘continuous ignition’ for flight in icing conditions. The continuous ignition system fitted to each engine employs two igniters and should restart the engine within five seconds following a flameout. The manufacturer reports that very few instances of icing related engine flameouts have occurred in the last eight years.

Original standard of air intake fitted to G-MAJE

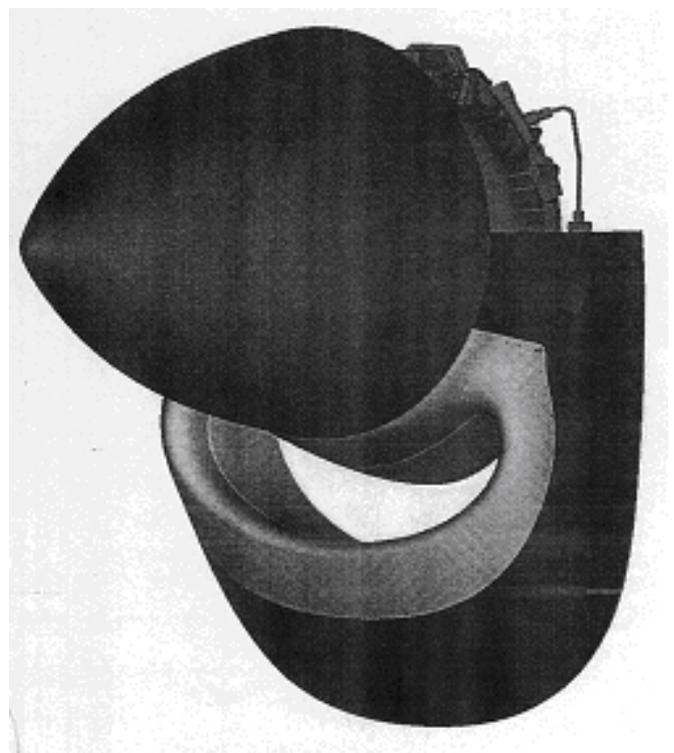
**Figure 3**

Diagram of the modified standard of air intake

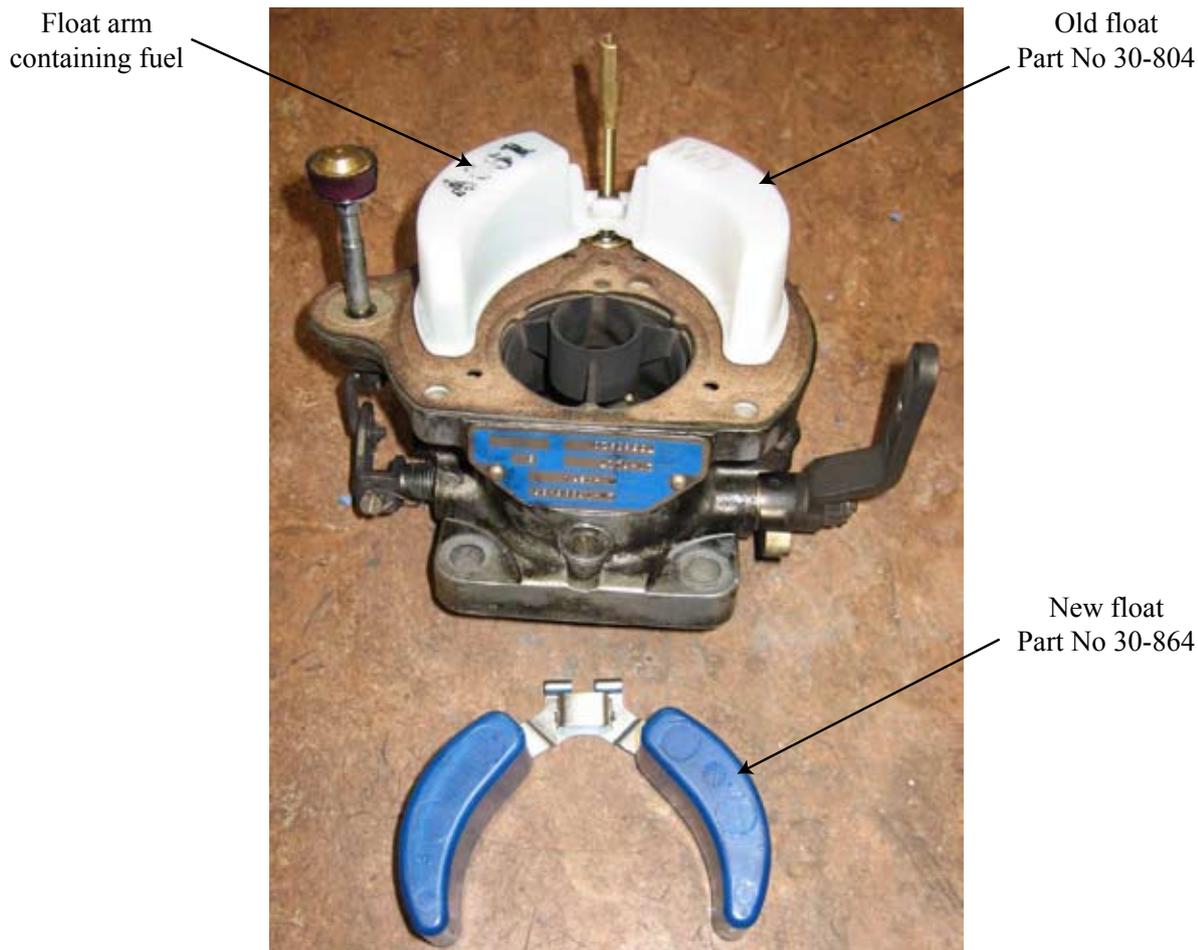
**Figure 1**

Review of occurrence reports, and other information, shows that Marvel-Schebler carburettor floats have a history of absorbing fuel and becoming heavy and therefore less buoyant. Consequently they do not fully close the needle valve between the fuel bowl and the main jets. This allows excess fuel to flow through the carburettor's jets giving a rich fuel mixture which can, at low power, cause the engine to suffer a fuel rich cut and fuel to pour out of the carburettor into the air box.

Over the years the Marvel-Schebler carburettor floats have gone through a number of design changes following incidents of the floats absorbing fuel, causing engine running problems and fuel leakage. In July 2002 the white hollow plastic float, part number 30-804, was introduced to replace the fabricated hollow brass float because of fuel ingress into the hollow arms around the soldered joints. After a period of time in service it was found that the white hollow plastic floats leaked fuel into the arms around the hot weld joints. A total of approximately 17,000 of these floats were manufactured.

Float arm containing fuel

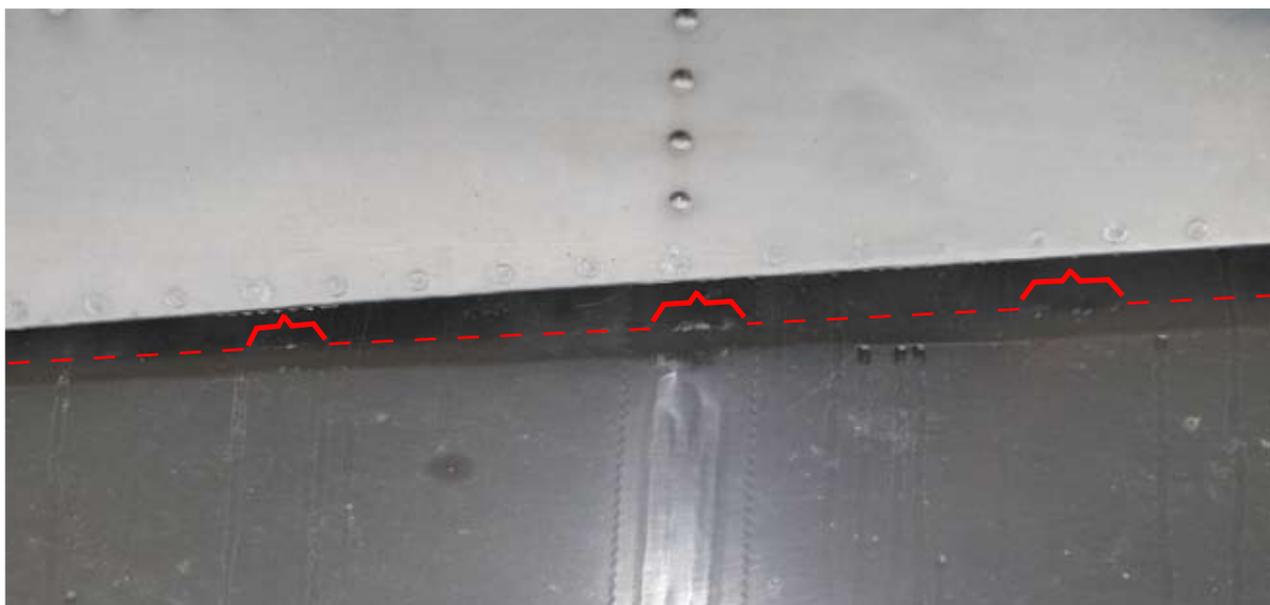
**Figure 2**

disconnections was found. However, close examination of the roll control system in the wings revealed indicators consistent with the right aileron being in the trailing edge up position and the left aileron in the down position at the time of impact, ie a roll input to the right. Several of these indicators are shown in Figures 2 to 5.

Witness marks on top surface of right aileron from shroud edge made when aileron trailing edge was up

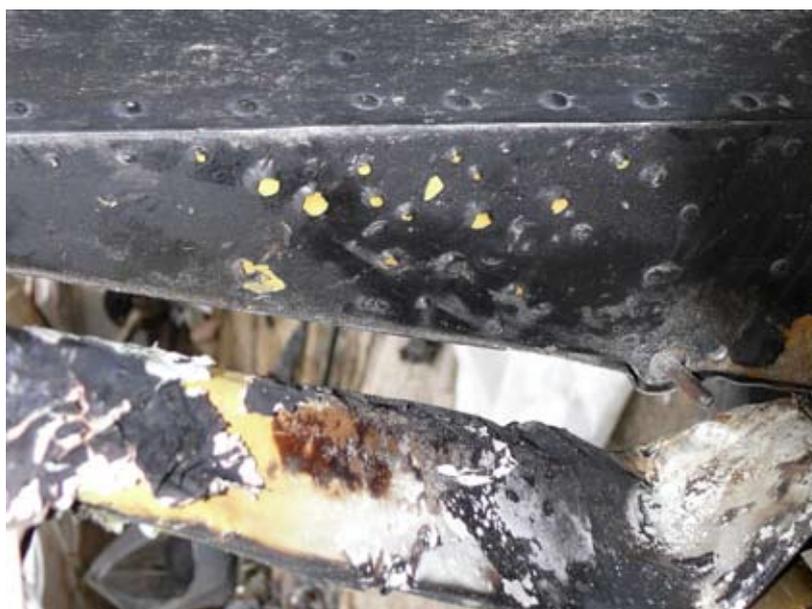
**Figure 3**

Witness marks of right aileron inboard edge against wing structure with right aileron trailing edge up

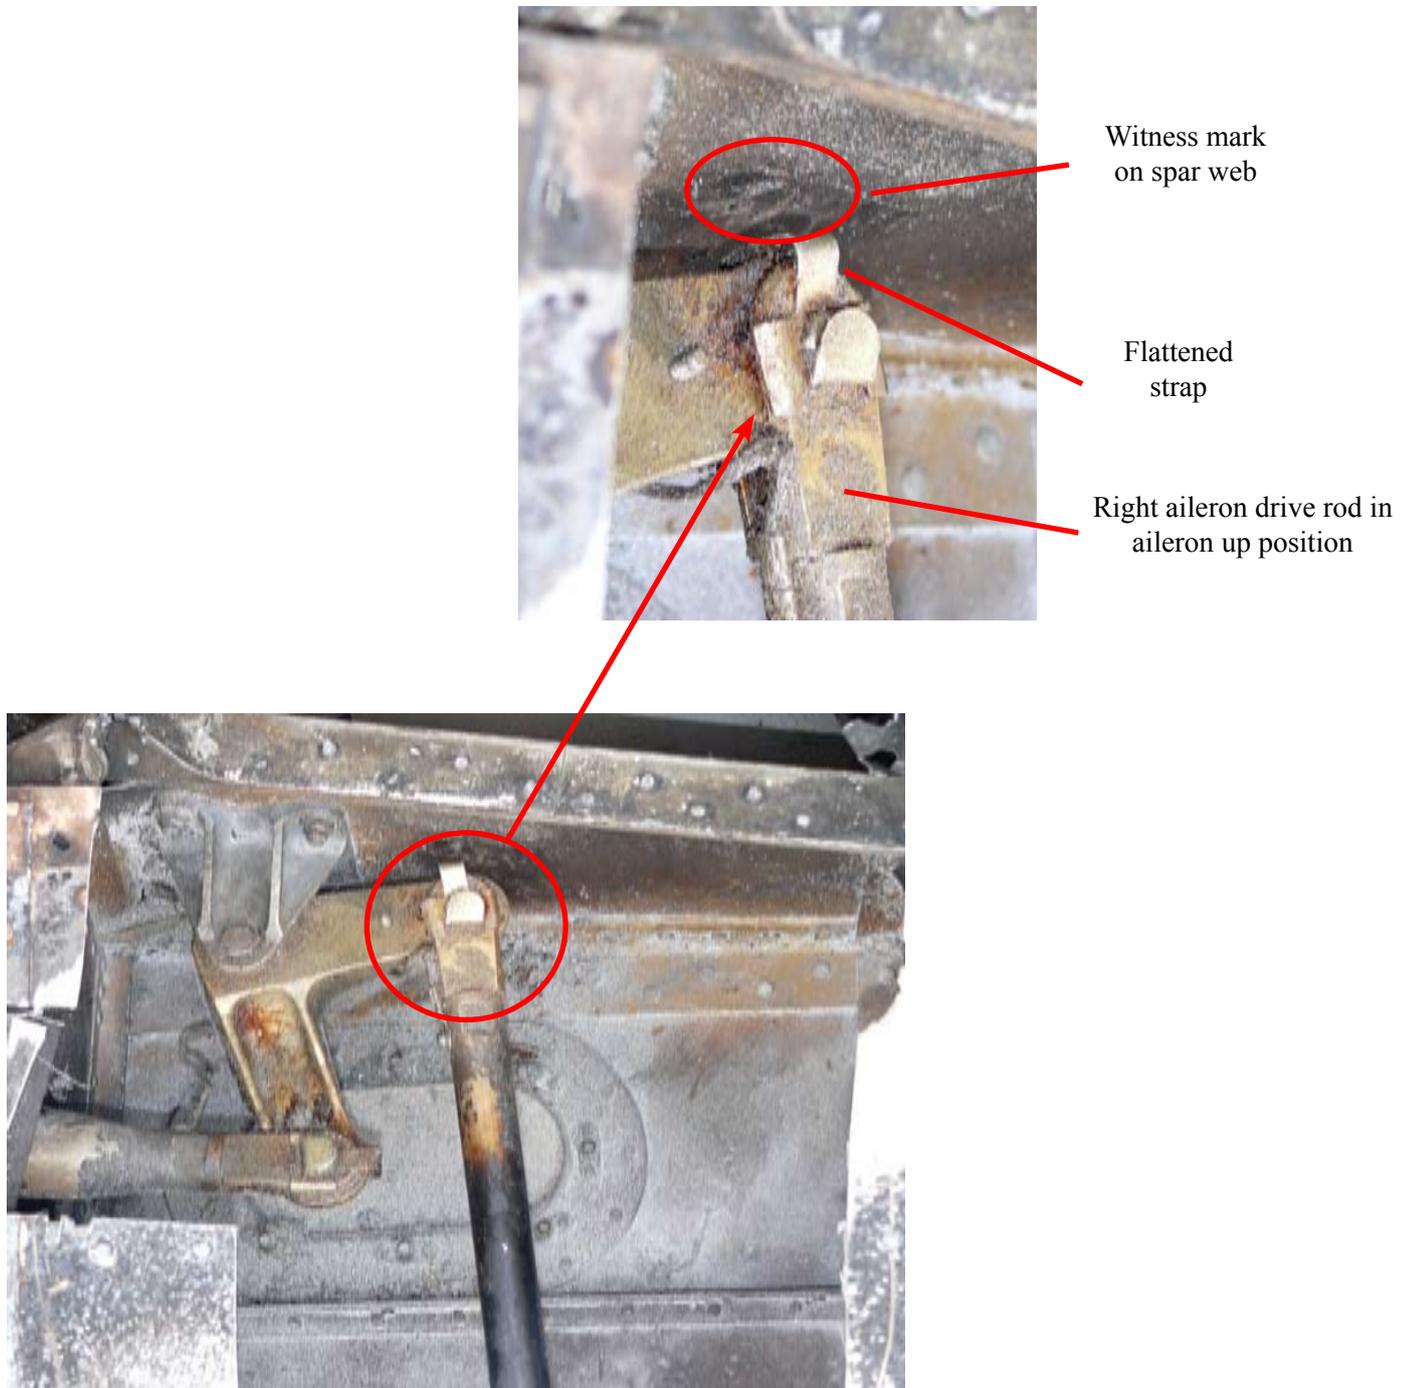
**Figure 4**

Right aileron drive bellcrank in aileron trailing edge up position.  
Note witness marks against rear face of the wing spar and flattening of safety strap (inset picture)

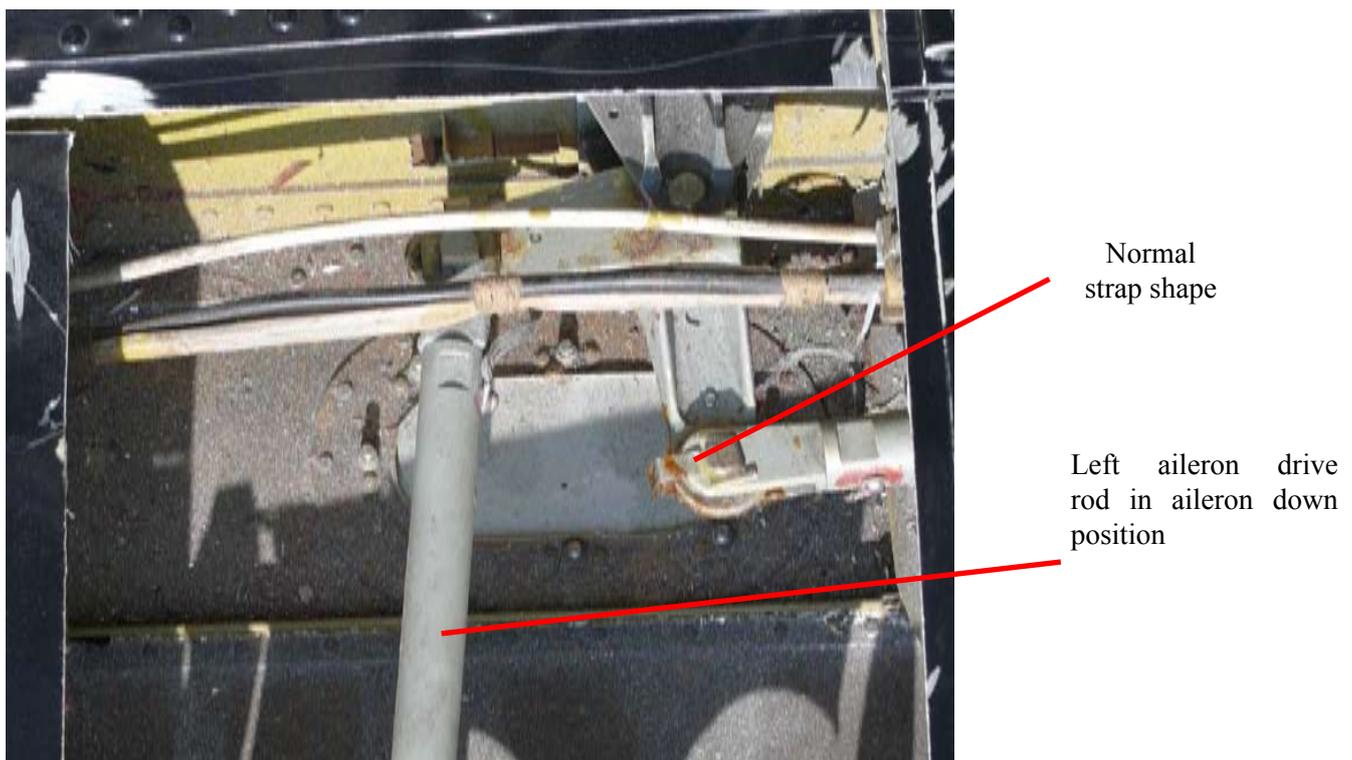
**Figure 5**

Left aileron drive bellcrank in aileron trailing edge down position

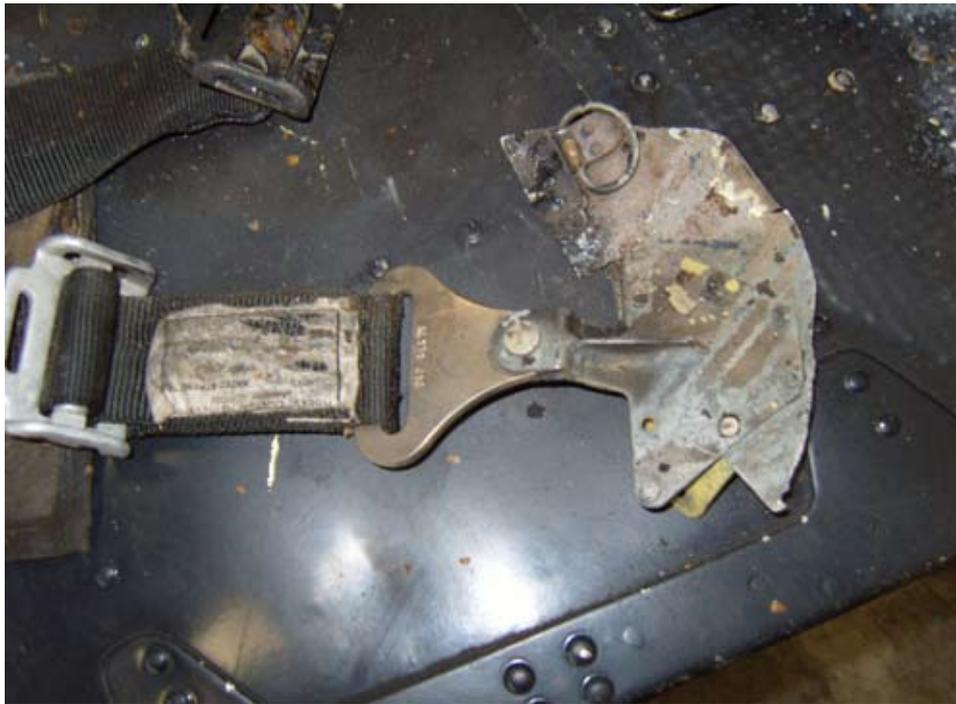
**Figure 6**

Example of seat belt attachment overload

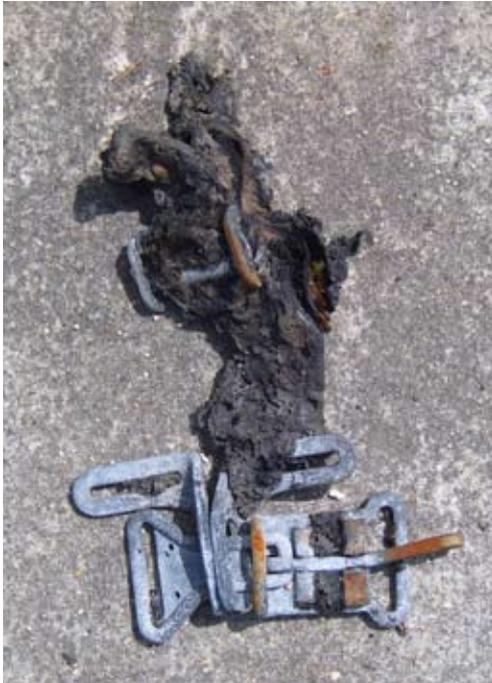
**Figure 7**

The front cockpit harness fittings were found indicating that the lap straps and the shoulder straps were in place, Figures 7. The crotch strap had not been used.

Front cockpit upper lap strap fittings, as found, showing shoulder straps secured to the lap strap

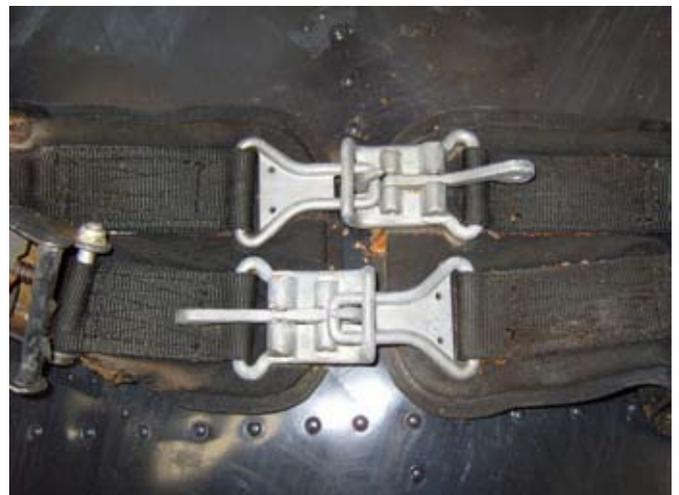
**Figure 8**

The harness in the rear cockpit, however, was found with the two lap belts fastened, but neither the two shoulder straps nor the crotch strap had been inserted, Figure 8.

Rear cockpit dual lap-strap buckles, as found

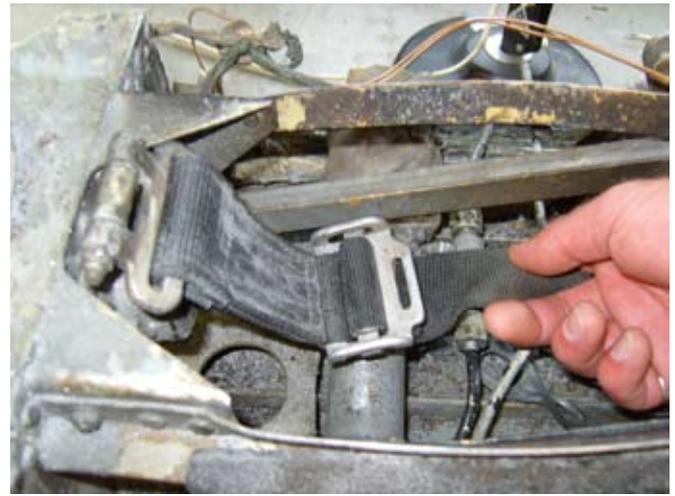
**Figure 11**

Crotch strap from G-LENA positioned in a similar manner to that shown in Figure 10. Paint damage was present to the upper and lower edges of the longitudinal structural member and on the upper section of the flap actuator casing. (Pitch control rod omitted)

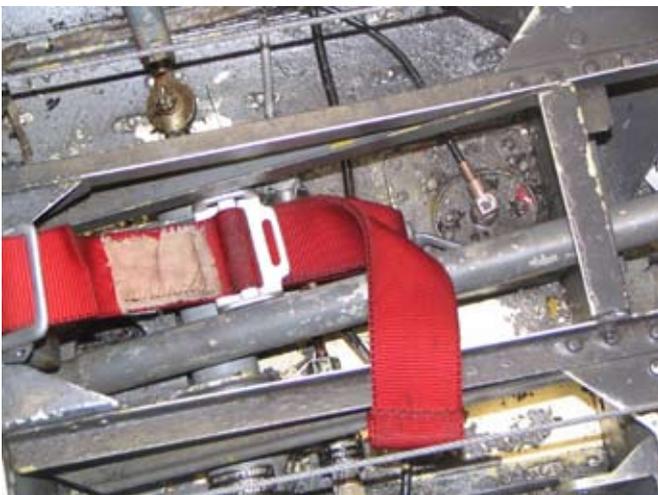
**Figure 10**

View showing crotch strap buckle jammed between the pitch control rod and fixed structure on a similar aircraft to G-LENA, with left roll being demanded but with the control stick positioned to the right

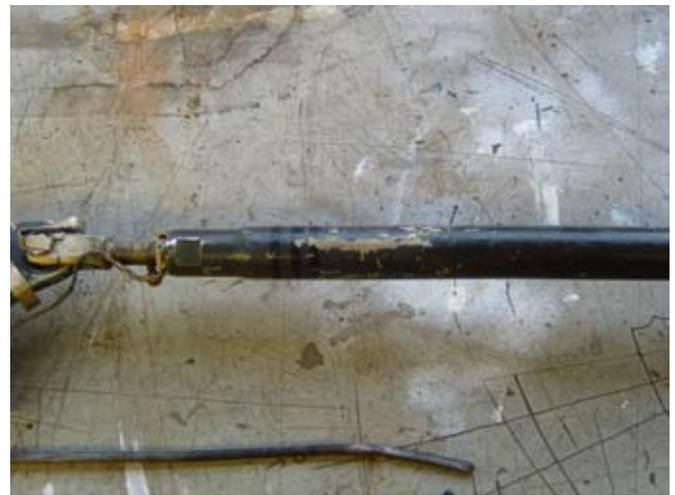
**Figure 12**

Paint damage to the pitch control rod in the area co-incident with the buckle location shown in Figure 11

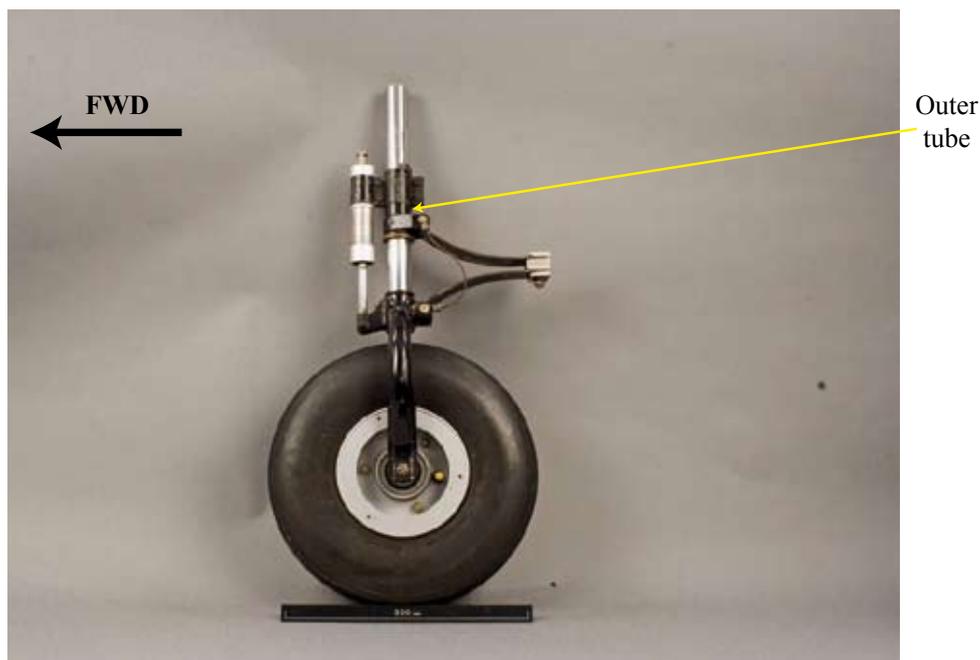
**Figure 1**

The detached NLG assembly (Figure 1) was taken to the Materials and Failures Department, Qinetiq, for metallurgical examination.

Section of NLG that detached from the aircraft

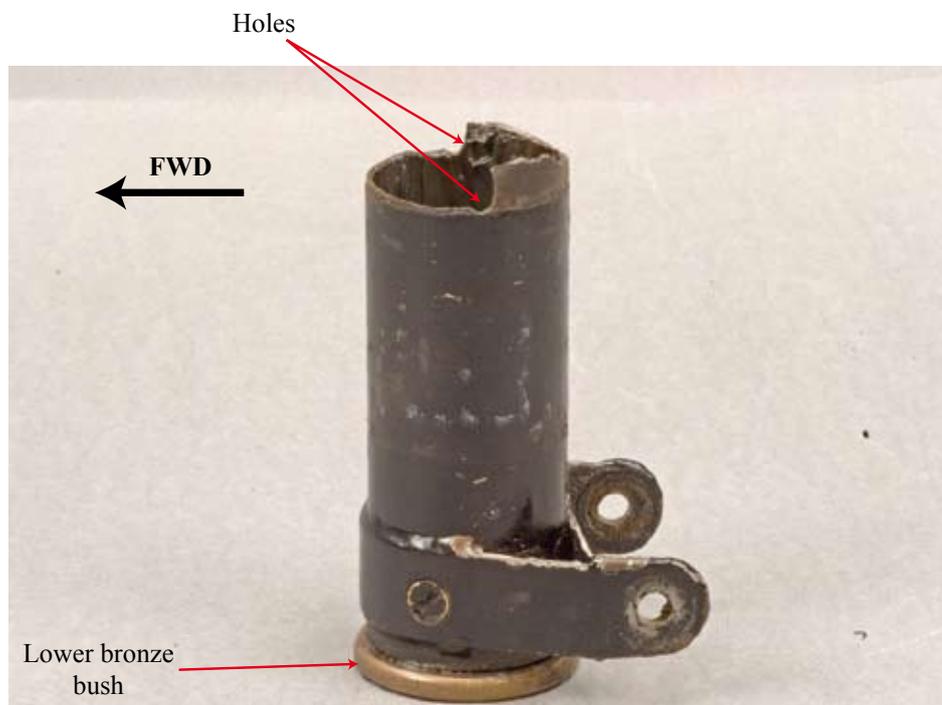
**Figure 2**

The outer tube had fractured between two holes that were located on either side of the tube in the area between the two bronze bushes (Figure 2). It was noted that the internal surface of the tube was well greased. Visual

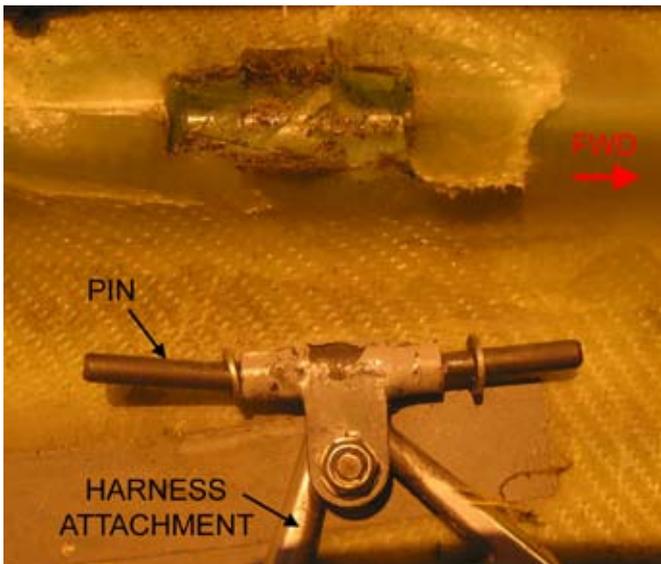
**Figure 3**

<sup>3</sup> To satisfy this requirement the lap strap must withstand a load of  $(115 \text{ daN}) \times (4.015\text{g}) \times 1.33 = 614 \text{ daN}$ . This load is shared between the two lap strap fittings so each lap strap fitting has a design limit load of 307 daN.

Overload failure of pin from left lap strap attachment

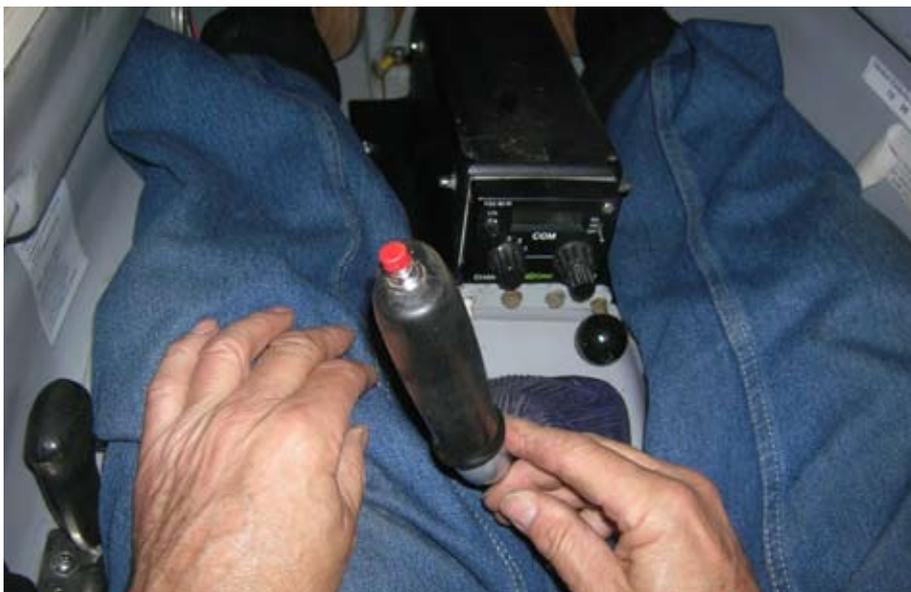
**Figure 4**

Figure 4 shows full left deflection of the control column in the ASW 19 using the right hand. During launch and in flight the right hand would usually be holding the hand-grip of the control column, but in this picture it is shown lower than usual to avoid obstructing the camera view. With the right hand on the hand-grip and with the control column deflected fully left, the pilot's right arm would obstruct his view of the cable release knob.

Full left deflection of control column in similar configuration ASW 19

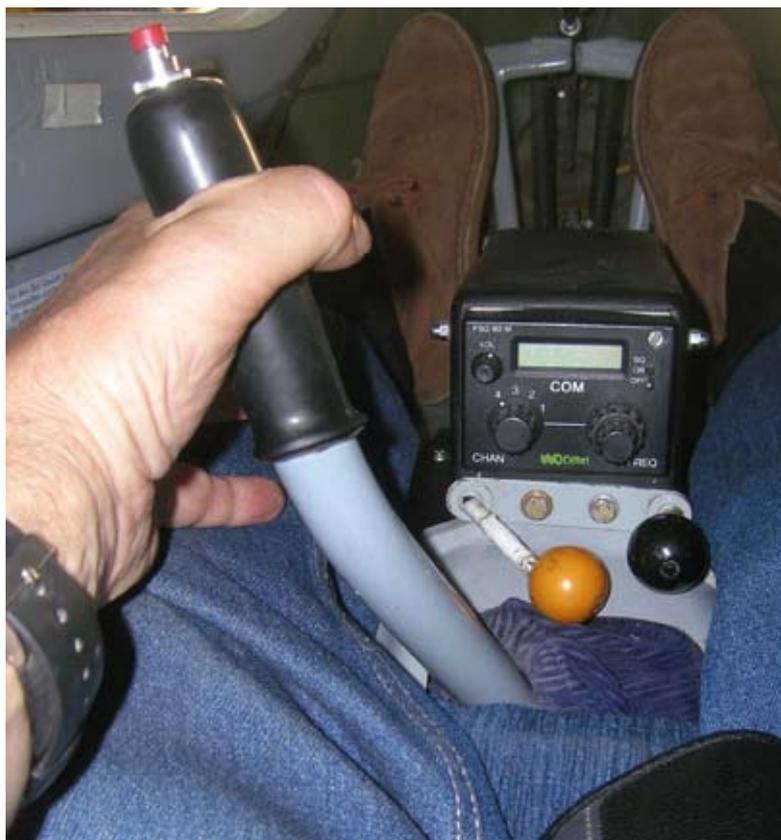
**Figure 5**

Cable length is limited to prevent the knob fouling the control column (a problem which is reported to arise on some other glider types) and in the case of BGA 4354 it was approximately 15 mm (visible in Figure 2 and shorter than on the similar configuration ASW 19 shown in Figure 5). The Safety Member of the RAFGSA considered that this combination of factors may have reduced significantly the pilot's ability to operate the cable release control in response to the right wing drop.

Cable release visible with full left control deflection
