CONTENTS

(ALL TIMES IN THIS BULLETIN ARE UTC)

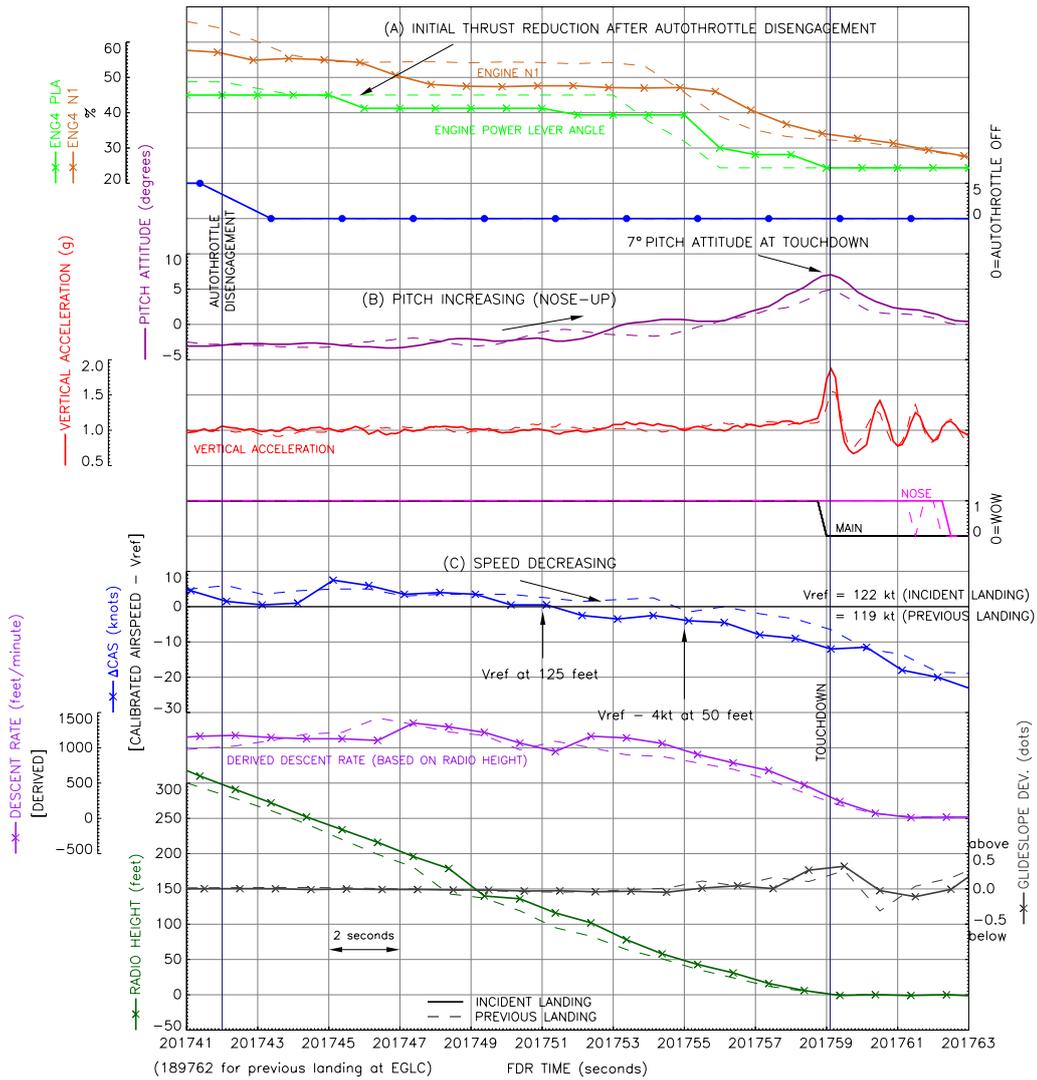
Figure 1
 Salient FDR Parameters
 (Incident to G-CFAH on 29 March 2005)

This tail scrape incident occurred because the thrust set, three seconds after the disengagement of the autothrottle, was too low to maintain the required airspeed for the landing profile whilst the commander attempted to maintain the correct glideslope. A high rate of descent developed which the commander attempted to reduce by increasing the flare which caused the aircraft fuselage to exceed the body contact angle of 6.9° causing minor damage to the tail strike protection plate.

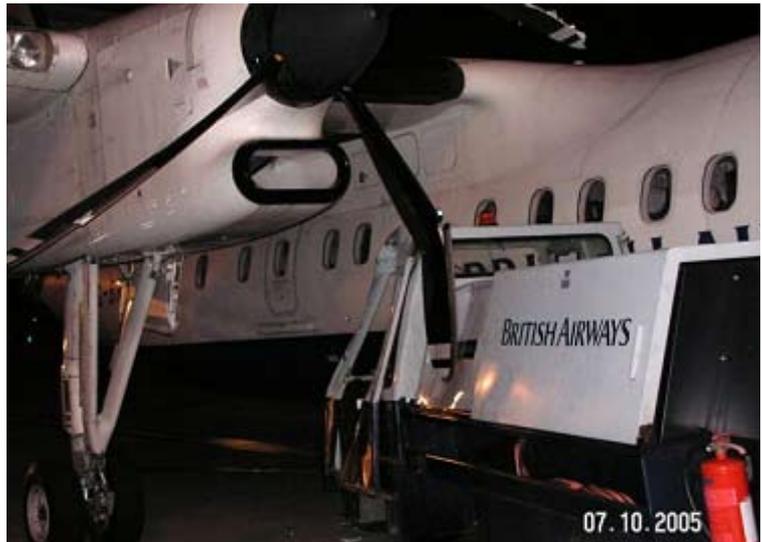
Figure 1

With both aircraft engines running the GPU operator selected IDLE and then started to gather the power cables which had been attached to the aircraft. Approximately 10 seconds later, the GPU started to move forwards, over the flat paved surface, towards the rotating right propeller, with nobody in the cab. As the GPU moved into the plane of the propeller it was struck by, and damaged, all four blades. The GPU subsequently struck the fuselage under the right wing, where it came to a halt.

Post impact photograph showing GPU and aircraft

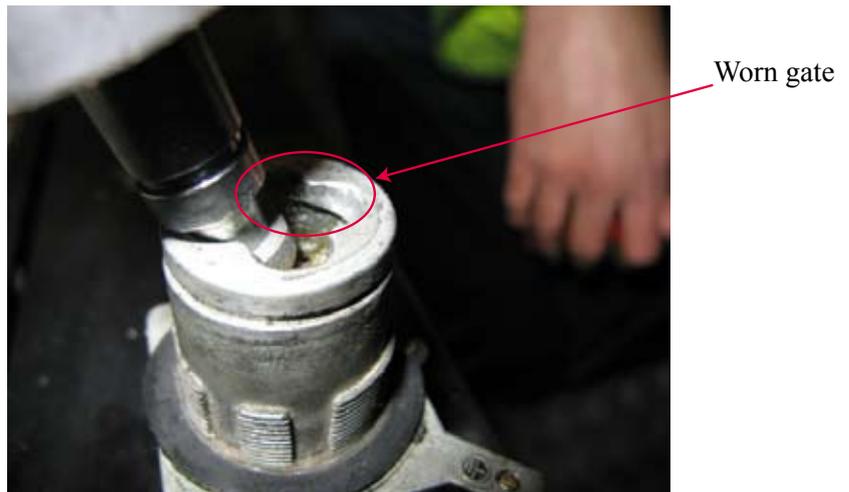
Figure 4 (right)

Photograph showing worn gate in the FORWARD-NEUTRAL-REVERSE selector (NB rubber gaiter removed)

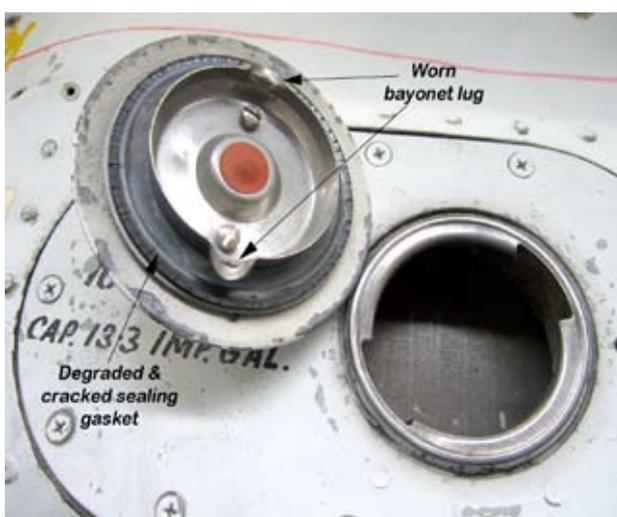
Examination of the filler cap bayonet mechanisms revealed that on each cap the projecting lugs (which abut the bayonet-cams) were grossly worn, to the extent that each lug was worn right through, beyond its full thickness, see Figures 1 and 2. The effect of this wear was to reduce significantly the extent to which the cap was pulled down onto its seat, with a commensurate reduction in the amount of compression of the seal assembly and an associated loss of seal effectiveness.

Figure 1
Fuel filler cap

Age-related cracking was clearly visible around the periphery of the rubber sealing gasket from the left cap, but for the most part these cracks did not extend into the working (contact) area of the seal. This cracking was less significant in terms of the deterioration in seal performance than the reduced compression of the seal assembly caused by the wear in the bayonet mechanism.

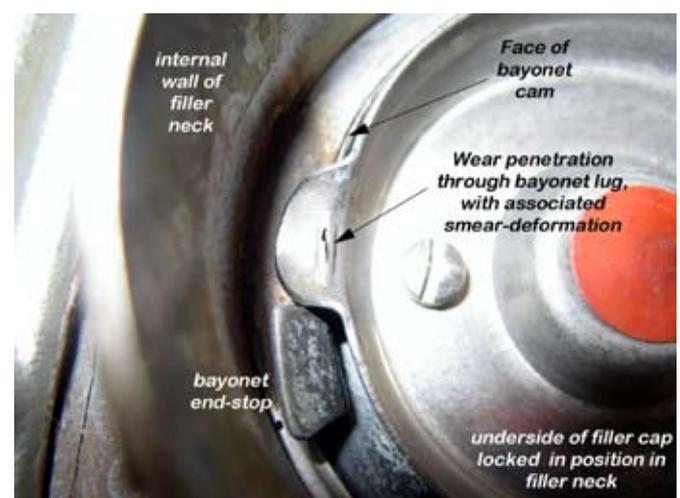
Figure 2
Underside of filler cap showing worn bayonet cams

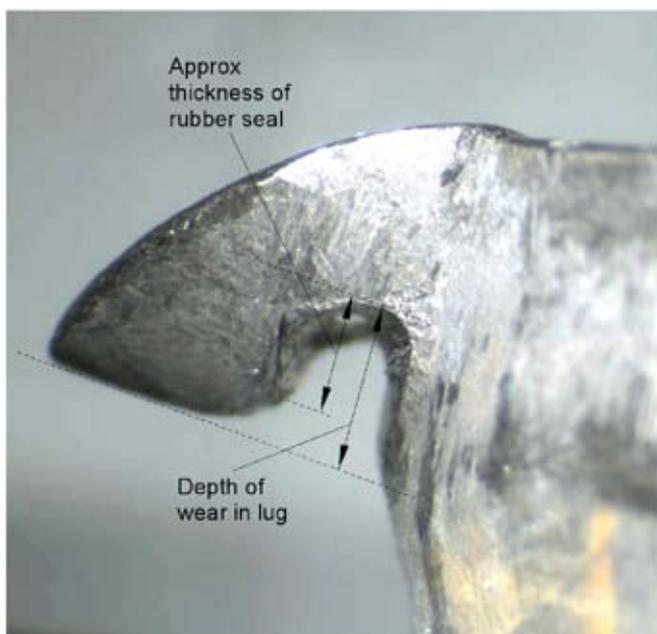
Figure 3

Whilst the rubber sealing gasket on the left cap had visibly degraded and cracked, for the most part these cracks did not extend into the interface region, and were not in themselves responsible for the absence of an effective seal. Rather, the loss of seal effectiveness was almost wholly caused by wear in the bayonet fittings, which reduced the distance through which the cap was pulled down onto its seat in the filler neck as it was locked down. It was not possible to measure precisely the extent of this wear, but the depth of wear in the lugs alone, illustrated in Figure 3, exceeded the rubber gasket's thickness by some 40% and approached the total thickness of the complete gasket

Illustration of wear in bayonet lug
(viewed from the side)

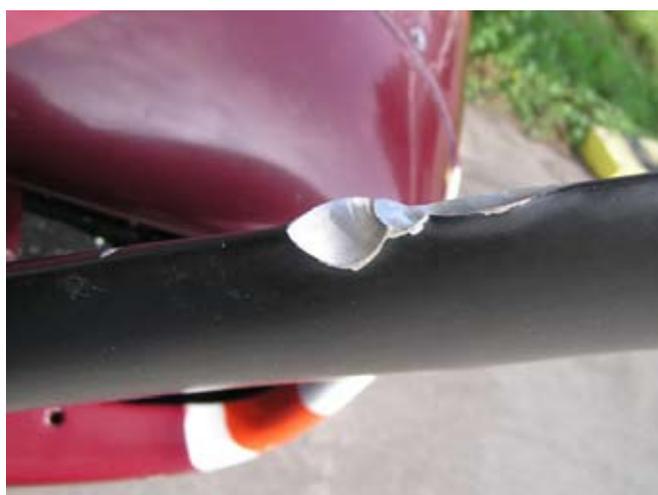
Figure 2

Damage to propeller leading edge

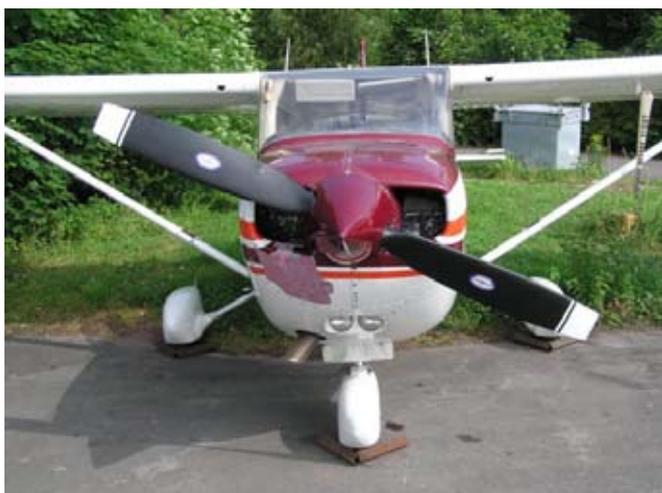
Figure 3

In addition, the forward face of the engine cowling had received one or more impacts that had caused the paint to flake off over a considerable area, Figure 3. Inside the engine compartment, there was evidence of mechanical damage over a small area of the fins of the front two cylinders (Nos 3 and 5) on the right side, Figure 4. No part of the aircraft had become detached which could have been responsible for the observed damage.

View showing damage to front of engine cowling

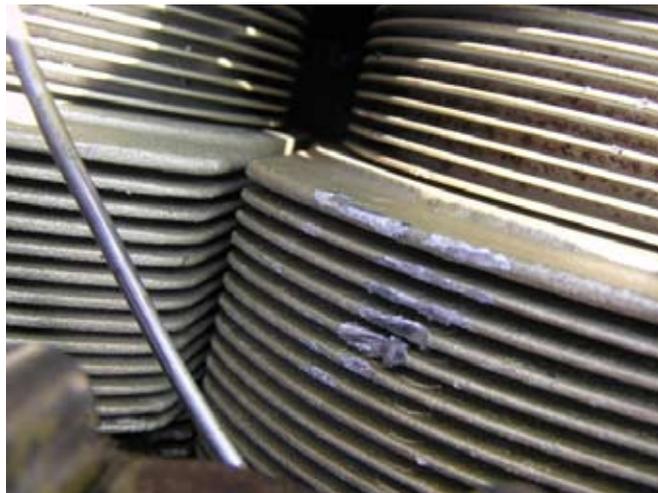
Figure 4

View of marks on cylinders

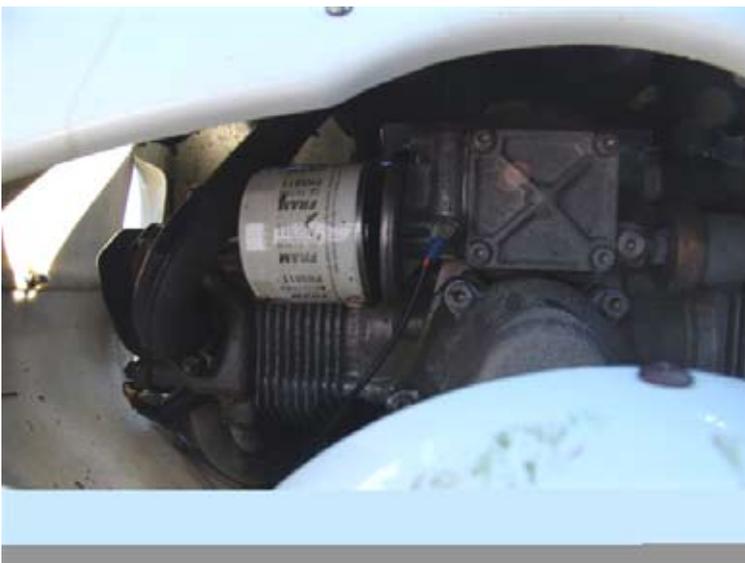
Figure 1

View on front of engine showing detached oil filter resting on exhaust pipe

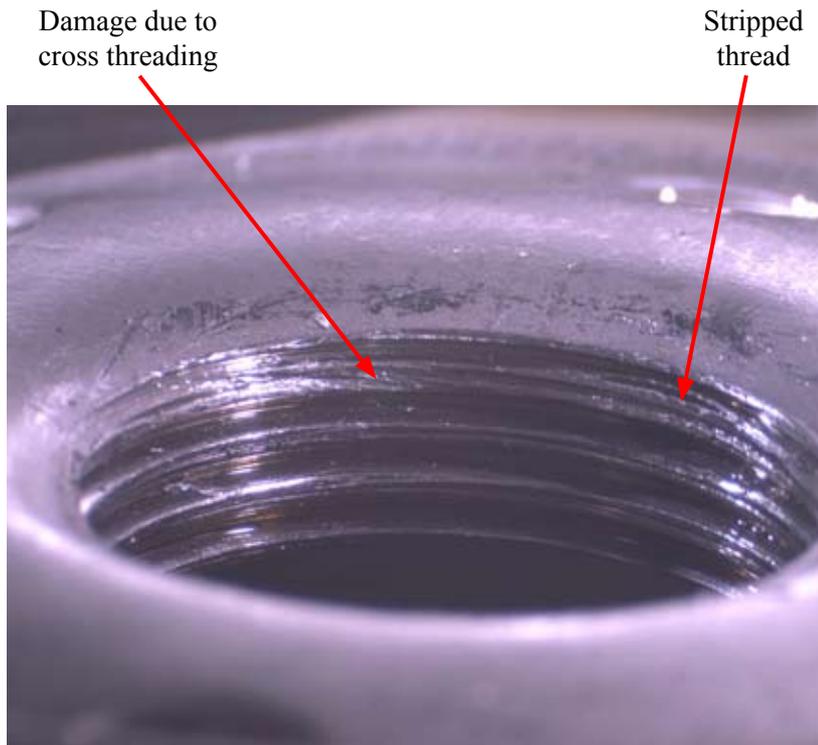
The PH5911 filter was examined by the AAIB. The thread on the filter was found to be severely damaged, with the majority of the threads having been stripped. It was also evident that the filter had been cross-threaded during installation. The thread damage is shown in Figure 2.

Figure 2
Oil filter thread damage
