CONTENTS

COMMERCIAL AIR TRANSPORT

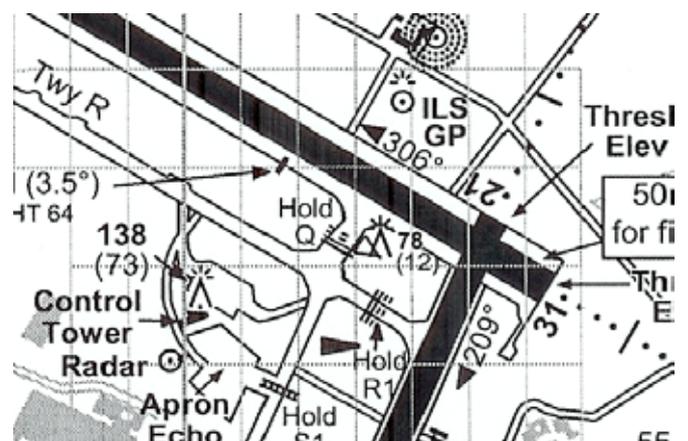
**Figure 1**

Disposition of the holds for Runway 31

He realised that he may have lined up on the left edge lights of the runway and obtained permission from ATC to return to ‘stand’. He subsequently informed ATC that the aircraft may have struck some lights. An inspection by ATC confirmed that five edge lights had been damaged.

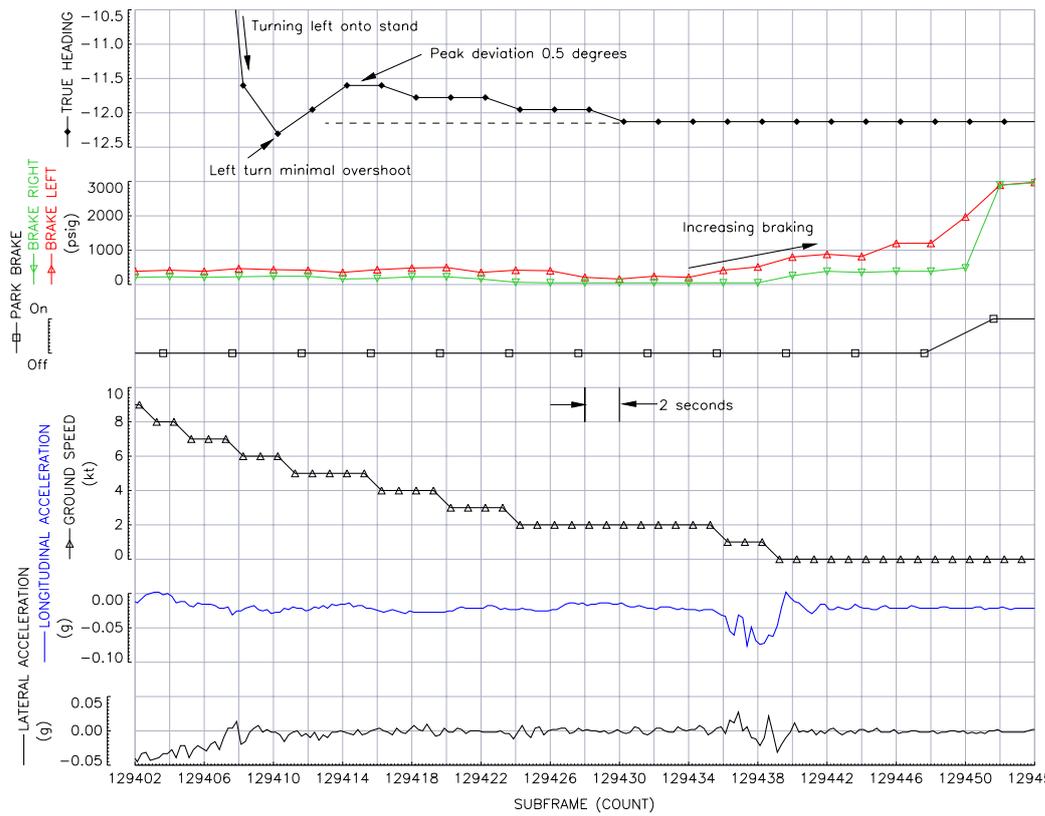
Figure 1

The pertinent data from the FDR is shown in Figure 1, commencing at the point when the aircraft had started to turn off the taxiway onto the stand, and ending shortly after the application of the park brake.

Time history of the key FDR parameters during the taxi onto stand.
Incident to N864DA on 20 May 2005 at Gatwick airport

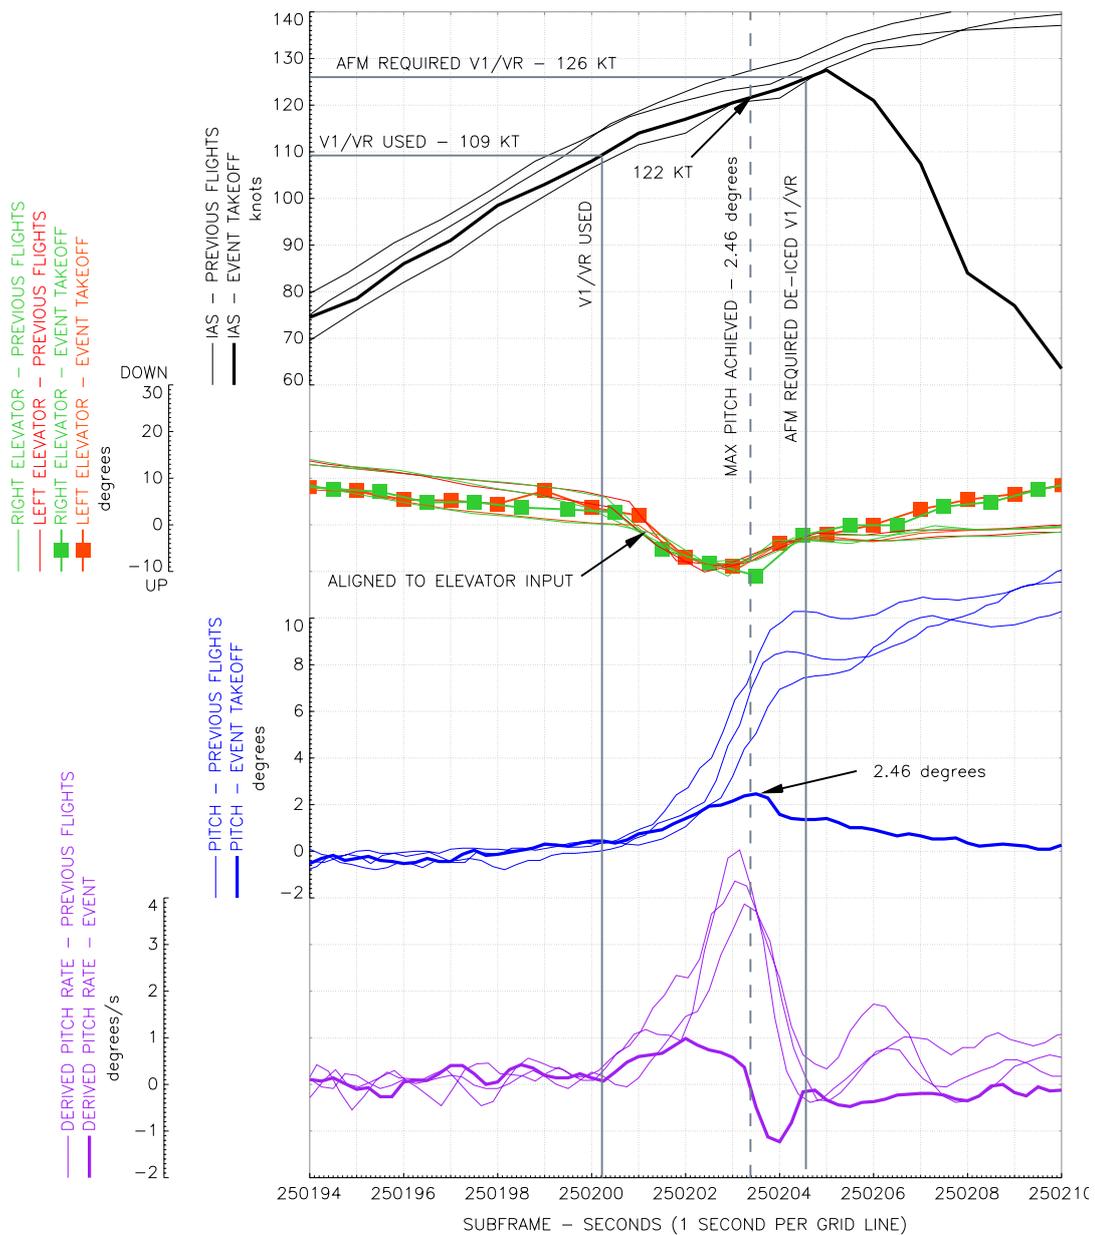
Figure 2
Comparison of Speed, Elevator Input, Pitch & Pitch Rate With 3 Other Flights

The aircraft was inspected by the AAIB some eight hours after the incident. The elevator movement was full and free and de-icing/anti-icing fluid residue was still present on the tail surfaces, wings and the aft fuselage. The de-icing/anti-icing fluid streak marks on the lower surface of the horizontal tailplane surfaces, made either during the takeoff run or by the effects of

gravity, provided some evidence that little or no fluid had been applied to the leading edge of the horizontal tailplane lower surfaces.

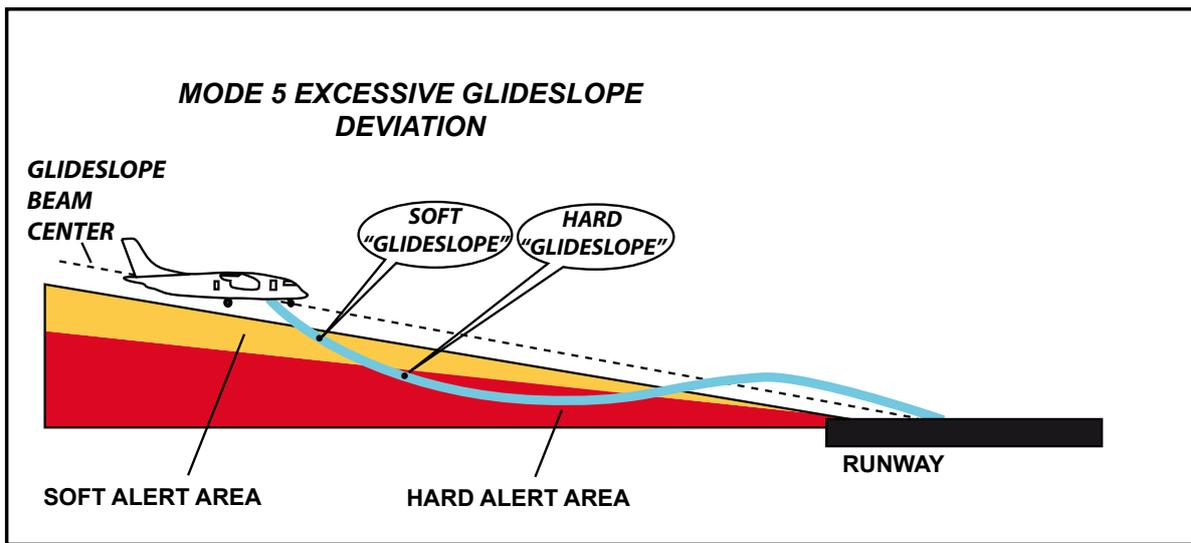
Figure 2

Excessive Deviation Below Glideslope
