## CONTENTS

### COMMERCIAL AIR TRANSPORT

**INCIDENT**

<b>Aircraft Type and Registration:</b>	Airbus A320-200, I-BIKE
<b>No &amp; Type of Engines:</b>	2 CFM-56 turbofan engines
<b>Year of Manufacture:</b>	1999
<b>Date &amp; Time (UTC):</b>	25 June 2005 at 0740 hrs
<b>Location:</b>	On approach to Runway 09L at London Heathrow Airport
<b>Type of Flight:</b>	Public Transport (Passenger)
<b>Persons on Board:</b>	Crew - 6                      Passengers - 98
<b>Injuries:</b>	Crew - None                      Passengers - None
<b>Nature of Damage:</b>	Failure of No 1 and 3 ADIRUs
<b>Commander's Licence:</b>	Airline Transport Pilot's Licence
<b>Commander's Age:</b>	41 years
<b>Commander's Flying Experience:</b>	8,300 hours (of which 1,300 were on type) Last 90 days - 130 hours Last 28 days - 50 hours
<b>Information Source:</b>	AAIB Field Investigation

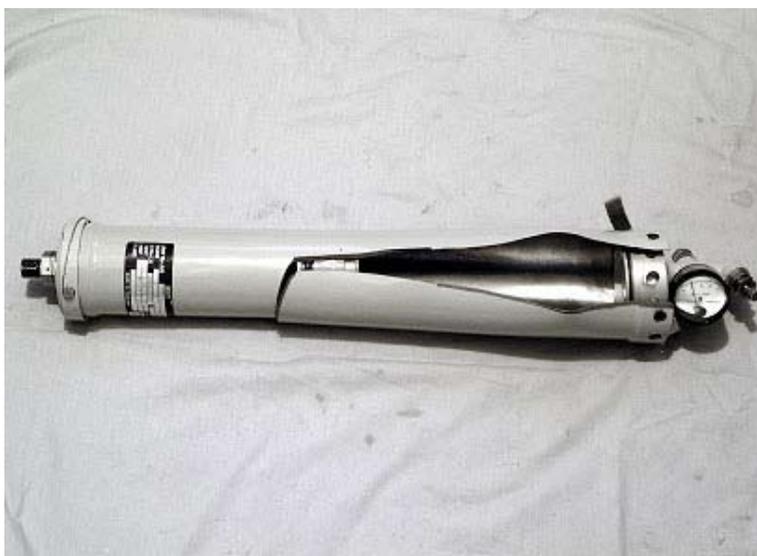
During the approach a loud bang was heard by the aircrew, followed by a loss of the yellow hydraulic system. After the aircraft landed safely a hydraulic accumulator was found to have burst. The failure was subsequently attributed to a material defect in the cylinder wall of the accumulator. No one was injured in the incident. A safety action plan is being put in place by the aircraft manufacturer, in conjunction with the accumulator manufacturer, to check other accumulators which might have similar defects.

**Figure 1**  
Accumulator as removed from  
the aircraft

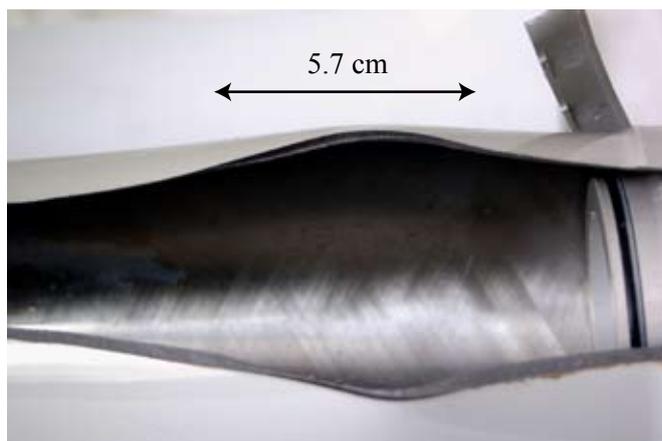
**Figure 2**

The damaged accumulator was subject to a metallurgical examination which resulted in two inclusions being found in the cylinder wall. These inclusions were thin strands of non-metallic material that were present in the bar stock prior to machining and were located on the outer face of the cylinder wall running longitudinally. The longer inclusion (see Figure 2) was 5.7 cm long and was where the cylinder initially burst. This was immediately followed by failure of the cylinder wall at the second inclusion. Both the inclusions had reduced the wall thickness locally by approximately two thirds and the discontinuities in the cylinder wall had subsequently grown as a result of low cycle, high stress fatigue (see Figure 3).

Photograph showing the location of the primary inclusion

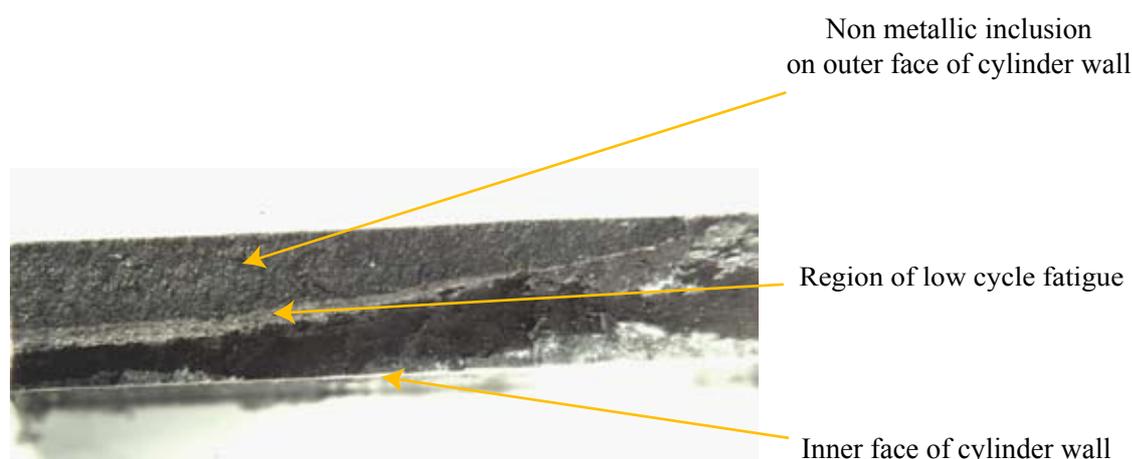
**Figure 3**

Photograph showing one end of the fracture face for the shorter of the two inclusions

The manufacturer of the accumulator and the manufacturer of the aircraft were promptly informed of the results of the metallurgical examination. They have examined their inspection records and, at the time of writing this report, are putting in place a programme which includes non-destructive crack detection of those components considered to be at risk. They

are also reviewing the inspection and manufacturing processes for the accumulators. In view of this it is not considered necessary for the AAIB to make any safety recommendations.

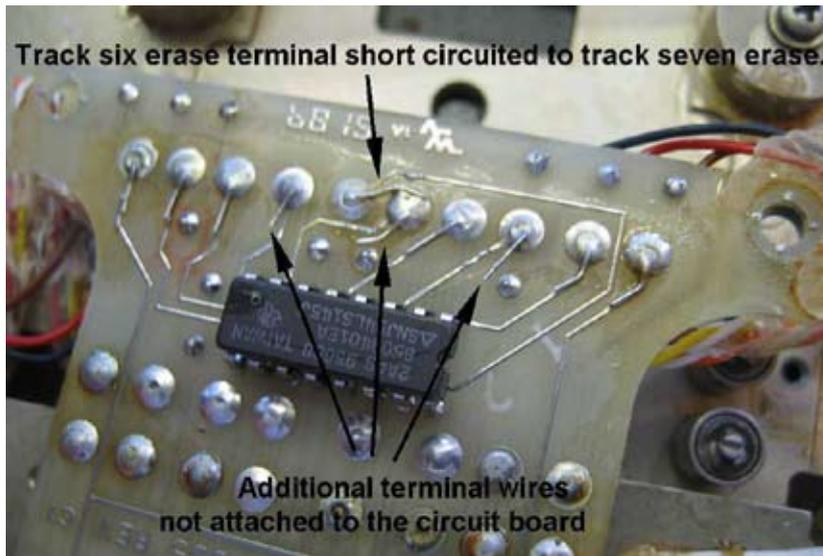
**Figure 5 (left)**  
Faulty distribution board

detached from its correct position and becoming soldered to the adjacent terminal, E49. It was also noted that other attachment wires were in close proximity to adjacent circuitry. Figure 6 shows the attachment wires in the correct positions.

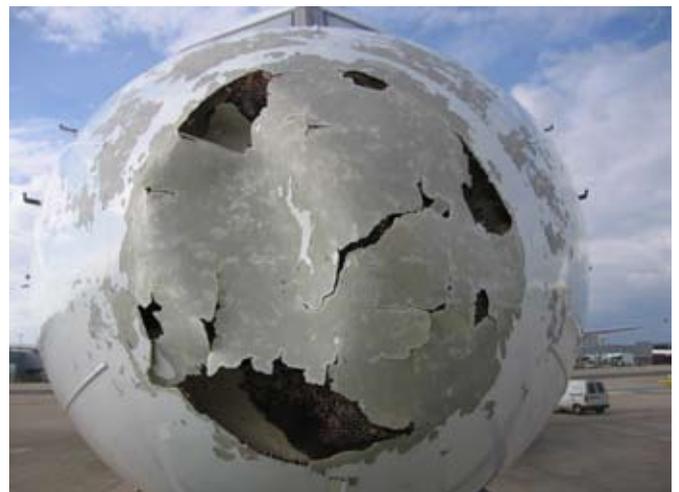
**Figure 1**  
Damage to radome

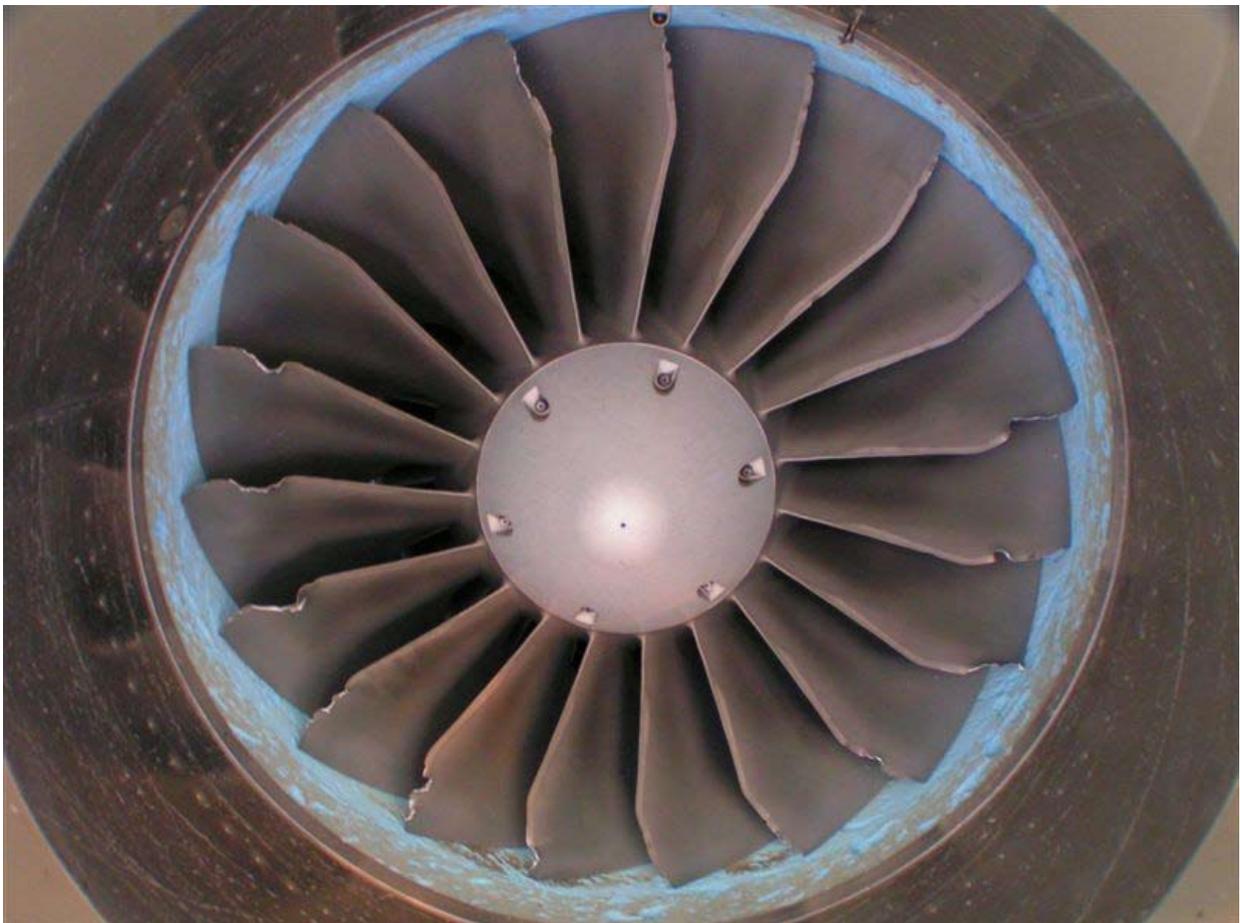
**Figure 1**

During the inspection of the runway, prompted by these reports of engine vibration and an unusual noise, a heavily damaged piece of red-painted metal was found. This was subsequently identified as the dust cover which is fitted over the refuelling point and attached to the airframe by a lightweight chain. On Cessna 560 XL aircraft this is positioned behind an openable panel in the wing root fairing, directly ahead of the leading edge of the right wing. After landing, inspection of the fan of the right engine of G-WCIN showed it to be severely damaged.

Condition of fan of right engine after landing

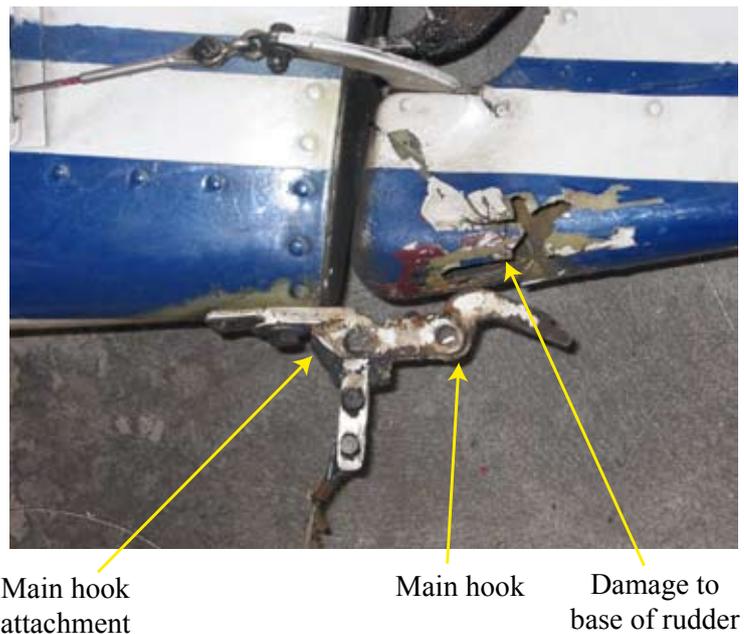
**Figure 1**

Evidence of repeated operation was apparent on G-OMAC by long term damage to the base of the rudder (see Figure 1). There was a possibility that the hook could become lodged within the rudder. However, given the lightweight fibreglass structure it is likely that rudder pedal pressure would liberate the hook and allow the rudder to move freely again.

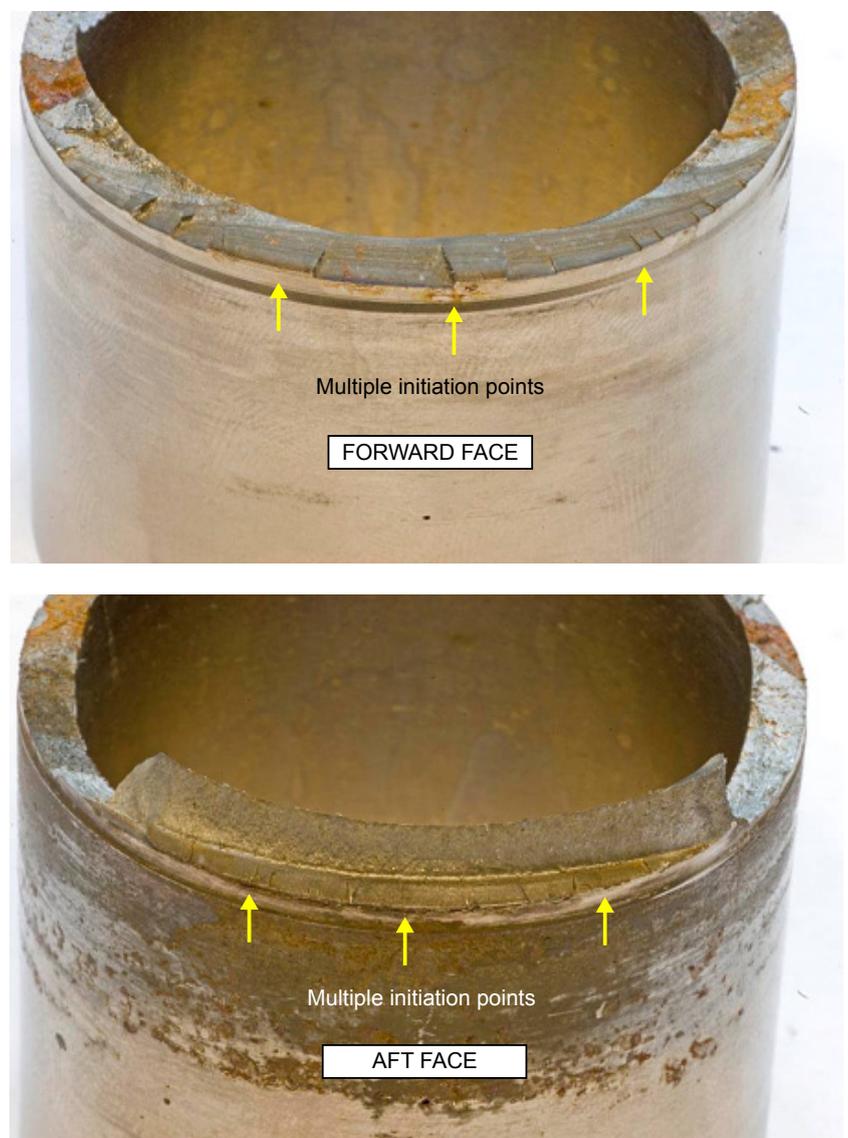
**Figure 2**

Detailed examination of the fracture surfaces showed evidence of corrosion which had removed a large area of the fine fatigue striation detail. However, the fracture topography was typical of the propagation of a fatigue crack in steel. The area of the overload failure of the pivot from ‘LB showed evidence of ductile dimples typical of an overload failure. There was no evidence of any material defects or machining abuse which could have influenced the initiation of fatigue cracks, although there was evidence of corrosion on

Forward and aft face of the fractures pivot from G-CCLB
