Aircraft Type and Registration:	Avro 146-RJ100, G-CFAD	
No & Type of Engines:	4 Lycoming LF507-1F turbofans	
Year of Manufacture:	2000	
Date & Time (UTC):	26 August 2003 at 0656 hrs	
Location:	London City Airport, London	
Type of Flight:	Public Transport (Passenger)	
Persons on Board:	Crew - 6	Passengers - 110
Injuries:	Crew - None	Passengers - None
Nature of Damage:	Lower rear fuselage scraped, tail bumper strip removed, skin, stringer and frame damage	
Commander's Licence:	Airline Transport Pilot's Licence	
Commander's Age:	35 years	
Commander's Flying Experience:	3,283 hours (of which 110 were on type) Last 90 days - 96 hours Last 28 days - 38 hours	
Information Source:	AAIB Field Investigation

Synopsis

After an uneventful flight the aircraft was positioned onto the ILS approach to Runway 10 which has a 5.5° glidepath. During the manually flown final stages of the approach the aircraft descended slightly below the glidepath. In regaining the glidepath insufficient power was used to correct for the resultant decay in airspeed and the thrust levers were closed early during the landing flare. These factors led to the aircraft being 8 kt below the correct speed at touchdown. In an

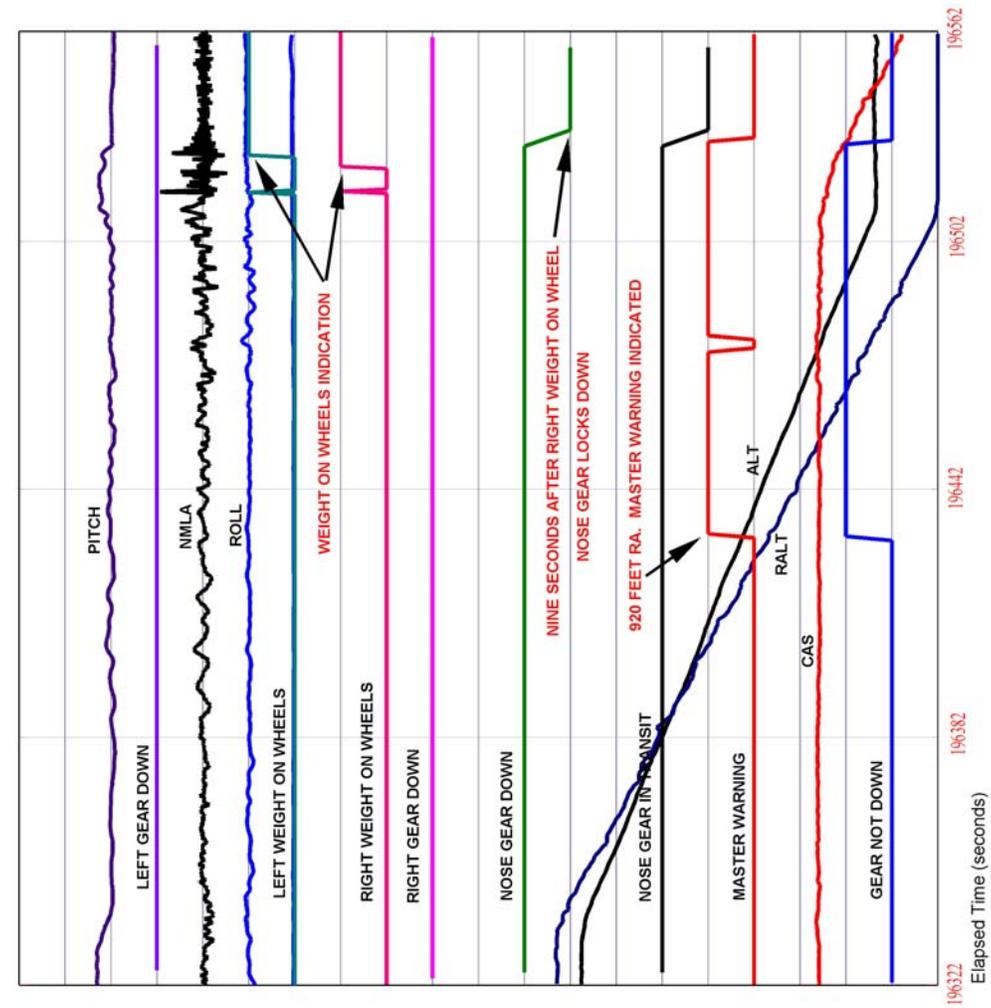
Figure 1

On the final approach to land, the nose gear unsafe warnings recurred and as the aircraft descended through 1,000 feet, the red 'LG NOT DOWN' message appeared, accompanied by the master caution triple-chime aural warning. The tower at London Heathrow advised the crew that all three landing gear and the main gear doors appeared to be down. The aircraft landed normally and was slowed using 'emergency maximum' reverse thrust, with normal braking being used only after the ground speed had decreased to below 10 kt. The aircraft stopped on the runway and contact was established with the emergency services by radio and via an open cockpit window. After disembarking the passengers via steps, the aircraft was recovered by engineers to the company's hangar at Heathrow.

G-BXWE Flight Recorder Data for Landing/Rollout

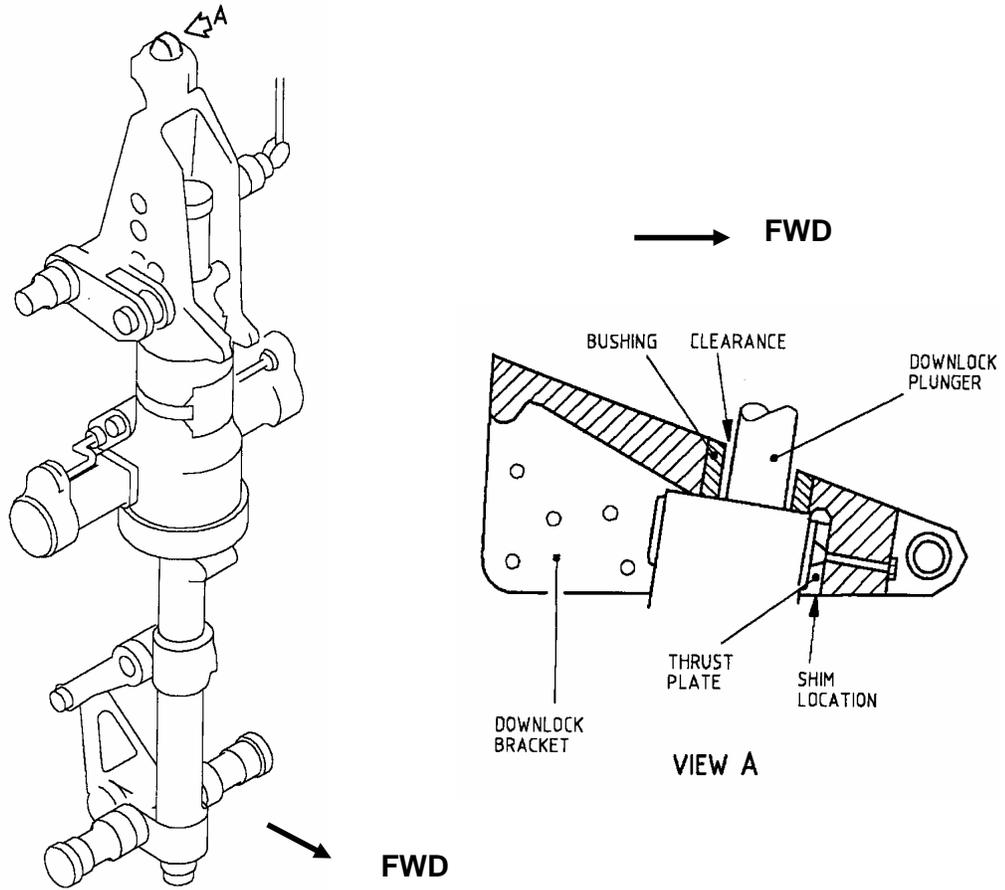
Figure 2

The downlock bracket is shimmed, to ensure that the downlock plunger is located centrally in the hole when the gear is down. If the clearance is incorrect, the downlock plunger may be prevented from fully extending due to the excessive friction caused by the plunger being forced against the sides of the hole. If the plunger is not fully extended, the down and locked proximity sensors may not be triggered.

The aircraft was subsequently on a Base Maintenance check between 19 and 28 September 2004, during which the downlock plunger clearance was rechecked after further consultation with the aircraft manufacturer. On this occasion, the clearance was found to be outside the Aircraft Maintenance Manual (AMM) limits of 0.003 to 0.020 inch and the shimming was adjusted to increase the clearance to bring it within limits. According to the aircraft manufacturer, too small a clearance increases the chances of the downlock plunger not fully engaging, due to the increased friction on the plunger caused by the misalignment.

The nose landing gear on G-BXWE was replaced in June 2003, following a towing incident. It is thought that the downlock plunger clearance may not have been correctly rigged after the nose gear was installed, because of the ambiguity in the AMM procedure. This might also explain why no anomalies were found during troubleshooting after this event and the previous event in September 2003. In-service wear tends to increase the downlock plunger clearance and thus too small a clearance could only have resulted from incorrect maintenance procedures.

Nose Landing Gear Downlock Mechanism

In response to the airline's recommendation, the aircraft manufacturer has agreed to amend AMM subtask 32-21-01-220-024-A00 and task 32-21-01-200-836-A to include a step to clarify that a second person is required to apply a rearward force to the nose gear when measuring the downlock plunger clearance, in order to obtain an accurate measurement.

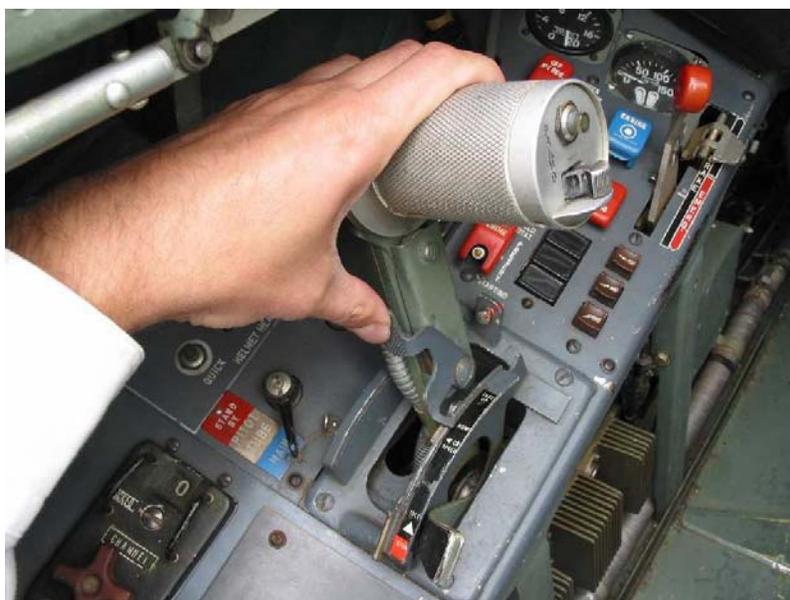
The throttle lever has a thumb actuated latch that when depressed permits the lever to move aft of the IDLE stop and into the fuel shutoff region. Inadvertent application of this latch while slamming the lever back to IDLE could result in an inadvertent engine shutdown. However, normal positioning of a hand around the throttle grip with one's thumb close to the airbrake switch on the side would make it

extremely difficult to accidentally depress the latch. Multiple hard throttle slams were performed to check that the IDLE stop gate had not worn down and on no occasion did the throttle move aft of the IDLE stop. It is conceivable that a pilot might deliberately, albeit subconsciously, depress the latch while reducing the throttle to IDLE and thereby inadvertently shut the engine down. The German Air Force

had two incidents whereby a low-time student pilot inadvertently shut down the engine in this manner. The aircraft manufacturer provides an optional modification that requires the throttle to be retarded to IDLE before the latch becomes effective.

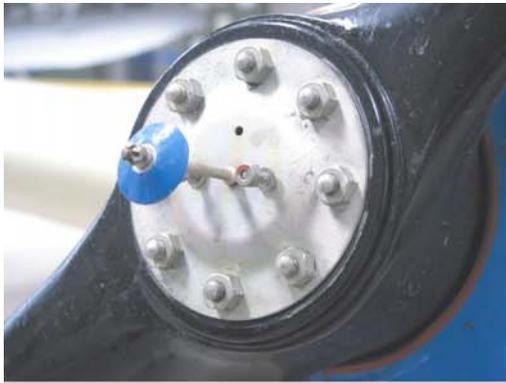
Figure 1a:-
Right propeller installation
(Spinner and lock plate removed)
Note NO Belleville washers

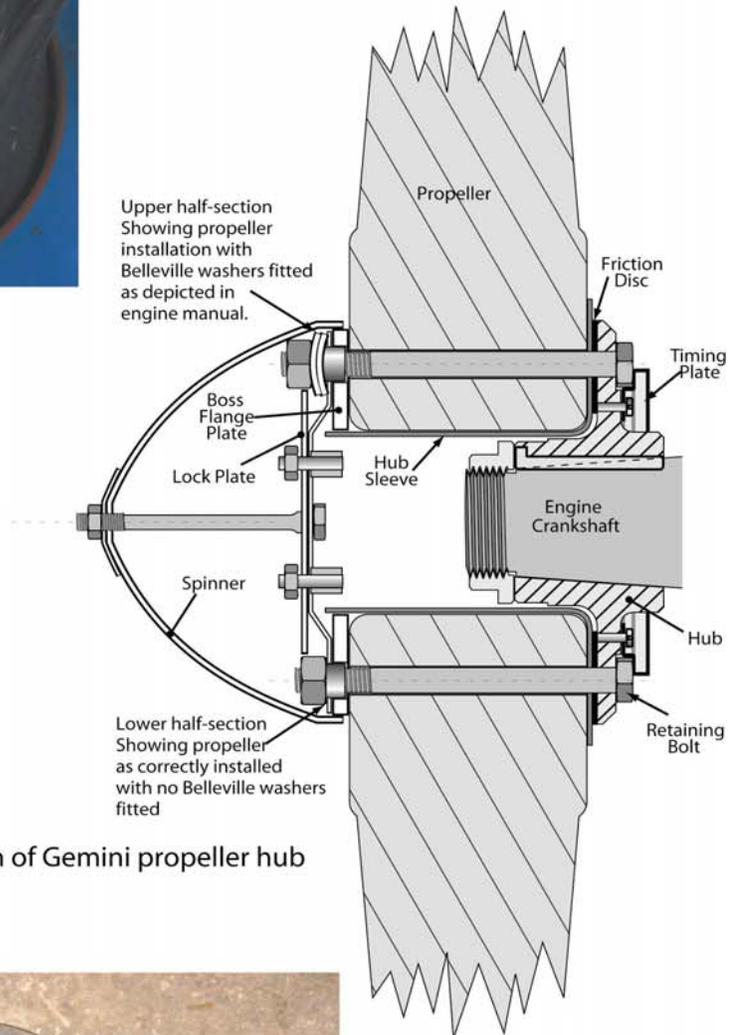
Figure 1:-
Cross section of Gemini propeller hub

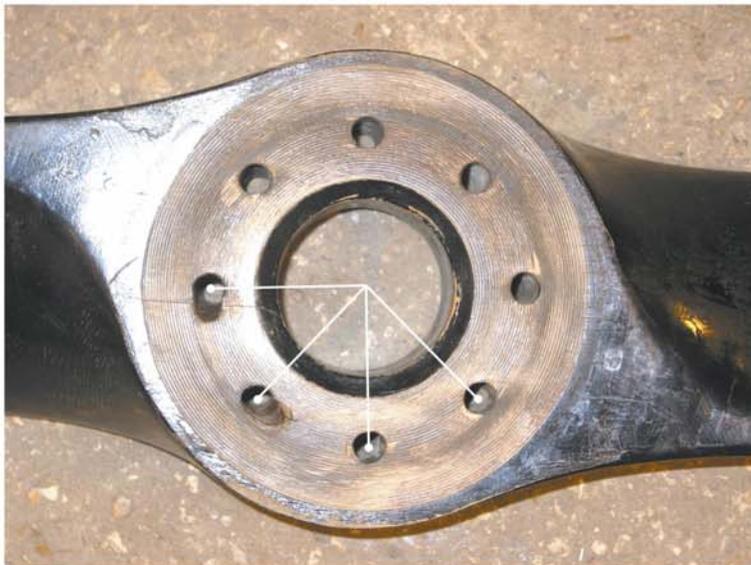
Figure 2:- Aft face of left propeller (note elongated holes)

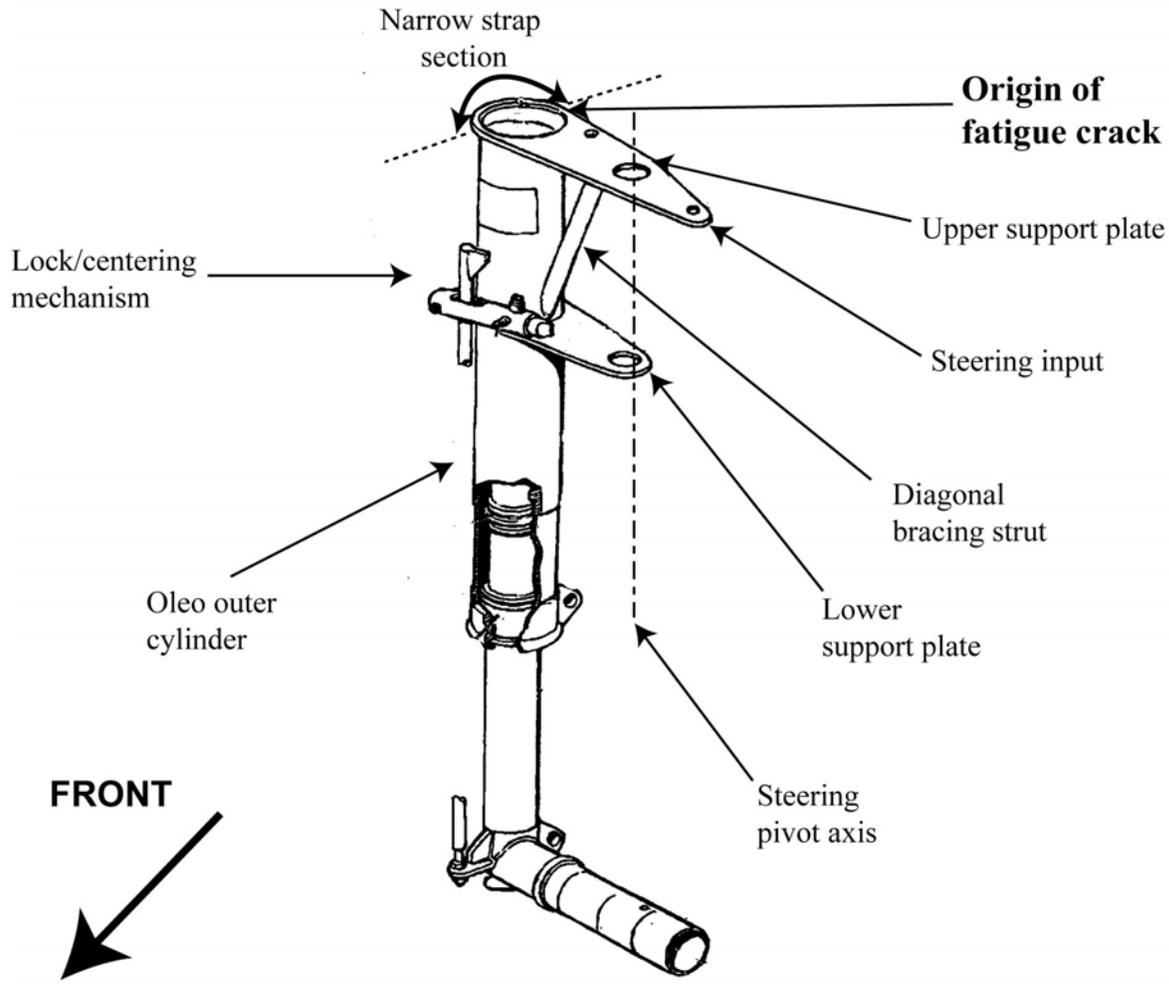
Figure 1 Robin DR400 NLG showing fatigue crack location

It is recommended that the Director Generale de L'Aviation Civile (DGAC), France assess the standard of welding made by Apex Aviation to ensure that it meets the European and French requirements and standards for the manufacture of aviation components.
