Aircraft Type and Registration:	Boeing 737-59D, G-BVKC	
No & Type of Engines:	2 CFM56-3C1 turbofan engines	
Year of Manufacture:	1990	
Date & Time (UTC):	21 February 2004 at 2300 hrs	
Location:	Cardiff Airport, Wales	
Type of Flight:	Public Transport (Passenger)	
Persons on Board:	Crew - 6	Passengers - 114
Injuries:	Crew - None	Passengers - N/A
Nature of Damage:	Damage to left main landing gear	
Commander's Licence:	Airline Transport Pilot's Licence	
Commander's Age:	49 years	
Commander's Flying Experience:	8,160 hours (of which 3,800 were on type) Last 90 days - 203 hours Last 28 days - 71 hours	
Information Source:	AAIB Field Investigation

Synopsis

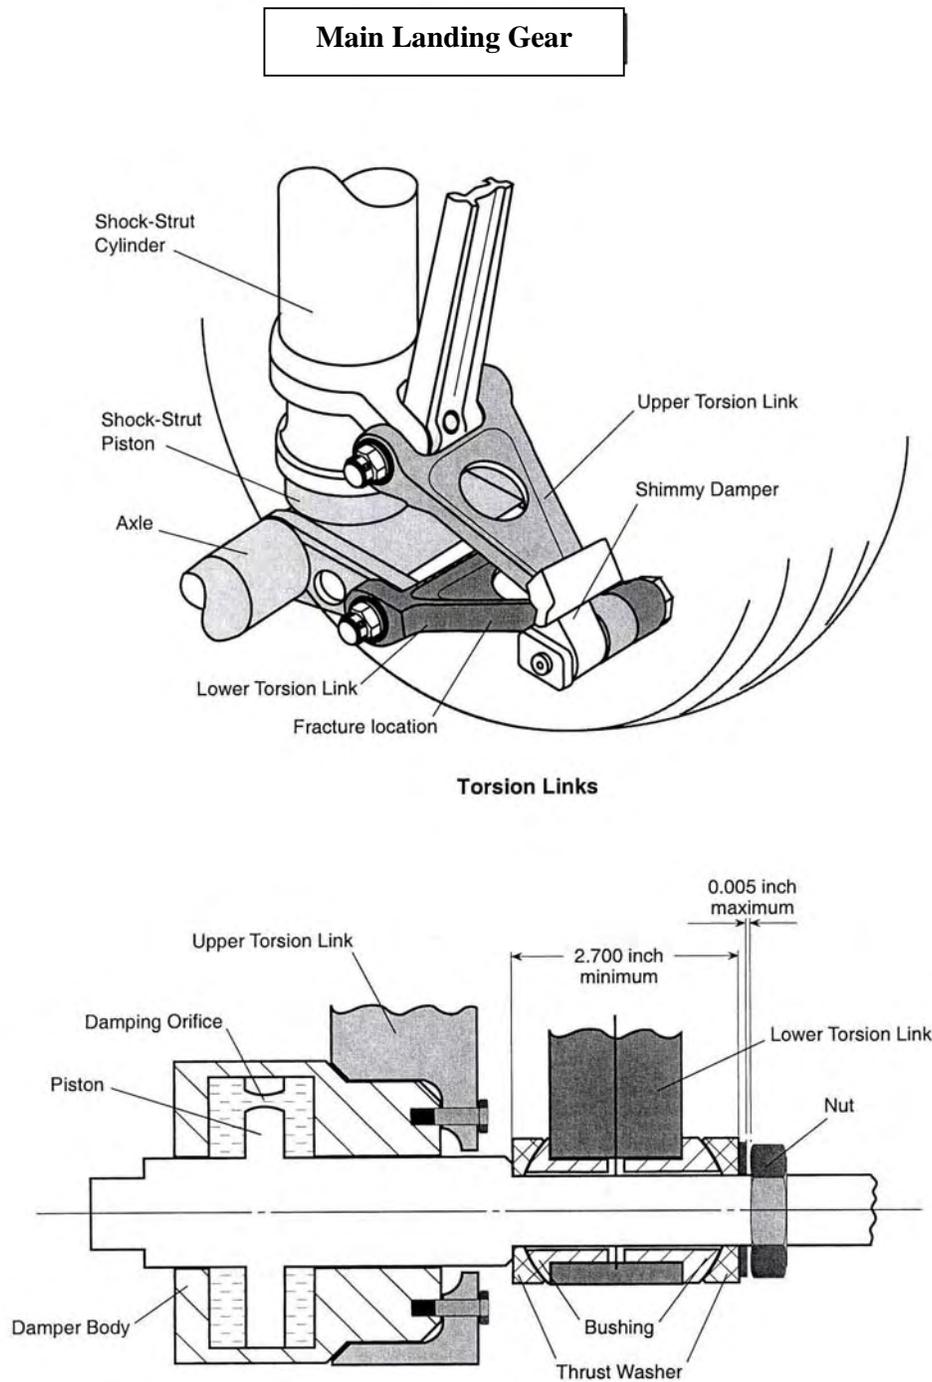
Figure 1

A fluid pressure of 30 to 70 psig is maintained within the damper by a compensator, in conjunction with two check valves. A further check valve allows fluid to enter the damper from the return side of the aircraft's Hydraulic System A to make up for leakage from the damper or to compensate for volume changes associated with temperature variation. Protection from excessive pressure resulting from thermal effects is provided by two relief valves. Air entering the damper during maintenance operations can be released via three bleed plugs.

Shimmy Damper Schematic

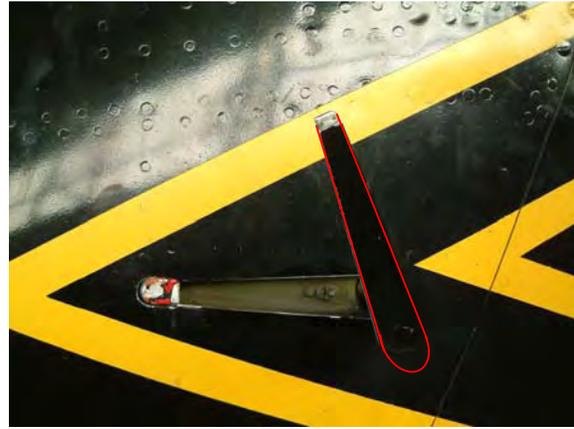
Figure 2

When the canopy is unlocked, the external handle will appear as shown in Figure 2. In order to lock the canopy from outside, the handle must be rotated anti-clockwise, beyond the stowed position. When released it should appear as shown in Figure 3. However, the handle can be stowed, as shown in Figure 4, regardless of whether or not the canopy has been locked. Consequently, visual confirmation that the handle is stowed does not guarantee that the canopy is locked.

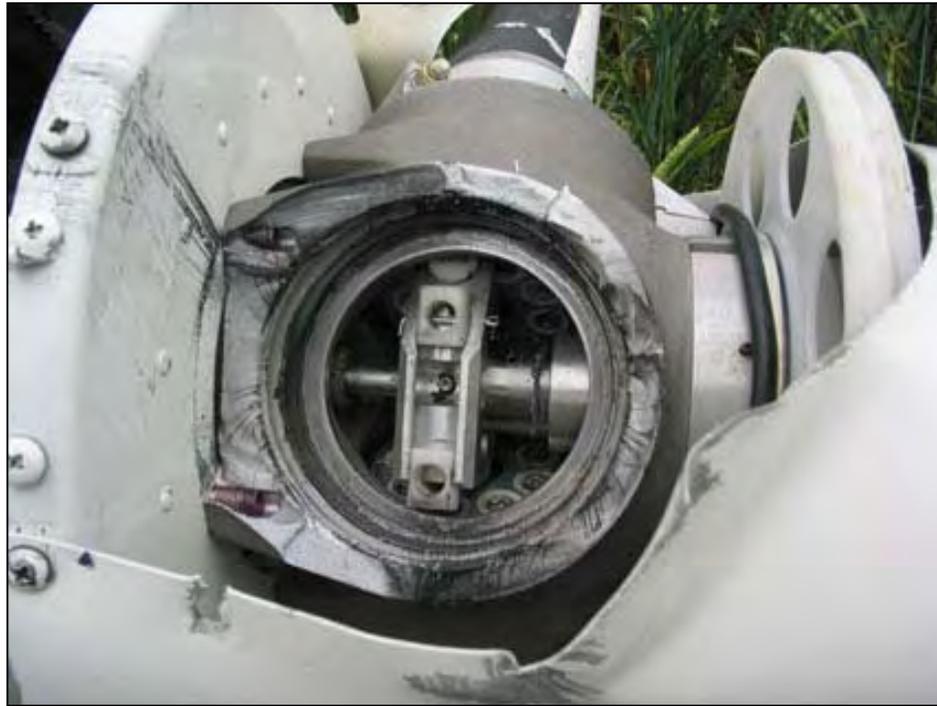
Figure 1

Propeller hub showing fractured No 1 blade socket

It is recommended that Hoffmann Propeller GmbH & Co KG introduce adequate, high confidence level, non-destructive test (NDT) procedures, that will detect cracks in the threads of the type HO-V343K-V/183GY propeller blade sockets during overhaul and whilst in operational service on Grob G 115E aircraft.

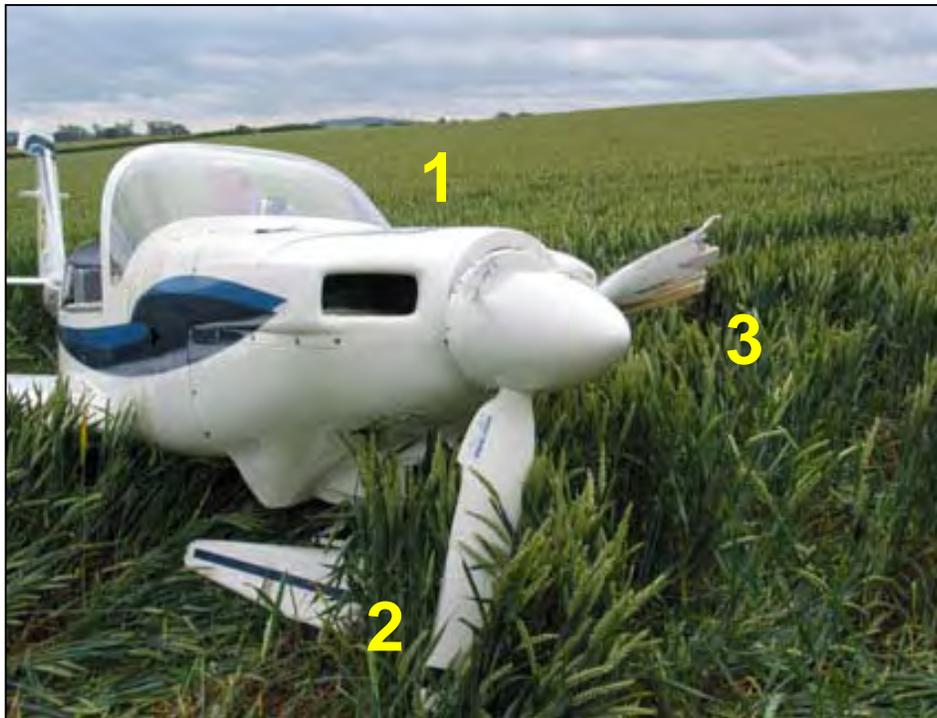
Figure 2

General view of propeller damage (blade locations numbered)

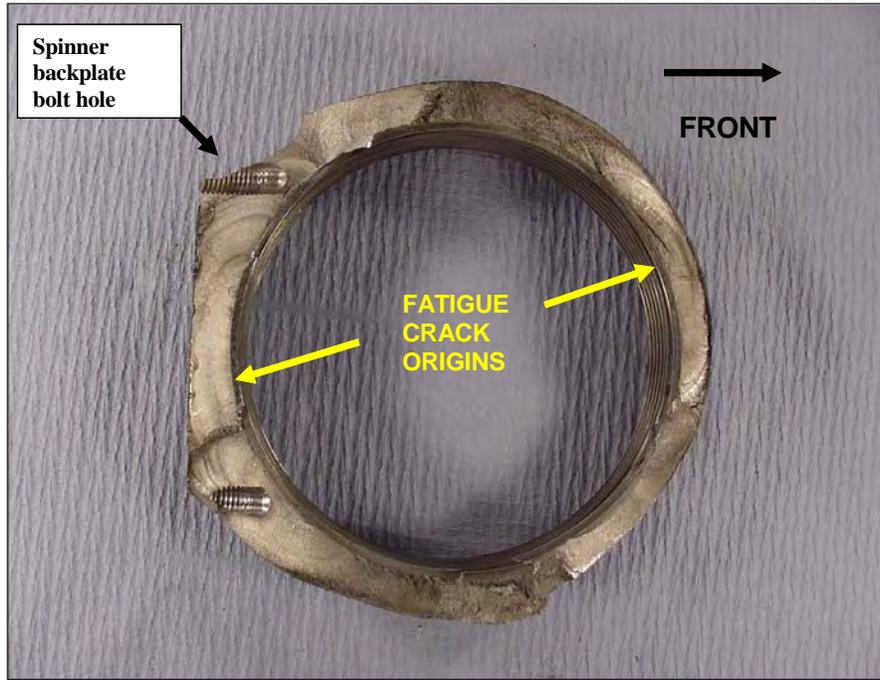
Figure 5

View on underside of separated portion of No 1 blade socket of Hub G22 showing locations of fatigue crack origins

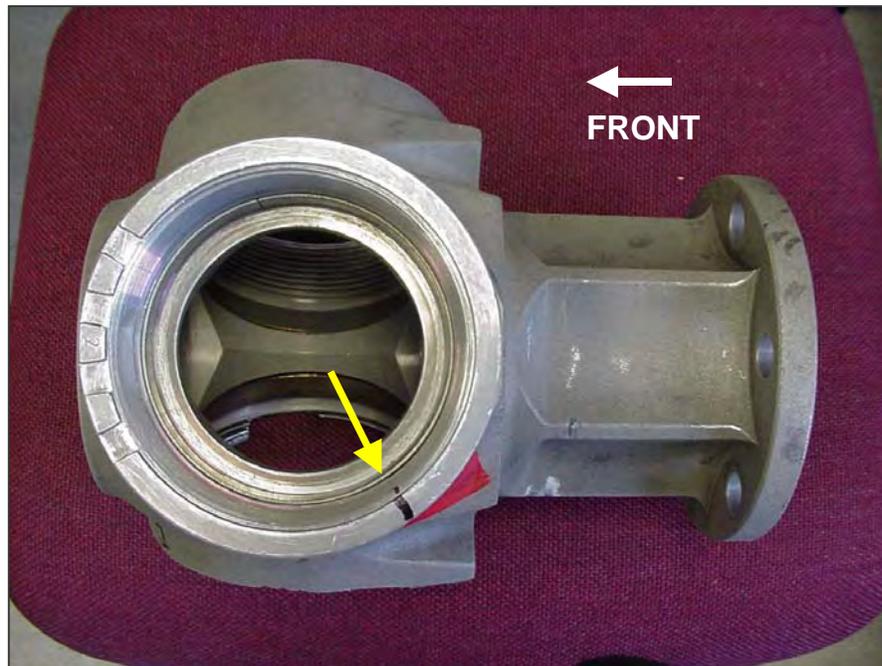
Figure 6

Circumferential location of crack in bottom thread of Hub G22 No 2 blade socket

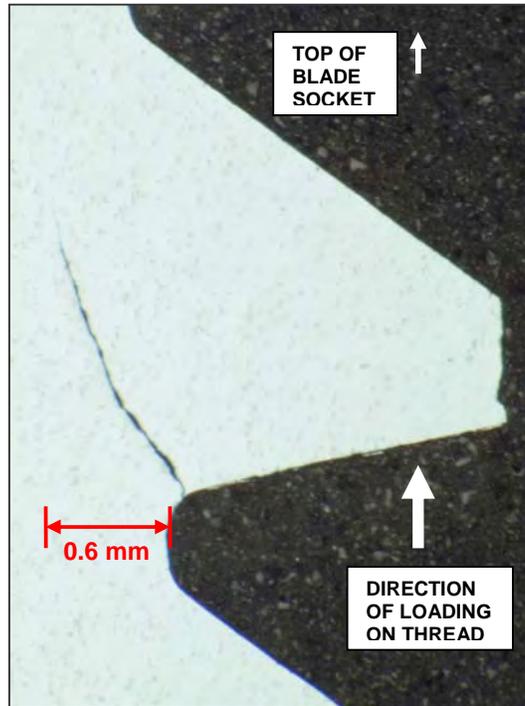
Figure 7

Fatigue crack in bottom thread of Hub G22 No 2 blade socket
(Crack penetration depth approximately 2mm; crack detected using 2 MHz eddy current procedure)

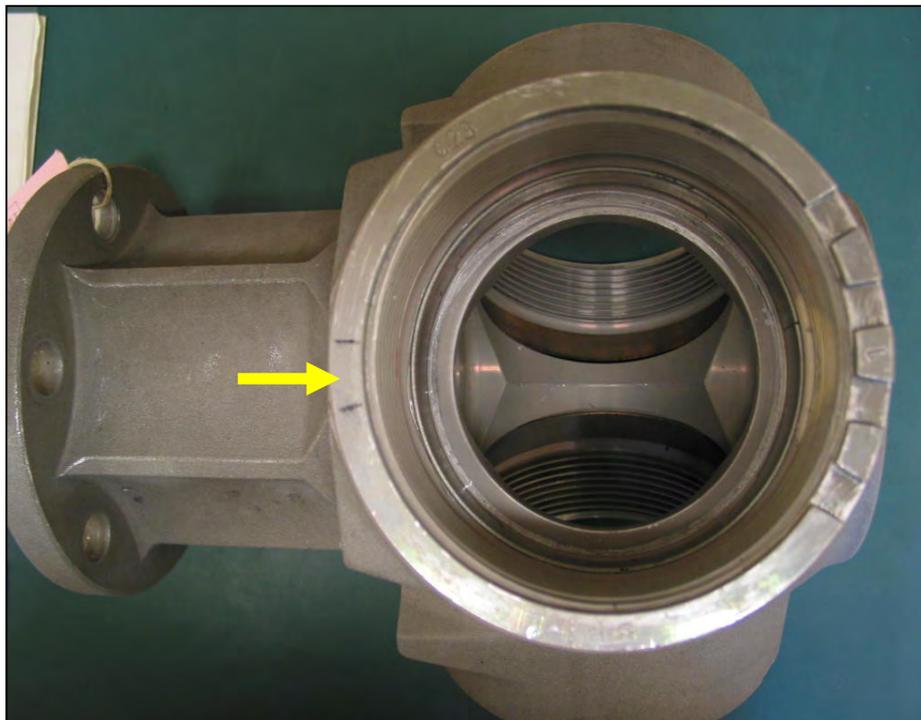
Figure 8

Circumferential location of crack indication in bottom thread of No1 blade socket - Hub G23

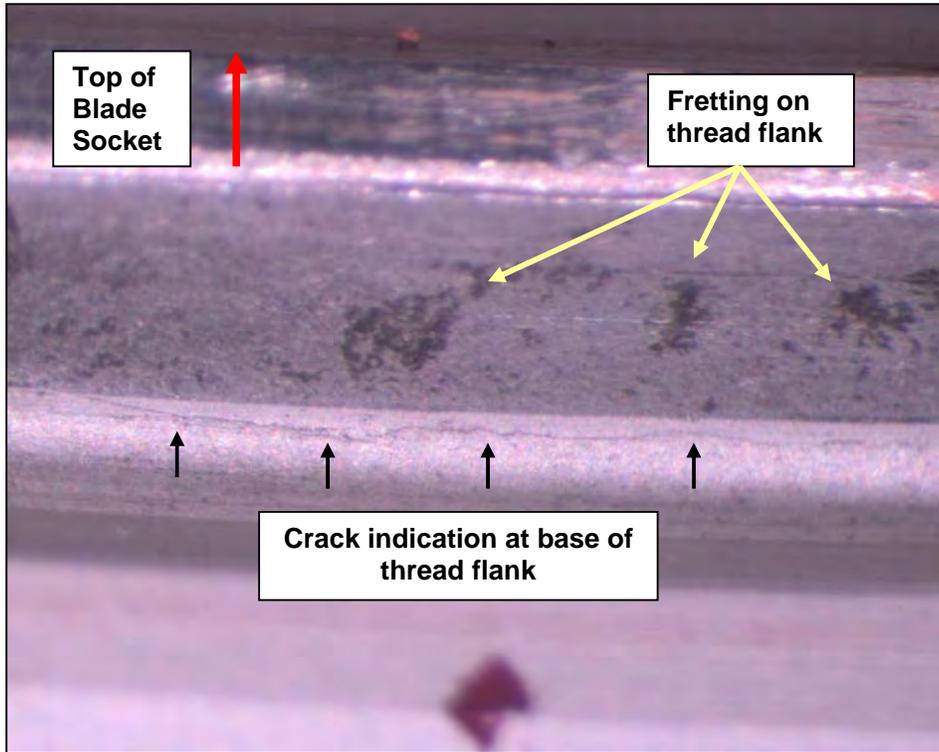
Figure 9

Visual appearance of crack indication - Hub G23

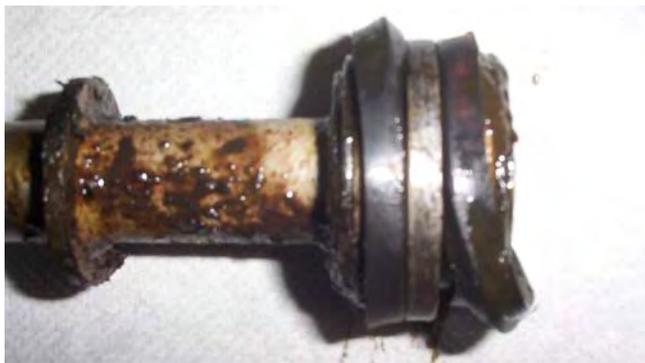
Both main gears collapsed on landing because they were not locked down. The gear did not lock down because there was insufficient pneumatic pressure to extend fully the main gear actuators in flight. The loss of pneumatic pressure was attributed to a leak in the right main gear actuator which was caused by a rolled O-ring seal on the actuator piston.

Figure 3 Rolled O-ring seals found on right main gear actuator piston
