Aircraft Type and Registration:	Boeing 777-236B, G-VIIA	
No & Type of Engines:	2 GE90-85B turbofan engines	
Year of Manufacture:	1997	
Date & Time (UTC):	26 June 2003 at 1000 hrs	
Location:	Near Reigate, Surrey	
Type of Flight:	Public Transport (Passenger)	
Persons on Board:	Crew - 14	Passengers - 272
Injuries:	Crew - None	Passengers - None
Nature of Damage:	Access door detached, cabin windows damaged, minor damage to fuselage and fin	
Commander's Licence:	Airline Transport Pilot's Licence	
Commander's Age:	49 years	
Commander's Flying Experience:	14,750 hours (of which 2,350 were on type) Last 90 days - 190 hours Last 28 days - 36 hours	
Information Source:	AAIB Field Investigation

Synopsis

Aircraft Type and Registration:	McDonnell Douglas DC-8-63F, 9G-MKO
No & Type of Engines:	4 Pratt & Whitney JT3D-7 turbofan engines
Year of Manufacture:	1971
Date & Time (UTC):	29 April 2003 at 1500 hrs
Location:	RAF Lyneham, Wiltshire
Type of Flight:	Public Transport (Cargo)
Persons on Board:	Crew - 4 Passengers - None
Injuries:	Crew - None Passengers - N/A
Nature of Damage:	Right main landing gear fractured
Commander's Licence:	Airline Transport Pilot's Licence
Commander's Age:	43 years
Comm

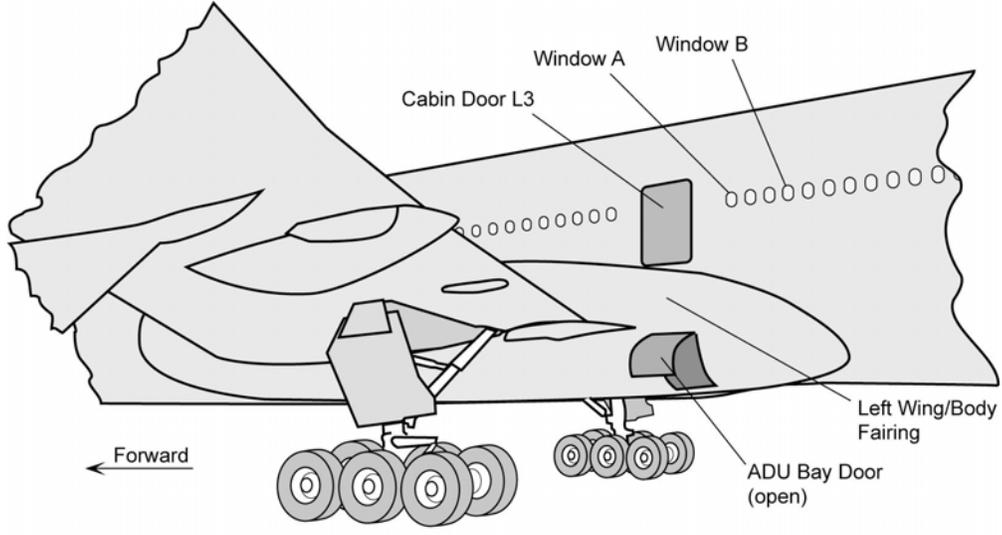
Figure 1

A portion of carbon-fibre laminate approximately 3 x 6 inch in size was found at the fourth window ('Window B', Figure 1) embedded between the window unit seal and the aft upper corner of the fuselage window aperture. This piece, identified as the outer skin of the aft lower corner of the ADU bay door (Piece 6, Figure 3), protruded partially into the cabin at Seat Row 29. The outer pane of Window B exhibited heavy scrape marks terminating in an approximately 3.5 x 0.7 inch irregular penetration hole, with associated local fracturing of the pane. The damage profile and paint deposits

It was evident that G-VIIA's ADU bay door had opened violently as the aircraft was accelerating and climbing towards 6,000 feet amsl. Over-rotation of the door had caused its three hinges to fracture and the door to detach and fracture. Corners of the door skin had snagged on the edge of the window

Air driven unit access door location

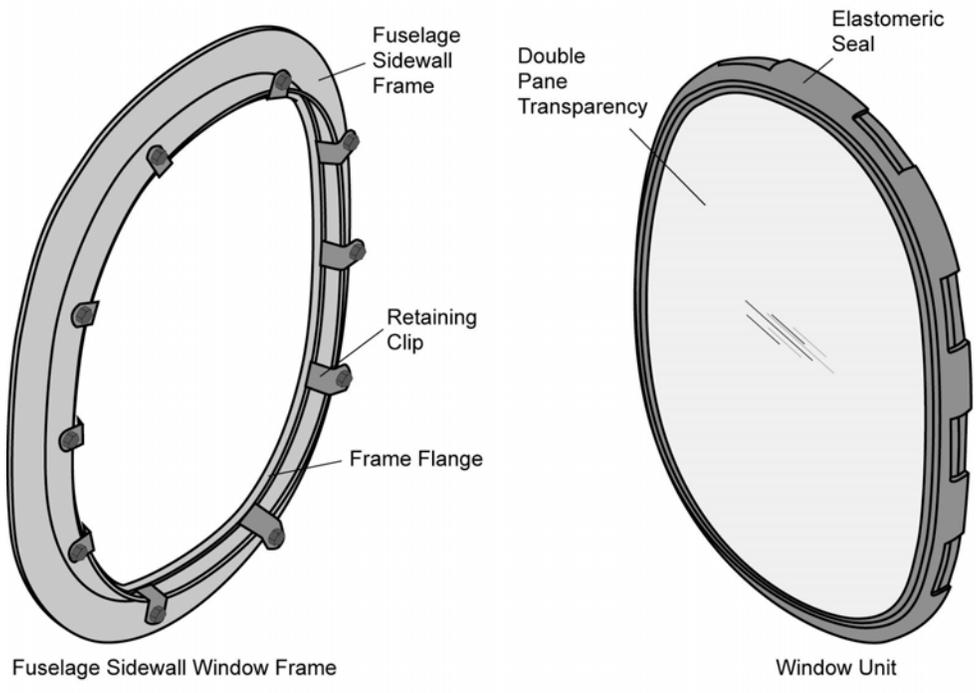
Figure 2

frame at Windows A and B as the door slid up the side of the fuselage and been driven between the frame and the window unit. This had allowed small parts of the door skin to enter the cabin and caused minor displacement of the cabin trim.

The window unit displacement was unsurprising as the fastening arrangement did not appear to be particularly robust, consistent with the lack of a design requirement for the fasteners to normally withstand substantial inward forces. The usual forces on the window unit are predominately outward-acting cabin differential pressure loads reacted by the frame flange. At the time of the door detachment only a small differential pressure would have been present to assist in reacting the impacts. The slight recessing of the window unit in this condition, together with the effect of the outer pane bevel, may have assisted in the snagging of the door. At greater altitudes a higher differential pressure would be expected both to reduce these effects and to increase the resistance to both window seal and window unit displacement.

Cabin window unit

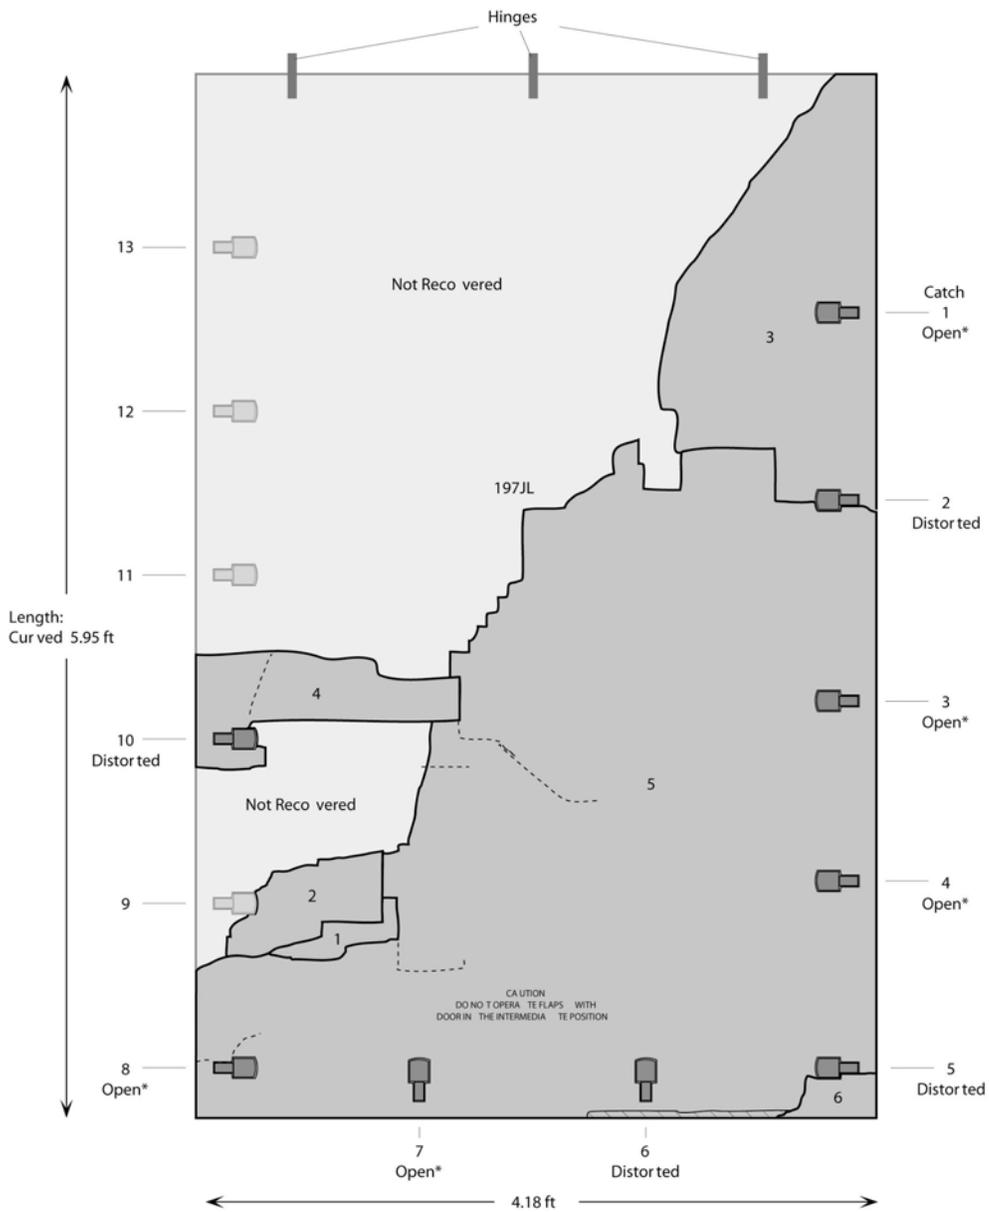
Figure 3

The recovered parts included 9 of the 13 catches. Five of these were found in the open state, with no apparent damage. The other four catches had been distorted. In the case of two of these (Catches 2 and 10) the damage was consistent with the effects of door fractures that passed through their location. Catch 10 also had marks suggesting that some damage had resulted from impact on the protruding latch lever. One (Catch 5) was located immediately adjacent to the door skin piece that had penetrated the cabin at Window B. The evidence suggested that the protruding latch lever of this catch had caused the hole in the window's outer pane and that the catch had been damaged in the process. The remaining distorted catch (Catch 6) had not been in a region of appreciable door damage; the evidence was consistent with it having been damaged by an inward overload applied to the closed latch lever.

The state of the four recovered catches that had been distorted could not be ascertained with certainty from examination but damage to the aircraft indicated that at least two of them (Catches 5 and 10) had been open. The damage to one of the others (Catch 6) was consistent with the effects of overload while the catch had been fastened. The remainder of the other five recovered catches were found undamaged but open. In addition, as the catches are flush with the door outer surface when closed, the deep regular gouge markings on the fuselage skin indicated that all six of the catches on the forward edge of the door were open. The evidence therefore indicated that 11 of the catches, and possibly all of them except No 6, had been open when the door detached. As examination of the catch mechanism identified no way in which it might spontaneously release, it appeared that 11 or 12 of the 13 catches had been open at the time G-VIIA had left the departure stand and that Catch No 6 had probably been fastened. This conclusion was supported by previous service history.

G-VIIA ADU access door schematic

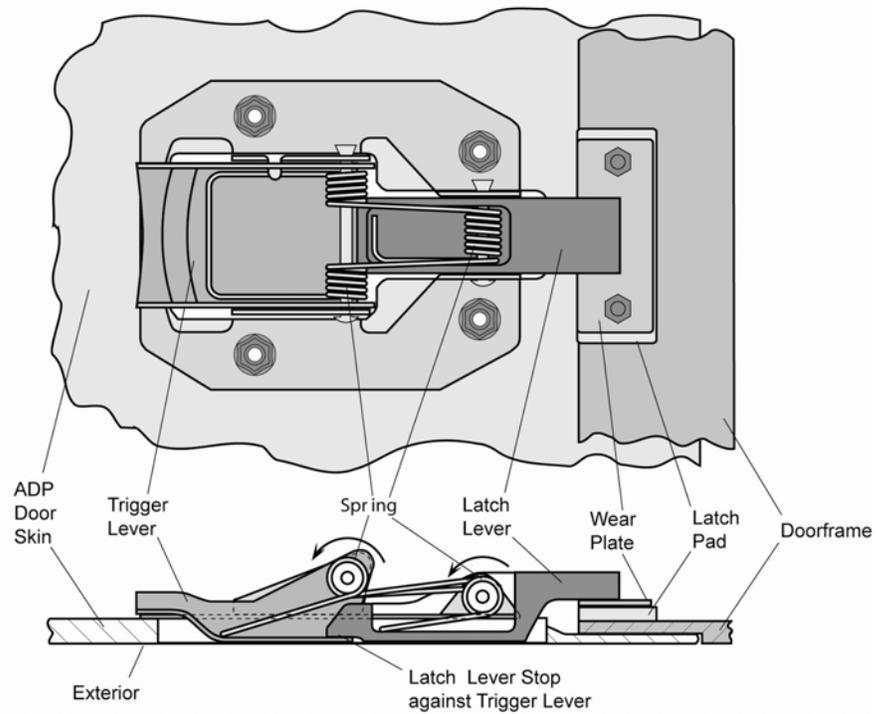
Figure 4

Each catch consists of a mechanism attached to the inner face of the door lip by 4 bolts (Figure 4). Cut-outs in the door skin provide external access to each catch and clearance for it to open. When the catch is closed, a pivoting latch lever bears against a latch pad fixed to the doorframe and fitted with a wear plate. Door adjustment is achieved by fitting different thickness wear plates; those on G-VIIA were between 0.015-0.040 inch thick.

The ADU bay doorframe had not been damaged and all the latch pads were in place and undistorted. Most of the pad wear plates had been severely worn by fretting against the latch lever of the associated catch. Seven of the plates had been completely penetrated and the wear had continued into the respective pads, in one case reducing the pad thickness from 0.112 inch to 0.046 inch, but none of the pads had failed. Within the ADU bay a duct insulation blanket had been disrupted and severely damaged. With this exception, the components in the bay showed no signs of damage.

ADU bay door latch

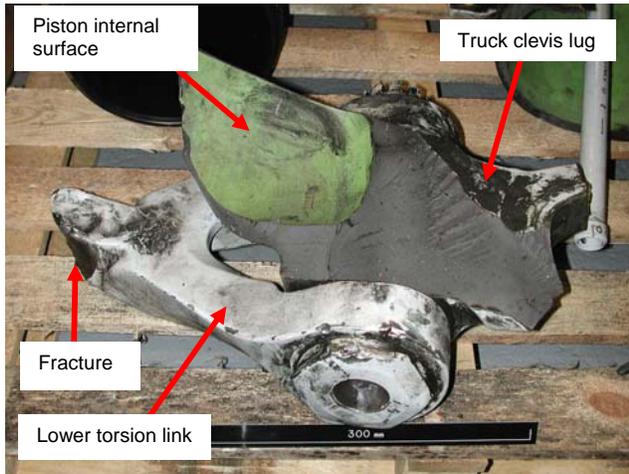
The upper torsion link of the scissor linkage remained intact and connected to the cylinder. The lower torsion link had fractured at the apex pin connecting it with the upper torsion link. At its other end, the lower torsion link remained intact, but the unfractured forward limb of the left truck beam clevis lug had twisted around 40°. Deformation and markings indicated that both the torsion link fracture and the lug twisting had resulted from loads transmitted by the scissor linkage as the cylinder had rotated clockwise relative to the truck beam, as viewed from above.

Part of piston and lower torsion link
Figure 2

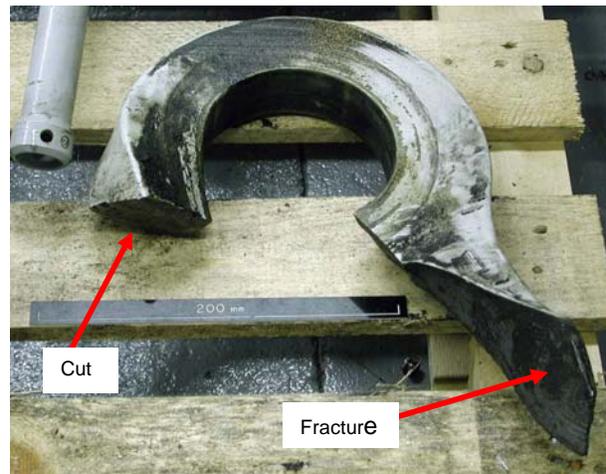
Initial examination revealed that the piston of the right MLG shock-strut had sustained extensive fracturing that had separated the piston into four main pieces and a number of fragments. A generally axial fracture passed through the base of the two lower torsion link clevis lugs and through the aft limb of the left (inboard) truck beam clevis lug (Figures 2 and 3). From this fracture, two fractures extended up the left side-wall of the piston. Around 9 inches from the base of the piston one of the fractures had become generally circumferential, separating the lower part of the piston into two pieces, detached from the remainder of the piston, with each piece including one of the truck beam clevis lugs.

Truck clevis left lug
Figure 3

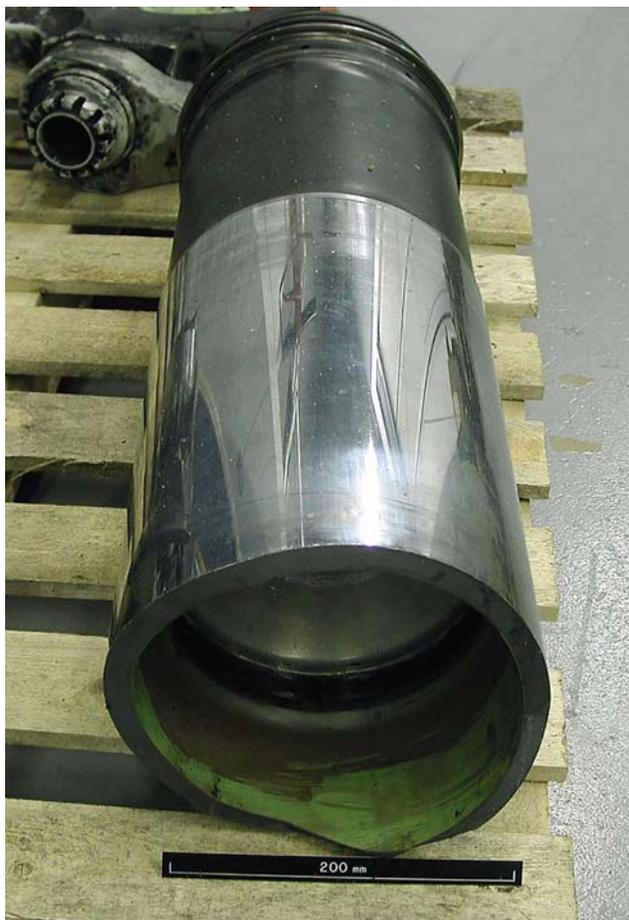
The right hand piston piece remained jammed into the cylinder and continued to support the aircraft weight. The smaller piston piece, on the left side, remained attached to the lower torsion link. Further fractures extended up the piston (Figures 4 and 5) beyond the circumferential fracture and separated an additional 6 inch length of the piston, which also remained in situ.

Piston upper part
Figure 4

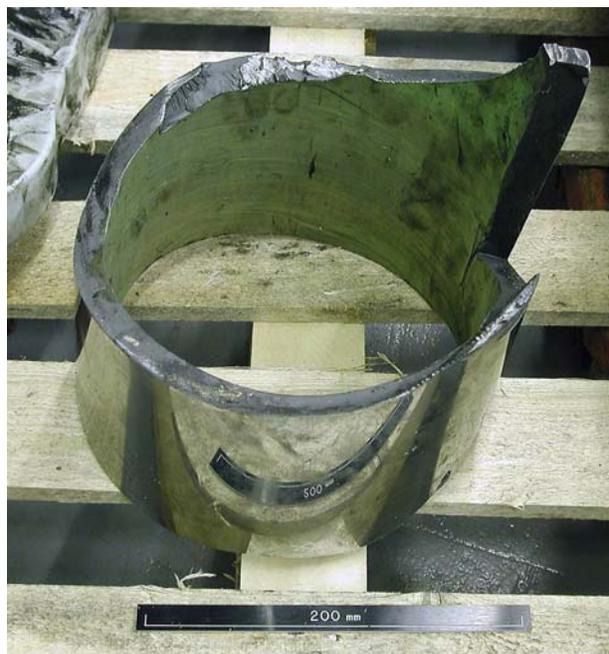
Separated portion of piston
Figure 5

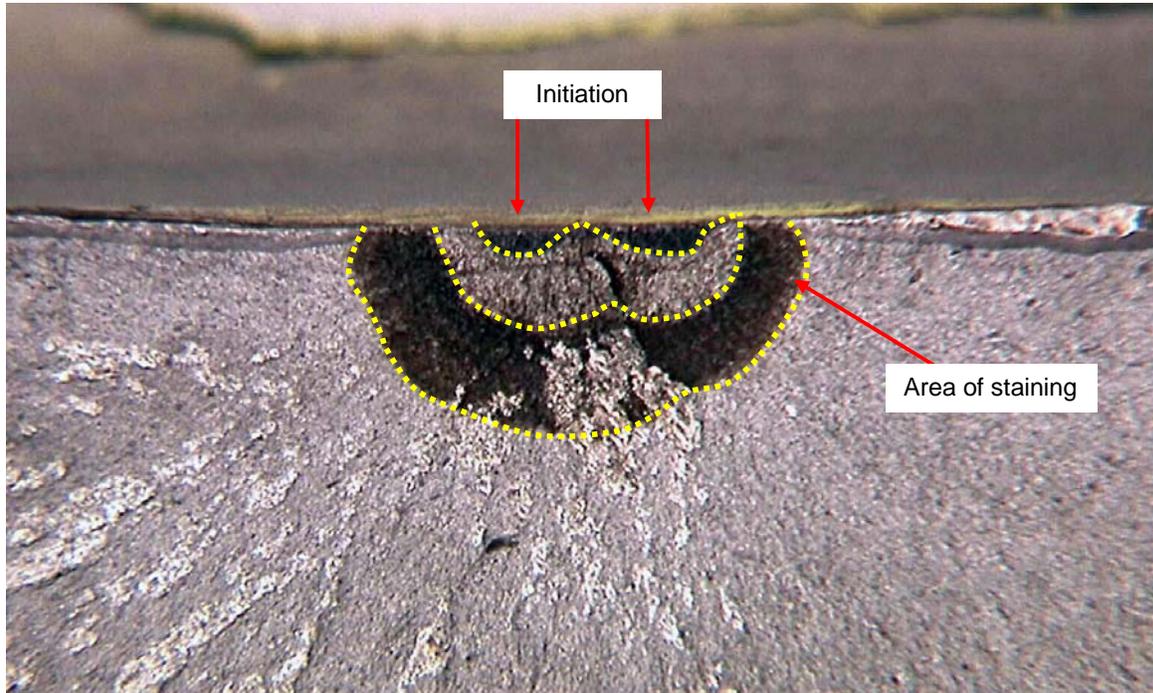
Detailed examination of the suspected region of the fracture origin revealed an area of staining approximately 5 mm (0.197 inches) across and 2 mm (0.078 inches) deep at the edge of the fracture (Figure 6). Examination by scanning electron microscopy showed that the fracture surface outside of the stained region exhibited ductile dimples, characteristic of static overload failure. Within the stained region, crack branching and corrosion product deposits were evident on the surface and the fracture surface had a more intergranular morphology, characteristic of stress corrosion cracking.

The origin area showed signs of three distinct discoloration bands, with evidence that the initial crack had originated at two points (heavily stained areas). The markings indicated that these cracks had combined into a single crack, which had progressed over an area that was less discoloured and then over a further heavily stained area. There was no clear evidence as to the cause of the banding but it may indicate that the crack had been retarded during its growth for a period, possibly due to a temporary reduction in the stress in the component.

Initial crack
Figure 6

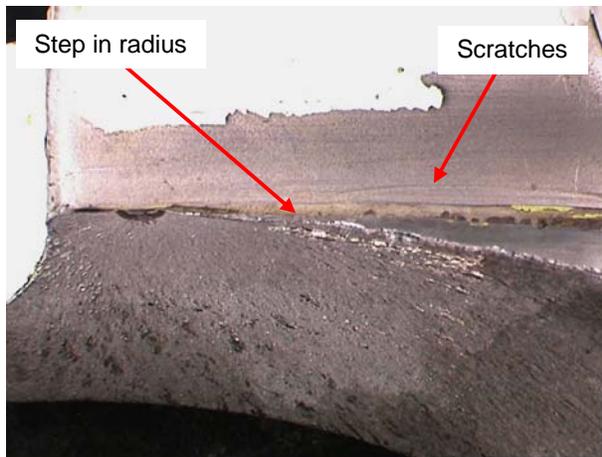
It was apparent from the examination that there was a step in the blend radius in the area of the crack origins and mechanical damage locally that was consistent with machining damage in the region (Figure 7). Additionally, EDX mapping showed that, while cadmium plating was generally present on the surface adjacent to the crack origin, it was absent near the edge of the crack (Figure 8). As cadmium is relatively soft and unlikely to spall off as a result of cracking, if correctly applied, it appeared that it had either not been applied in the area of the crack, had not been applied correctly or had been removed during service.

There were no signs that the step and the scratches could have been formed in service and it appeared likely that they had resulted from machining operations during overhaul of the piston, possibly when the chromium plating on the associated lug had been replaced. The reason for the local absence of cadmium plating could not be established but did not appear to have been due to wear in service. No evidence was available to determine when the features had been formed, but they should have been apparent during the last overhaul of the landing gear.

Lug radius showing step
and poor machining
Figure 7

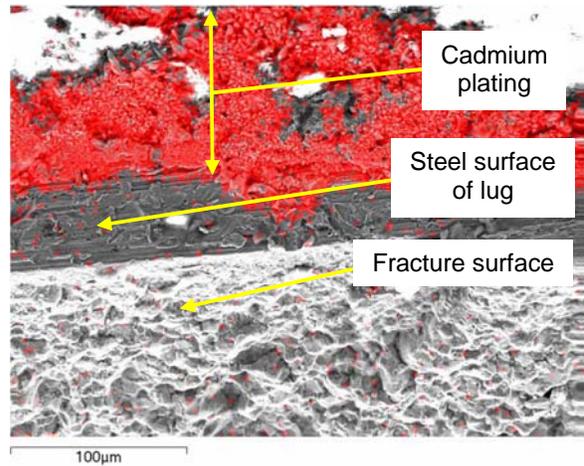
Surface at fracture origin showing cadmium
distribution (red)
Figure 8
