## CONTENTS

## SPECIAL BULLETINS

## COMMERCIAL AIR TRANSPORT

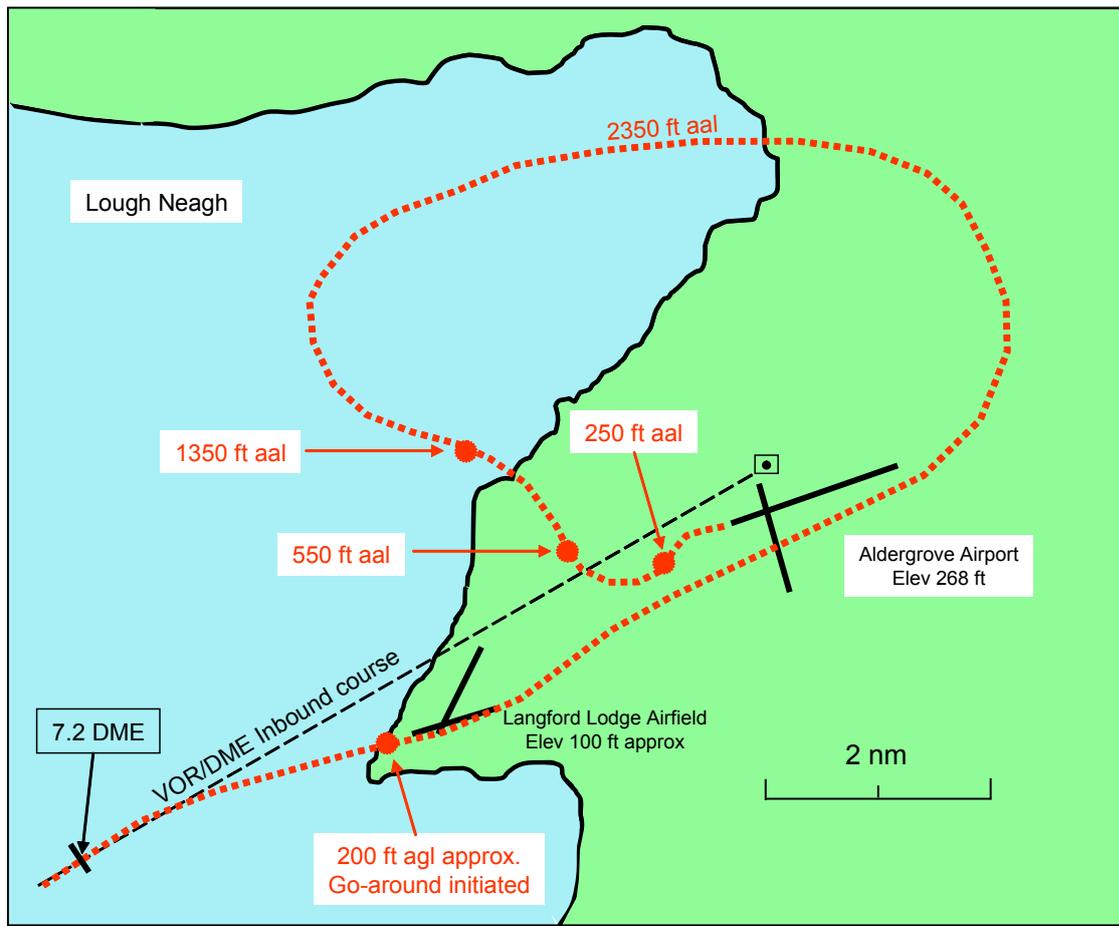
Figure 1

Radar data shows that the aircraft began to deviate to the right of the inbound VOR/DME course at about 2.5 nm from Runway 08 at Langford Lodge, or about 6.5 DME from the VOR/DME (Figure 1). Descent from 2,400 ft had begun at 7.2 DME, which was the correct descent point for the procedure. Mode C information showed the average descent rate to the point of go-around to be about 1,700 ft/min. The vertical profile also showed a gradually increasing rate of descent, with the lower 1,000 ft being flown at an average of approximately 2,000 ft/min. The aircraft took 74 seconds to travel from the final descent point at 7.2 DME to the point of go-around, just short of the runway at Langford Lodge. There are two returns at a minimum altitude of 300 ft amsl, about 200 ft above the airfield level, before the aircraft Mode C indicated a climb.

Radar-derived track and height information

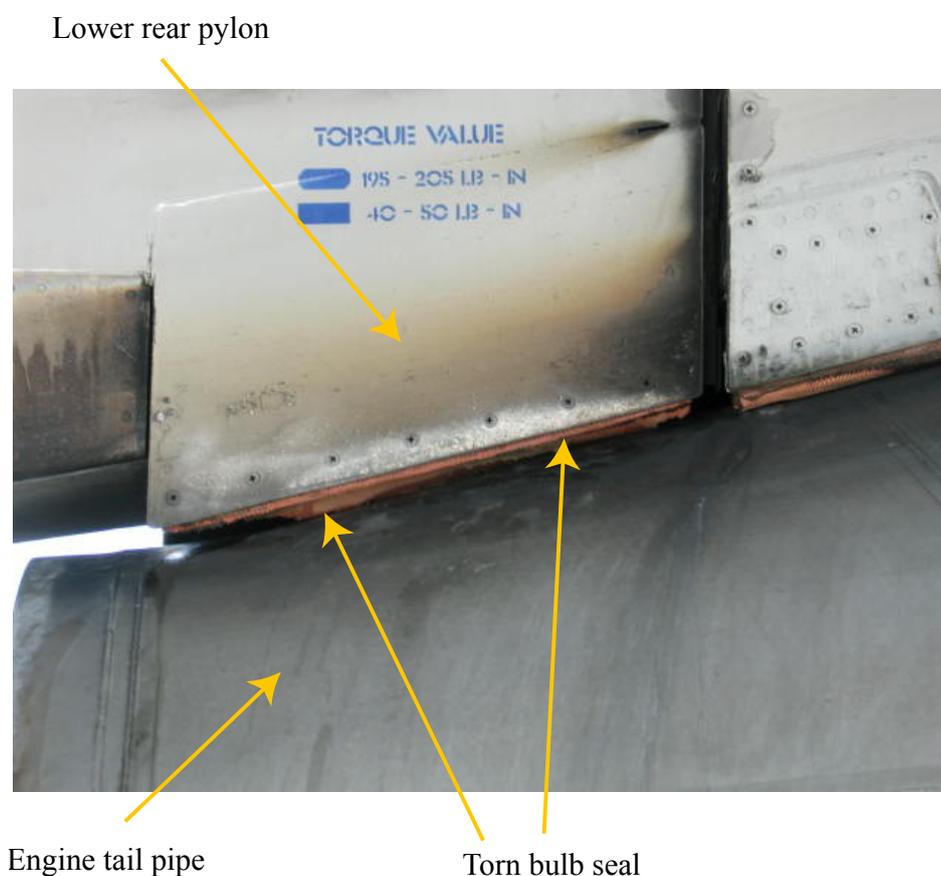
**Figure 1**

Initial examination of the rear lower pylon area did not reveal any evidence of burning or of fluid leaks. The area, both externally and internally, showed evidence of a dark 'sooting' type of staining that was dry and of a long-term nature. There was no evidence of hydraulic fluid loss from the aircraft reservoirs nor a fuel loss or fuel tank imbalance. The aircraft's hydraulic and fuel systems were 'powered up' and no fluid leaks were observed. The No 1 engine was 'motored' with the fuel selected off and on and no fluid leaks were observed. All the pylon panels, including the upper wing panel, and the engine cowls, including the 'C' duct, were opened and no evidence of any fluid leaks was seen.

airport where low and high engine power runs were carried out. During these engine runs no fluid leaks were noted and all flight deck indications were normal. An observer was placed in the seat in the cabin from where the 'cruise' co-pilot observed the flames during the aircraft's descent and he noted that during the full power run the torn bulb seal 'flapped' in the airflow in a way that could very easily be mistaken for a flame. This 'flapping' bulb seal was also seen by ground observers.

damaged pylon tailpipe bulb seals being mistaken by passengers and flight crew members for flames as it fluttered in the air stream.

The FTD article advised operators of Boeing's efforts to find a suitable replacement for the orange/red seal that would be less likely to be mistaken for a flame. In March 2006, Boeing advised operators that a suitable 'brown' coloured replacement part for the orange/red seal had been identified, although production and retrofit incorporation had not yet been scheduled. Boeing recommended that operators inspect the affected area on a periodic basis and replace damaged seals.

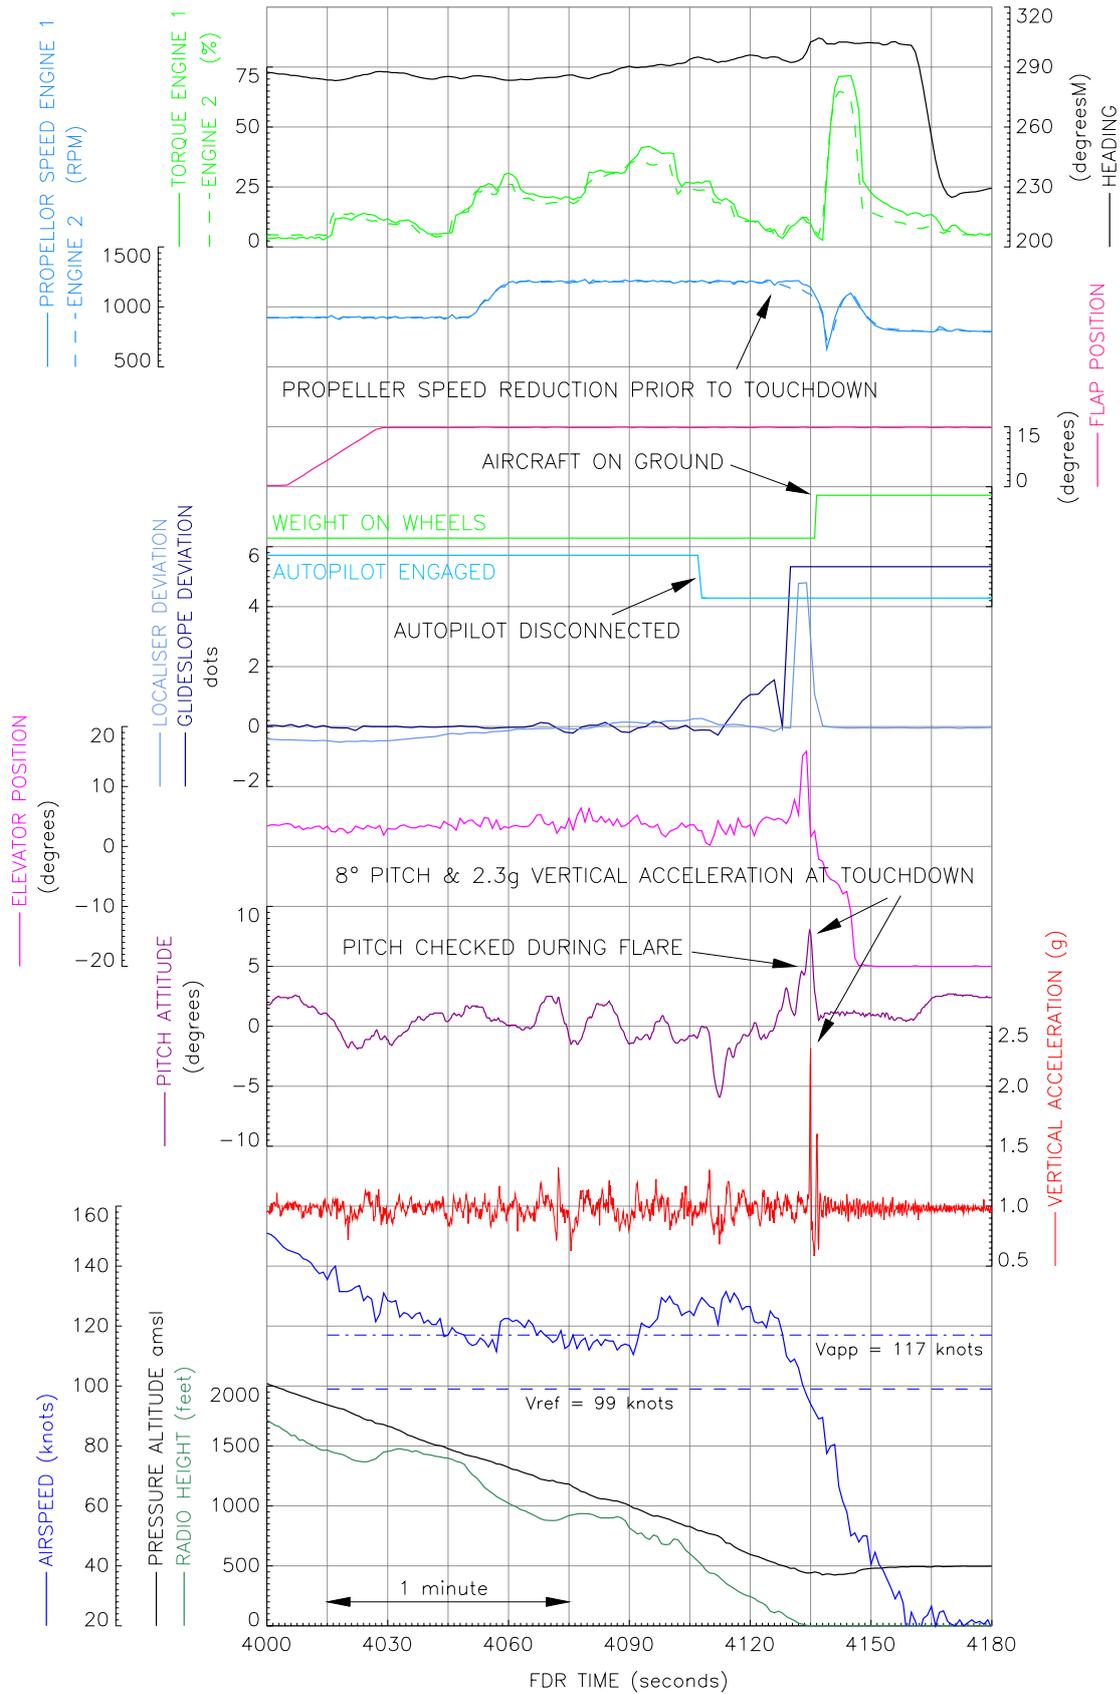
Figure 1

G-WOWC touched down with a maximum recorded pitch attitude of +8° at 94 kt (31 kt below the appropriate  $V_{APP}$  and 13 kt below  $V_{REF}$ ), with a peak vertical acceleration of +2.3g. The nose gear contacted the ground 1.6 seconds later.

Salient FDR Parameters - Approach and Landing

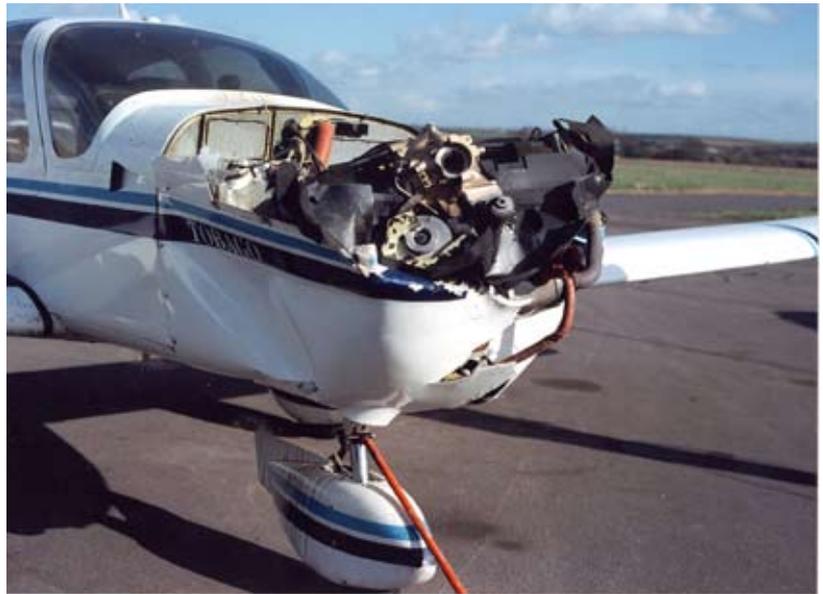
**Figure 1**

Analysis of the photographs provided to the AAIB confirmed that the engine had partly separated from the aircraft structure and had become re-orientated both in plan and in side elevation at angles between 30 and 40 degrees to the normal location (Figure 1). The two-bladed, constant speed propeller had detached and was found, with one blade missing, alongside the runway close to the point at which the aircraft came to a halt. The missing blade was on the other side of the runway closer to the touch-down point. Two depressions in the paved surface indicated where propeller debris had impacted with considerable force.

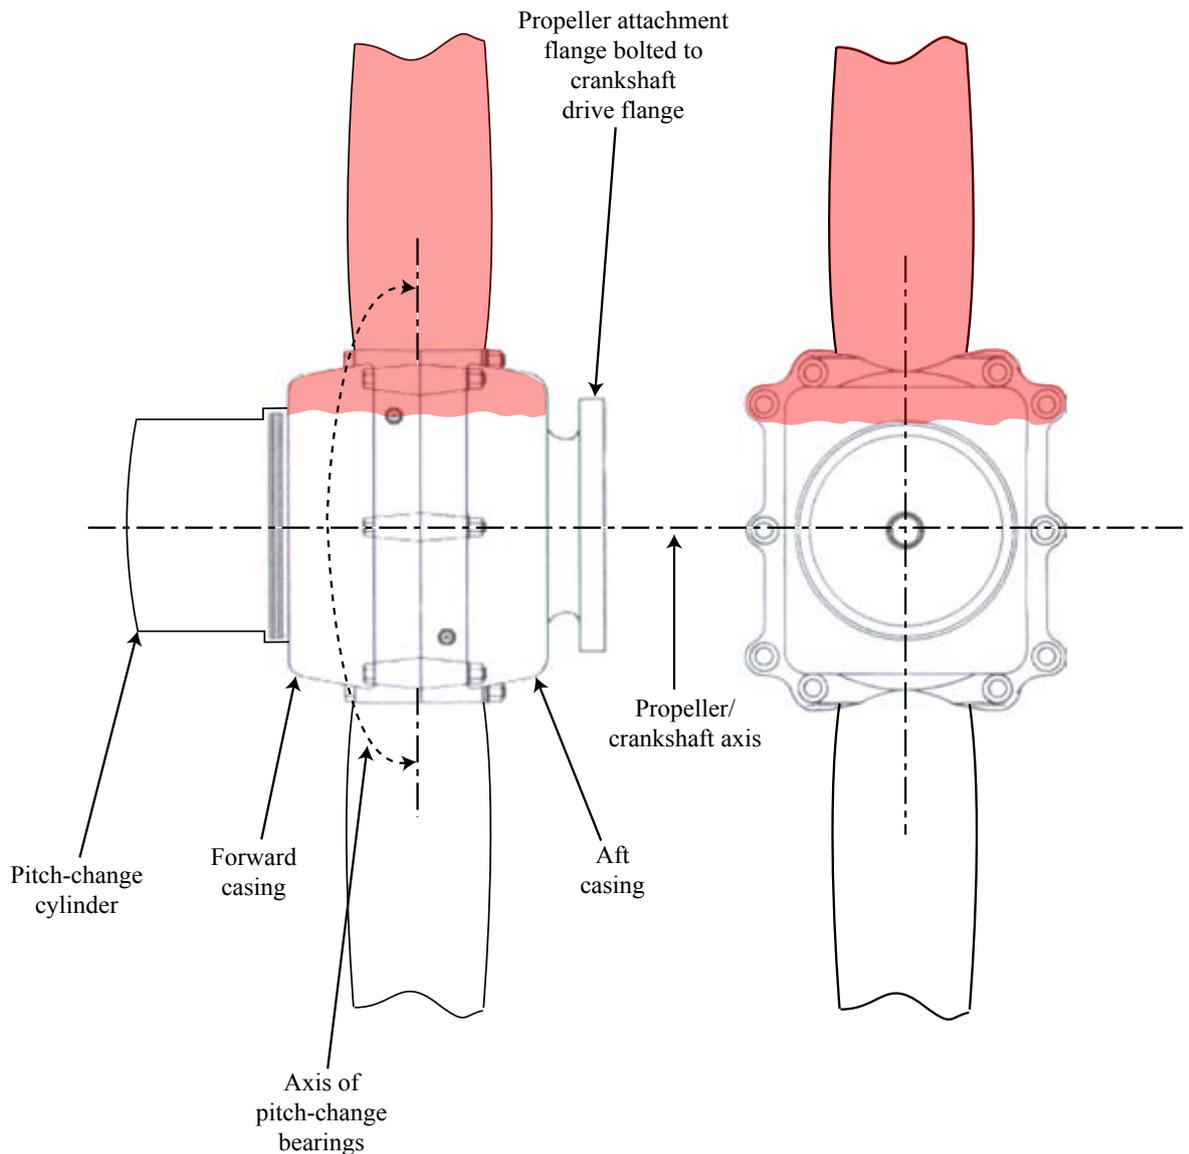
**Figure 2**

Initial metallurgical examination of the fracture faces of the hub indicated that although the fracture of the aft section of the casing appeared to be in simple overload, the forward section had a more complex failure mechanism which included some fatigue.

More detailed examination confirmed that a crack, circumferential to the blade root, had propagated from several closely spaced locations on the inside surface of the hub forward casing. An axial fatigue fracture had also propagated from the outer corner of the blade

Schematic view of propeller hub with separated portion shown in orange

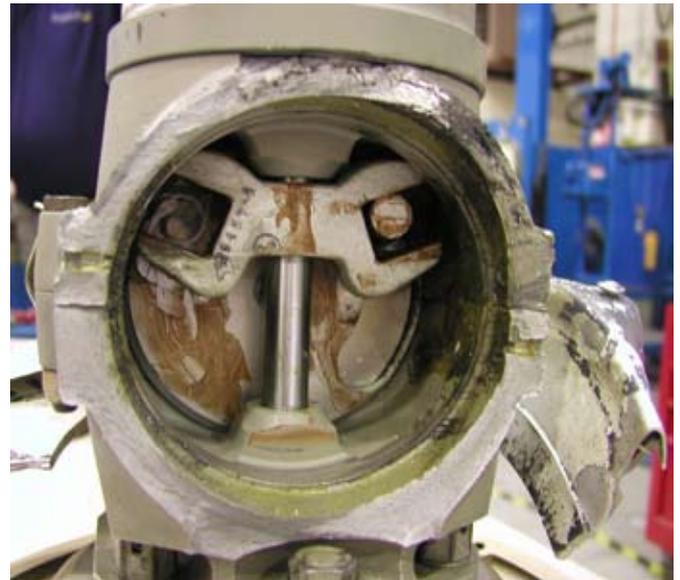
**Figure 3**

The similarity of the position of the unusual fracture face on the hub to the area highlighted in the Manufacturer's Service Bulletin, as well as the absence of grease from the pitch-change bearing of the separated blade, strongly suggested that the failure was of the type which the Service Bulletin was intended to address. The absence of an Airworthiness Directive on the subject had inhibited

Hub fracture faces

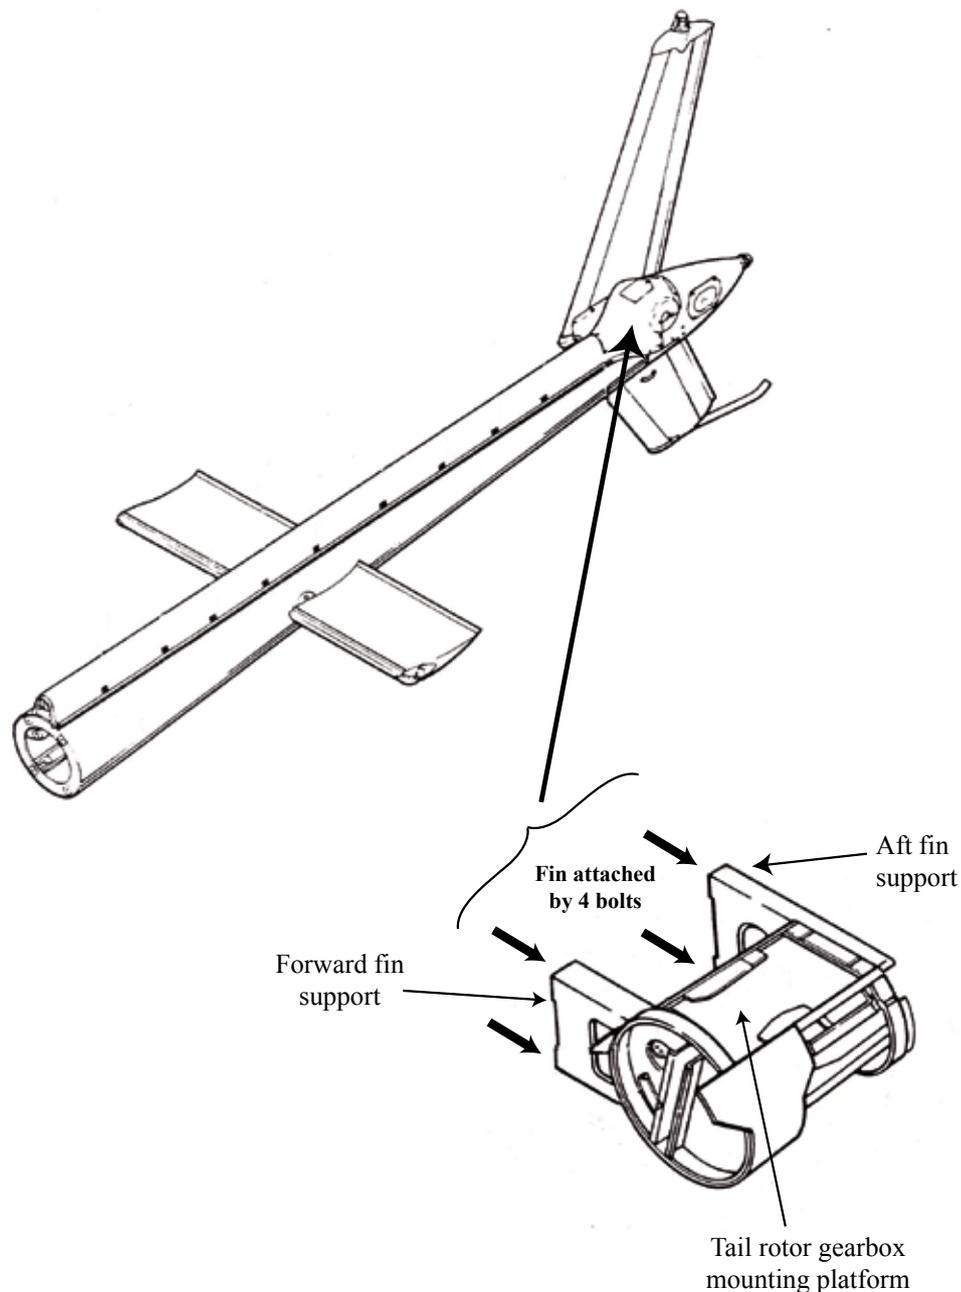
**Figure 1**

The riveted and bolted attachments of the rear and front supports on the tail boom respectively were found to be secure. The rear support had the number 206-031-418-1

Tail boom and fin support

stamped on it, which was one of several part numbers listed in the Illustrated Parts Breakdown (IPB) for this component. However it was specified for use on tail booms with the part number 206-031-426-001 (as opposed to 206-031-004-71B, the subject tail boom). The front support had no number on it; the appropriate part number in the IPB was 206-031-417-003 or -007.

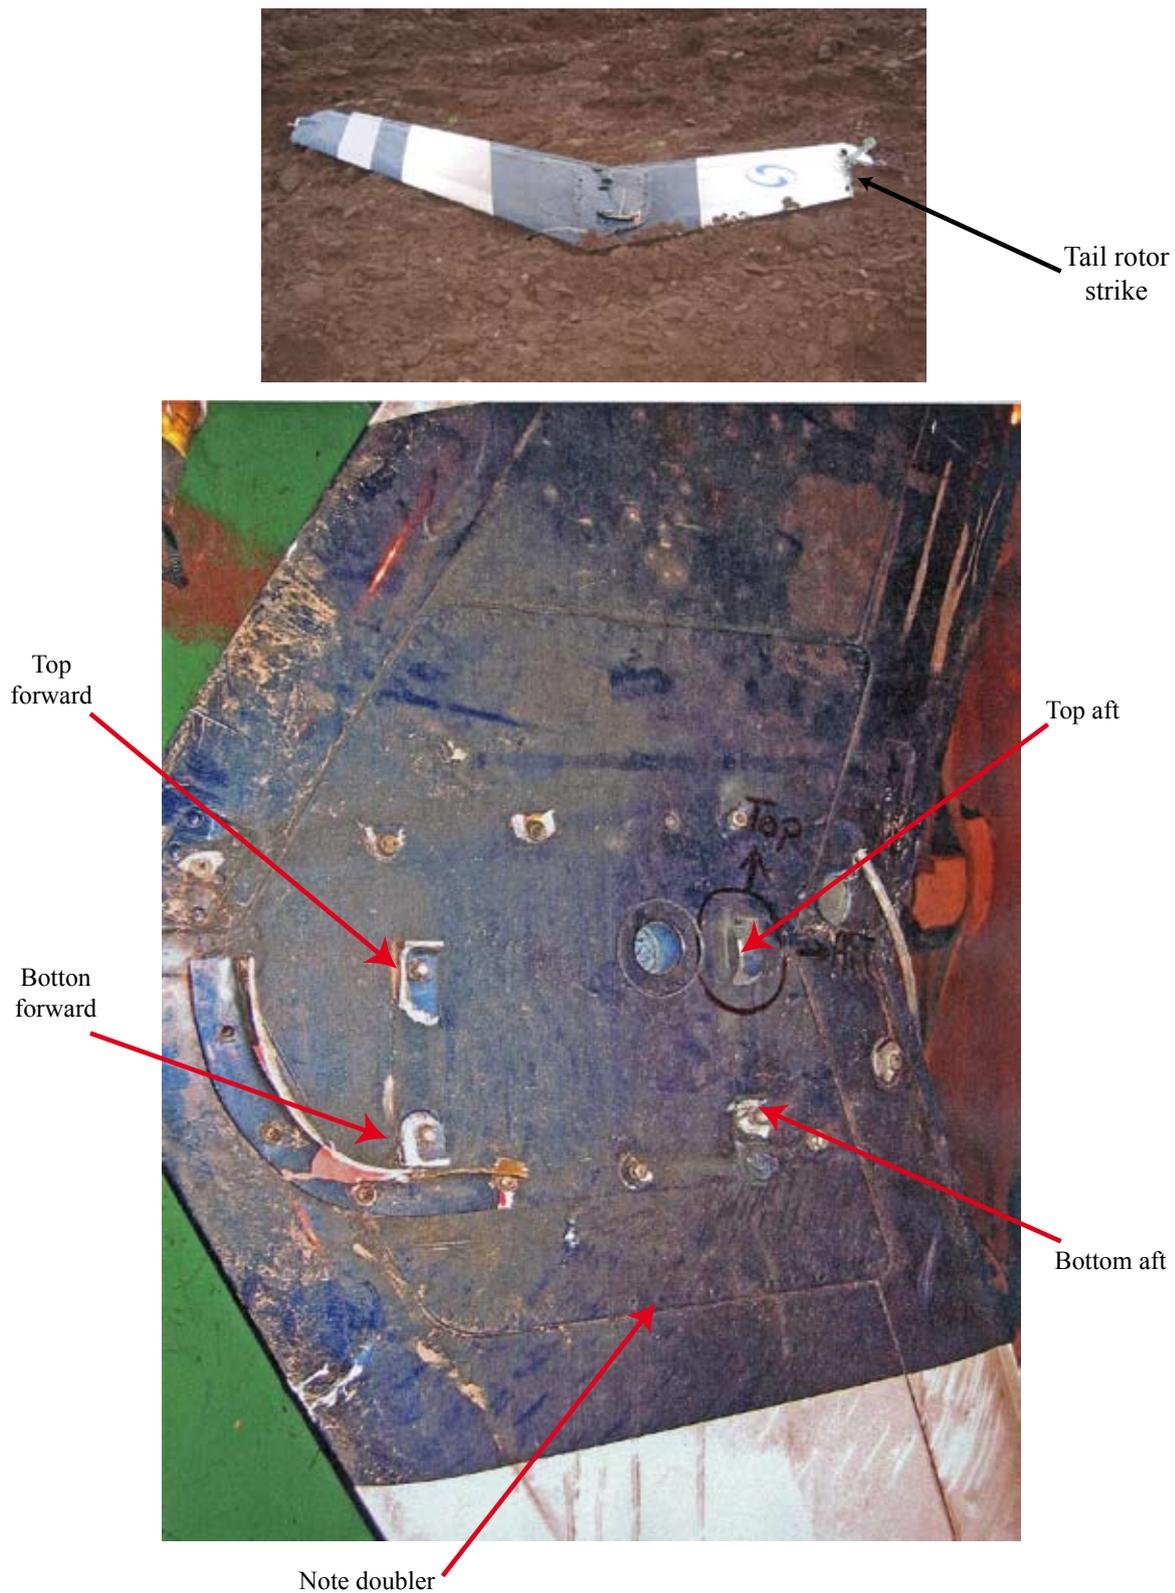
**Figure 2**  
Views of inboard surface fin showing attached portions of fin supports

The vertical fin bore no part number, but there was a log book certificate that stated: ‘...*unserviceable fin replaced with P/N 206-020-113-011*’, dated 3 August 1990. This was found listed in an old IPB, although the current version lists only -005, -007, -009, -107, and -109. It can be seen from Figure 2 that the inboard skin had been reinforced with a doubler. This was the result

of complying with Bell Service Letter 206-203, dated December 1972, which was introduced following an in-service problem of cracks developing in the fin. Later fins were manufactured with a strengthened central area, dispensing with the need for a doubler.

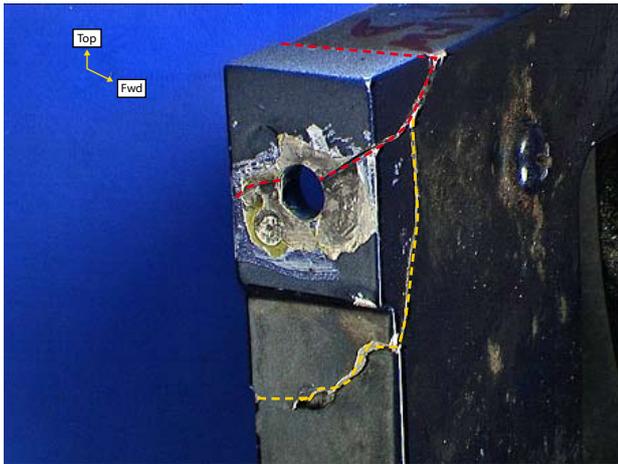
**Figure 3***Photo: QinetiQ*

Top forward attachment

those that passed through the holes, with the others being secondary. For example, in Figure 3, the 'yellow' crack in the top forward attachment can be seen branching off from the primary 'red' crack on the front face of the forging. Consideration of all the fractures led to the sequence of the attachment failures being established as: top aft, top forward, bottom aft and bottom forward.

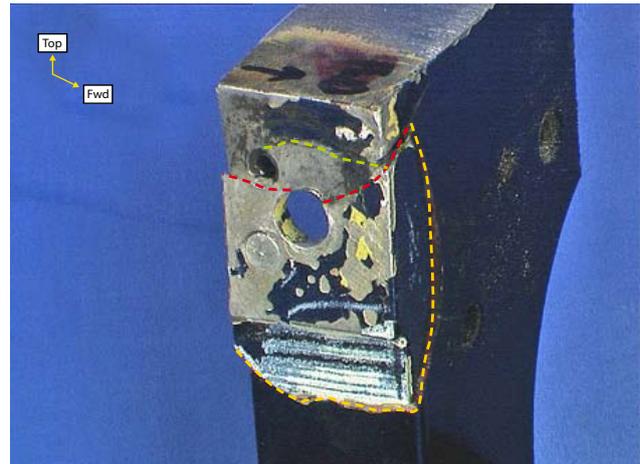
**Figure 4***Photo: QinetiQ*

The majority of the undamaged crack lengths in the upper attachments were due to fatigue, whereas the fractures in the bottom sections had smaller fatigue cracks in the bolt and rivet holes and larger areas of overload failure. Significantly, the cracks passed through the bolt holes at all four attachments, with origins visible on opposite sides of the outboard surface of the bore of the top forward attachment. It can also be seen from Figures 3 to 6 that, on the other attachments, the cracks passed through one of the rivet holes in each case, with origins occurring on opposite sides of the bore in the top aft attachment.

Top aft attachment

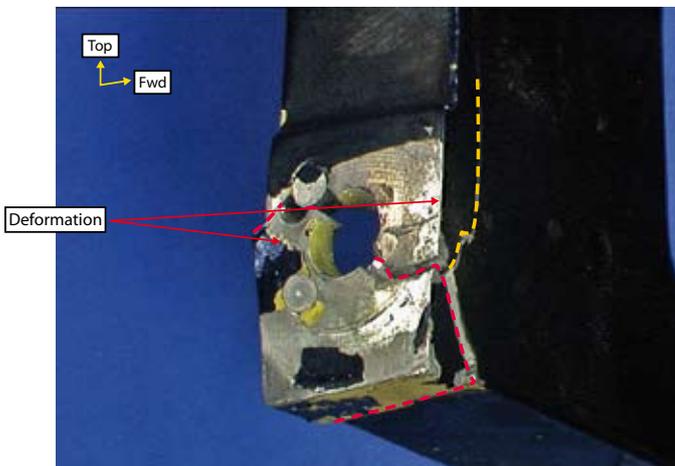
**Figure 5***Photo: QinetiQ*

The Maintenance Manual specifies assembly torque values of 50-70 lbf.in. It should be noted that the bolt in the bottom forward attachment was found to be slightly bent; any structural joint in which plastic deformation has occurred is likely to have lost the torque figure set on assembly, thus the 15 lbf.in value was not considered reliable.

Bottom forward attachment

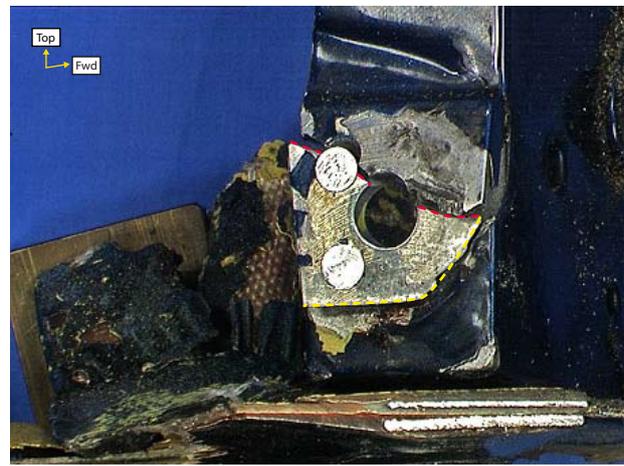
**Figure 6***Photo: QinetiQ*

Bottom aft attachment

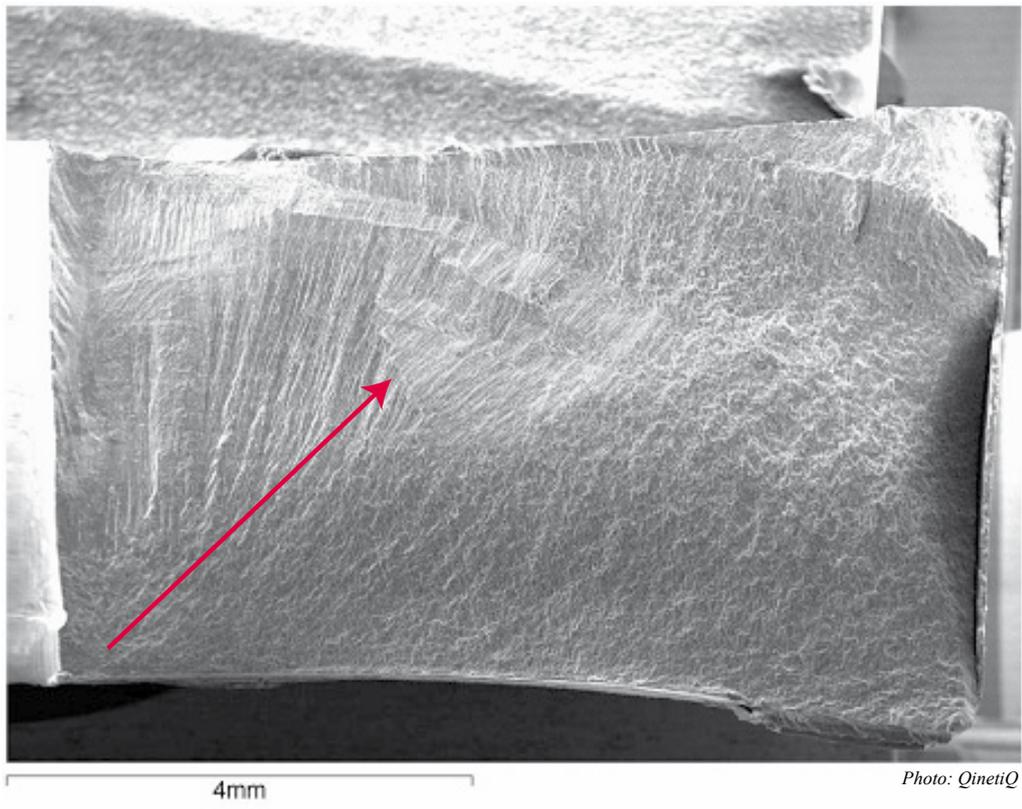
Fatigue crack originating from edge at bolt hole on stabiliser side of top forward support

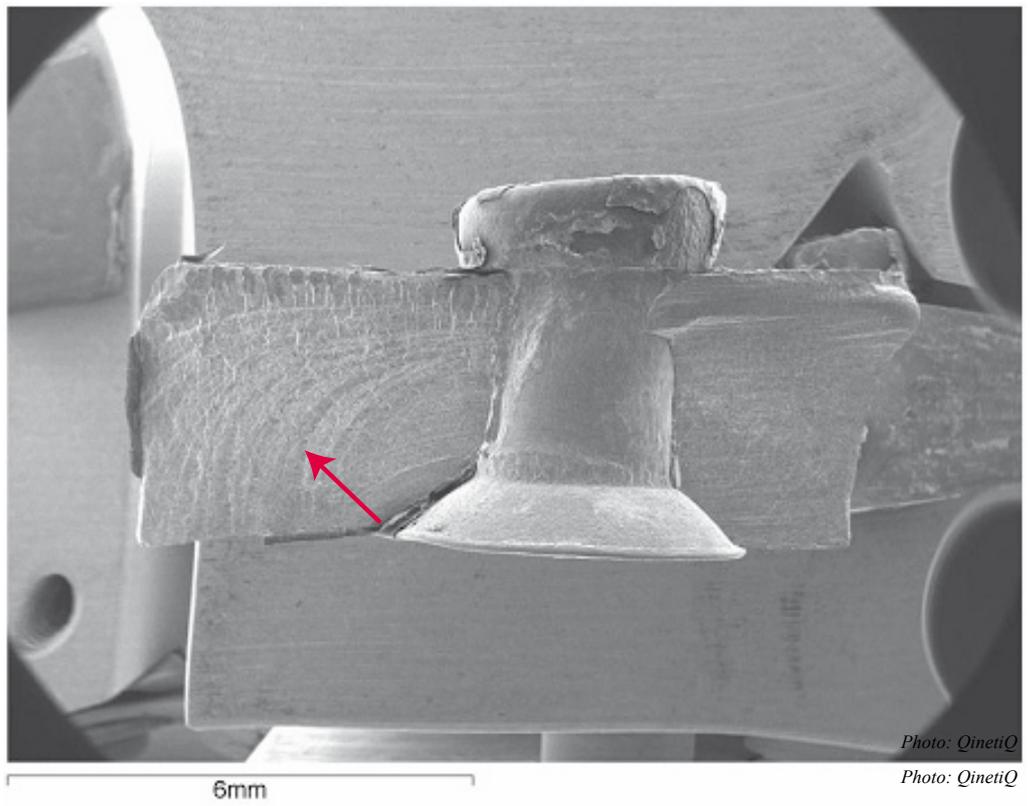
Fatigue crack originating from rivet hole on stabiliser side of bottom aft support

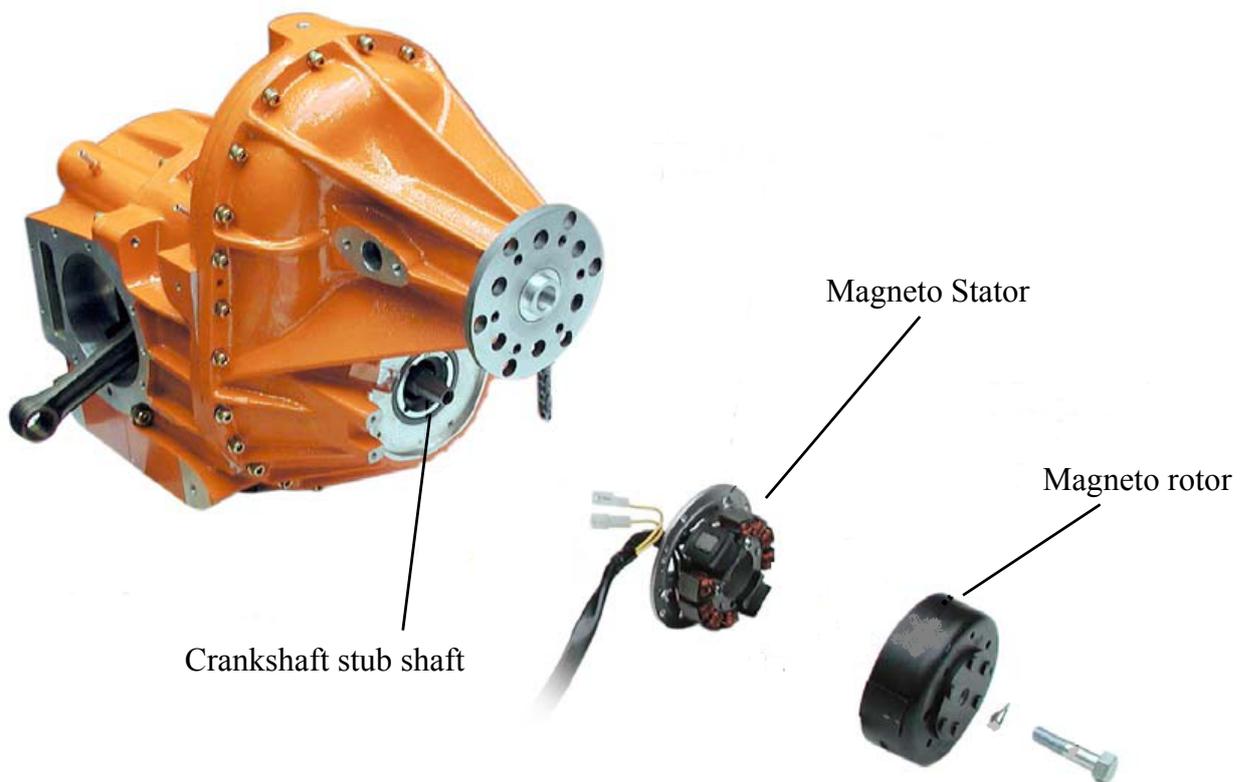
**Figure 2**

The magneto on the Verner 133M engine is located on the front of the engine, immediately below the propeller shaft. It consists of eight primary and two secondary coils secured to the front of the gearbox casing (Figure 1). Magnets are secured to the inside of a rotating casing which covers the entire assembly. The casing is bolted to a steel stub shaft, pressed into the forward end of the crankshaft, which passes through the centre of the coils, (Figure 2).

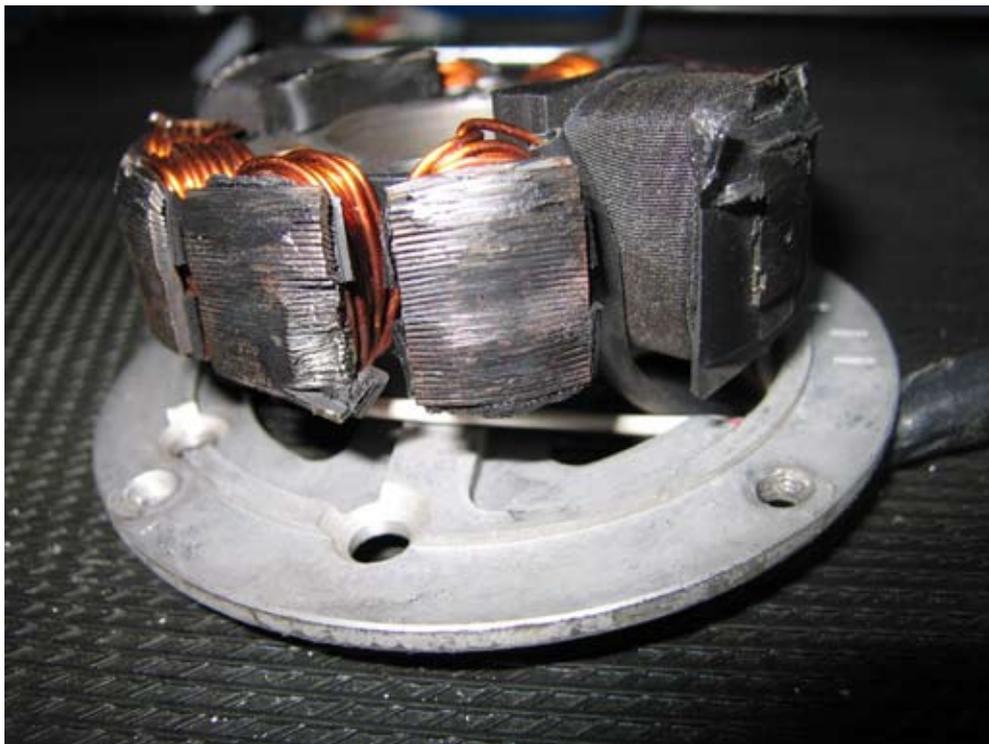
**Figure 3 (left)**  
Damage to stator formers

magnitude to cause crack initiation or progression in the shaft. The damage to the magneto coil formers indicated that the rotor had been sufficiently out of alignment, prior to the failure, to make contact with the formers

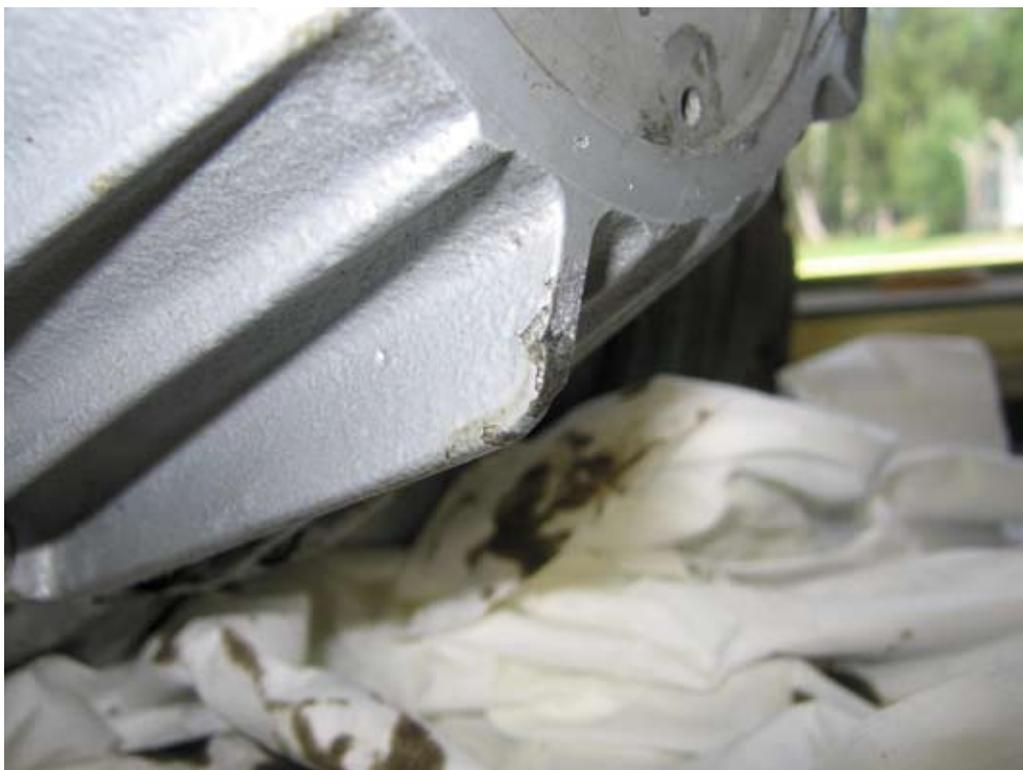
**Figure 4 (right)**  
Damaged stiffening rib
