INCIDENT

Aircraft Type and Registration:	Boeing 747-2D7B, N523MC	
No & Type of Engines:	4 General Electric CF6-50 turbofan engines	
Year of Manufacture:	1979	
Date & Time (UTC):	12 December 2004 at 1611 hrs	
Location:	On approach to Runway 05 at London Stansted Airport, Essex	
Type of Flight:	Public Transport (Cargo)	
Persons on Board:	Crew - 3	Passengers - None
Injuries:	Crew - None	Passengers - N/A
Nature of Damage:	None	
Commander's Licence:	FAA Airline Transport Pilot Certificate	
Commander's Age:	56 years	
Commander's Flying Experience:	Approximately 14,000 hours (of which 6,000 were on type) Last 90 days - 196 hours Last 28 days - 66 hours	
Information Source:	AAIB Field Investigation and operating company report

Synopsis

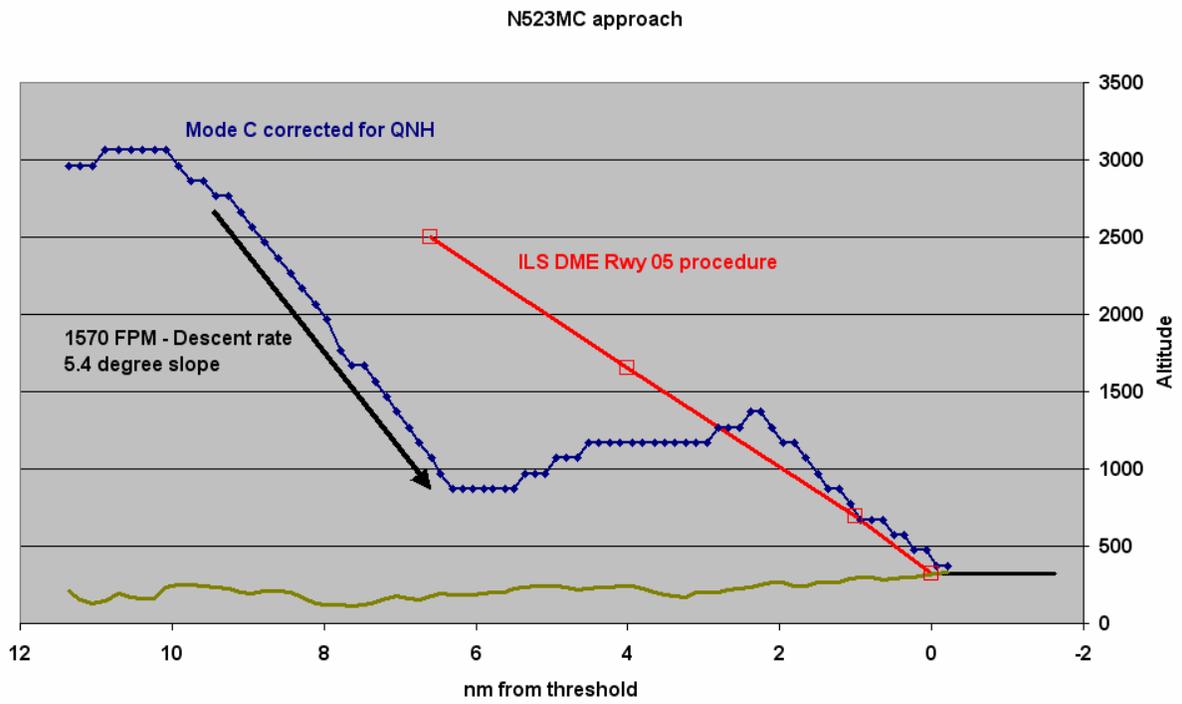
The incident occurred when the crew became involved with an apparent unserviceability, which resulted in no-one in the cockpit monitoring the flight path of the aircraft during an ILS approach. The aircraft broke cloud at 900 feet amsl just over 6 nm from the threshold. The commander then disconnected the autopilots and manually flew the aircraft to acquire the proper glideslope. Subsequent to the incident, the crew did not report the incident to the airport authority nor to their company. The incident and subsequent lack of proper reporting procedures by the crew indicated a serious breakdown in crew effectiveness.

Figure 1 N523MC Approach and normal glideslope

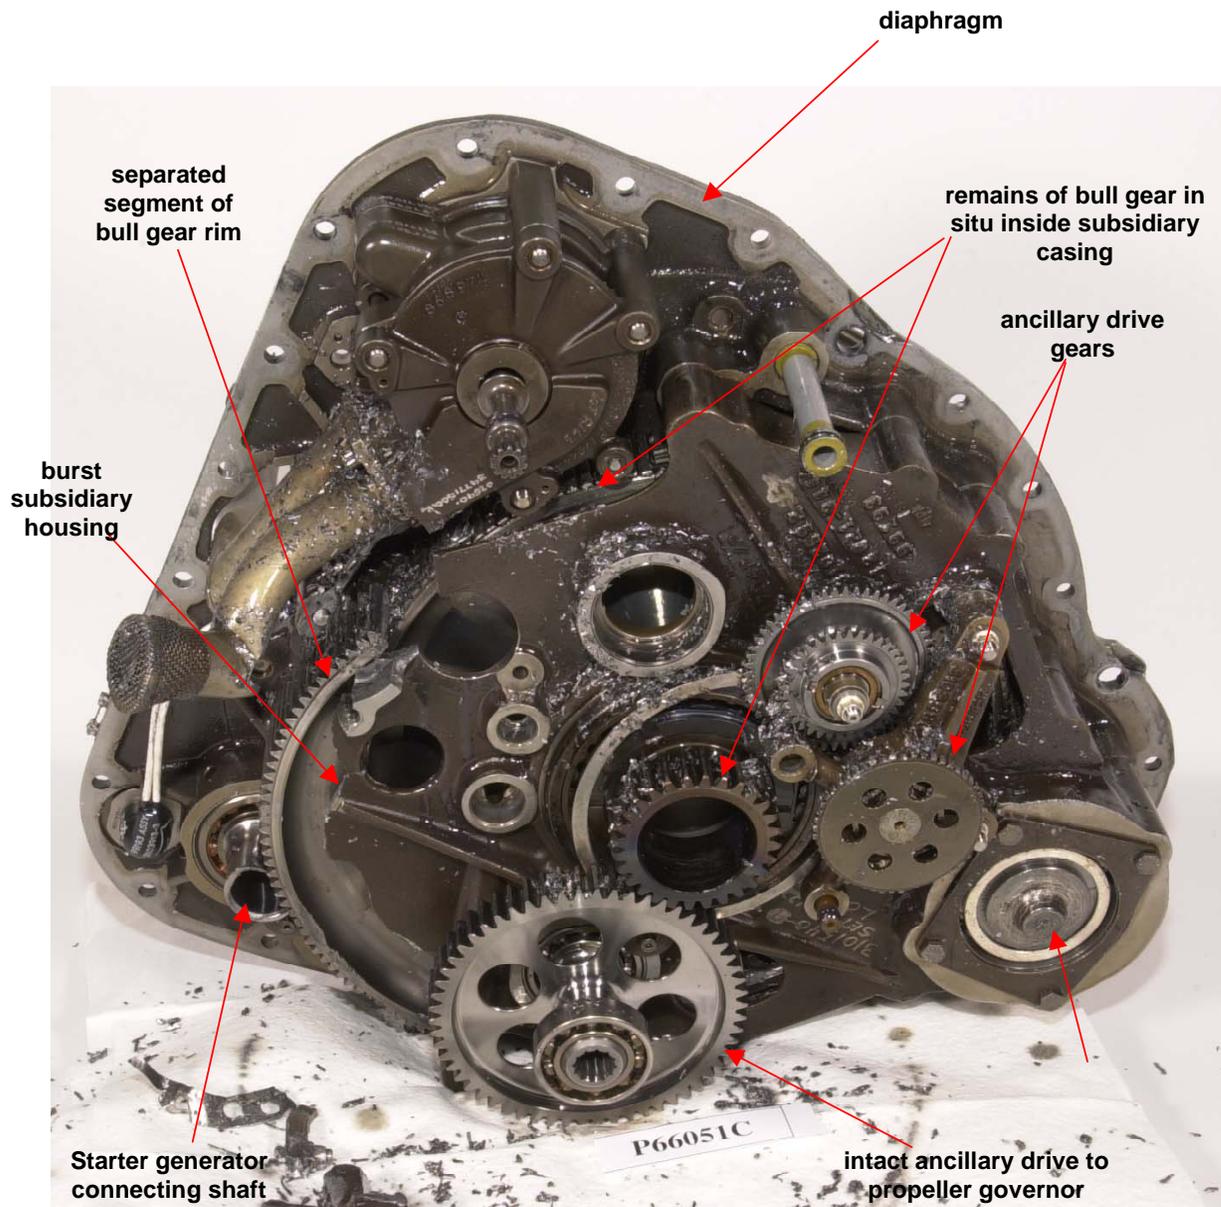
When the diaphragm plate was split from the rear section of the gear case, it was evident that a major failure of the first stage gears had occurred, see Figure 3. The debris thus exposed included: broken pieces of gear tooth; crushed remains of various bolts and studs; fragments of the subsidiary housing which enclosed the input gears; and a large quantity of general debris.

Figure 3:
View onto aft face of diaphragm, with damaged components in situ

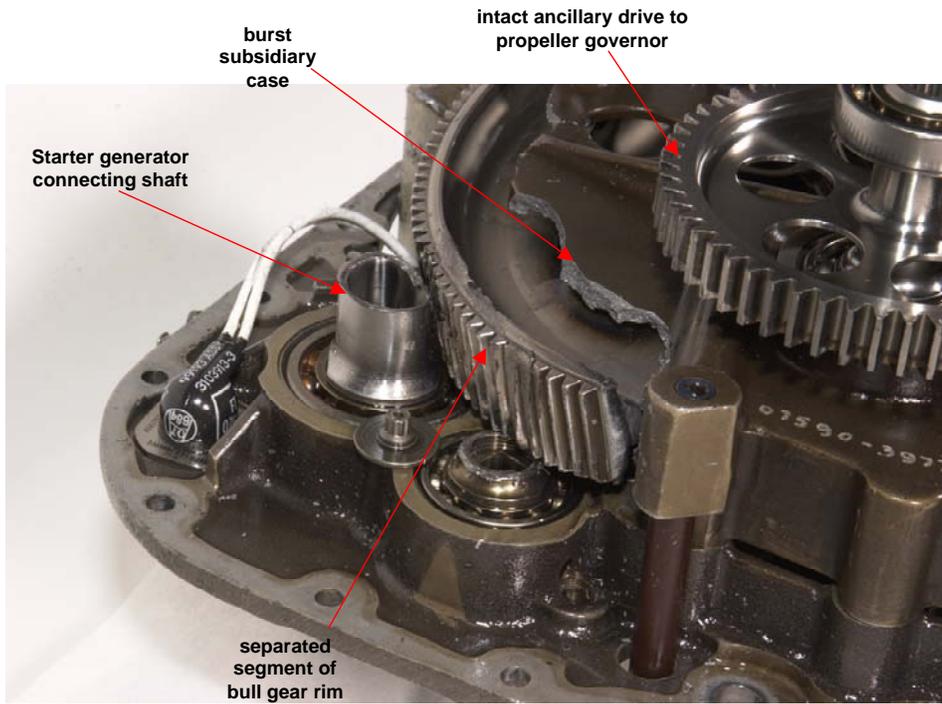
A large segment of the bull gear rim, comprising approximately one third of the gear's circumference, had separated and burst out through the side of the subsidiary housing and had become jammed hard up against the starter generator shaft, fracturing and crushing the hollow shaft, see Figure 4.

Figure 4:
Detail of separated segment of bull gear

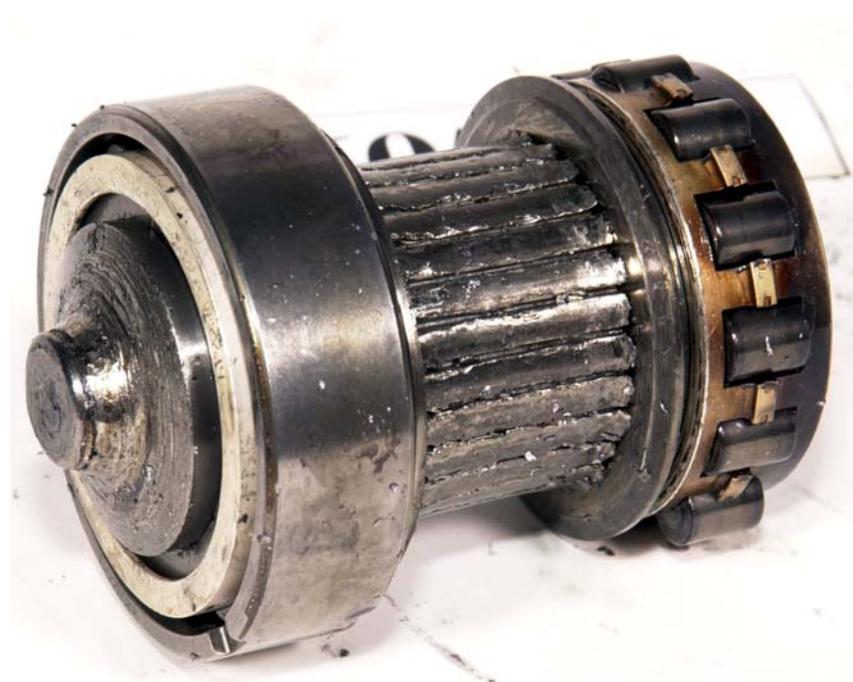
Figure 5
Input (high speed) pinion, showing sheared drive neck

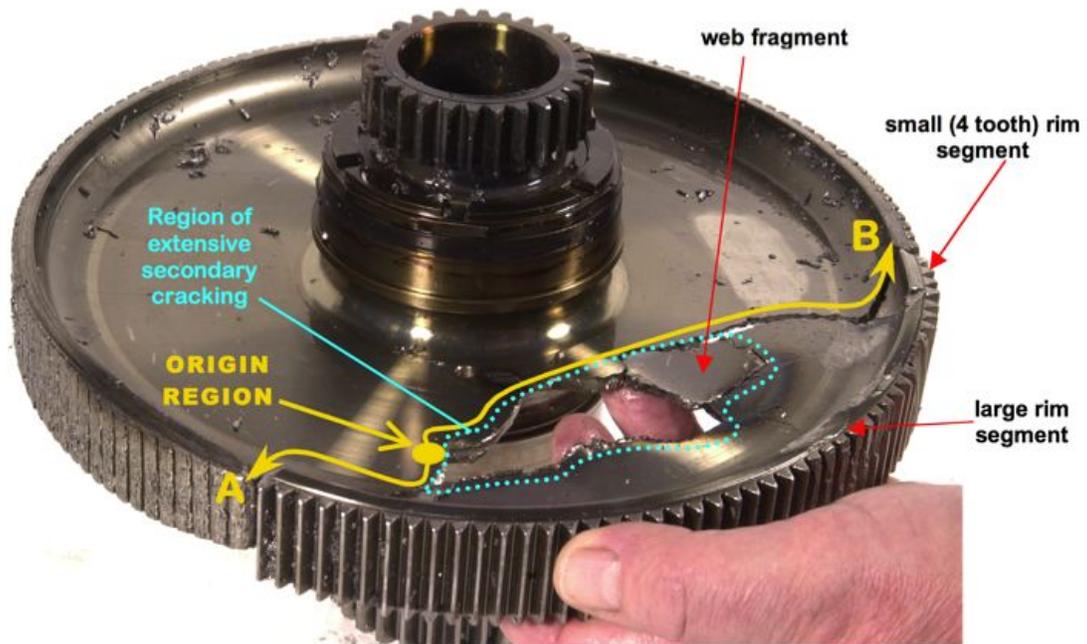
Close inspection of the fractured pieces of bull gear revealed clear indications of fatigue consistent with propagation from an origin region in the web at approximately 60% radius. Figure 6 shows the fractured bull gear, with the principal separated fragments held in position to illustrate the fracture paths and position of the origin region, from which two primary crack fronts propagated, labelled 'A' and 'B' respectively.

The shorter of the two primary cracks ('A' in Figure 6) propagated radially outwards for a short distance until it met the thicker section of the rim, where it turned and ran circumferentially for a short distance before reverting back to a radial direction and intercepting the free edge of the wheel at the root of a tooth. The much larger primary crack ('B') propagated radially inwards initially, in opposition to crack 'A', then turned briefly in a circumferential direction (also away from crack 'A') before turning back inward again to follow an oblique path towards the centre of the wheel. As it approached the blend radius marking the transition from the web into the hub, the crack was

The fractured bull gear was subjected to detailed metallurgical examination at the manufacturer's materials laboratory. This confirmed the provisional assessment of crack propagation made during the teardown, and established that the fracture origins were on the aft face of the web approximately 3.7 inches from the rotational axis.

Figure 6
Fractured bull gear, showing principal fracture paths

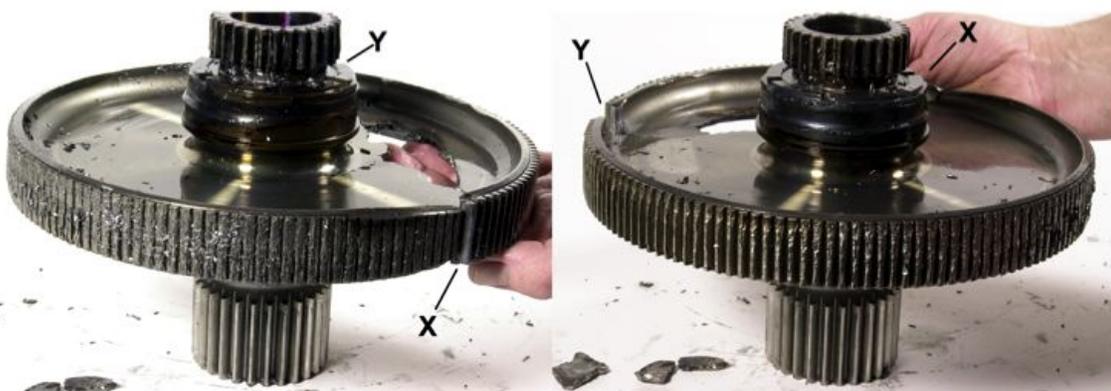
The condition of the teeth on the main section of the fractured bull gear varied progressively from completely stripped at 'X' in Figure 7 (adjacent to the large segment) through to a substantially undamaged state at 'Y' (adjacent to the small separated rim segment). This pattern of damage, together with the completely stripped condition of the high-speed pinion, was consistent with the main segment of the fractured bull gear attempting to re-mesh with the high-speed pinion following separation of the rim segments.

Figure 7
Pattern of post-fracture tooth damage

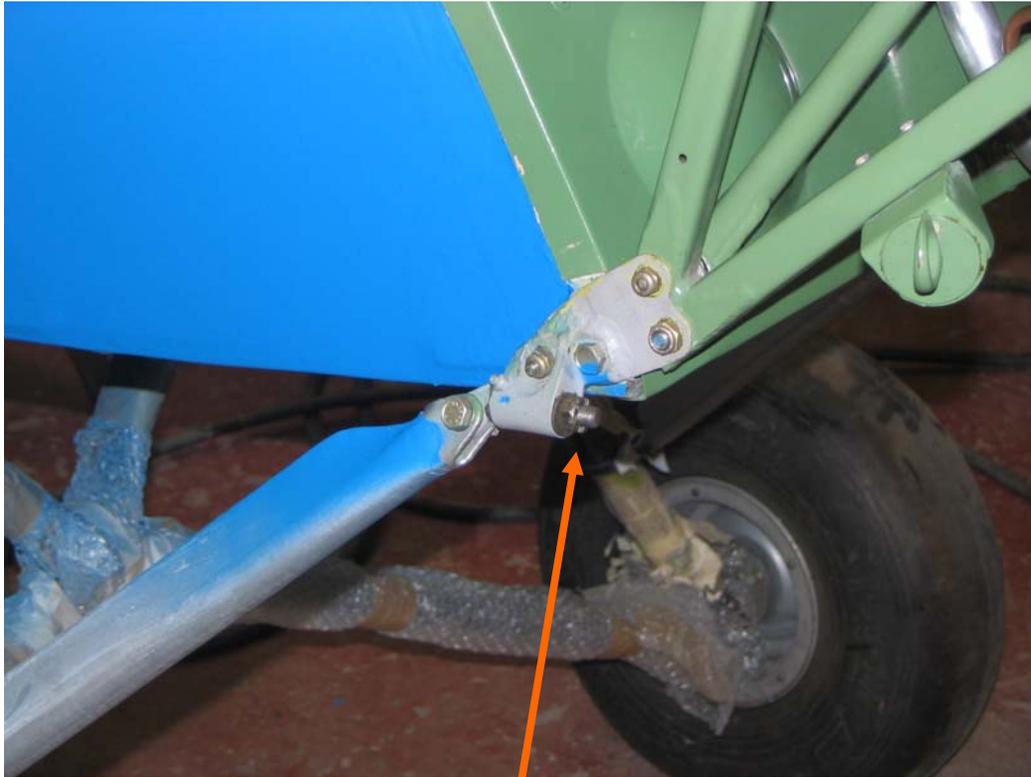
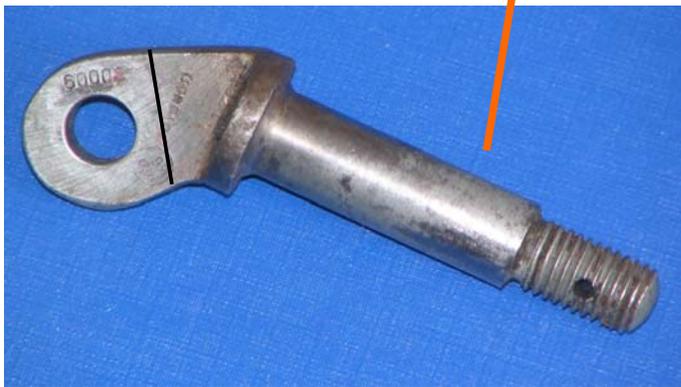
Figure 1

Tiger Moth Main Undercarriage drag strut showing location of failed pin and approximate line of fracture.

The maintainer of the aircraft has advised that he intends to inspect the swivel bolts during annual inspection of Tiger Moth aircraft in future and it would seem prudent for other maintainers to do likewise. The age and history of these components is scarcely ever recorded and loads experienced can vary greatly with runway conditions and also the effectiveness of lubrication, since the bolt must be free to articulate in the fitting as the undercarriage struts 'spread' under load.
