Aircraft Type and Registration:	Falcon 900EX, VP-BMS	
No & Type of Engines:	3 Garrett TFE 731-60-1C turbofan engines	
Year of Manufacture:	1999	
Date & Time (UTC):	9 February 2004 at 0130 hrs	
Location:	London (Stansted) Airport, Essex	
Type of Flight:	Private	
Persons on Board:	Crew - 2	Passengers - 2
Injuries:	Crew - None	Passengers - None
Nature of Damage:	Extensive damage to right wing and landing gear doors	
Commander's Licence:	Airline Transport Pilot's Licence (FAA) with Bermudan validation	
Commander's Age:	52 years	
Commander's Flying Experience:	20,954 hours (of which 700 were on type) Last 90 days - 105 hours Last 28 days - 35 hours	
Information Source:	AAIB Field Investigation

Aircraft Type and Registration:	DHC-8-311, G-BRYU	
No & Type of Engines:	2 Pratt & Whitney PW123 turboprop engines	
Year of Manufacture:	1997	
Date & Time (UTC):	21 December 2004 at 0723 hrs	
Location:	Edinburgh, Scotland	
Type of Flight:	Public Transport (Passenger)	
Persons on Board:	Crew - 4	Passengers - 49
Injuries:	Crew - None	Passengers - None
Nature of Damage:	None	
Commander's Licence:	Airline Transport Pilot's Licence	
Commander's Age:	43 years	
Commander's Flying Experience:	5,350 hours

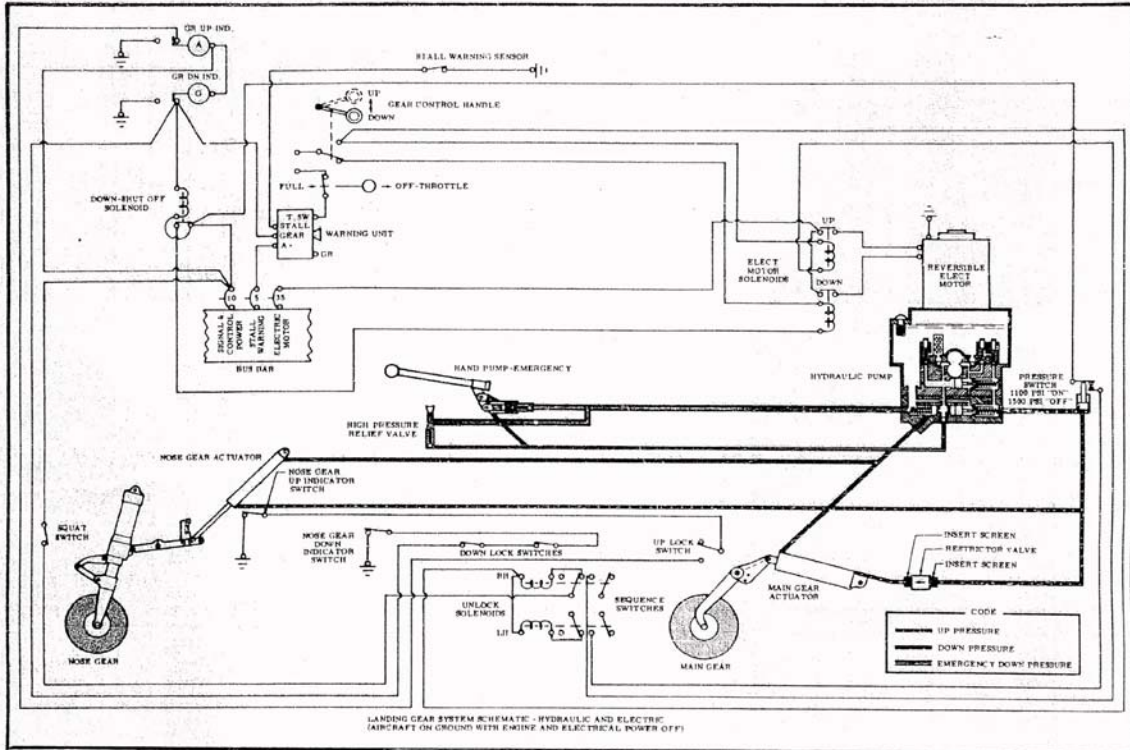
Figure 1
Diagram of the landing gear hydraulic and electrical system

The aircraft was flown to a maintenance organisation for the rectification of a landing gear retraction problem. It was flown with the landing gear extended and the electric circuit breaker for the electrical hydraulic pump 'pulled'. The accident flight was uneventful and the landing very smooth. As the aircraft decelerated, its nose dropped and the propeller struck the ground. Post accident rectification revealed defects in all three landing gears. The nose landing gear overcentre downlock was out of adjustment, and the breakout force was minimal. Both main landing gear downlock latch pivot pins had double fatigue and the left one had failed which was the reason for the original landing gear problem.

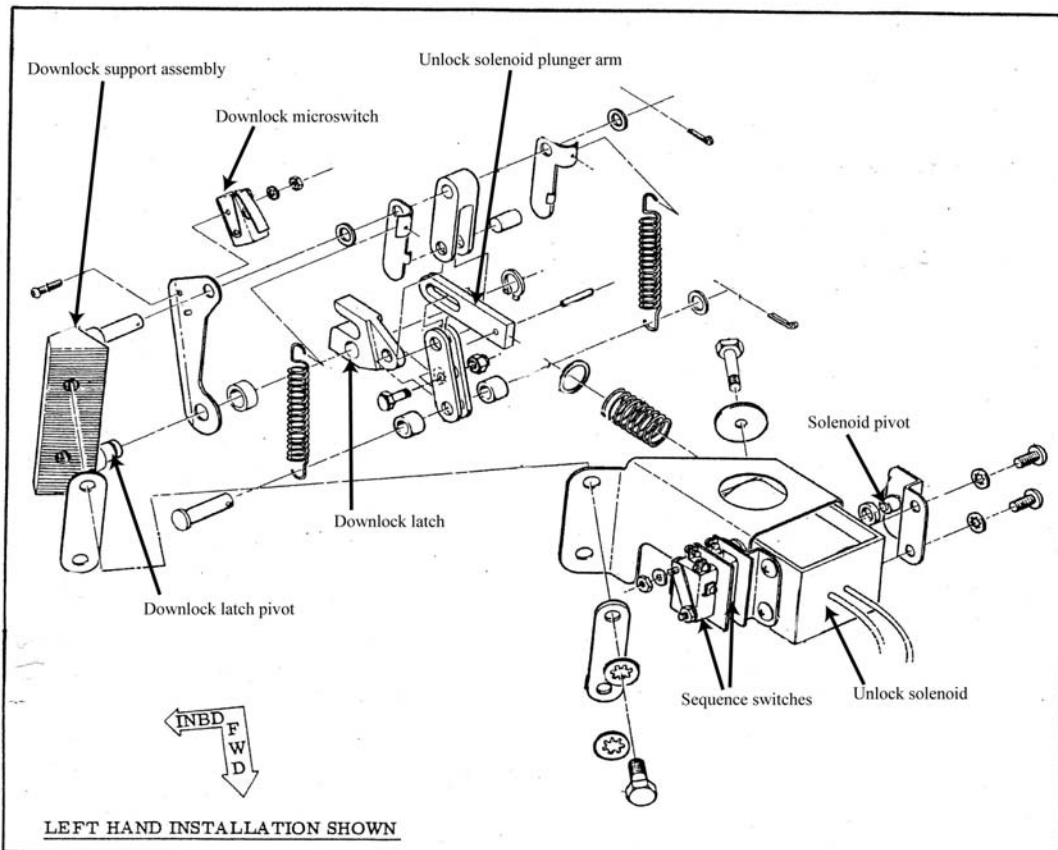
Figure 2
Diagram of the left main landing gear downlock mechanism

The aircraft was first registered in the UK in 1971 as G-AZKH. In July 1979 the aircraft was involved in a take-off accident which resulted in damage to the propeller, engine, nose and left main landing gears, and lower fuselage skin (see AAIB Bulletin 10/79). Following repair in May 1982 the aircraft was re-registered G-OADE. In April 1983 when the landing gear was selected down, no landing gear down and locked green light illuminated in the cockpit. The emergency landing gear lowering system was operated (a hydraulic hand pump) but there was still no down and locked indication. A visual examination from the ground indicated that the landing gear was fully extended. A successful landing was carried out whilst operating the hydraulic pump throughout. An engineering examination revealed that the right main landing gear downlock latch pivot pin had failed in fatigue.

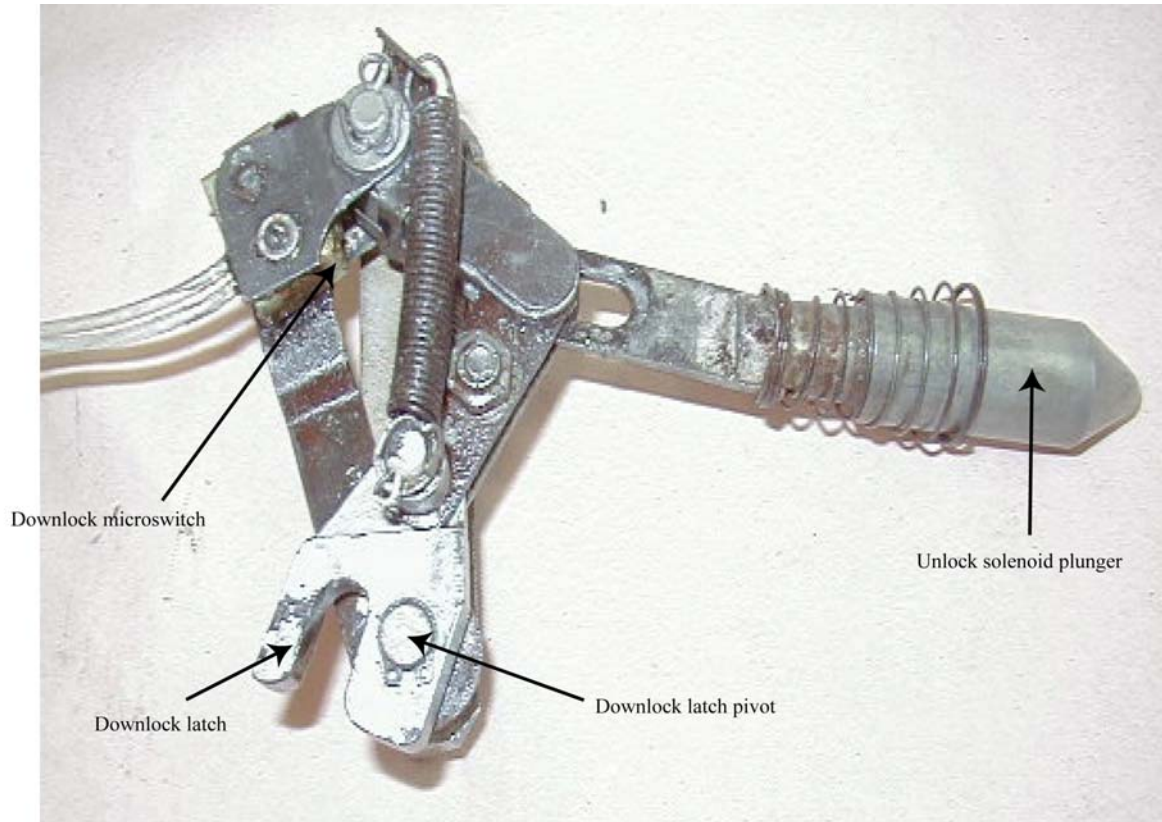
Figure 3

Photograph of part of the main landing gear downlock mechanism

It was recommended to the Cessna Aircraft Company that consideration be given to making available to owners and operators of Cessna 177RG Cardinal aircraft a Service Kit that will enable them to upgrade their aircraft's landing gear extension/retraction system to the standard fitted to aircraft serial number 0283 onwards.

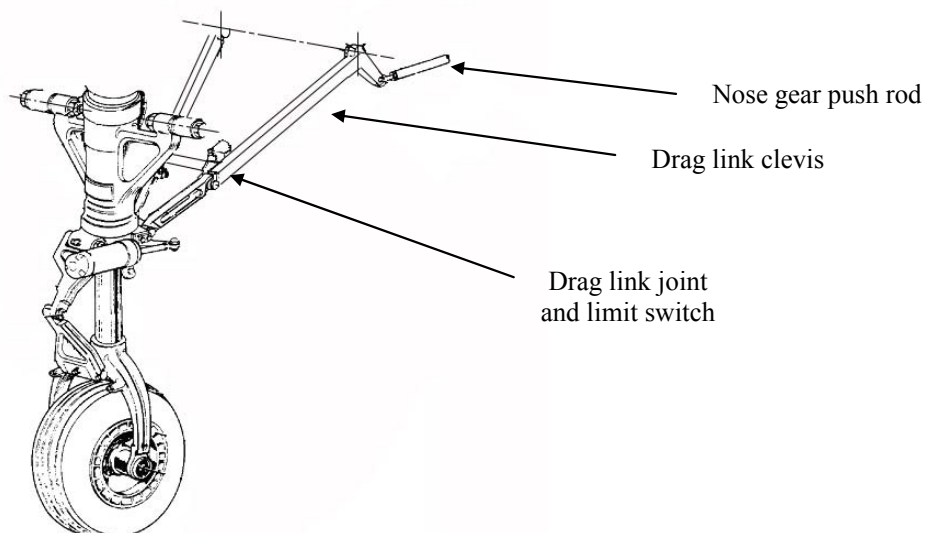
When the landing gear selector is placed in the down position, the screw jack pushes the main gear cables and pulls back the nose gear push rod. The push rod is connected to a drag link clevis, which forms the upper half of the two-piece nose gear drag link. As the push rod retracts, the drag link unfolds as shown below.

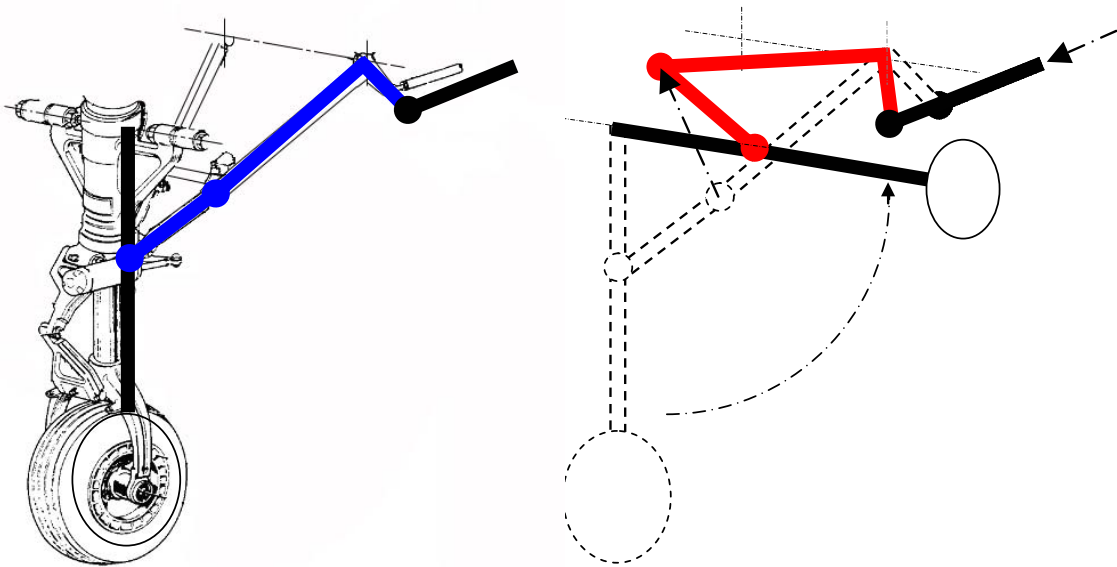
In normal operation, the drag link joint is driven slightly over centre (shown below in blue), and rearward forces on the nose gear leg are resisted by a mechanical stop in the drag link structure. If the drag link does not travel over centre, any rearward force will cause it to fold upwards (shown in red), resulting in a pull force on the screw jack. Because the screw jack is rigid when the electric motor is not running, the pull force will be transmitted directly to the motor itself, which is attached to the front of the wing spar where it passes beneath the cabin floor. The motor attachments, however, are not designed to resist landing forces directly.

If all of the limit switches close before all of the gear legs are fully down and locked, the motor will stop prematurely, even though the green "down locked" light is illuminated. Dirt collects readily on the nose gear drag link, and rigging tolerances are such that a small accumulation is sufficient to cause the nose gear limit switch to close before the nose gear drag link has locked over centre.

The nose gear limit switch is mounted above the drag link joint and is designed to close when the drag link locks over centre. If the rearward force on the nose gear leg was sufficient to force the drag link further over centre, (for example during a heavy landing), the limit switch components would be bent or broken away from the direction of over travel and the mechanical stop would be damaged. No such damage was present on G-AVPS. Consequently, the possibility that the drag link was forced to fold downwards, through the mechanical over centre stop, can be discounted.
