**CONTENTS****MESSAGE from the CHIEF INSPECTOR**

**COMMERCIAL AIR TRANSPORT****FIXED WING**

## MESSAGE FROM THE CHIEF INSPECTOR OF AIR ACCIDENTS

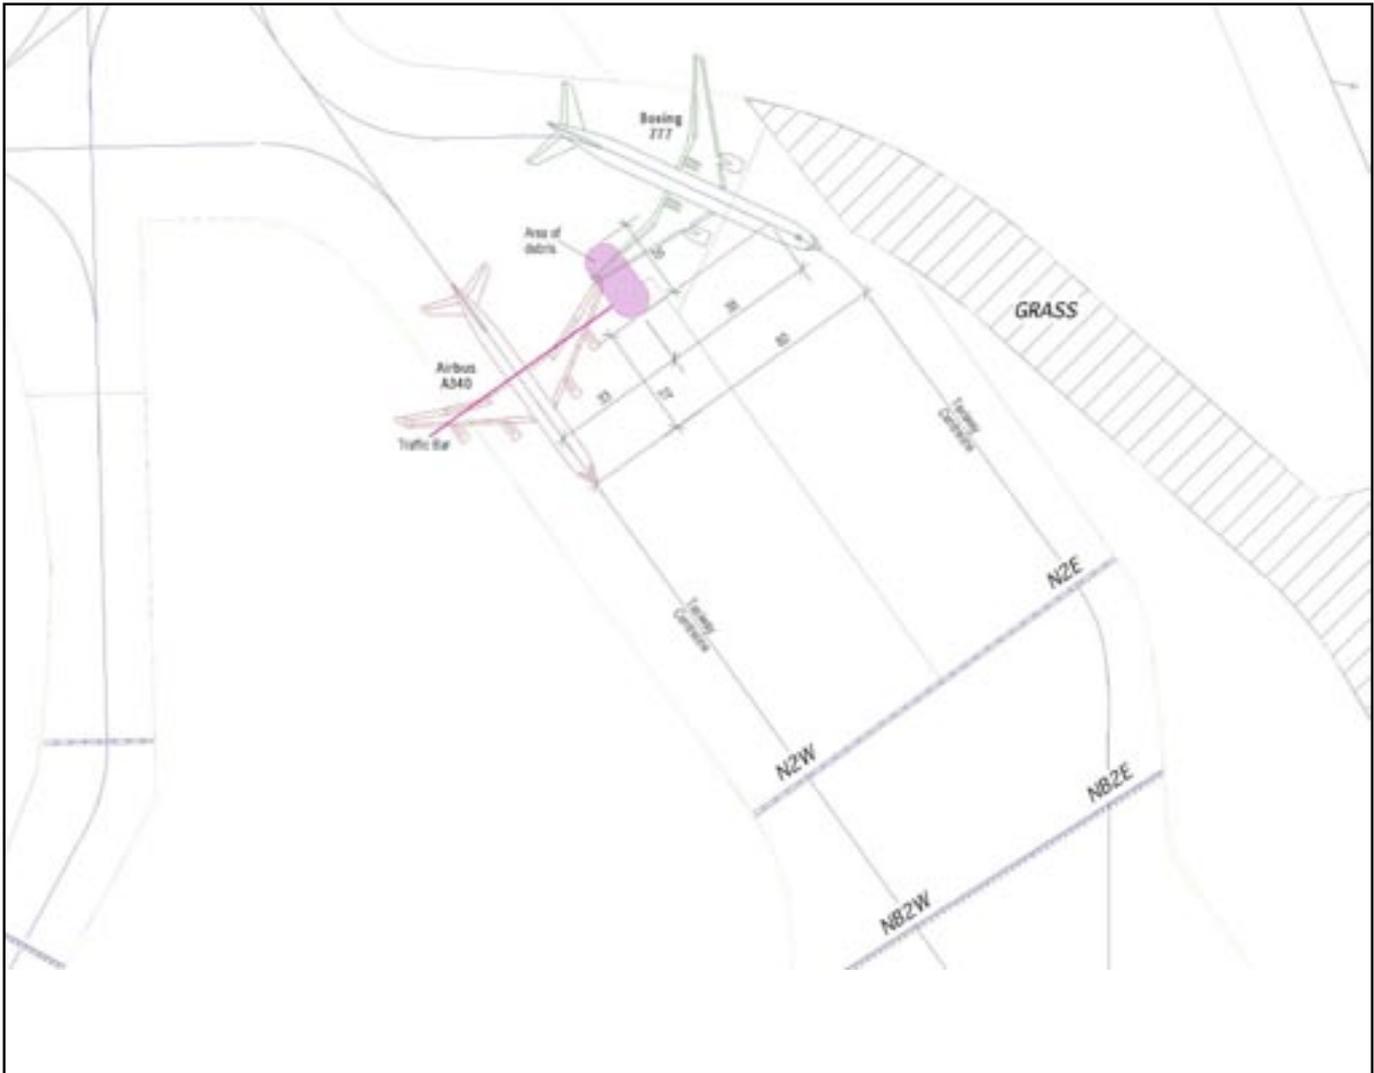
**Figure 2**  
Aircraft positions at Runway 27L Holding Area  
(measurements in metres)

Although the taxiway was cleared of debris by a mechanical sweeper before any record of its position could be made, a careful examination of the taxiway surface revealed some coloured glass shards consistent with the fractured lens on the B777's right wing tip. Although the precise position of the collision could not be determined from this debris, due to potential disturbance by the sweeping machine, it was considered unlikely that these items would have been displaced significantly from their original post-collision positions. Accordingly, the boundary of the region containing these items was noted for inclusion in a later analysis of aircraft and taxiway geometry, Figure 2.

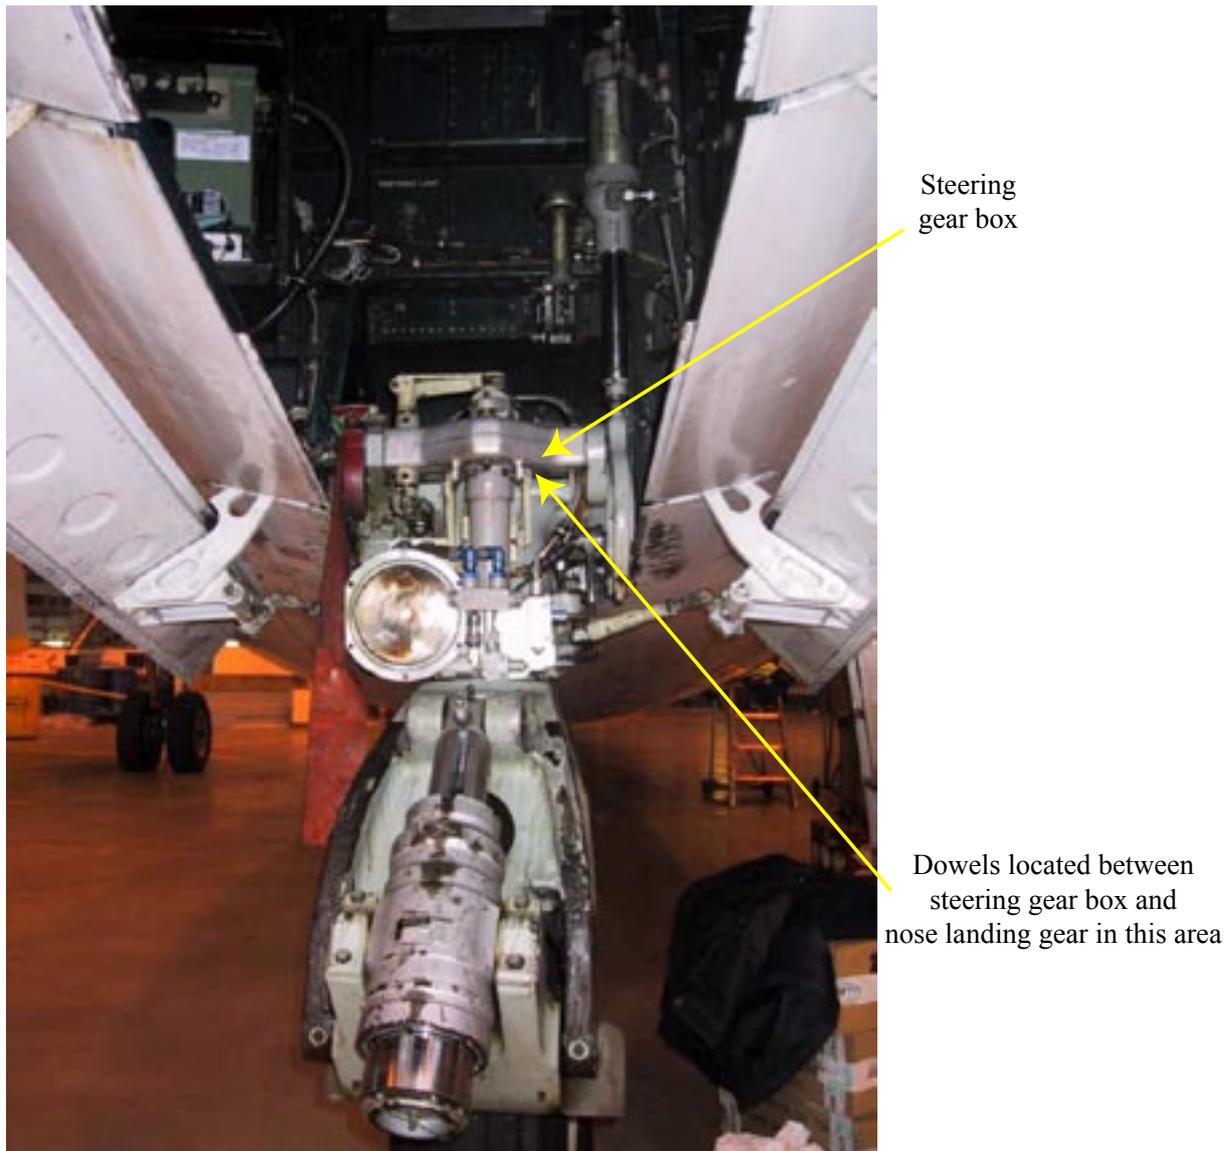
**Figure 2**  
F27 Nose Landing Gear

The Nose Landing Gear and Steering Gearbox were separated. (Figure 2). Four dowel pins, three of which were broken, located the steering gearbox. It is unusual for these pins to break, but if they are broken or distorted they can permit the steering gearbox to rotate relative to the nose gear itself, and thus induce a steering error on a random or erratic basis. The Steering Gearbox was despatched for investigation and overhaul. The survey and test report stated that the unit had a broken housing tube assembly, a damaged gasket and was supplied with a missing grommet and plate. When these parts were repaired and replaced, the unit functioned satisfactorily. The four dowel pins were not recovered at the time and were subsequently unavailable for investigation.

The defect in the FUCV would have caused vibration of the NWS, and some difficulty with steering the aircraft. It would also have caused large forces to be repeatedly applied to the steering gearbox and nose landing gear. These forces could have damaged the dowel pins in the steering gearbox and would lead to erratic changes in

the NWS datum. Unfortunately, attempts to recover the dowel pins were unsuccessful, so this possibility could not be confirmed from their condition. Even so, the only two faults found throughout the investigation concerned the FUCV and the dowel pins, and while the former could have caused the latter, the opposite is not true.

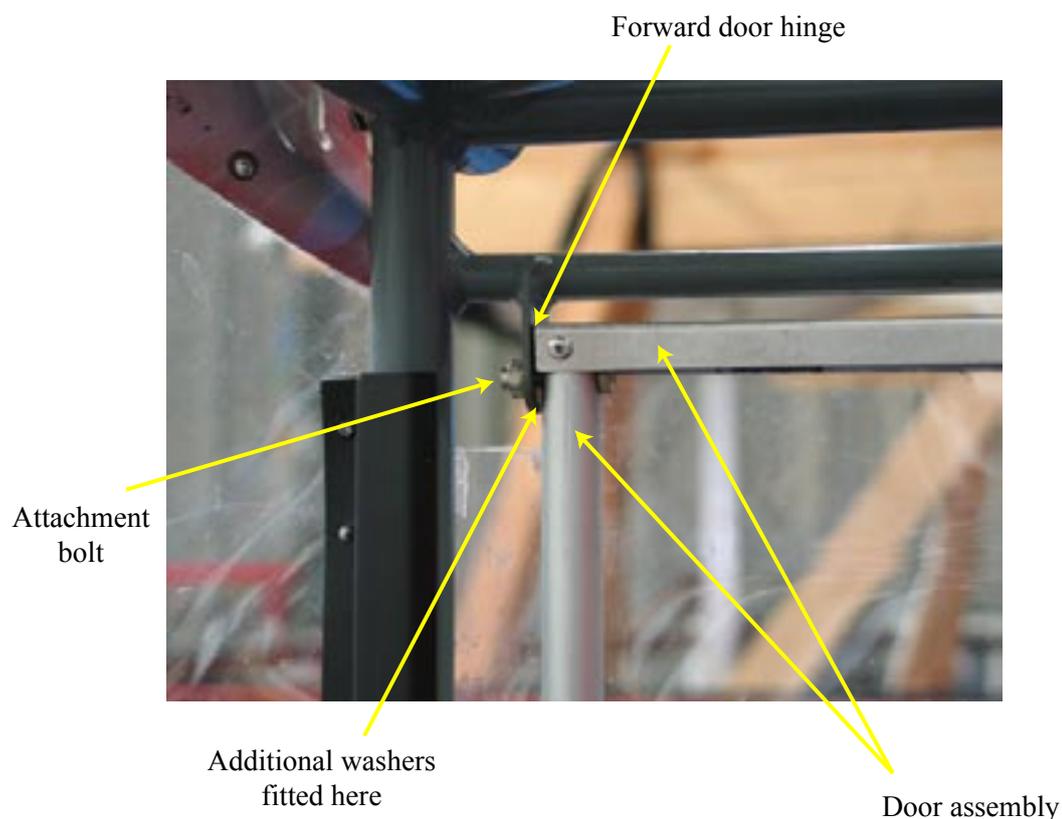
**Figure 1**  
Door attachment arrangement on a similar aircraft

The presence of the nut on the cockpit floor, and undamaged front door hinge, indicated that the nut had come off the door attachment bolt thereby allowing the bolt to migrate from the hinge and door assembly. As the door would not now be attached at the forward position, air pressure would most likely have caused the door to move upwards and outwards, allowing the front door catch to unlatch. The door would then have continued to pivot about the rear hinge and latch, until the hinge failed and the door fell from the aircraft.

It was not possible to determine why the lock nut came off the front attachment bolt. The condition of the bolts on the left door suggests that the front attachment bolt on the right door might not have protruded through the lock nut sufficiently to ensure positive locking. Assuming that the correct length bolts were used, the need to fit additional washers to take out excessive sideways movement of the door suggests that the accumulation of manufacturing tolerances was such that the distance between the front and rear hinges might have been close

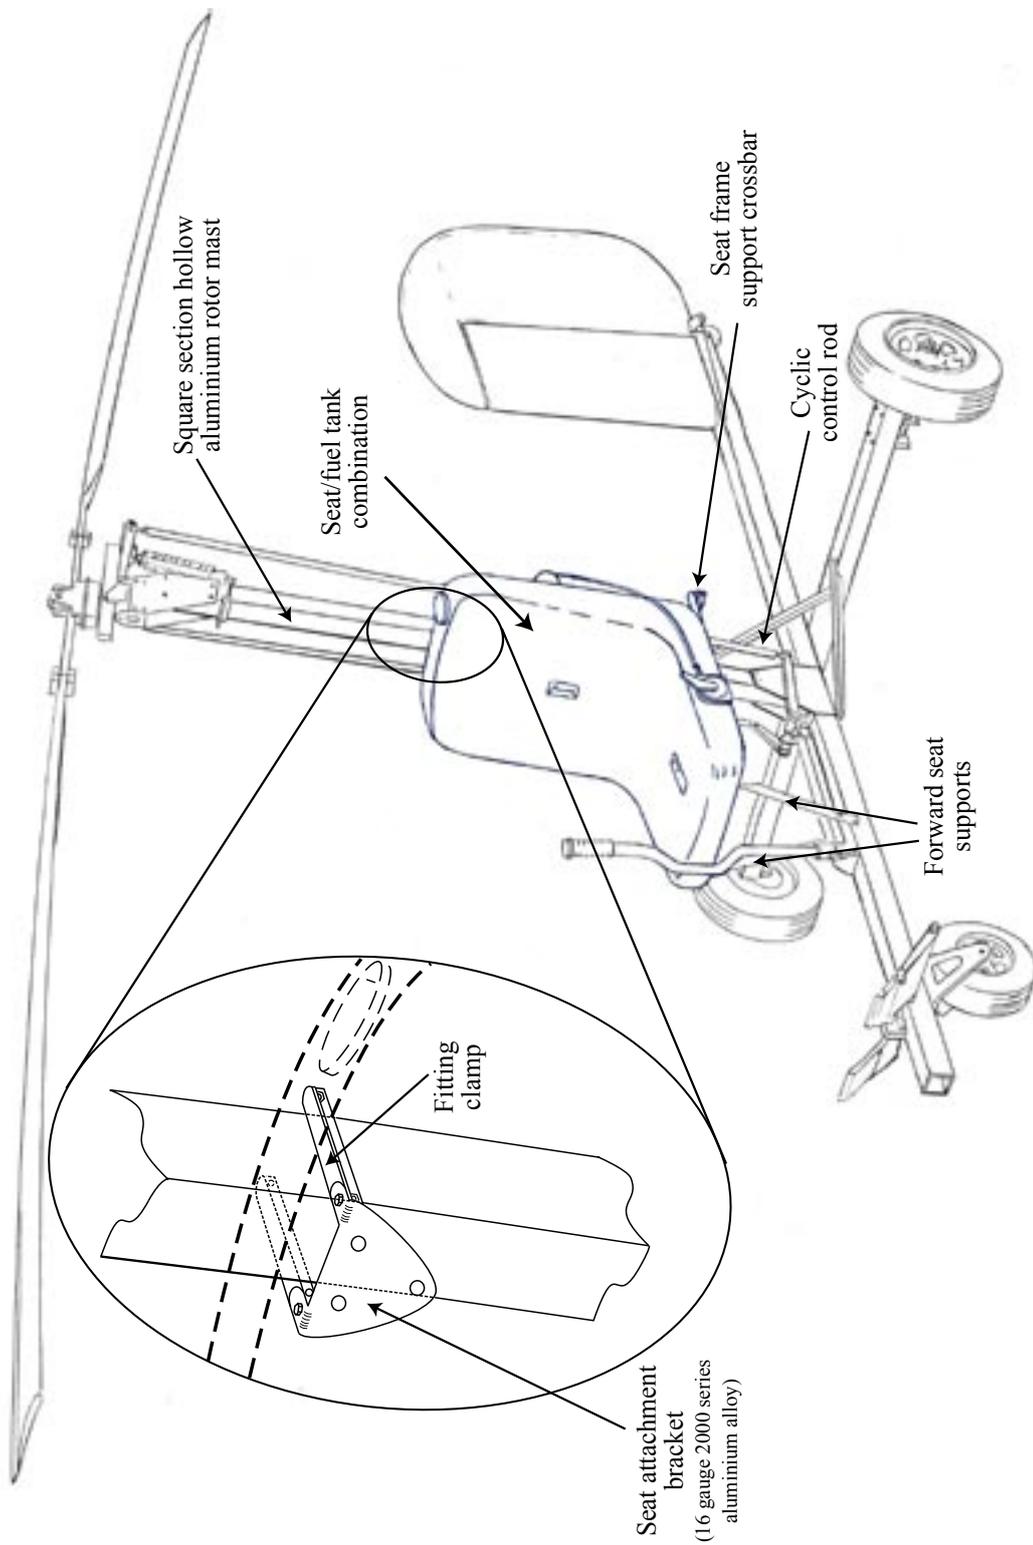
**Diagram of the combined seat/fuel tank fixture**

Examination of the seat revealed that the left side lug of the attachment bracket at the top of the seat, at its connection to the clamp around the mast, had failed by a fatigue cracking mechanism, prior to the first impact with the trees. The right side lug had also partially failed in fatigue and then failed completely in a one-off overload mechanism. It was not possible to determine if the overload failure had occurred before the first impact or during the impact sequence. There was very good evidence of fretting between the attachment bolt washers and both the left and right lugs of the attachment bracket, indicating that there had been relative movement between the attachment bracket and the mast clamp over a period of time. Examination of the seat frame support crossbar, at its attachment to the rotor mast, found it to be loose and able to be 'rocked' laterally. There was very good evidence of fretting of the crossbar steel attachment bolts and ovalisation, in a downward direction, of the bolt holes in the aluminium rotor mast, indicating that this damage had occurred over a period of time. It was also found that the cross section of the hollow square section rotor mast had reduced in the immediate area of the attachment bolt holes, deformation being present on both the front and rear faces, in a manner consistent with excessive torque tightening of these attachment bolts. It was not established when this deformation occurred.
