**(ALL TIMES IN THIS BULLETIN ARE UTC)**

**INCIDENT**

<b>Aircraft Type and Registration:</b>	Airbus A340-311, 4R-ADB
<b>No &amp; Type of Engines:</b>	4 CFM56-5C2 turbofan engines
<b>Category:</b>	1.1
<b>Year of Manufacture:</b>	1994
<b>Date &amp; Time (UTC):</b>	26 June 2005 at 0913 hrs
<b>Location:</b>	School Hill Lane, Wargrave, Berkshire
<b>Type of Flight:</b>	Public Transport (Passenger)
<b>Persons on Board:</b>	Crew - 14                      Passengers - 304
<b>Injuries:</b>	Crew - None                      Passengers - None
<b>Nature of Damage:</b>	Damage to right inboard flap, No 3 flap fairing and No 3 engine exhaust nozzle
<b>Commander's Licence:</b>	Air Transport Pilot's Licence
<b>Commander's Age:</b>	54 years
<b>Commander's Flying Experience:</b>	17,000 hours (of which 5,760 were on type) Last 90 days - 223 hours Last 28 days - 48 hours
<b>Information Source:</b>	AAIB Field Investigation

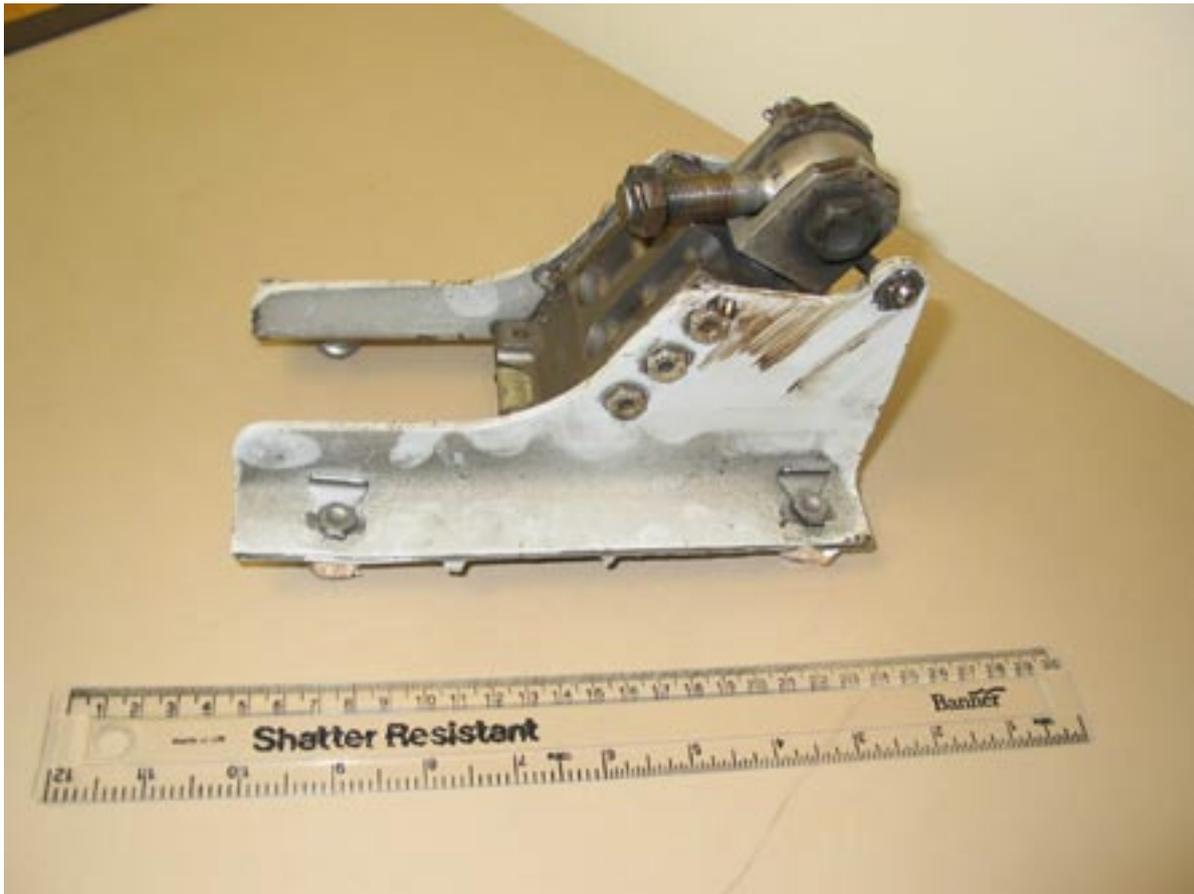
**Figure 1**

The object, shown in Figure 1, had little distinguishing features except for part numbers on the bolt heads and the threaded eye end; it weighed approximately 1.5 kg. After a lengthy investigative process, it was established that the object had come from an Airbus A330, A340-200 or A340-300, and in fact was a flap fairing lower attachment fitting, see Figure 3.

From the nature of the damage it was evident that the No 3 flap track fairing attachment fitting had departed the aircraft via the rear of the fairing and, in the process, made contact with the trailing edge of the inboard flap. Fortunately, it landed in an unoccupied wooden outbuilding albeit in a relatively highly populated area.

The reason for the detachment of this fitting from the flap fairing was not established. The four attachment bolts had remained with the fitting and did not appear to have come loose, as their locking tabs were intact, and they were still engaged with the inserts. This, together with the fact that the inserts had been pulled from the honeycomb structure, suggested that the fitting had either experienced higher than intended loading or, possibly, had not been manufactured or repaired properly. However, had the fairing been defective since manufacture, then it might be expected that a failure would have occurred earlier in its life. Excessive loading on a serviceable fairing is not likely to be generated by normal 'operational' loads, otherwise detachment of the fitting from any fairing would likely be a fairly common event. Therefore, the possibility remains that excessive loads could have been generated by a combination of in-service loading, defective repair and/or incorrect rigging of the fairing to the flap upon its last fitment.

The departure of the fitting from the aircraft, once free from the fairing, was likely due to the airflow through the fairing having caused the unattached fitting to rotate and eventually unscrew from the lower eye end of the connecting rod. With the fitting now totally detached, it then departed the aircraft rearwards hitting the inboard flap in the process. Had the lower eye end not been able to unscrew, then the fitting would have remained with the aircraft, albeit with some damage being caused to the fairing and flap assembly.

The manufacturer has been made aware of this incident and has already changed the design of the connecting rod such that the lower eye end always remains attached to the connecting rod. A Service Bulletin will be introduced to rework or replace existing connecting rods.

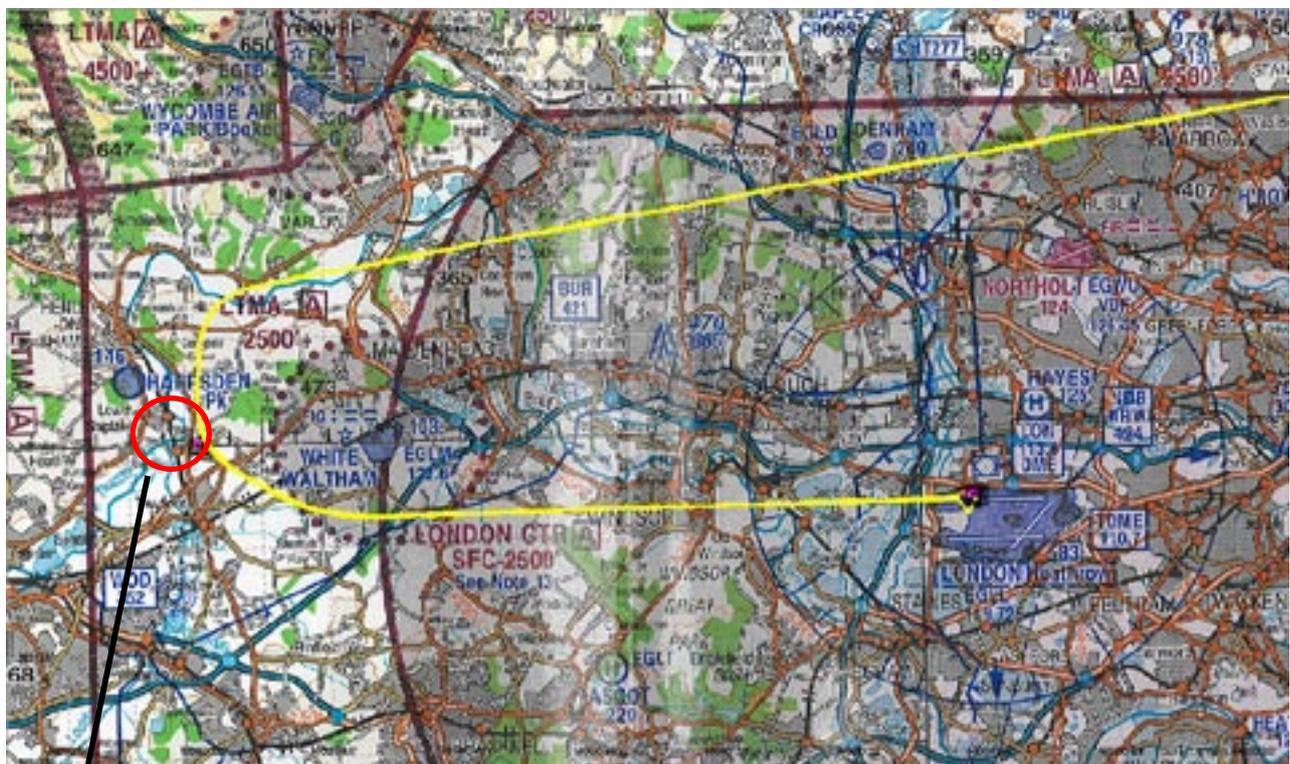
Figure 2

The AAIB were informed by a member of the public that an item had been found in their wooden outbuilding on the morning of 26 June 2005, and that it appeared to have entered through the building's roof. The outbuilding was in a garden in Wargrave, Berkshire, which is overflowed by many types of aircraft, including airliners which operate in and out of London Heathrow Airport (LHR). As this item appeared to be a component from such an aircraft, it was collected by the AAIB for examination.

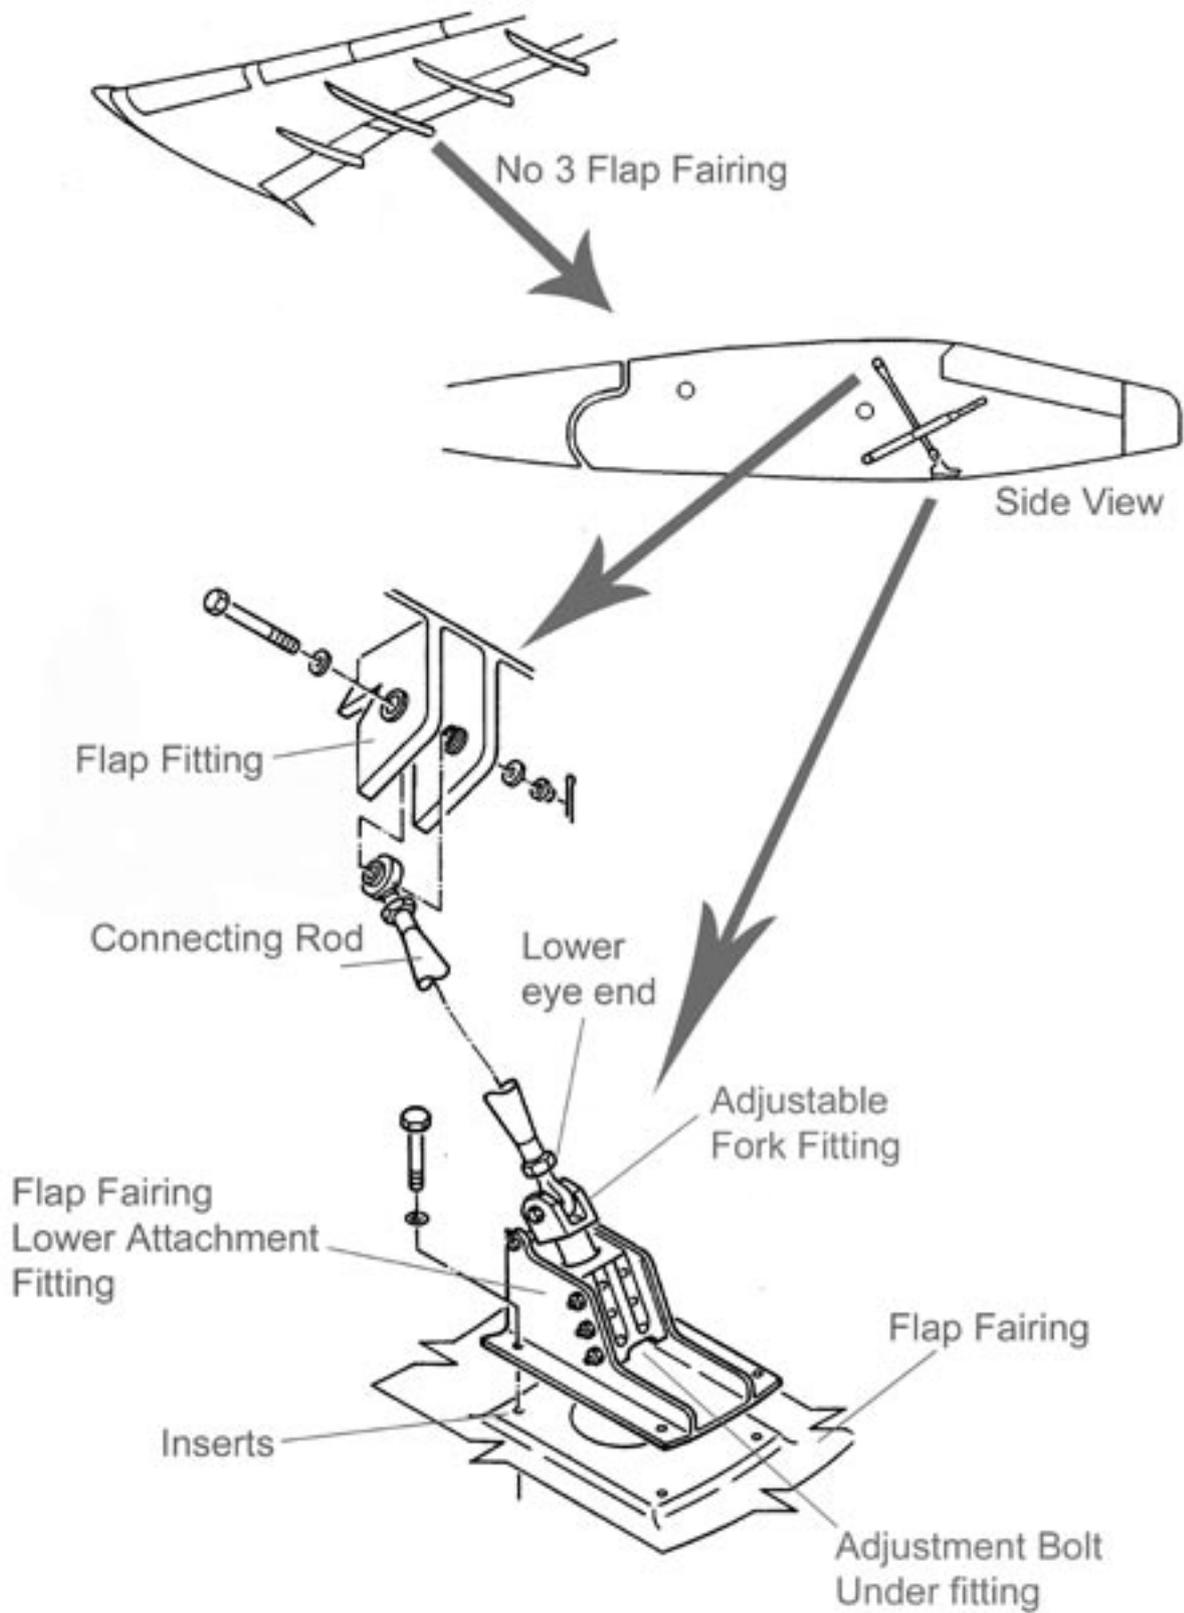
Figure 3

the flap by the use of a connecting rod attached to the underside of the flap at one end, and to a fork fitting on the flap fairing lower attachment fitting, at the other. As the flap moves aft and downward, the connecting rod transfers this motion to the flap track fairing lower attachment fitting, and pushes the rear section of the fairing downward.

Adjustment of the clearance between the fairing and flap is accomplished at the lower fairing attachment fitting. An access hole on the underside of the fairing gives access to a bolt that, in turn, alters the height of the fork fitting to which the connecting rod is attached. This changes the distance between the flap and the fitting. This means of adjustment is designed to preclude the need to perform any adjustment on either of the eye ends on the connecting rod.

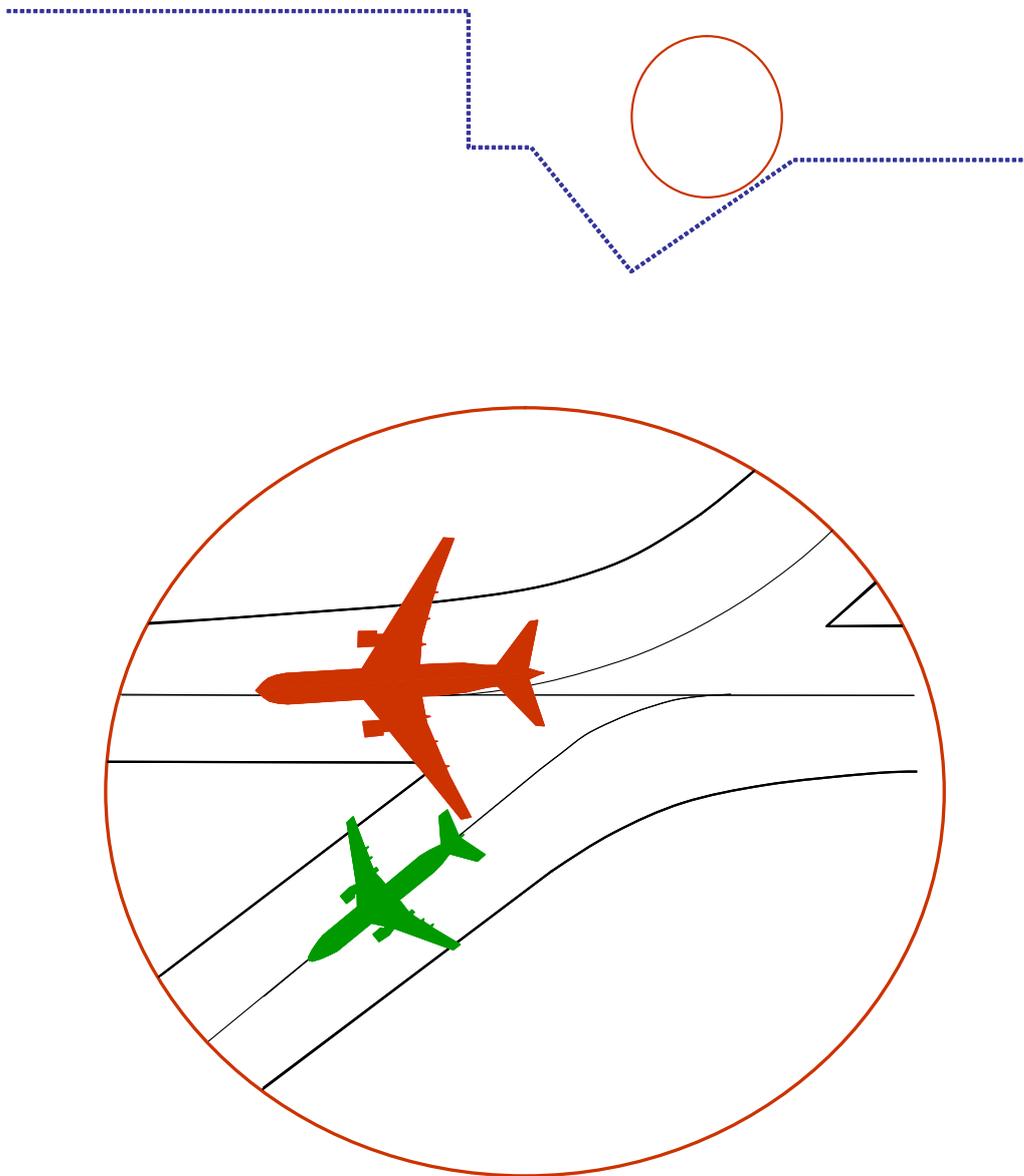
**Figure 2**

The left wing of the taxiing Boeing 767-200 struck the right horizontal stabiliser of the stationary Boeing 737-300. Both aircraft were awaiting departure from Runway 24 Left at Manchester. The investigation concluded that the B767 commander, who bore primary responsibility for collision avoidance, misjudged the available separation

South Side Taxiways and Geometry of Collision

Analysis of the SMR and the nature of the damage to both aircraft indicated that the B767 was on or very close to the marked taxiway centre line during the turn and at the point of collision. The aircraft would therefore have begun to turn away from the B737 when it was still some distance from it. As the turn continued, the B737 would have moved into the commander’s left side window, giving him the impression that his aircraft was moving away from the B737 when the wingtip was still, in fact, moving towards it. As the tail of G-ODSK moved further aft, the task of monitoring it and looking ahead and to the right to follow the taxiway would have become increasingly difficult, with the commander having to monitor two points separated by about 150°. It is not certain that the pilot was physiologically equipped to assess the separation between a wing tip which he could not see and which was behind him, and the tail of

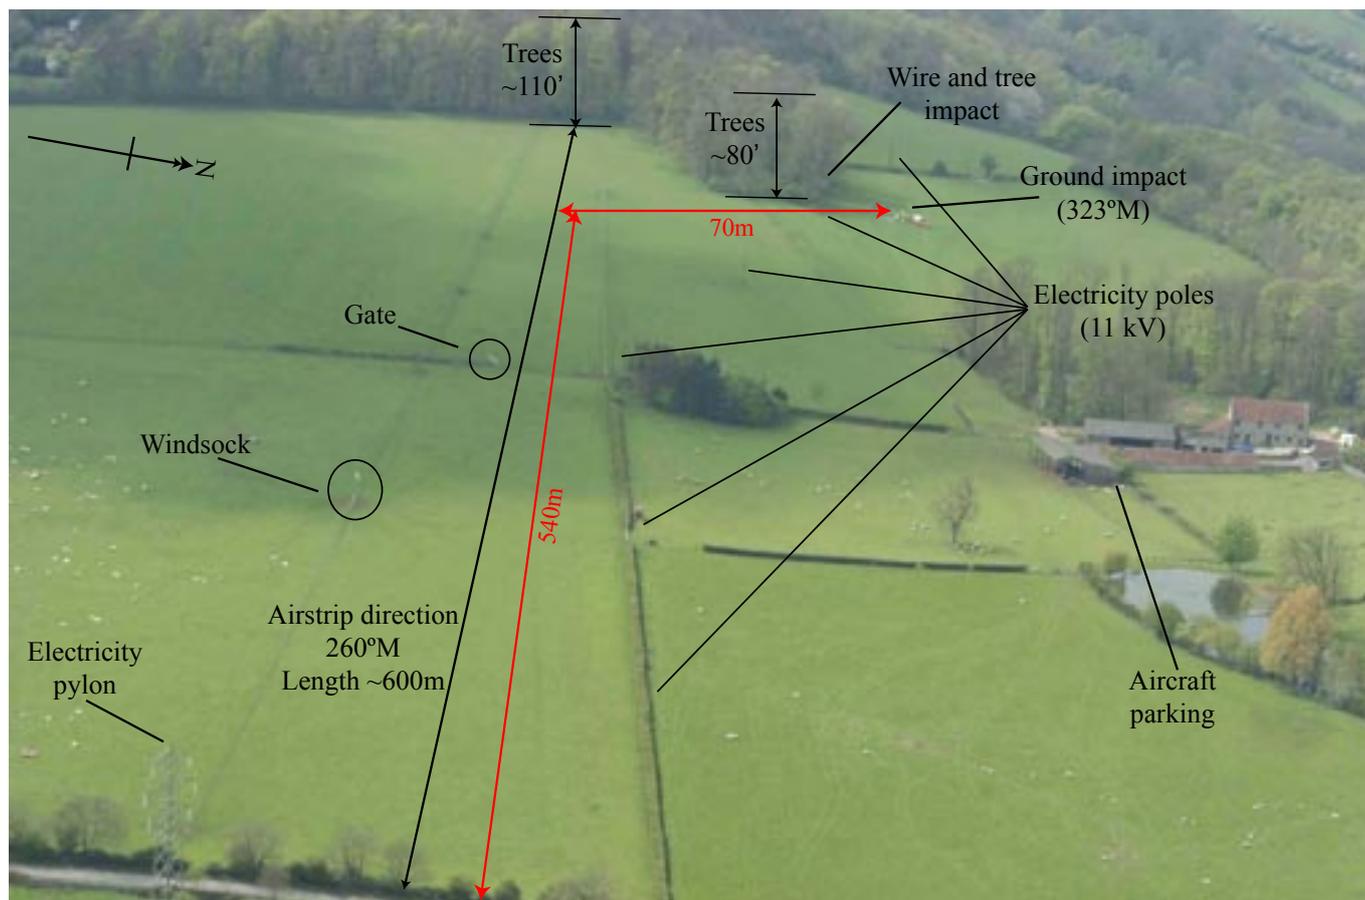
**Figure 1**

The airstrip is orientated 260°/080° and is approximately 600 m long. It is at an altitude of approximately 400 ft amsl and has a level grass surface, which was firm and dry at the time of the accident. The area is normally used for sheep grazing and the grass varied in length from no greater than two inches long in some areas up to four inches long in other areas. To the east, a road with a hedge bounded the end of the airstrip and there were power lines, on pylons, crossing north to south just beyond the airstrip boundary. Further 11 kV power lines, on wooden poles some 27 ft high, were located parallel to the northern edge of the airstrip and these diverged towards the northwest from a point approximately 420 m along the airstrip. At the western edge of the airstrip, there was a line of trees orientated north/ south; these were approximately 110 ft high. Entries in the pilot's log book indicated that G-TARV was the only aircraft that he had operated from the airstrip. He had first flown the aircraft into the airstrip in October 2001. His next recorded flight from the airstrip was in July 2003 and he had subsequently flown out of the airstrip on 15 occasions prior to the accident. There was no evidence that any other aircraft had operated from there. Witnesses commented that the pilot would only takeoff in a westerly direction. Figure 1 shows the layout of the strip in the direction of takeoff on the accident flight.

Airstrip at Naish Farm, 30 April 2005

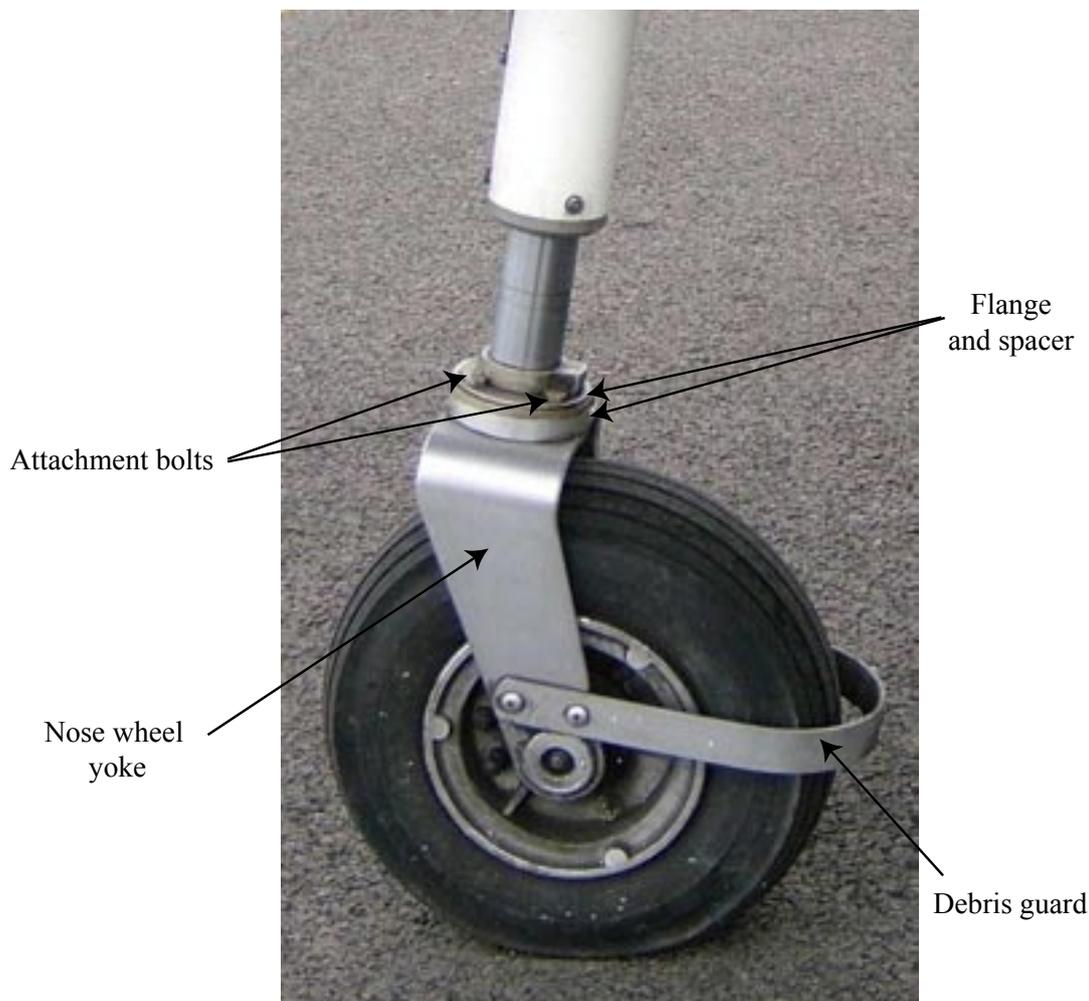
**Figure 1**

Examination of the aircraft showed that the nose wheel mounted in its attachment yoke had become detached from the nose leg (Figure 1). All four bolts that attached the yoke to the nose leg had remained located within the flange and spacer assembly that was fitted at the bottom of the nose leg. Three of the four stiff nuts from the attachment bolts were found scattered between the aircraft and the runway threshold.

All these items were taken to a metallurgical laboratory for examination. It was seen that the debris guard had been deformed to an extent that allowed it to come into contact with the tyre, stopping the wheel from rotating. The tyre was in a very good condition with no evidence of scuffing which would suggest that the wheel was free to rotate at touchdown and that the damage to the debris guard had occurred after the wheel had detached from the aircraft. Evidence of mechanical damage was seen at the forward edge of the nose wheel attachment yoke which is consistent with impact damage with the runway after the wheel had become detached.

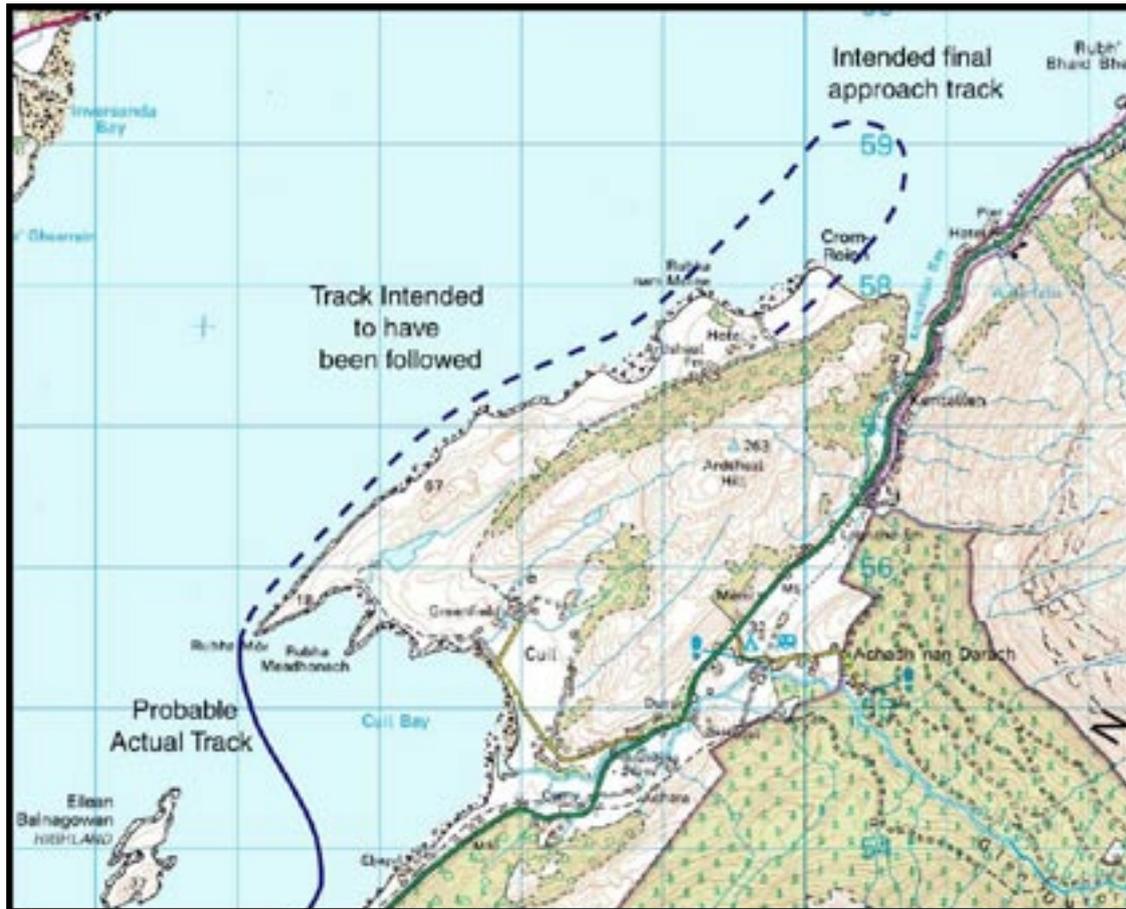
**Figure 1**

He had flown in this area in poor weather before but never at night. Passing Oban Aerodrome the pilot still felt content to continue the flight but he was agitated by the incident with his passenger. A strong tailwind component gave the aircraft a groundspeed of 147 kt, so the pilot prepared his arrival strategy for the landing site on that basis. The pilot provided a sketch map of his intended track and this is shown at Figure 1.

Pilot's intended approach path to landing site

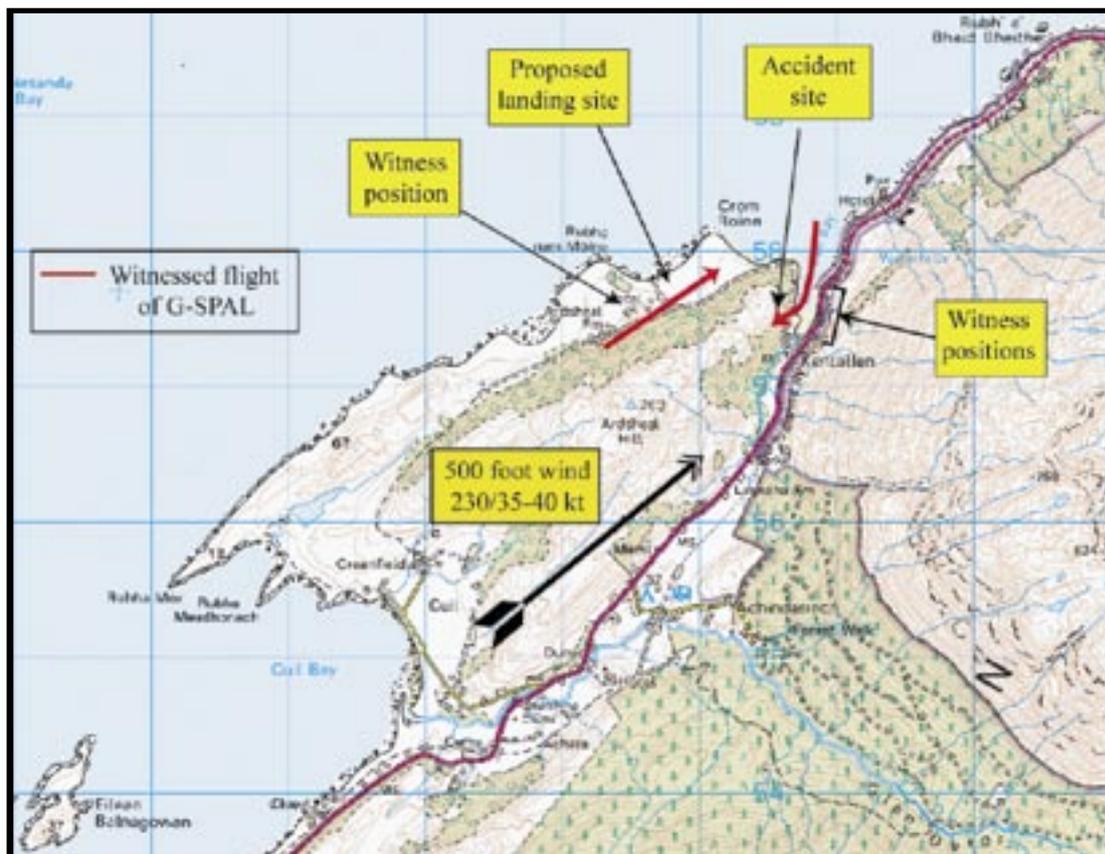
**Figure 2**

The passenger’s wife observed what she believed to be the helicopter, flying between the landing site and Ardsheal Hill (see Figure 2), heading north-east. She had earlier switched on some of the house lights to assist the pilot with locating the landing area, approximately 400 m away. She thought it “seemed to be quite high” and that it was “a bit unusual that the helicopter seemed to be towards Kentallen Bay”. Another witness on the eastern side of Kentallen Bay observed the helicopter’s lights. The helicopter was flying down the Bay, on a steady heading at low height and with a groundspeed of between 20 and 25 mph. Further witnesses reported seeing the helicopter flying at a height similar to Ardsheal Hill in a south-westerly direction along Kentallen Bay. These witnesses, also situated on the eastern side of the Bay, stated that the helicopter “was coming up towards Ardsheal, it would have been from the Onich/Balachulish direction” meaning from the north-east. The only lights seen on the helicopter were two red/purple lights, possibly flashing. The helicopter was then seen to continue down the Bay before turning slowly to the right and impact the hillside. One witness saw it, when directly opposite him, drop about 30 ft followed immediately by flames appearing from the same location. Another witness said the helicopter “travelled diagonally across the Bay in front of our living room window. I then saw it drift into Ardsheal Hill. I did not think it fell from the sky”. She saw flames appear “within 5 to 10 minutes of hitting the hill”.

Witnessed flight path and position of accident site
