## FLYER TO THE PORT MARINE INDUSTRY GROUNDING OF A GENERAL CARGO SHIP

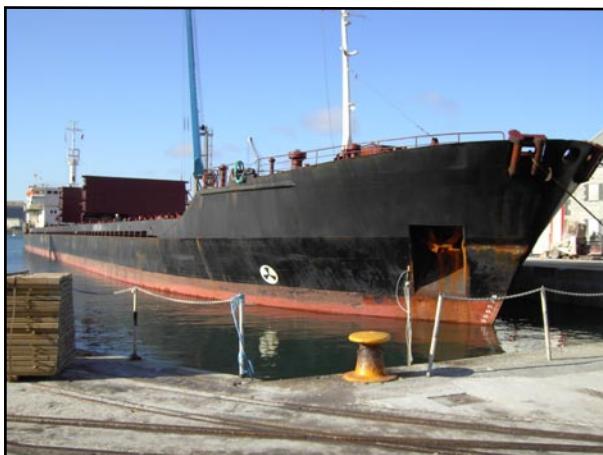
The ship left the Western Channel at the New Ground buoy and set a direct course towards the Cobbler Channel. The engines were slowed down to half ahead, giving a speed of about 4.5 knots. The pilot judged the ship's progress across Plymouth Sound by observing the lights of the buoys around Mallard Shoal, the end of Mount Batten Breakwater and Fisher's Nose. As the ship travelled across the Sound, she was set by the ebb tide to starboard to such an extent that she eventually passed very close to the end of Mount Batten Breakwater while on a heading of due north. To make the turn into Cobbler Channel, the pilot gave increasing amounts of starboard helm, which included the nozzles, until it reached hard to starboard. The head needed to reach  $048.5^\circ$ , and, realising that it was not turning quickly enough, the pilot asked for full ahead on the port engine, full astern on the starboard engine, and the bow thruster to full to starboard. He also ordered the pilot boat to push on the port bow. Although the head began to turn, it was apparent that the ship was closing the shoreline immediately to the east of Fisher's Nose Point, and the pilot asked for full astern on both engines. The ship gently grounded forward on a mixture of mud and sand. However, the falling tide precluded re-flootation attempts, even with the assistance of two tugs, until the tide had risen sufficiently after low water. A diving survey of the hull found that there was no damage to the ship.

- This is not the first time that the power of this class of ship has been underestimated, and groundings while under pilotage have happened before.
- Designed to operate in river currents, these ships are not as manoeuvrable in cross-tidal streams.

- The pilot was not fully prepared for the ship's lack of power and the effect on the course over the ground of cross-tidal currents.
- A leading or directional light at Fisher's Nose would have helped the pilot keep the ship on track while approaching Cobbler Channel and to enter the channel on an ideal heading.

A recommendation has been made to the UK Port Marine Safety Code steering group to consider the safety issues identified by this accident when discussing best practice.
