MAIB

FLYER TO THE SHIPPING INDUSTRY

THOMSON CELEBRATION:

Fatal Accident to Crew Member During Passenger Tender Recovery

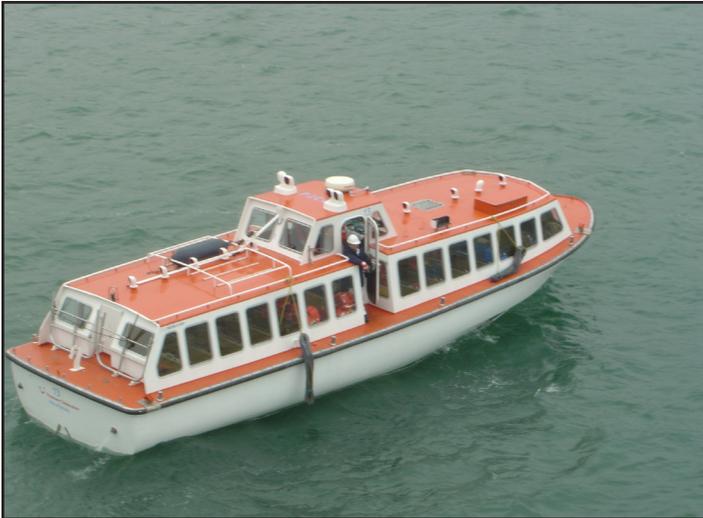
On the afternoon of 26 September 2006, the passenger vessel *Thomson Celebration* prepared to depart from the anchorage at St Peter Port, Guernsey. All passengers had been confirmed on board and the passenger tenders were recalled for recovery. As one of the tenders, *Tender 15*, was being manoeuvred under the falls, it was affected by the 1.5 knot tide and the driver lost full control. A member of the tender's crew became trapped between the ship's side and the tender coach house as the boat came heavily alongside the ship. He received fatal crush injuries to his upper chest.

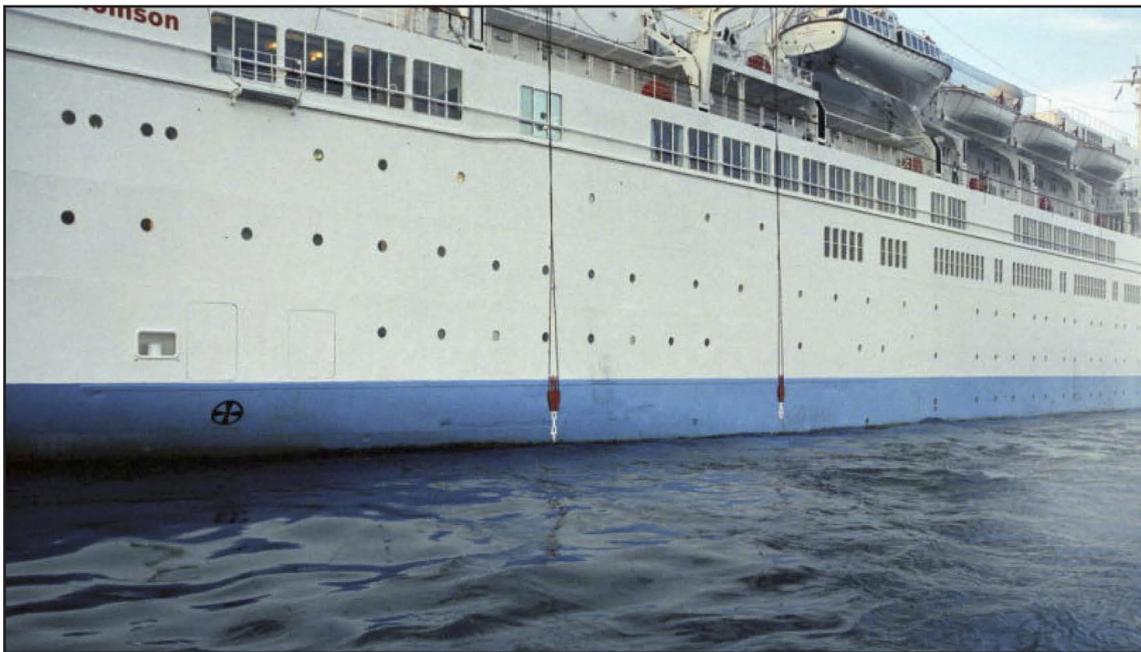
The launch/recovery position for *Tender 15* was in way of the part of the hull where it began to taper away from the parallel side towards the transom. In this position the boat's coach house roof was able to contact the ship's side if the boat accidentally came alongside.

- Where a lifeboat is operated as a passenger tender, great responsibility is placed on the coxswain and crew, and it is reasonable to expect them to be highly skilled in this task. This accident, and a number of others, highlights the need for internationally agreed standards of training and certification of tender coxswains and crews, covering the handling, navigation and general safe operation of lifeboats operating as passenger tenders.
- There is a need for internationally agreed standards for the design and equipping of boats that are used as passenger tenders, given that many carry large numbers of passengers to remote destinations.
- Where feasible, bearing in mind the frequency with which passenger tenders may be deployed and recovered, ship designers should site them in way of the ship's parallel side.
