MARINE ACCIDENT INVESTIGATION BRANCH

## FISHING ACCIDENT FLYER

### Engine room fire started by shrimp boiler

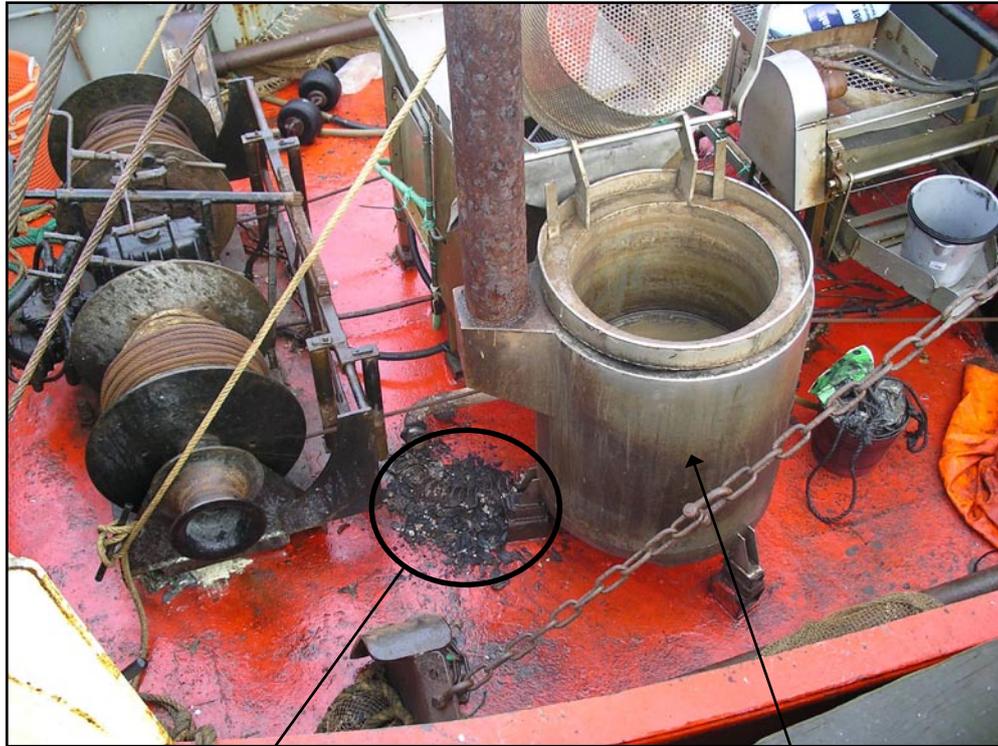
Burnt section of plastic air supply trunking

Shrimp boiler

Whenever the boiler was lit or shut down, it was possible for unburned fuel to enter the air supply line, if the blower was switched off before the fuel was burnt off. Diesel oil was therefore able to accumulate in the air supply trunking, particularly in the corrugations of the plastic connecting pipe. The investigation determined that the boiler flame was drawn into the engine room, through ignition of the oil in the boiler air supply trunking after the boiler air blower was switched off. The air flow reversal was due to the partial vacuum created by the main engine in the engine room because the ventilation system was completely blocked by rust flakes. This resulted in a plastic section of the blower air trunking on the main deck and seating material, and a plastic oil drum in the engine room, catching fire.

- The boiler air blower and fuel pump switches were positioned adjacent to each other, within the same switch moulding. There was nothing to distinguish the two switches so it was very easy to switch off the blower first instead of the fuel pump. When this occurred, it allowed fuel to spill back into the air supply pipework, creating a fire hazard.
