FLYER TO THE SHIPPING INDUSTRY

HILLI:

EXPLOSION DURING BOILER CHEMICAL CLEANING PROCEDURE

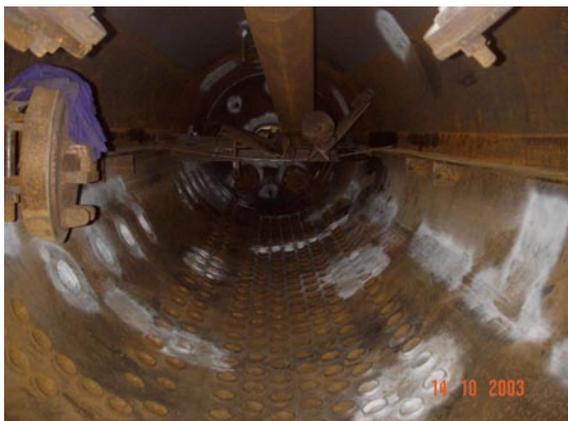
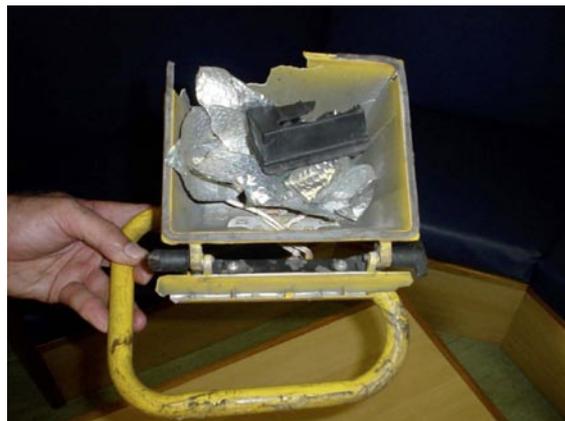
At 2145 the steam drum door was removed, and there was a noticeable suction as air was drawn into the drum from the outside. At 2200 both specialists approached the steam drum door. No tests were conducted to check the steam drum atmosphere for either toxic or flammable gases. One of the specialists picked up a conveniently close, non-intrinsically safe, halogen lamp and placed it just inside the steam drum. A small, blue flame or spark was seen and an explosion immediately followed. The

specialist who had positioned the halogen lamp inside the steam drum was thrown backwards by about 4.5 metres; he was unconscious and had suffered fatal burns. The other specialist was also burnt, but less severely. There was no fire or notable damage to either paintwork or structure.

All the evidence points to an accumulation of hydrogen gas in the steam drum which evolved during the cleaning procedure. As the steam drum door was opened, the air combined with the hydrogen to create a mixture that was within the hydrogen explosive limits. As the halogen lamp was introduced, either the hot lens or bulb, or an electrical spark from the lamp ignited the mixture, causing the explosion.

Had the boiler been properly ventilated, the hydrogen build up would not have occurred. The introduction of the hot halogen lamp into the untested, confined space of the steam drum, which was known to have possibly contained flammable gases, was a serious error of judgment.

- There was an acceptance that the boiler repairer's chosen chemical cleaning specialist was the "expert" and there was little need to evaluate his cleaning procedures. Had risk assessments and a Method Statement been submitted, and there had been greater involvement by ship's and technical staffs and the primary contractor, then it is possible that the need to adopt the well known confined space routines, including testing the steam drum atmosphere for toxic and flammable gases, would have made the accident far less likely.

- The evolution of hydrogen gas during chemical cleans is well known. It is unclear how the boiler was ventilated to ensure that the gases were safely discharged to atmosphere to prevent them building up in the steam drum. However, regular checks to confirm that the ventilation arrangements were unrestricted should have been identified in risk assessments, had they been compiled. Filling the boiler with fresh water, to purge the steam drum of gases before opening would have been a safer option than simply draining it.

- Those involved in repairs should be aware that non-intrinsically safe equipment will often be brought onboard. Indeed, in this case, a large amount of hot work had been authorised through Permit to Work procedures. The lamp had been used to illuminate the hot work areas and did not need to be intrinsically safe. However, a momentary lapse of concentration caused the close at hand lamp to be introduced into the steam drum, with devastating effect. Supervisors, ship's staff and contractors need to be vigilant to these risks.
