MARINE ACCIDENT INVESTIGATION BRANCH

FISHING ACCIDENT FLYER

Fatigue - take it seriously!

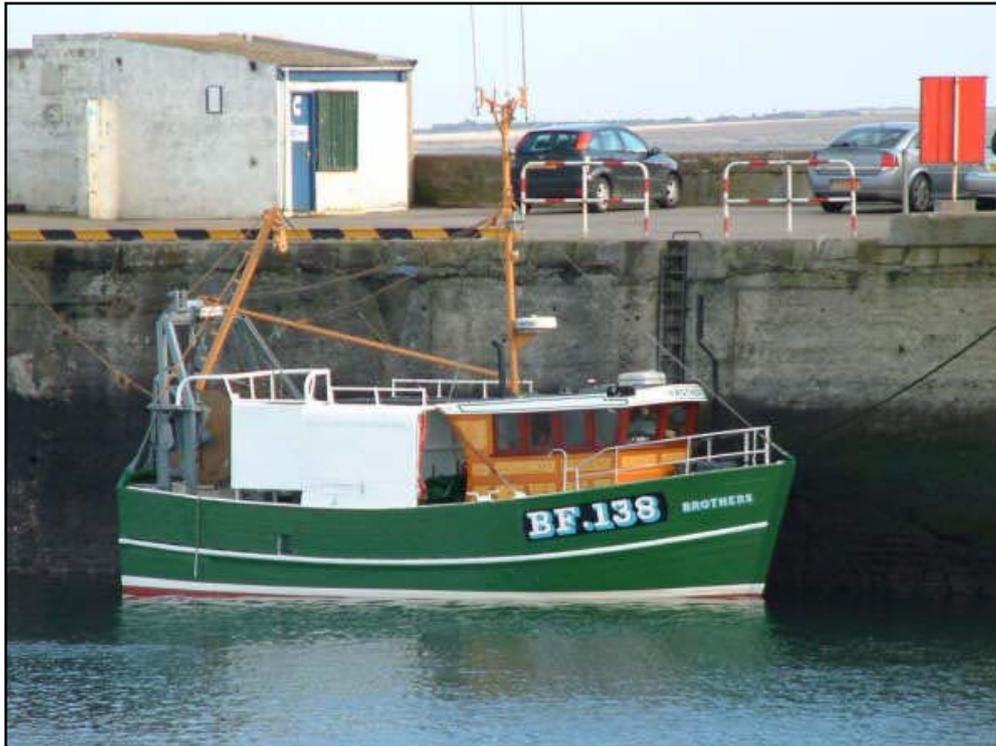
The Banff registered stern trawler *Brothers* BF138 sailed from Gairloch with a skipper and one crew at about 0225 on the morning of 1 June 2006 intending to fish for prawns in the Trodday fishing grounds. At about 0520 the vessel grounded and then sank off Eilean Trodday, a small uninhabited island off the north coast of Skye. No "Mayday" message had been broadcast.

The evidence indicates that the vessel probably grounded due to one of the crew falling asleep in the wheelhouse, which allowed the vessel to continue on autopilot past her intended fishing grounds and onto the rocky shore. Both crew would have been suffering the effects of fatigue brought on by a number of long days at work, with only short, broken sleep periods. Both crew had also drunk some alcohol before the vessel left the harbour.
