MARINE ACCIDENT INVESTIGATION BRANCH

FISHING ACCIDENT FLYER

Meridian: Catastrophic loss - 26 October 2006

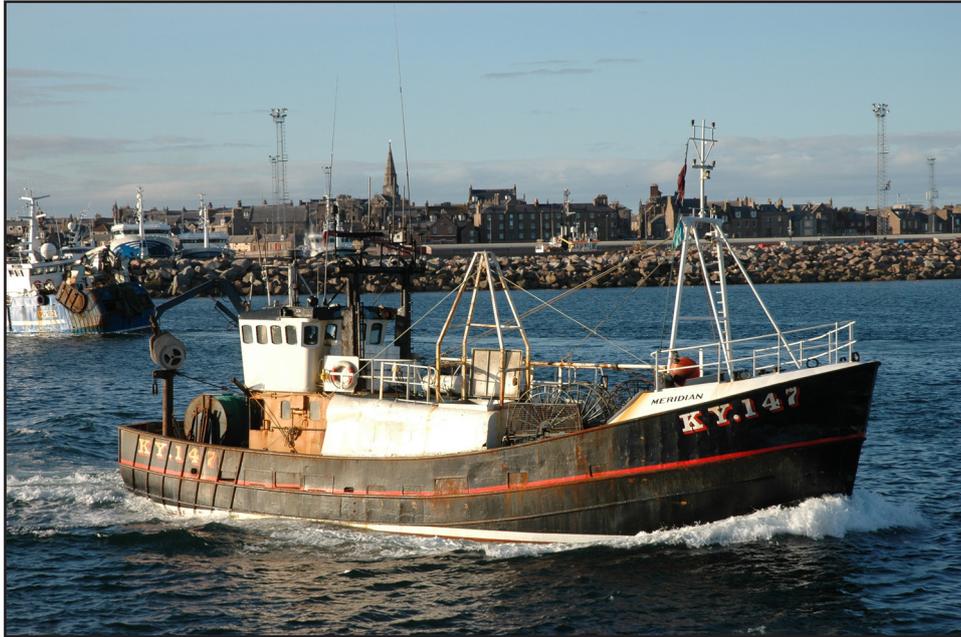
Meridian KY147, a 22.63m trawler, left Aberdeen on 11 October 2006 with four crew members onboard, and for the next 15 days she performed guard ship duties at the Blane Development Oilfield, 160 miles off the coast.
