MARINE ACCIDENT INVESTIGATION BRANCH

FLYER TO THE SHIPPING INDUSTRY

SICHEM MELBOURNE

CONTACT WITH OIL REFINERY MOORING STRUCTURES

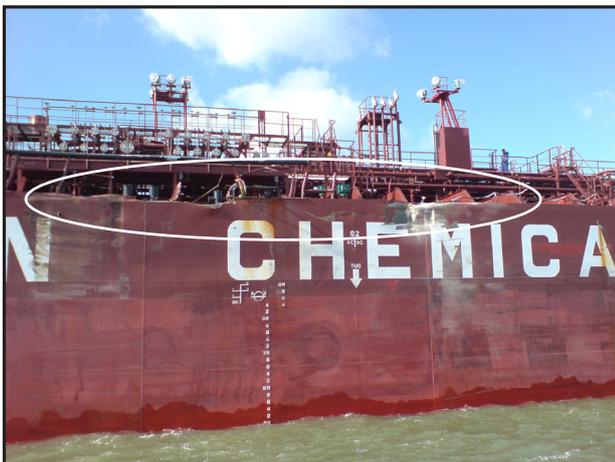
Damage to *Sichem Melbourne*'s
sheer strake and deck edge

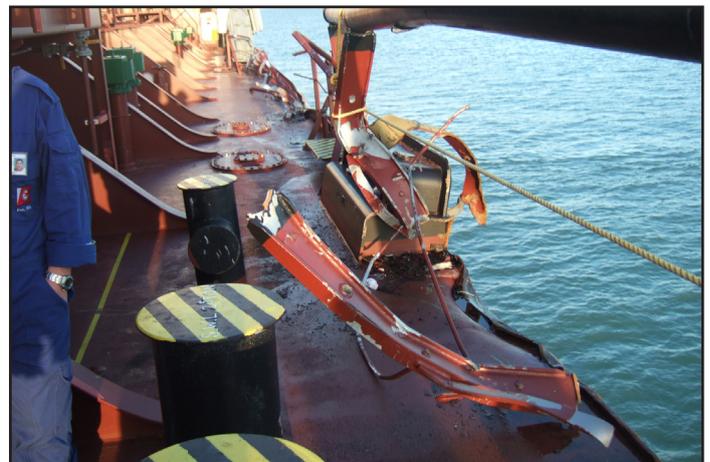
Deck edge damage

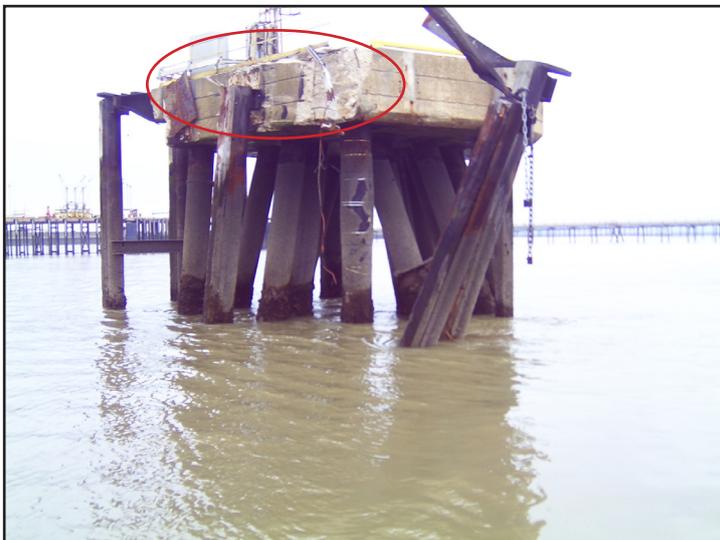
On commencement of departure, the pilot gave instructions to come ahead on the forward springs with hard port rudder, intending to create a wedge of water between the ship and the jetty, before coming astern. When a small angle had developed between the ship's stern and the jetty the master applied bow thrust to starboard to prevent the vessel leaning against the jetty; this caused the pilot to request the engine to be stopped to take the strain off the forward springs. It was the master's understanding, at this point, that the pilot was now ready for the bow springs to be let go and so instructed, in Russian, the springs to be cast off, allowing the ship to move forward before the current. Combined effects of increased starboard bow thrust and wind on the starboard quarter caused the ship's port quarter to fall back and scour the jetty, before she cleared the structure. Once clear of the jetty, the pilot attempted to retrieve his original plan of getting the stern outwards by applying port wheel and more ahead power. The master, however, was under the impression that the pilot was trying to lift the vessel bodily into the river, and applied more starboard thrust to assist. The following tidal stream prevented transverse lifting of the ship and she was carried down onto other mooring structures, causing considerable damage as she did so.

Damage to mooring structure
