MARINE ACCIDENT INVESTIGATION BRANCH

FLYER TO THE SHIPPING INDUSTRY

Fatal accident to a crew member during mooring operations

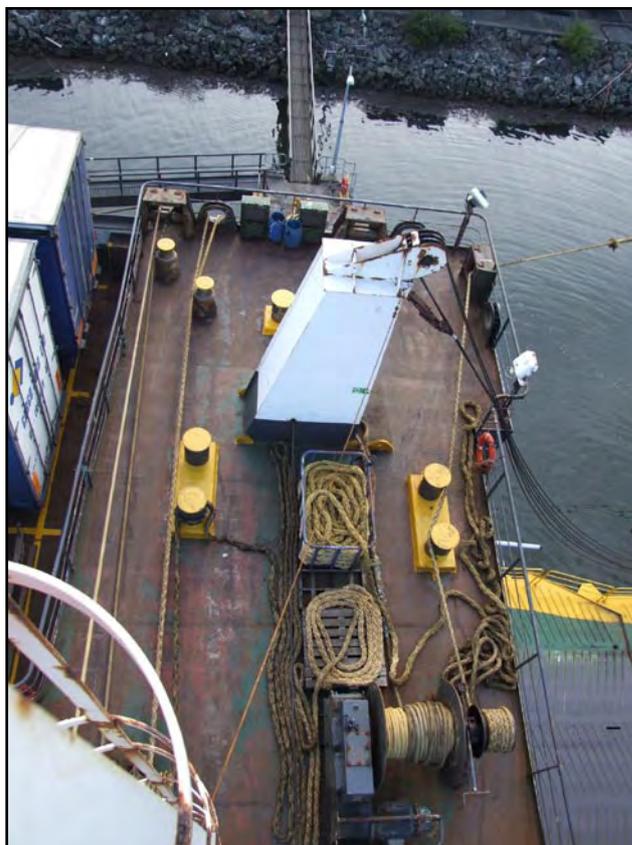
The stern line was made up of a polypropylene length from the ship, which connected to a High Modulus Polyethylene (HMPE) line permanently secured ashore. The difference in elasticity of the two lines meant that the shorter, more elastic, polypropylene length was subject to material fatigue effects from the constant cycle of stretching and release. It was further degraded by exposure to ultraviolet (UV) radiation from sunlight. Subsequent tests revealed its breaking load to have reduced from 60, to some 35 tonnes.

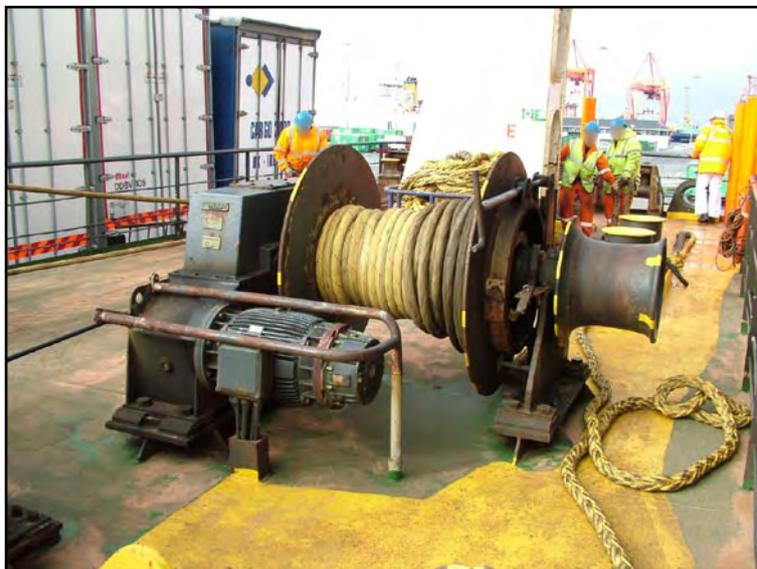
The electric mooring winch used for the stern line had a stated nominal load of 12.7 tonnes, and it was not immediately clear how this could have parted the rope, even in its degraded state. However, tests showed that the winch was capable of pulling up to 37 tonnes for a short period on first starting. There were no indications, either on the winch markings or in the manufacturer's manual, that the starting load was so much greater than the running load, nor was there any reference to the Minimum Breaking Load (MBL) of the rope to be used on the winch.
