MARINE ACCIDENT INVESTIGATION BRANCH

## FLYER TO THE SHIPPING INDUSTRY *STENA VOYAGER:* THE SHIFT OF AN ARTICULATED ROAD TANKER 28 JANUARY 2009

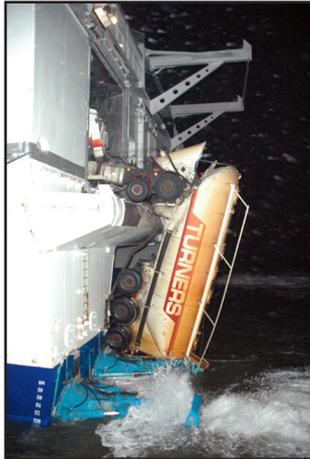
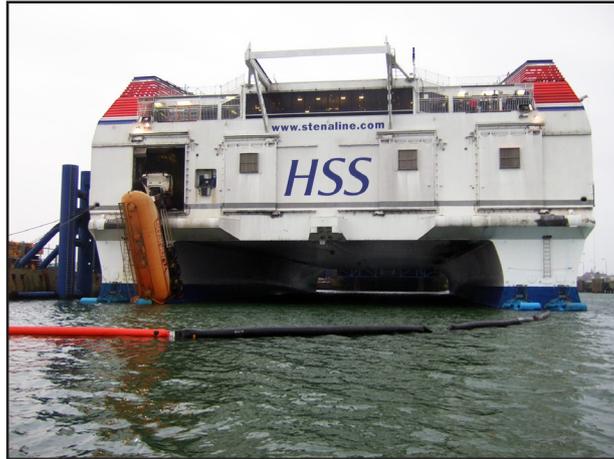
An articulated road tanker crashed through a stern door of the high speed service 1500 (HSS 1500) vessel *Stena Voyager* shortly after the ferry had commenced a scheduled crossing from Stranraer, Scotland to Belfast, Northern Ireland. The vehicle's semi-trailer came to rest on the vessel's port water jet units; its tractor unit remained on the vehicle deck. The ferry was quickly stopped and her crew were able to make the vehicle secure before returning to Stranraer.

Contrary to instructions posted on the vehicle deck, the vehicle's parking brakes had not been applied and it had been left out of gear. Although the vehicle had been lashed to the deck and its rear wheels chocked, this failed to stop it from rolling backwards as *Stena Voyager* accelerated. As neither the lashing points on the ferry's deck nor those fitted to the vehicle accorded with the applicable international and national codes of practice, the crew were unable to lash the vehicle as required by the ferry's cargo securing manual. The lashing straps were also found to be of insufficient strength and post accident tests strongly indicate that the chocks were not correctly positioned.
