MARINE ACCIDENT INVESTIGATION BRANCH

FLYER TO THE SHIPPING INDUSTRY

EUROVOYAGER:

MAJOR INJURY TO A FITTER TRAPPED IN A WATERTIGHT DOOR 3 NOVEMBER 2008

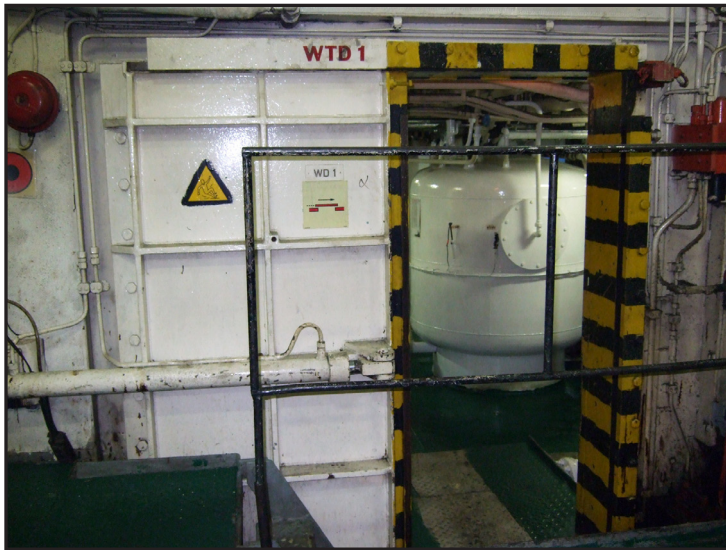
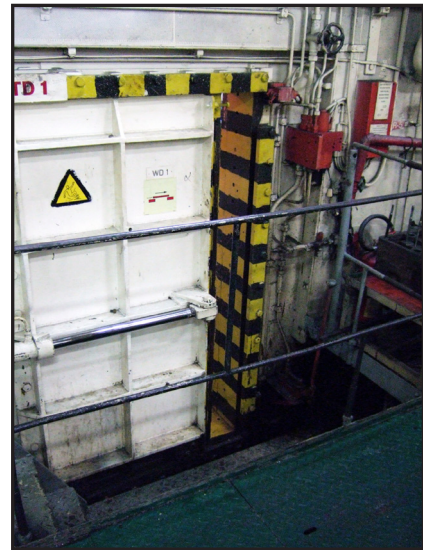
While the passenger ferry *Eurovoyager* was en-route to Ramsgate, UK, from Ostend, Belgium, an engine fitter was trapped for almost 4 minutes in a hydraulically operated steel watertight door in the engine room. He sustained major crush injuries and was airlifted to a London hospital shortly after the ferry arrived in Ramsgate.

Following the accident, tests on the doors highlighted that the watertight door in which the fitter was trapped, closed in 7 seconds. VDR data showed that many of the crew did not fully open the watertight doors when passing through. It also showed that when the watertight doors were operating in local control, a number of frequently used doors were left open when the ferry was on passage.

- The closure rate of the watertight door was almost three times as fast as allowed by current SOLAS regulations. **Watertight doors closure rates should be periodically checked, particularly on older vessels, to ensure that crew are not exposed to unnecessary risk.**

- There was very little signage by the door advising the crew of its safe operation, and the labelling on the door control panel on the bridge was potentially confusing. **Notices and posters showing the correct transit procedures to be followed and the dangers and consequences of entrapment, serve as timely reminders before passing through a watertight door. The labelling on any control panel should be clear and unambiguous.**
